Southern Utah Fuel Company

**ANNUAL MINESITE SEDIMENTATION POND
CERTIFICATION -- 1996**

**ANNUAL WASTE ROCK SEDIMENTATION POND
CERTIFICATION -- 1996**

**ANNUAL WASTE ROCK DISPOSAL SITE
CERTIFICATION -- 1996**

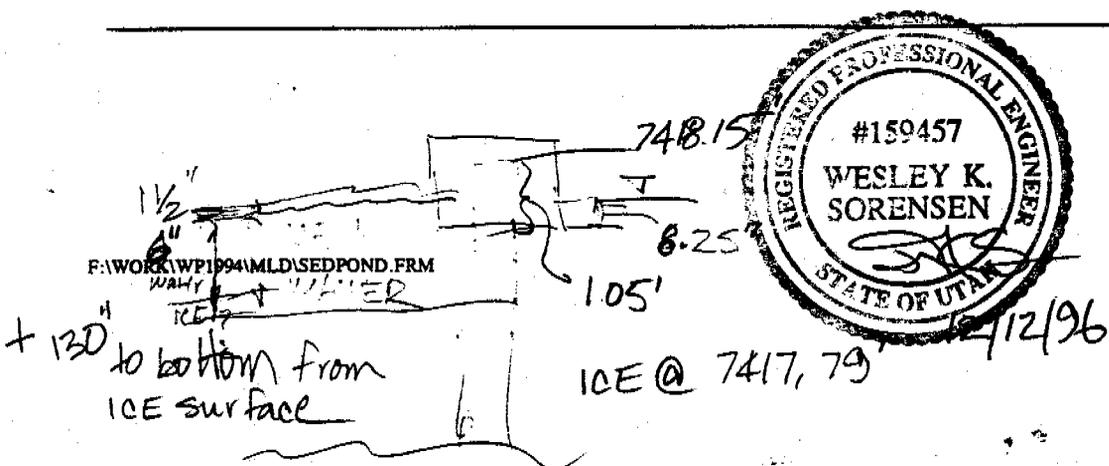
Minesite Sediment Pond ^{Annual}~~Quarterly~~ Inspection Report

8. Weir level Yes No

9. Other Comments

Sun shining. Thawing conditions. Bare slopes
Some snow on top.

The water in the pond was froze during the inspection at and elevation of 7417.79 ft, which is 0.36 ft below the standpipe spillway elevation. An additional 0.002 acre-ft of storage volume was available in the pond above the current water level. The sediment level in the pond was at less than 7407 ft, which was below the 60% sediment level (7408.9 ft). A total of 1.6 acre-ft of storage volume is available above the 7407 ft level.

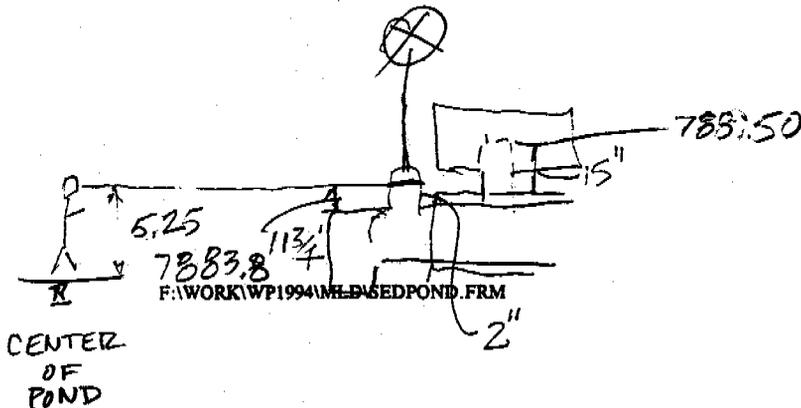
Rock Waste Sediment Pond ^{Annual} ~~Quarterly~~ Inspection Report

NO EROSION

A small amount of water was present in the pond, about 0.1 ft in the south end consisting mostly of ice. The sediment level near the center of the pond was at 7883.7 ft. The 60% sediment level for the pond is at 7885.15 ft. About 0.72 acre-ft of storage volume was available in the pond. No sediment or water was observed in the decant impoundment.
