**Canyon Fuel Company, LLC**  
SUFCO Mine  
397 South 800 West  
Salina, Utah 84654  
(801) 637-4880 Fax: (801) 636-4499

Re: Annual Report for Canyon Fuel Company LLC, SUFCO Coal Mine

**ANNUAL MINESITE SEDIMENTATION POND  
CERTIFICATION -- 1997**

Minesite Sediment Pond <sup>Annual</sup> Quarterly Inspection Report

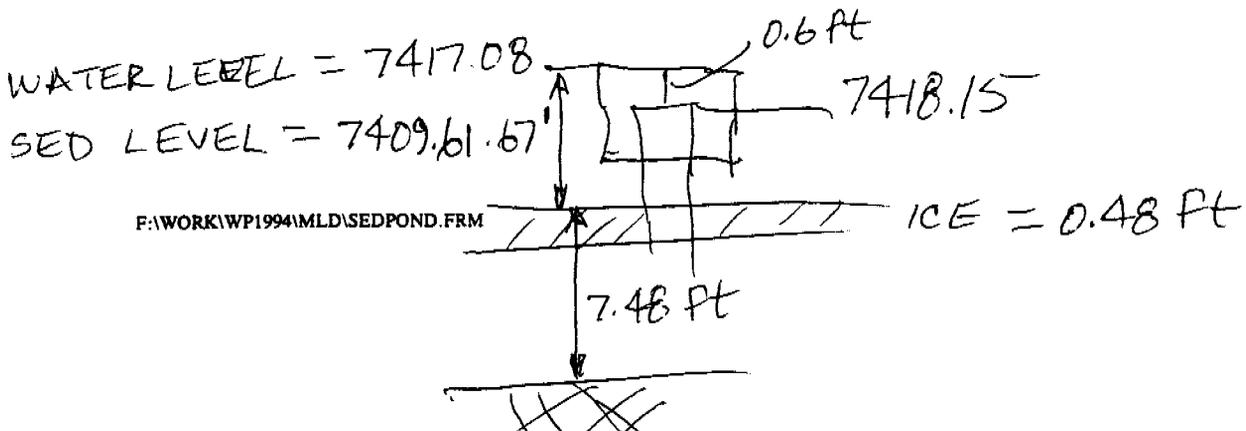
9. Other Comments

Barc slopes, Sun shining 30°F

The water in the pond was froze during the inspection at and elevation of 7417.08 ft, which is 1.07 ft below the standpipe spillway elevation. An additional 0.226 acre-ft of storage volume was available in the pond above the current water level. The sediment level in the pond was at 7409.61, which is above the 60% sediment level (7408.9 ft). A total of 0.081 acre-ft of sediment storage volume is available between the 7409.61 ft level and the maximum sediment level of 7411.4.

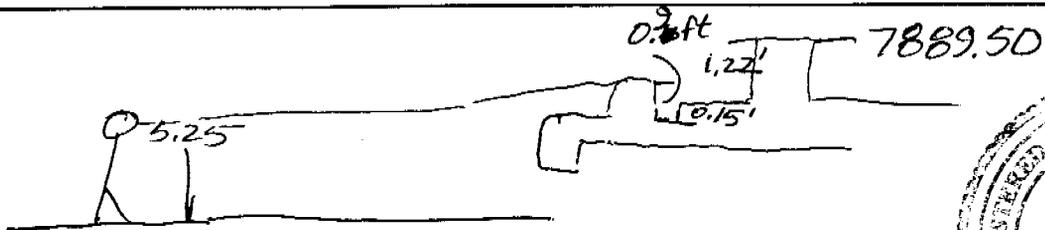
8. Other Comments

Decant pond okay, structurally sound, no erosion, deer & elk in area
