RE: East Fork of Box Canyon Rim Subsidence Crack Repair
Proposed Scope of Work

SUBSIDENCE CRACK REPAIR PROJECT EAST FORK OF BOX CANYON RIM

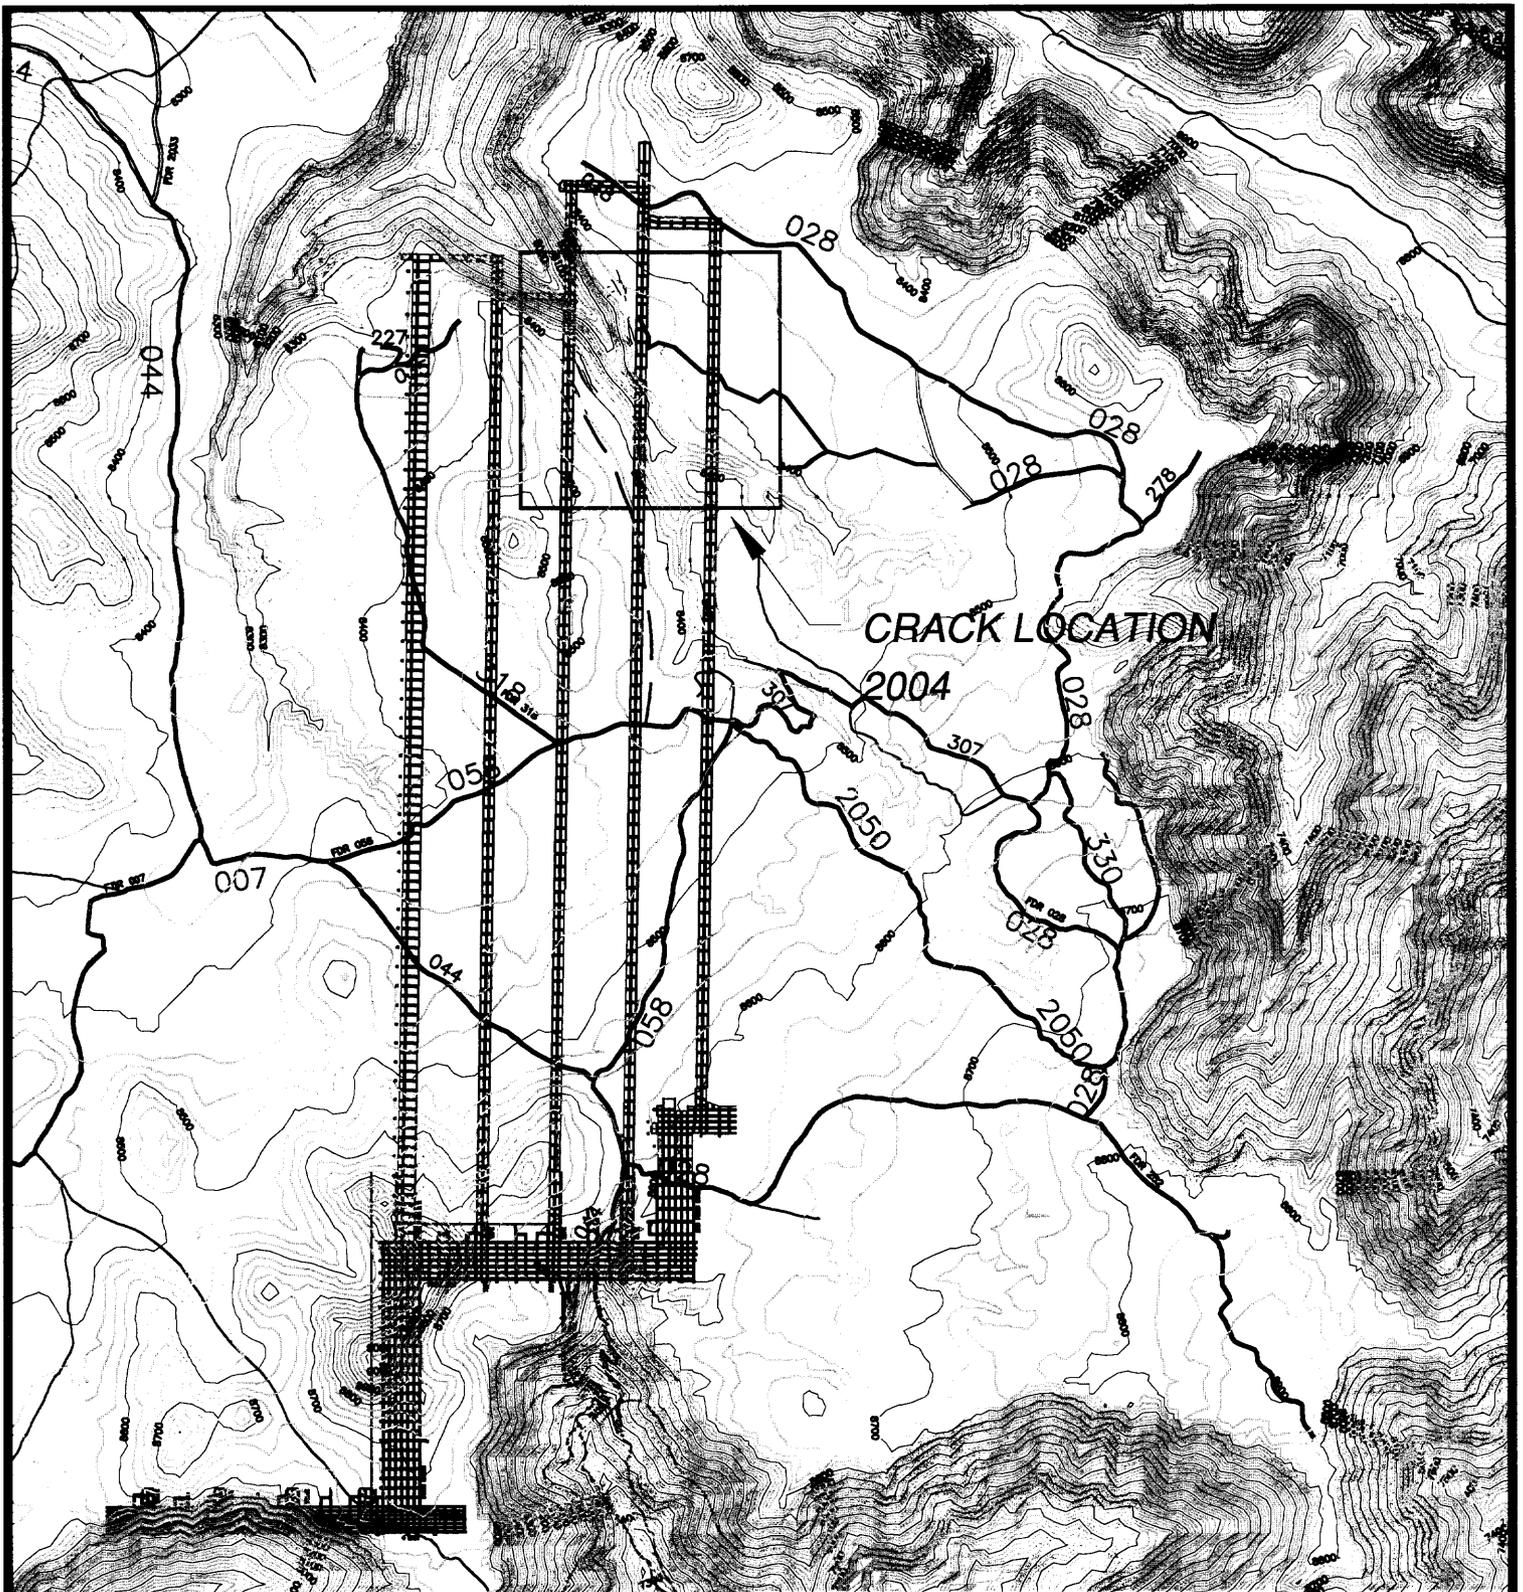
MAP: FIGURE 1

EAST FORK BOX CANYON
LOCATION OF SUBSIDENCE CRACKS

A map of the location of the cracks has been attached to this project description. Access to the site will be on Forest Roads 007, 028, 044, and 058. Use of these roads by Canyon Fuel Company for drilling access, with the exception of 058, has been previously granted under existing Road Use Permit 0410-02-08 (Pines/Muddy). Additional access will be on unimproved nonservice four wheel tracks that branch off Roads 058 and 028. These tracks will not be improved during the subsidence crack repair process.

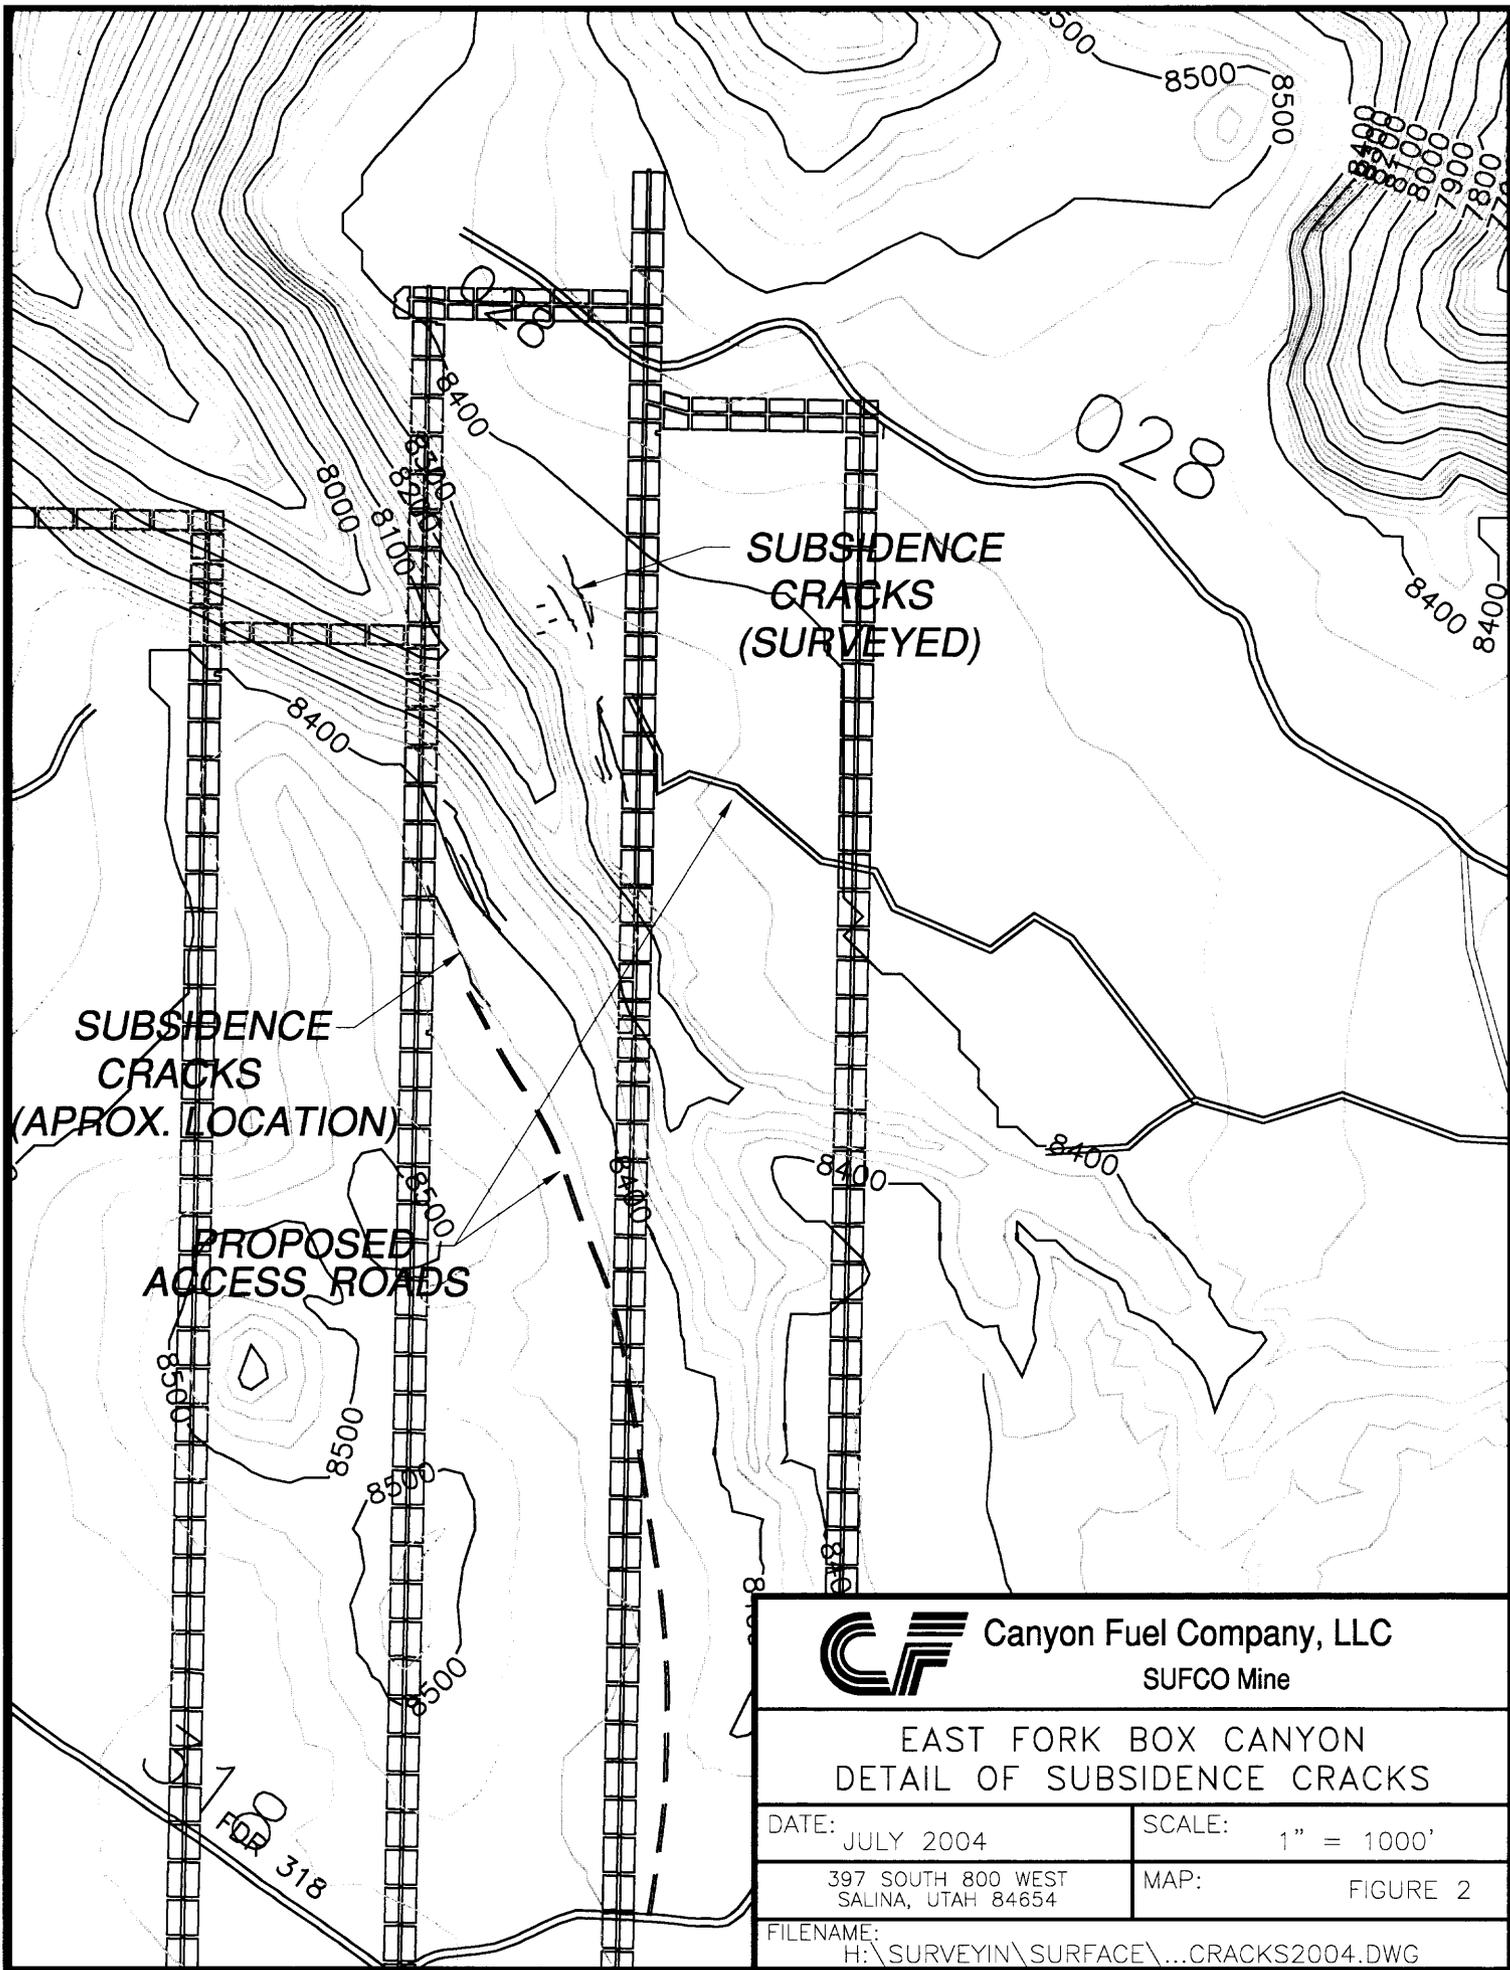
DATE: JULY 2004	SCALE: 1" = 1000'
397 SOUTH 800 WEST SALINA, UTAH 84654	MAP: FIGURE 2
FILENAME: H:\SURVEYIN\SURFACE\...CRACKS2004.DWG

SUBSIDENCE
CRACKS
(SURVEYED)

SUBSIDENCE
CRACKS
(APPROX. LOCATION)

EAST FORK BOX CANYON
DETAIL OF SUBSIDENCE CRACKS
