SUBJECT: Permit - C/007/001 White Oak Mines
Updated Whisky Creek Mine Projections

RE: Whiskey Creek Mine Topsoil Salvage

Whiskey Creek Mine Topsoil Salvage

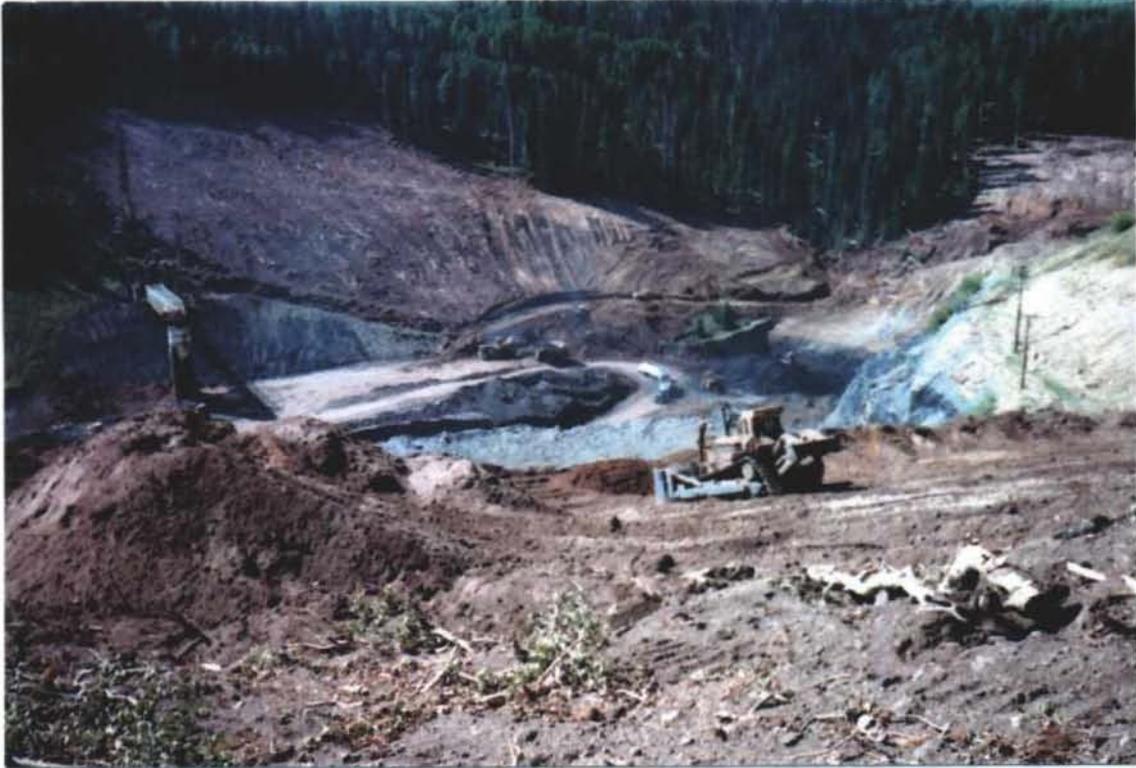
Photo WCM-SI

An overview of the Whiskey Creek Mine from the site being cleared on the north side (south-facing slope) looking southwest. About half of the cleared area on the north-facing slope has had topsoil salvaged.
(07/24/02)

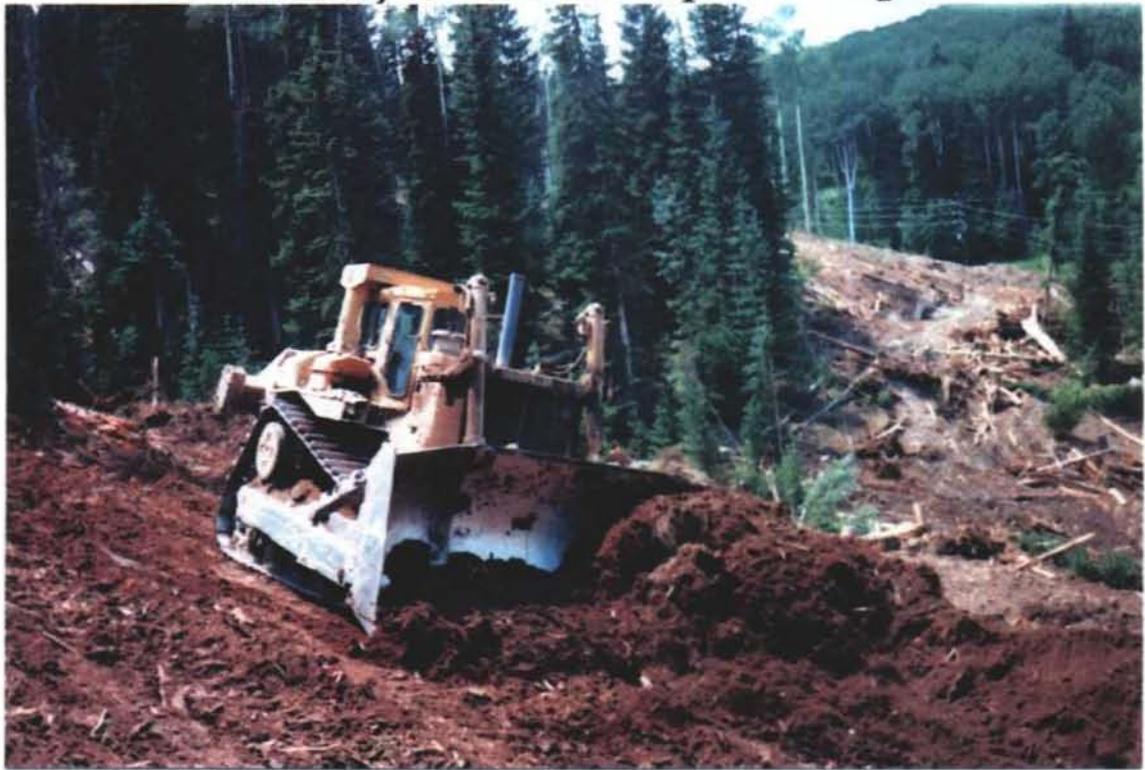
Photo WCM-S2
Removal of topsoil on the north facing slope.
(07/16/02)

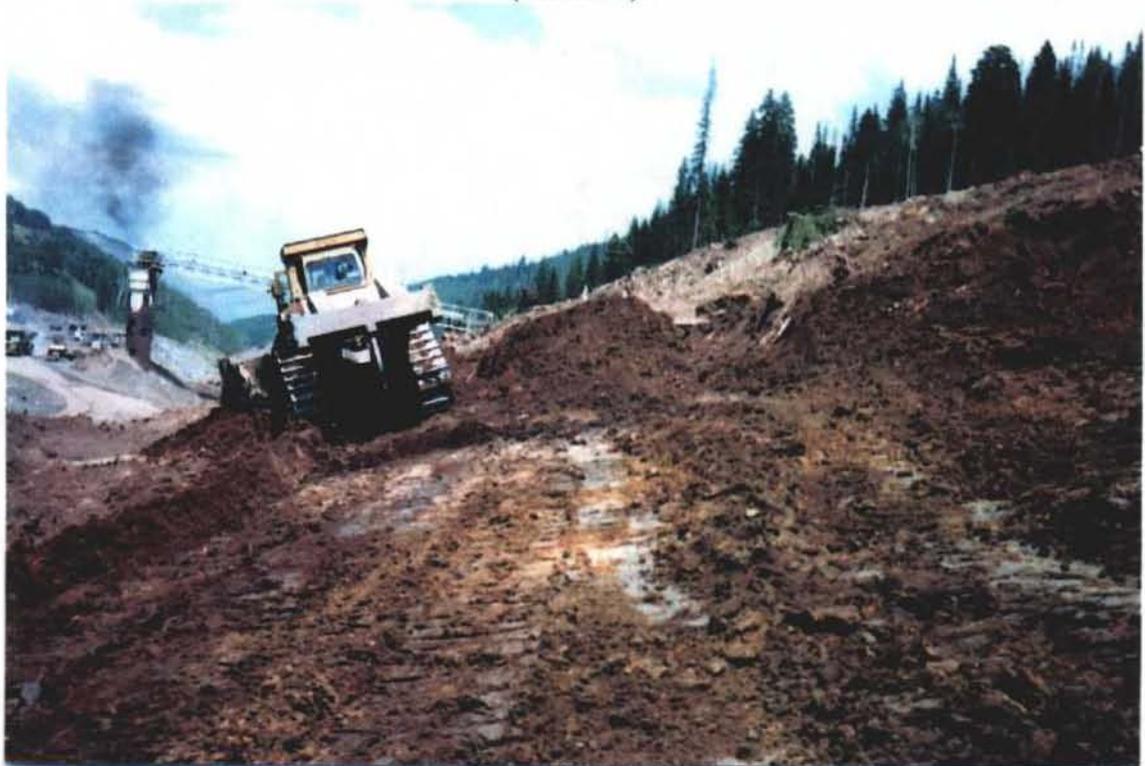
Photo WCM-S3
Yellowish-brown subsoil exposed during topsoil salvage. Some mixing of subsoil material with the topsoil occurs when removing as much topsoil as possible.

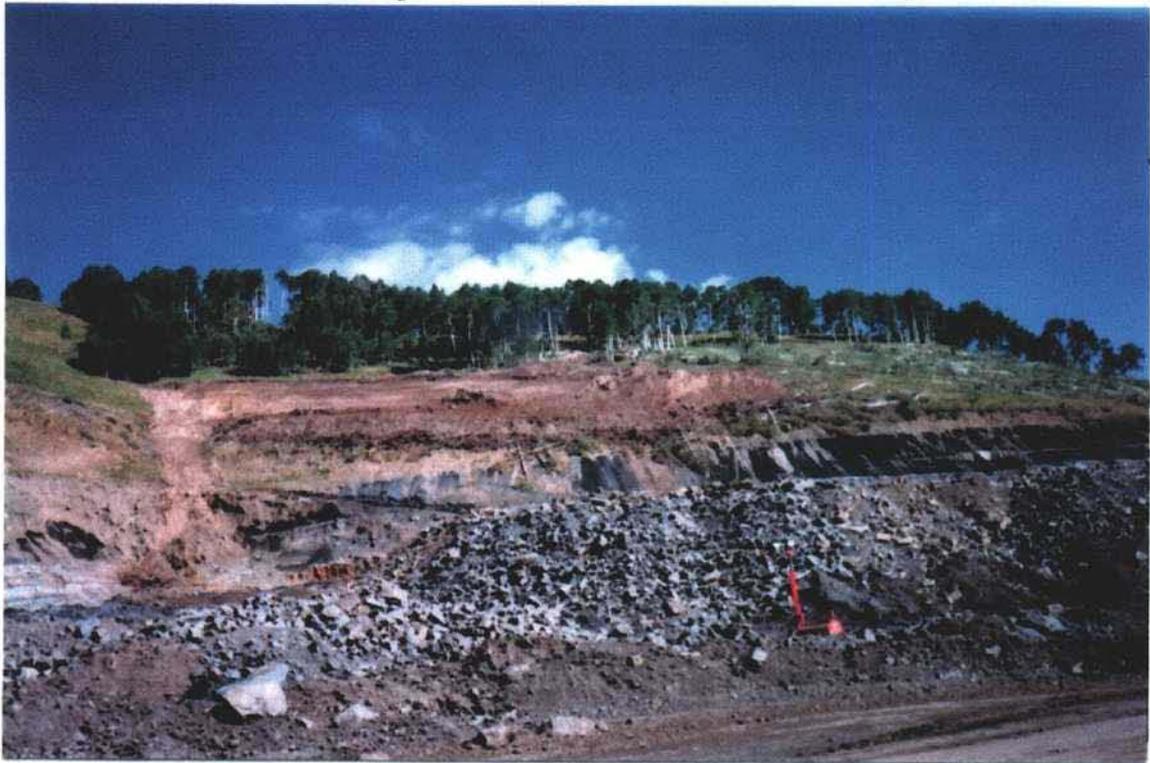
Photo WCM-S4

A view showing the south-facing slope and piling of topsoil.

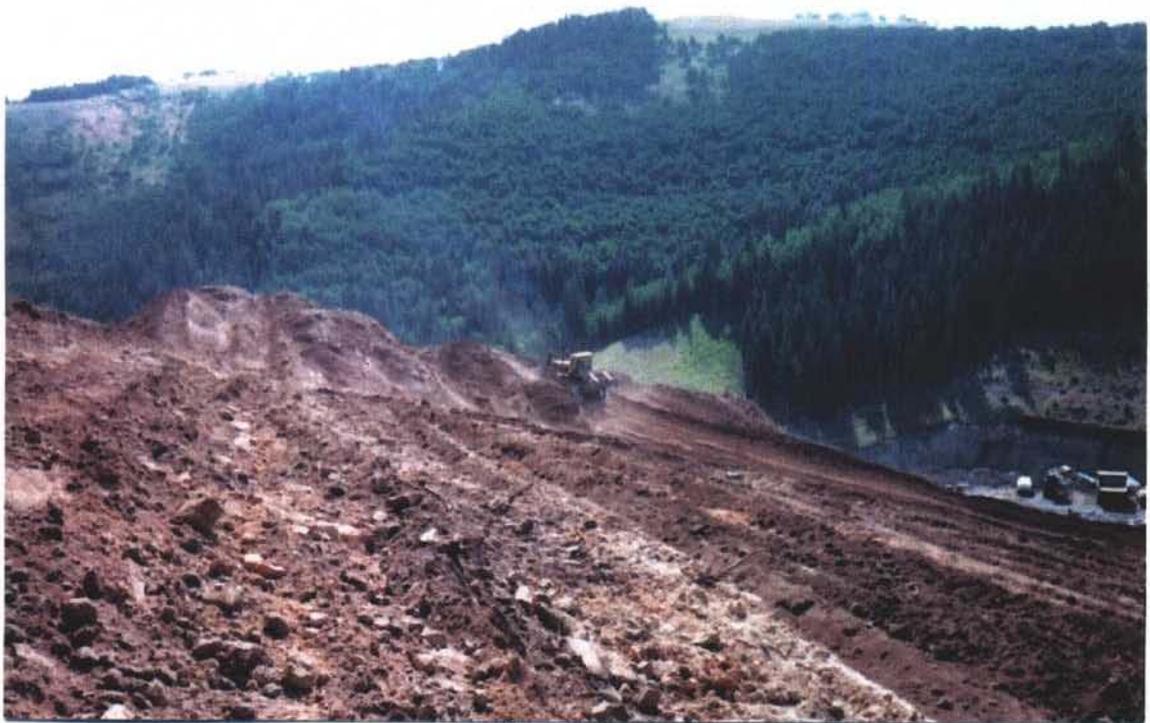
Photo WCM-S5

Subsoil Exposed on the south-facing slope is yellowish-brown and cobbly at this site. About 30 inches of topsoil has been removed and piled.

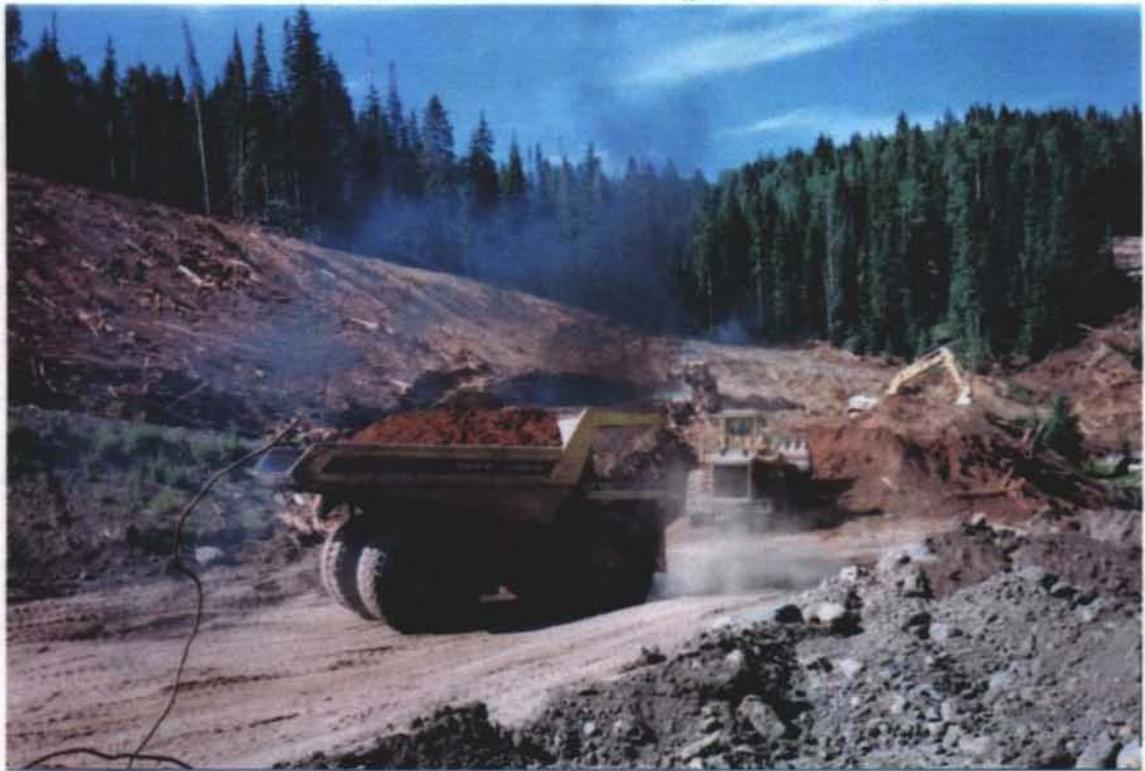
Photo WCM-S6

Topsoil being loaded and hauled to the topsoil storage pile at the tippie site.

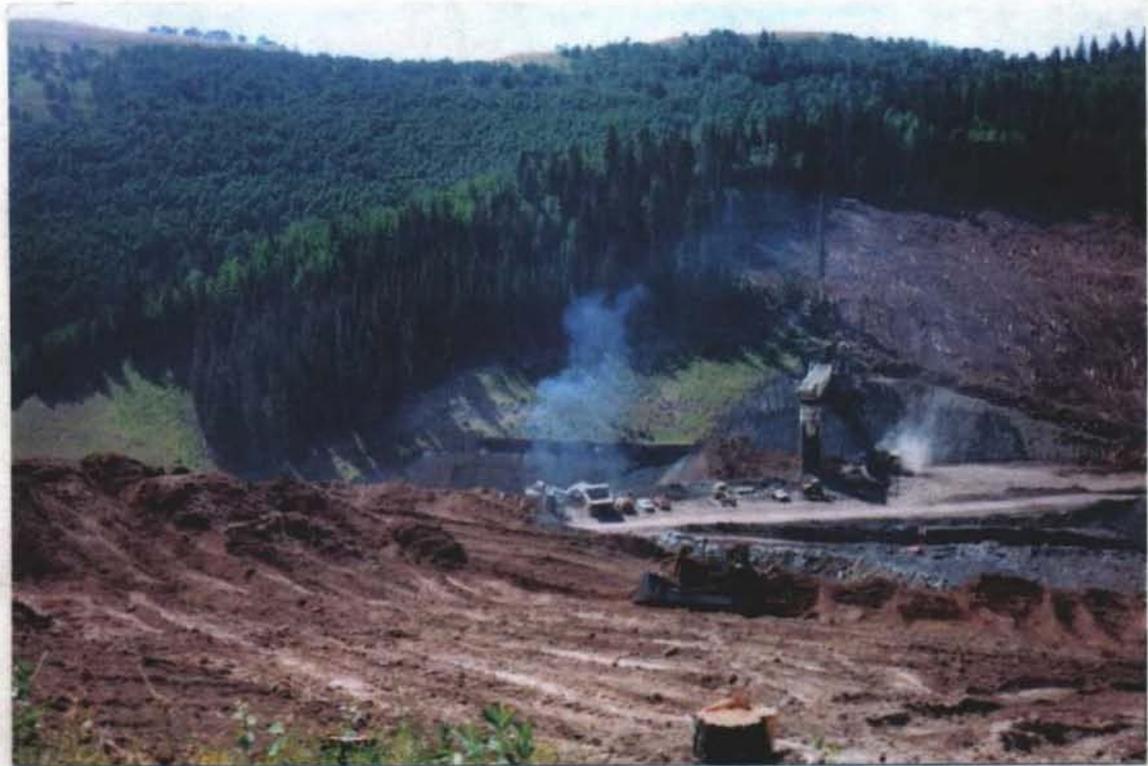
Photo WCM-S7

Topsoil from the north-facing slope is being stored near the tippie. The foreground shows topsoil being removed and piled on the south-facing slope.
