## Inspection Report

Site: **WHITE OAK MINE**

White Oak Inspection July 29, 2010  
Inspection Report #2443  
Attachment

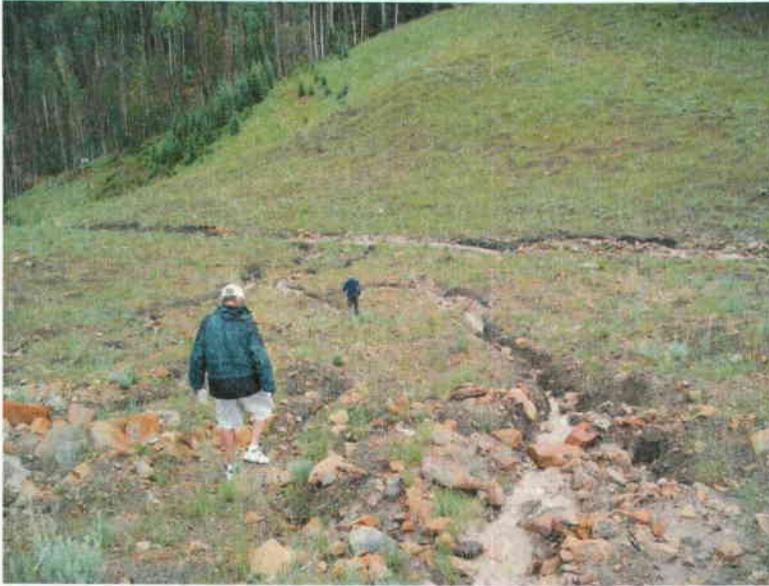
Upon arrival at the White Oak site, flow was observed in the Whiskey Creek channel and in numerous gullies on the south facing slope. The water was brown and highly turbid with suspended sediment. In the Whiskey Creek channel, water was observed flowing under torn geofabric. Flows at the site dissipated quickly after the precipitation ceased, and no flow was observed in the channel at the completion of the inspection.

Water in gullies.

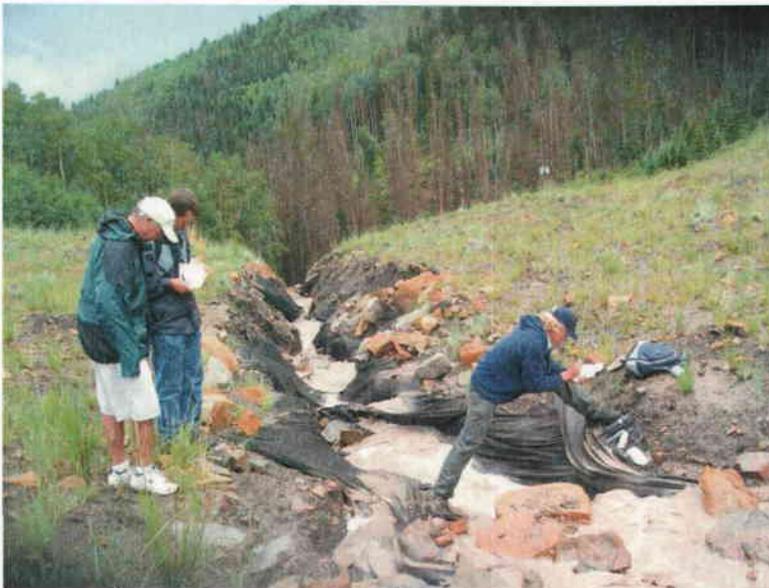
The Division had planned to collect samples of groundwater discharge in the Whiskey Creek channel to evaluate the potential source of orange staining observed in the channel during a site visit completed June 2010. Heavy rainfall and flow in Whiskey Creek on July 29 precluded collecting representative groundwater seep samples. However, water samples were collected from Whiskey Creek to gain information on water quality during storm flow events. The sample location was directly below the end of the paved access road. Samples were collected and placed in a cooler on ice. Field measurements were: pH = 8.24, temperature = 14.1 C, conductivity = meter error. Samples were submitted to the UT Unified State Lab for analysis of total iron, TDS, TSS and nutrients.

Mark Schmitz collected a sample from Whiskey Creek to provide visual evidence of suspended solids levels in the creek during storm events. No samples were collected by Mr. Schmitz for off-site analysis.

Sampling from stream.
