Division of Oil, Gas and Mining

Inspection Report

Permit Number:	C0070001
Inspection Type:	COMPLETE
Inspection Date:	Monday, September 16, 2013
Start Date/Time:	9/16/2013 11:30:00 AM
End Date/Time:	9/16/2013 4:30:00 PM
Last Inspection:	Tuesday, August 13, 2013

Site: **WHITE OAK MINE**

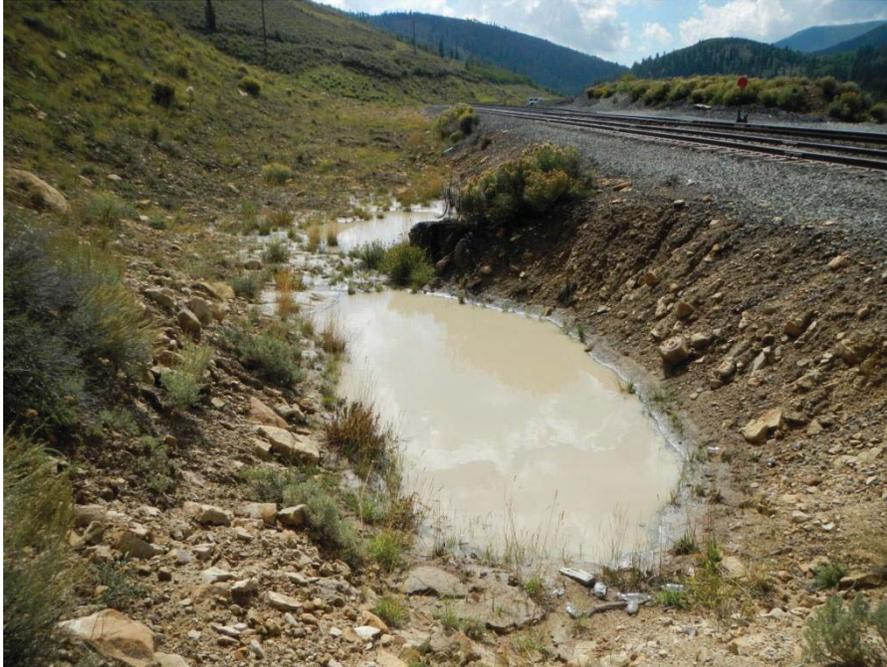
Loadout RR culvert

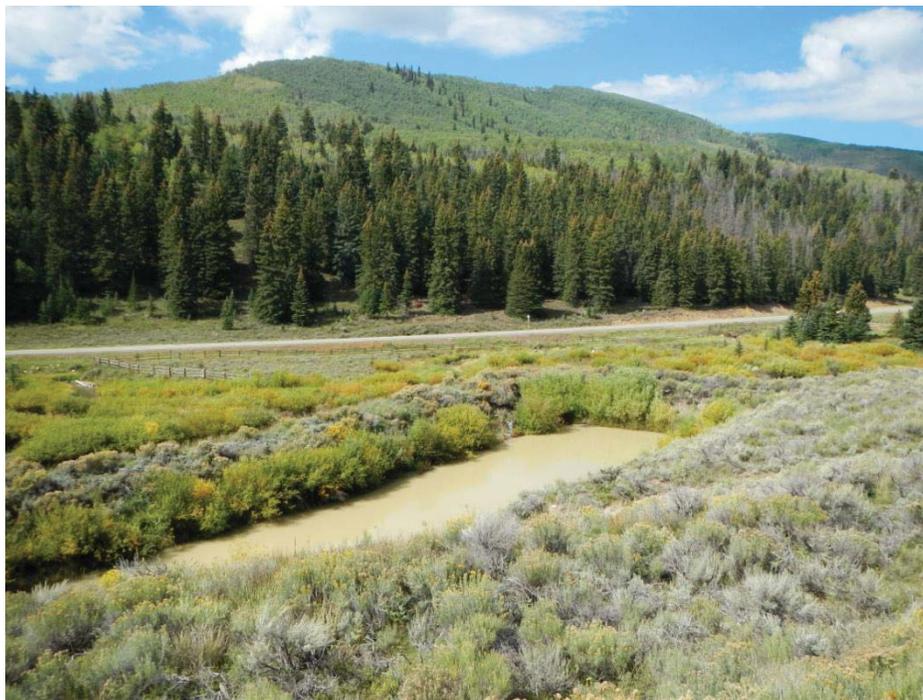
The water level in sediment pond 1 at the loadout is higher than usual, but still below the overflow.

Loadout Sediment pond

Enlarging Pond #3.

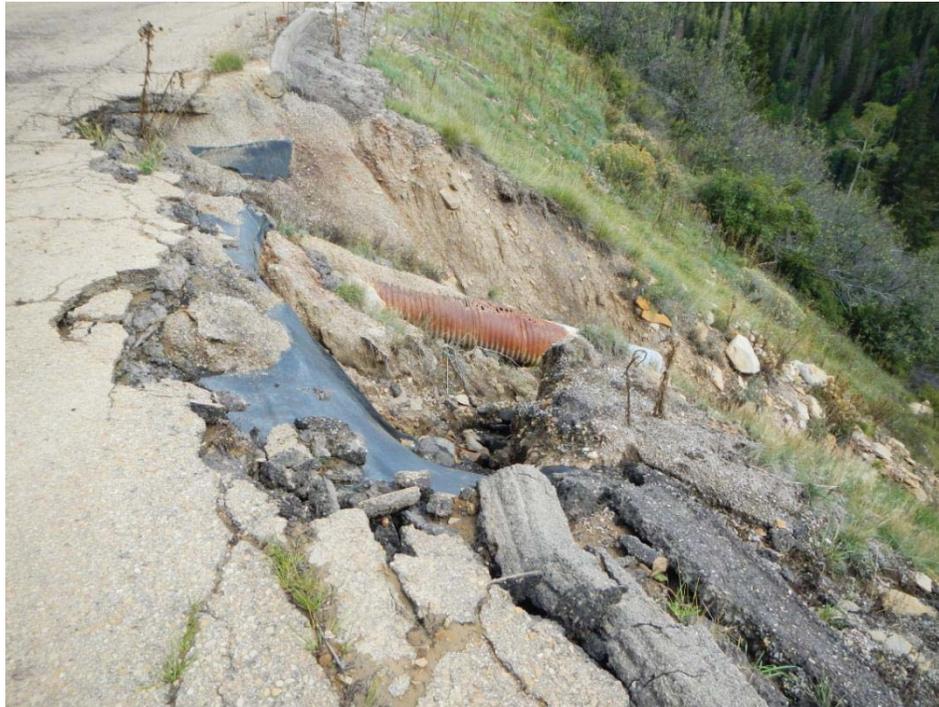
The access road to the mine site requires maintenance in the location of several culverts. Water flowing down the road has created large gullies that are contributing sediment to the Whiskey Creek channel and Eccles Creek. Approximately 6 inches of sediment covers vegetation at the confluence from the last storm system.

Culvert XX on the RR access road at the mine site is crushed and flow is beginning to erode the roadway.

White Oak mine site access road culvert

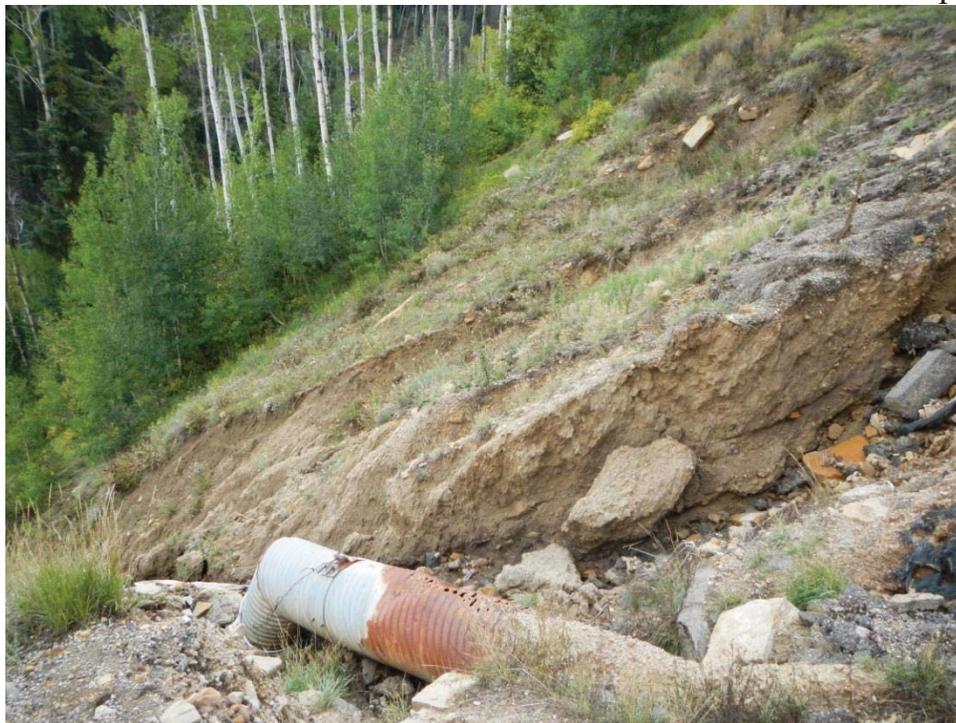
erosion of road outslope

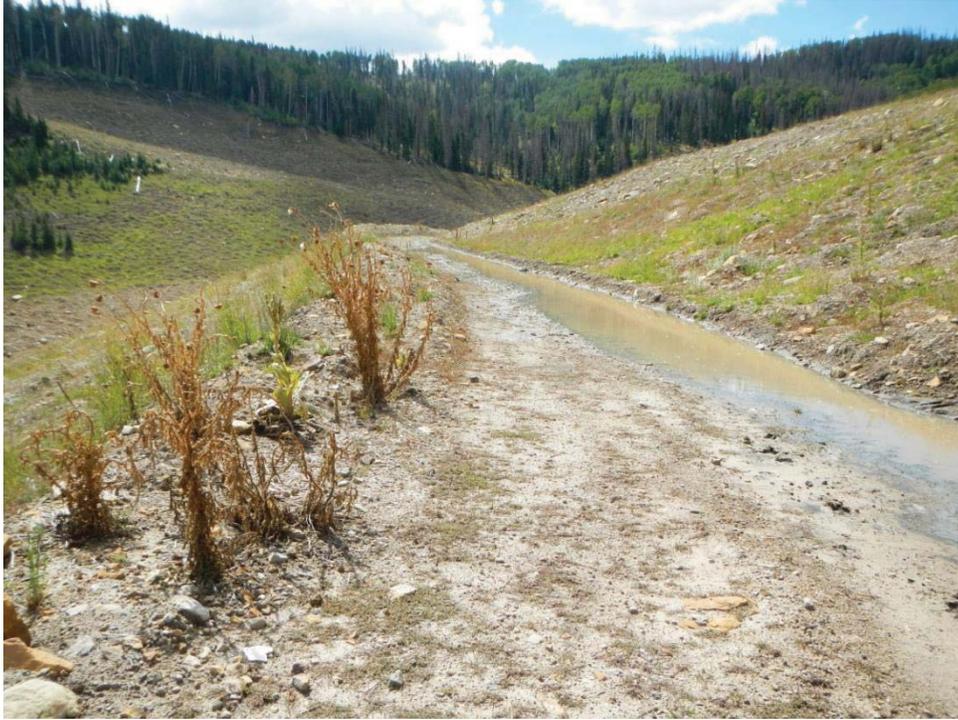
Water bars along Terrace A at the mine site need maintenance. The additional water bars installed last year on Terrace A have captured a lot of sediment.

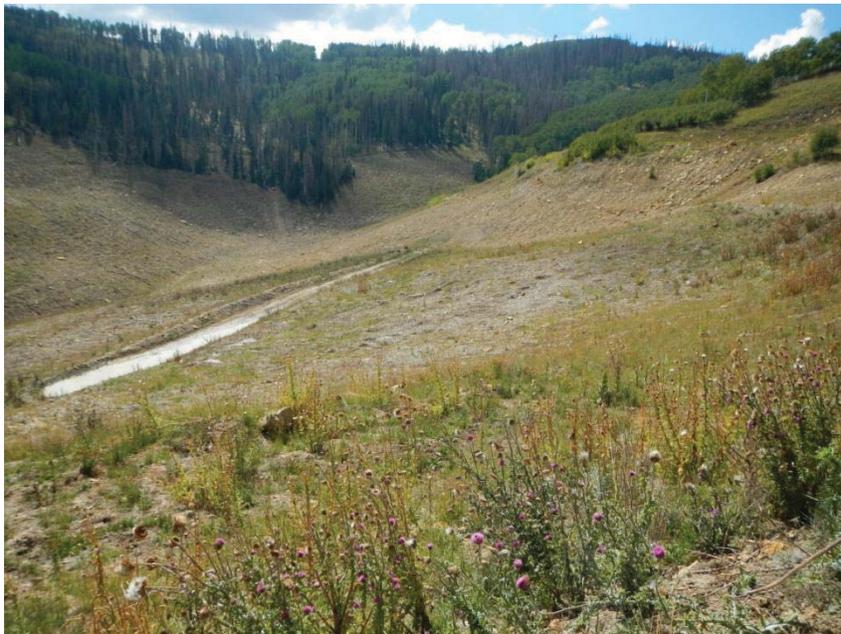
None. Sink hole repair is still sound.

View south from Terrace C. Stable sink holes.

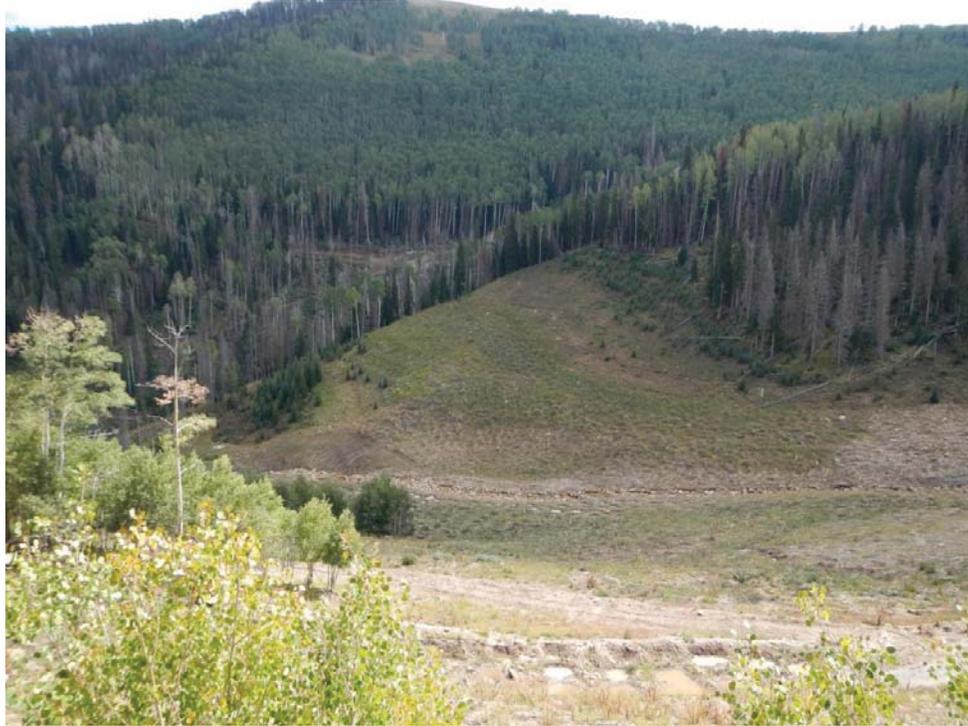
View of channel from Terrace C.

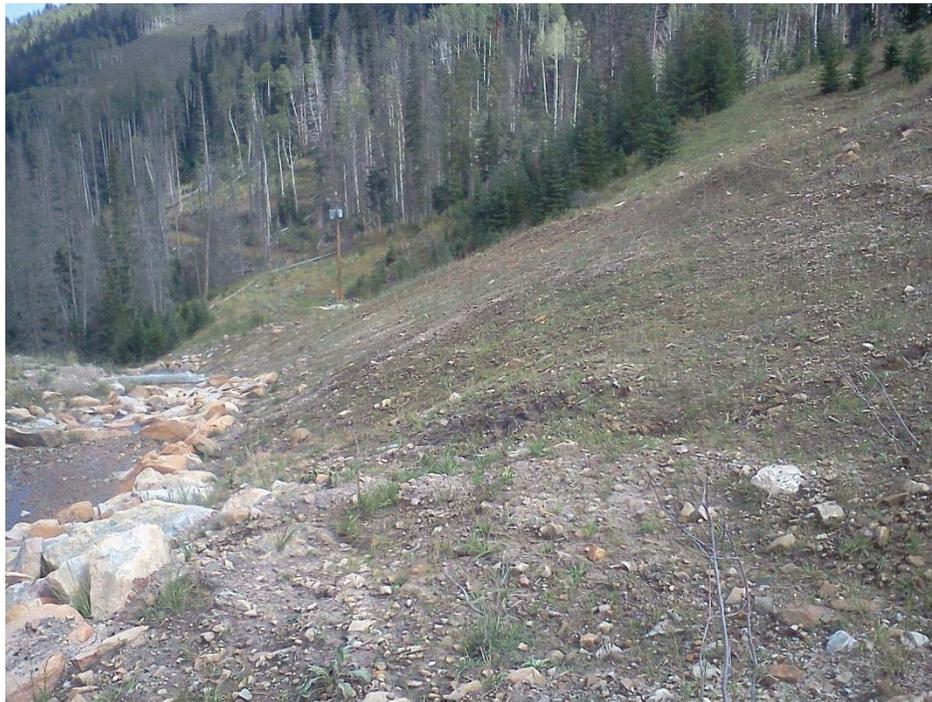
Vegetation growing on the steep north facing bank of Reach 3 and Reach 4 is a reflection of the Division's seeding efforts last fall and is encouragng.

Vegetation growing on the east bank of the channel give a green cast to the slope and is the result of re-seeding by the Division last fall (see 10/15/2012 inspection report #3264).
