Moving dirt!

DOGM, Daily Construction Progress Report

Eccles Creek pad and culvert removal project C/0070001,NELCO Contractors, Inc,
PO# _560 610000000000007

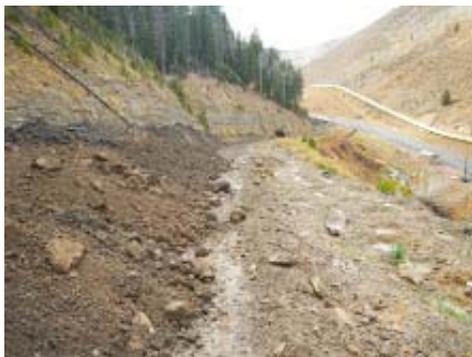
DSCN4236 moving dirt.JPG
7054K

All asphalt has been removed and the loader has buried asphalt against the road cut The larger trackhoe is working from the northwest corner of the pad and has lowered that area by about 5 feet. A pullout that is about 15-20 feet wide was left along the highway.

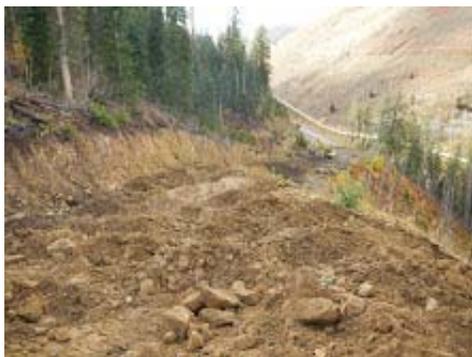
DSCN4242 water bars and pocks on logging road.JPG
6735K

Five loader buckets of fill were hauled up to the logging road (approx. 45 CY- 50 CY) and placed against the outslope, providing additional cover on the asphalt. The smaller hoe was used to create 5 water bars/ditches to direct water off the logging road and onto the vegetated slope between the logging road and access road. The portion of the logging road affected by the work was pocked. The access road affected by the work was re-pocked and water bars were re-established.
