CIVIL PENALTIES GRANT S14AP20030 PERFORMANCE REPORT
Priscilla Burton, Utah Division of Oil, Gas & Mining, April 8, 2016

In July 2014 the Office of Surface Mining (OSM) Civil Penalty Funds were awarded to complete the remaining reclamation at the White Oak Mine, C007/001. That reclamation included reclamation of the roadway, removal of fill and restoration of Eccles Creek, as follows.

Photographs of Work completed under Civil Penalties Grant S14AP20030

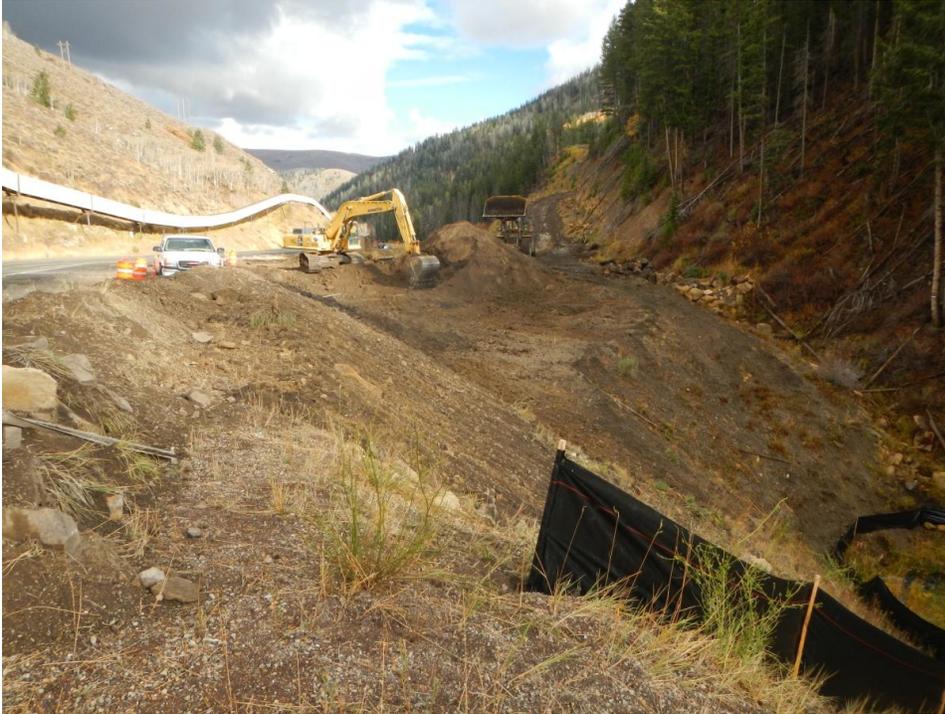
Begin removal of pad above creek 10/22/2015.

A highway encroachment permit was obtained for work within the right of way of State Route 264. A hand crew installed silt fence on both sides of the creek, from one side of the creek to another, above the culvert and up both sides of the embankment. A trackhoe broke up asphalt on the pad surface into 6 inch minus pieces, leaving a pullout along the highway that is 15-20 ft wide. A loader hauled the broken asphalt to the cut slope on the access road above Eccles Creek. Below the asphalt and road base an estimated 4,000 CY of fill. The fill was moved using a front end loader, until the slopes became too steep for the loader to negotiate. Then five 10-wheel dump trucks were used and the fill was hauled off to a third party location. In all, the contractor removed 7,600 CY of fill from the pad.

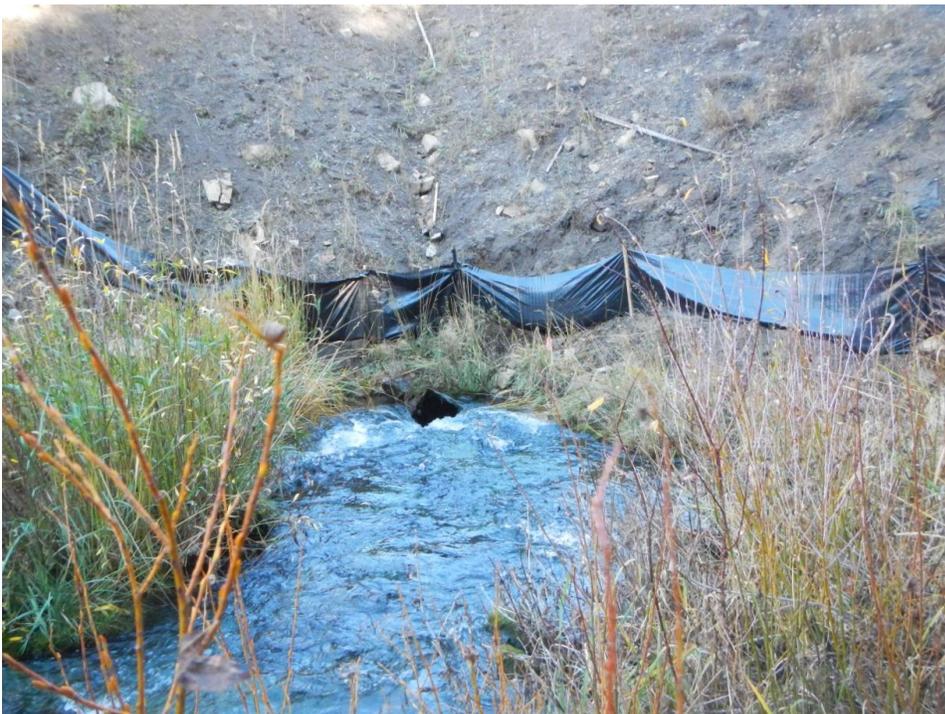
Eccles Creek funnels into the 4 foot culvert 10/26/2015

A change of plan was agreed upon by all parties to leave the existing 48 inch culvert buried below the reconstructed Eccles Creek channel, because it is two feet below the existing water surface at its inlet

and four feet below the water surface at its outlet. i.e. The river drops down into the culvert at its inlet and the river bubbles up from the culvert at its outlet. Constructing the channel on top of the culvert was advantageous for several reasons.

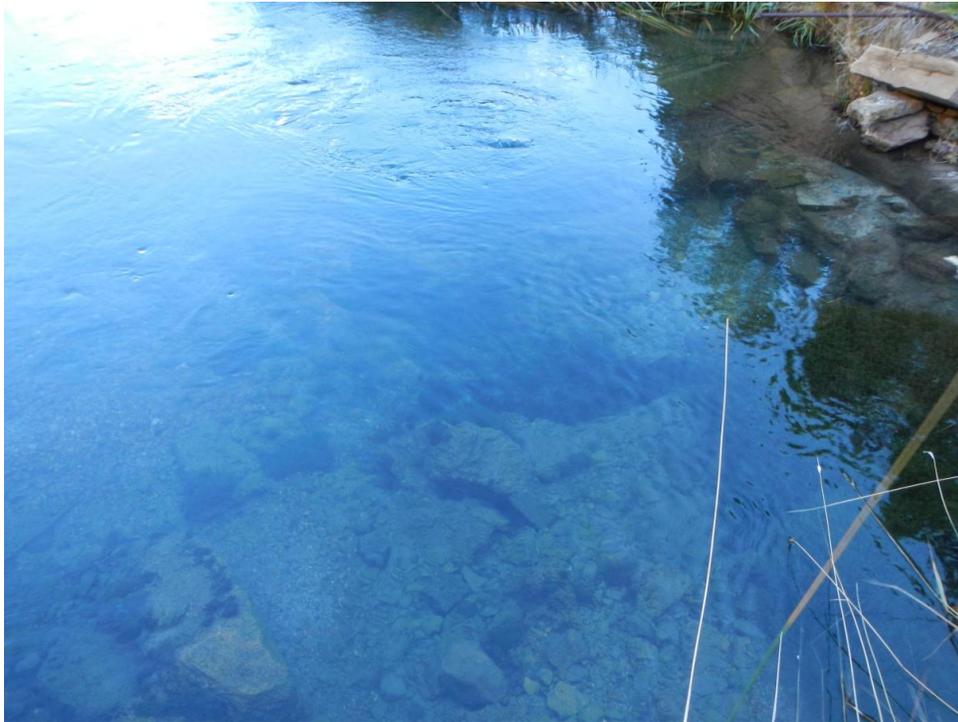
10/26/2015. Eccles Creek emerges from pipe which is submerged 4 feet below the surface.

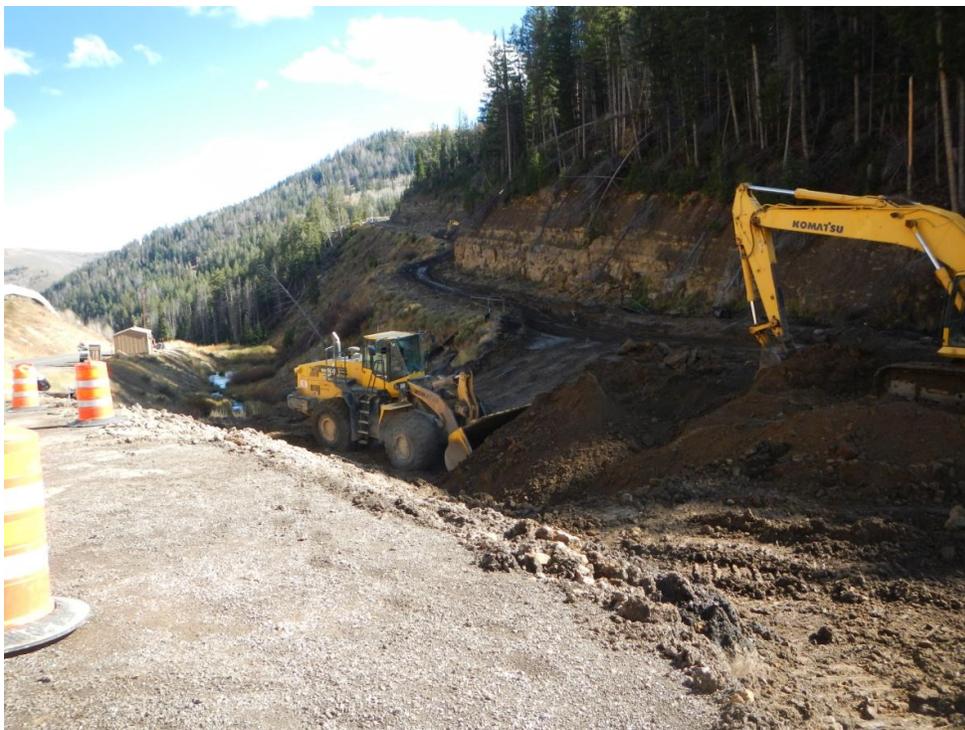
10/26/2016 Fill removal from pad and placement on access road.

Very little rock was encountered until the last seven feet of fill. The fill was placed on the access road to bury the asphalt in the cut, while maintaining a 10 foot access way for foot traffic. The fill surface was roughened with pocking, seeded and covered with 1.5 ton/ac straw mulch. Water bars were established along the road at 50 ft. intervals. A swale was created in the location of a former culvert. The seed mix was as described in the construction specifications with two replacements: for species that were unavailable: dogwood (*Cornus stoloniferus*) was replaced with smooth sumac (*Rhus glabra*) and longstyle rush (*Juncus longistylis*) was replaced with alkali bulrush (*Bolbuschoenus maritimus*).

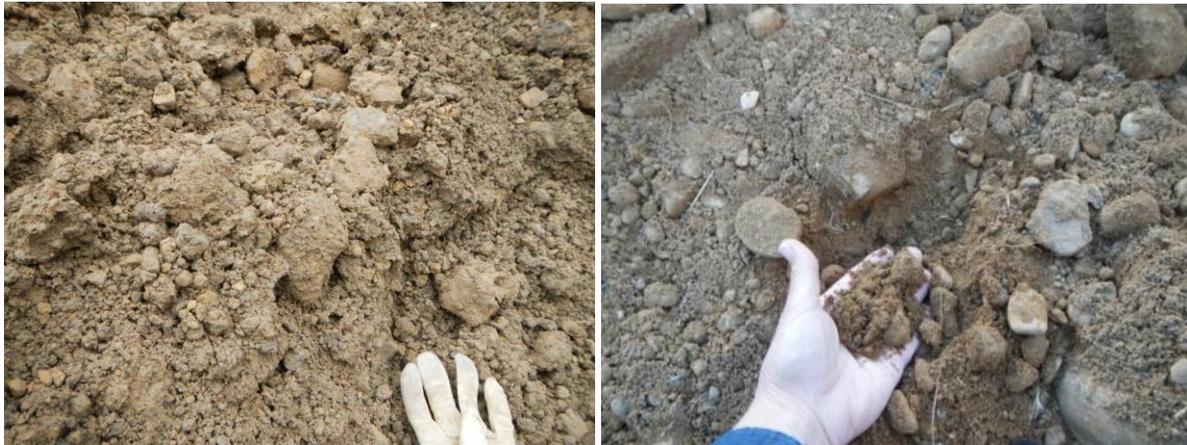
10/29/2015, Below: Gravelly clay fill found above culvert. Below right: imported filter rock.

The channel grade was established. South slope was laid back to an average of 40% (2h:1v or less) and pocked as much as possible, given the steep drop into the channel. The channel is approximately 12 feet wide and 100 ft. long. Filter rock was imported and placed on the excavated grade. Rock riprap was placed. Four drop structures were constructed. On Wednesday November 18, water was directed into the new channel. A track hoe filled 48 inch culvert inlet with rock and cement and put a HUGE rock on top. Several bags of cement were placed in front of the rock.

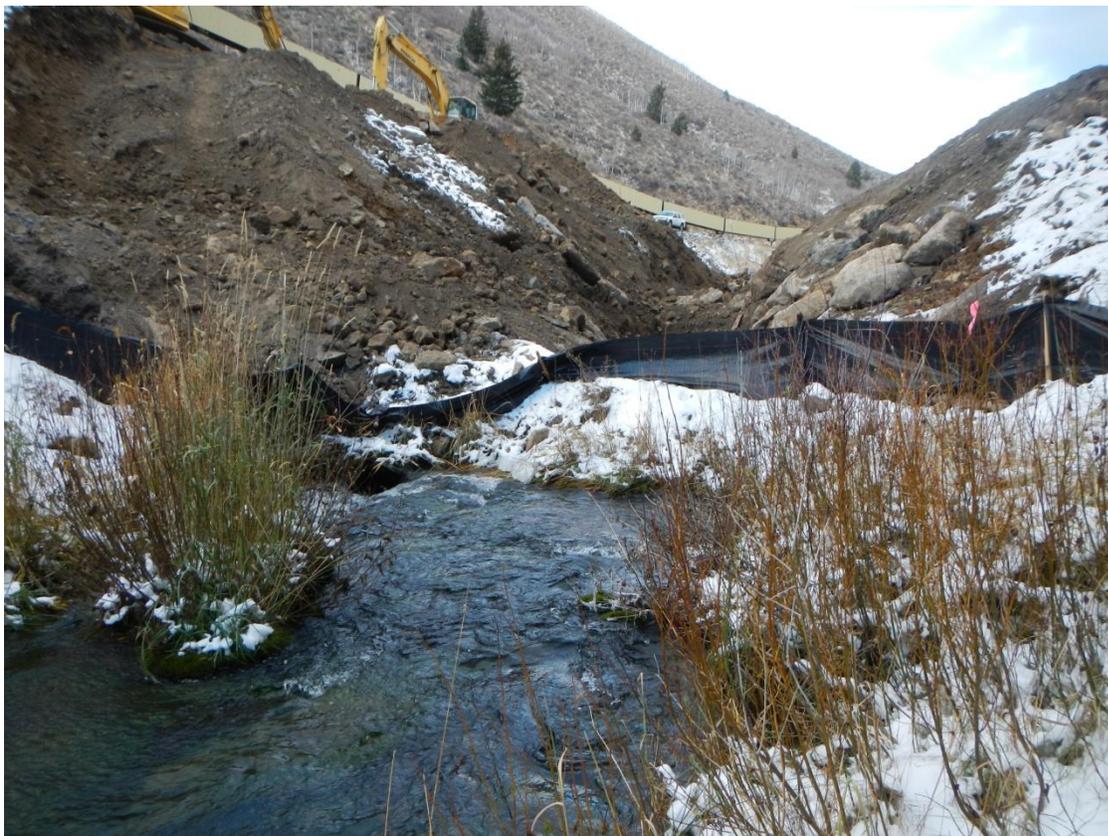
11/6/2015. Below Flow into the culvert during construction of the new channel two feet above.

- 1) Eccles Creek continued to flow in the culvert during construction of the new channel.
- 2) We did not have to over-excavate the existing channel to remove the culvert and then build on fill.
- 3) The culvert was plugged at both ends by rock and cement and buried by rock in the channel.
- 4) The temporary 36 inch bypass was installed which eliminated issues surrounding installation and removal of the bypass culvert (i.e. the over-excavation of the highway outslope and sediment entering the creek during removal).

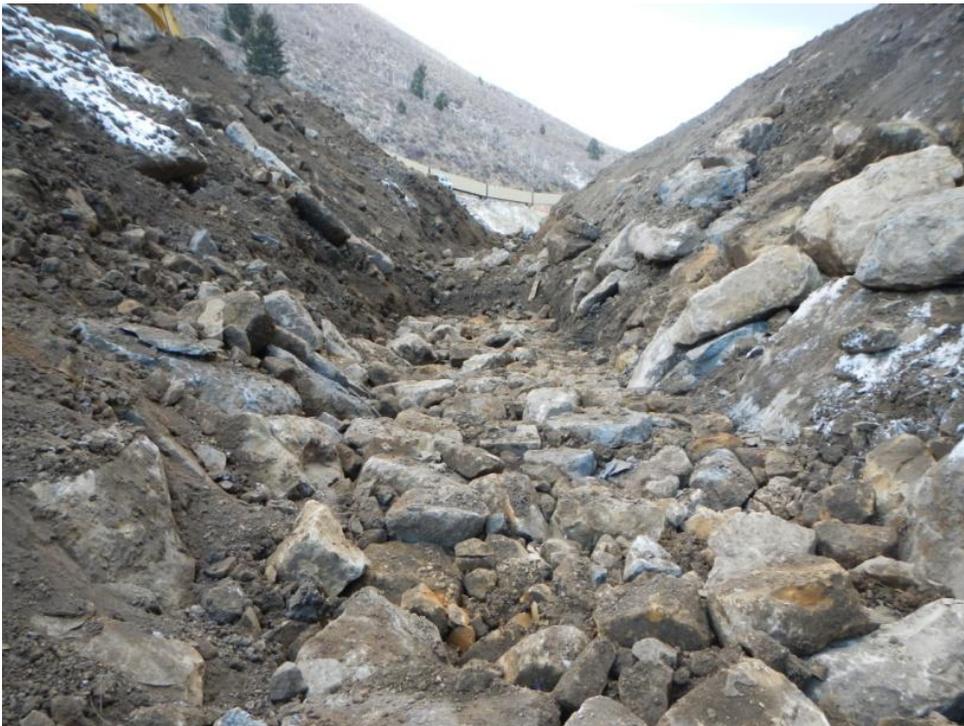
11/06/2015 Center of Channel.

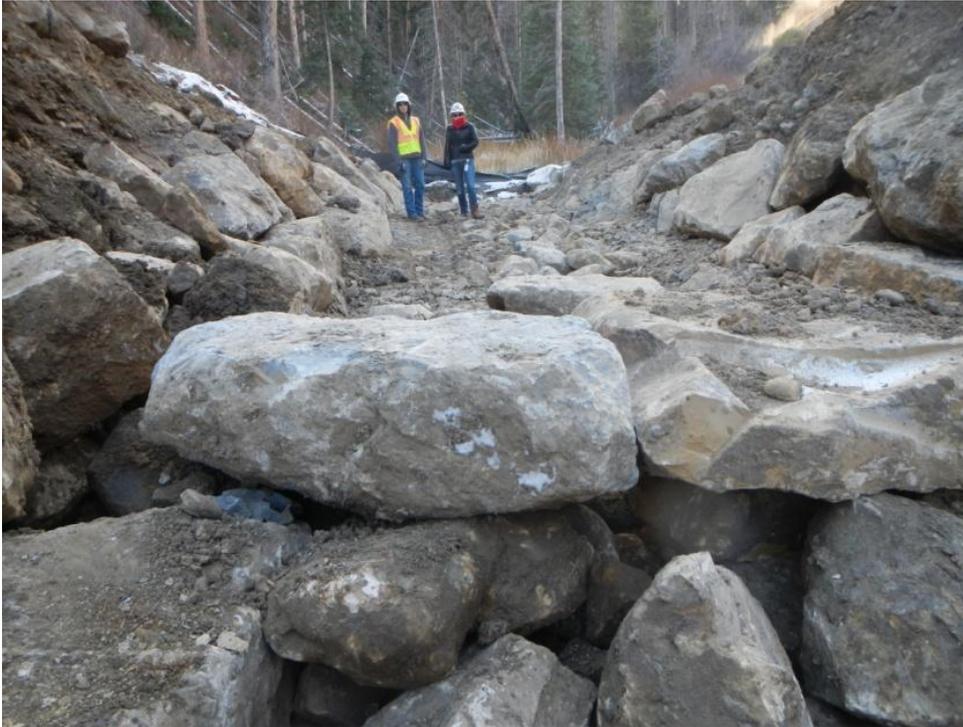
11/9/2015 Cheryl Parker, OGM, and Hugh Christensen, NELCO, evaluate stream grade rock structures.

There were deep pools at the inlet and outlet of the new channel. Four riffles were visible in the channel. There is a slight meander. A small water fall brought flow to a pool at the outlet. Some sediment was carried downstream during the final stages of the work, but afterwards the water appeared clear.

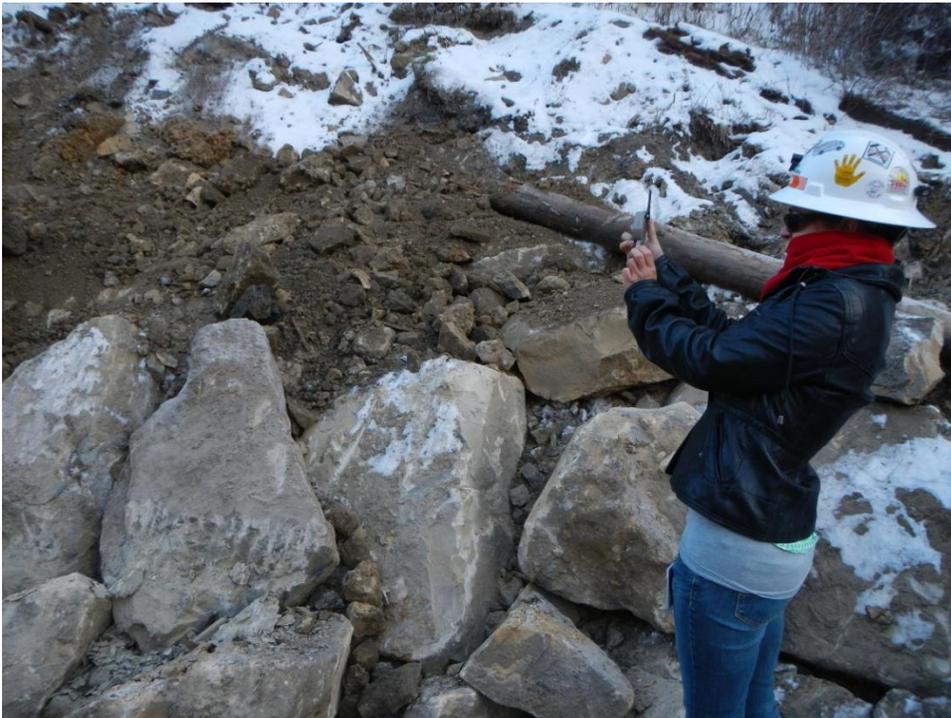
11/9/2015 Cheryl Parker checks southslope gradient.

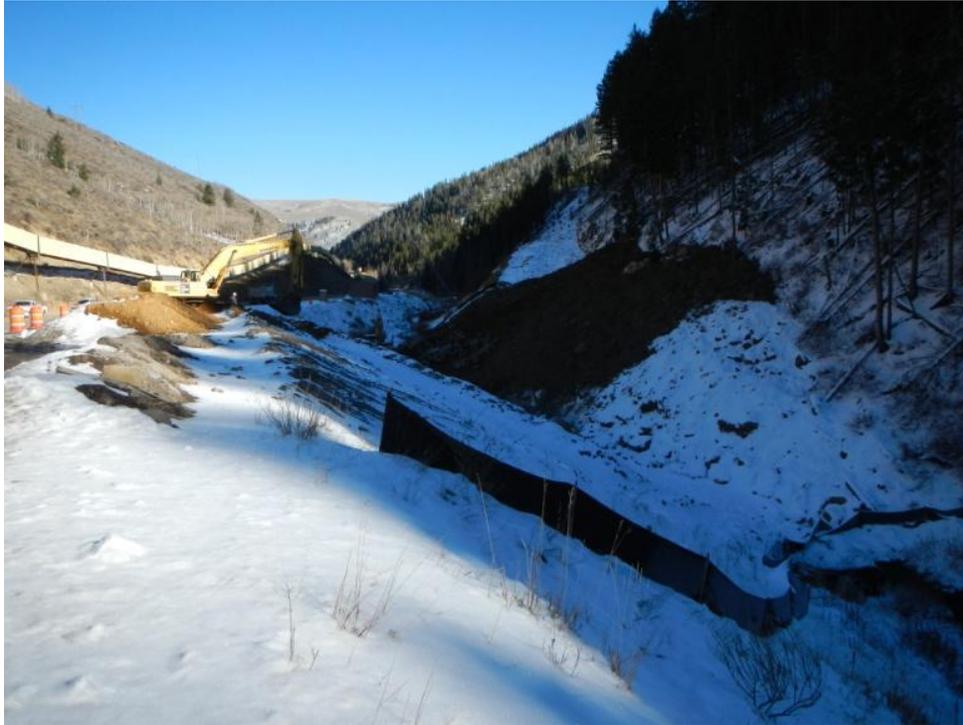
11/13/2015 Slopes are laid back and pocked

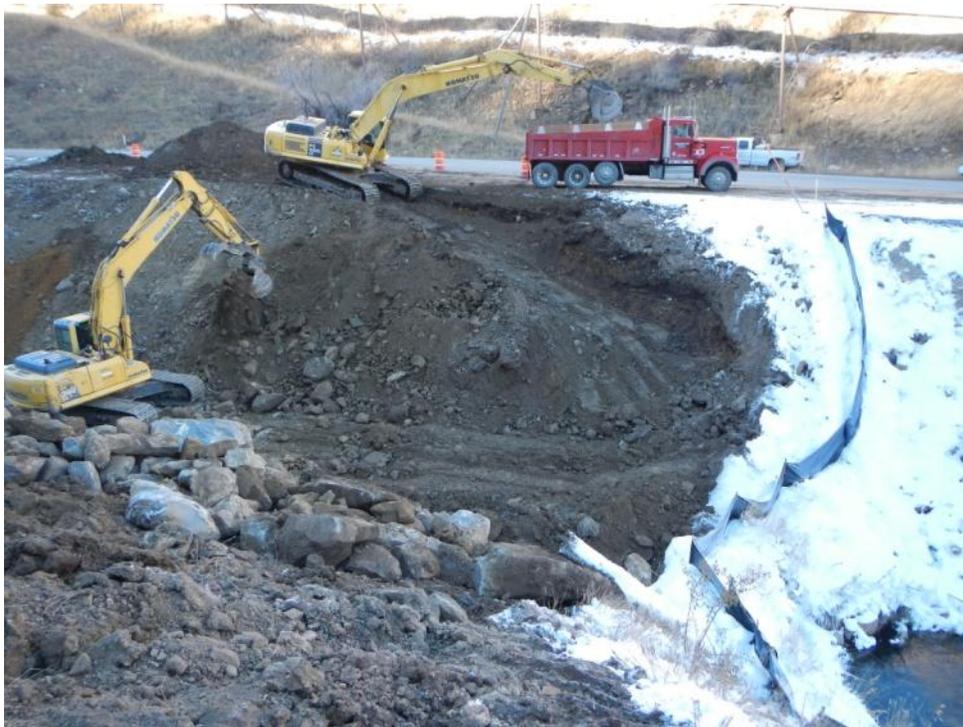
11/13/2015 A short segment remains to be constructed at the downstream outlet.

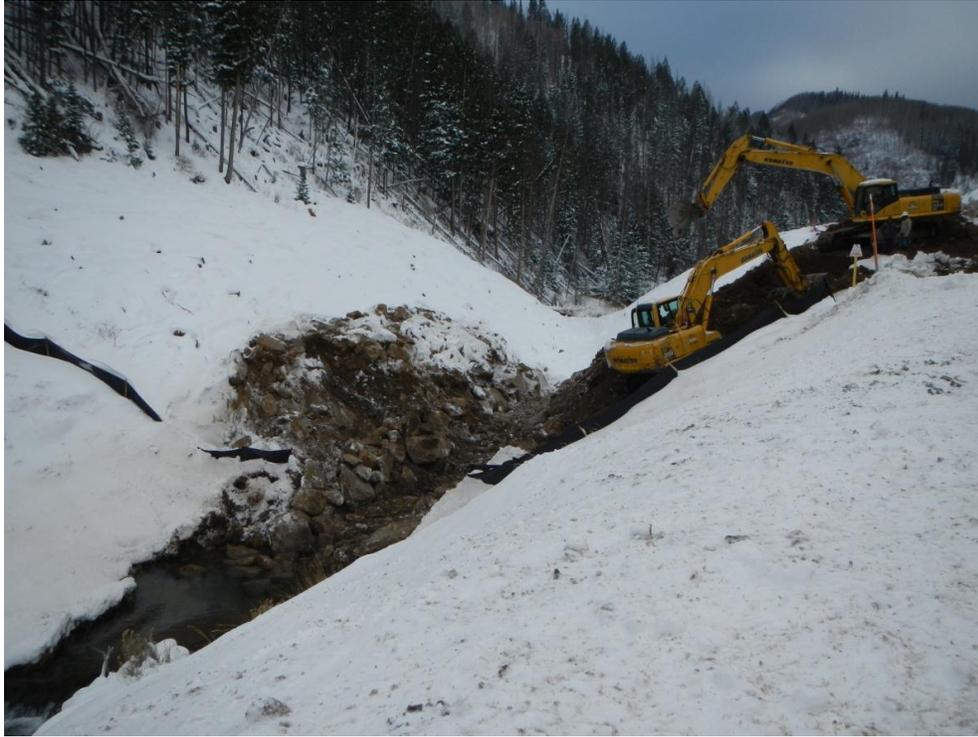
11/17/2015. The culvert outlet is plugged with rock.

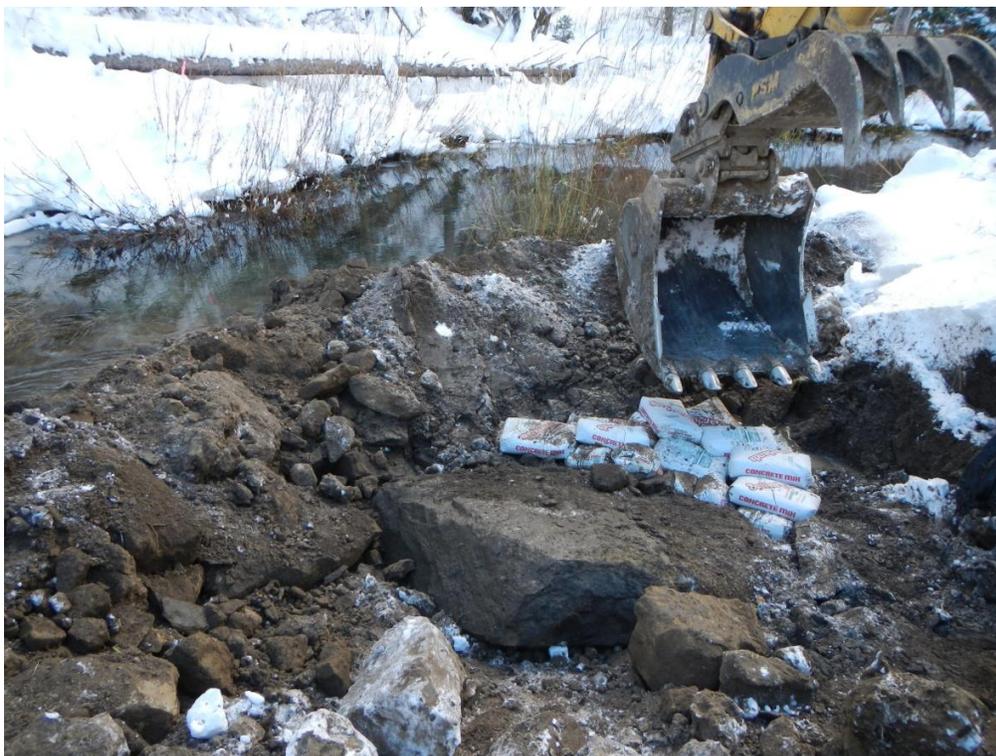
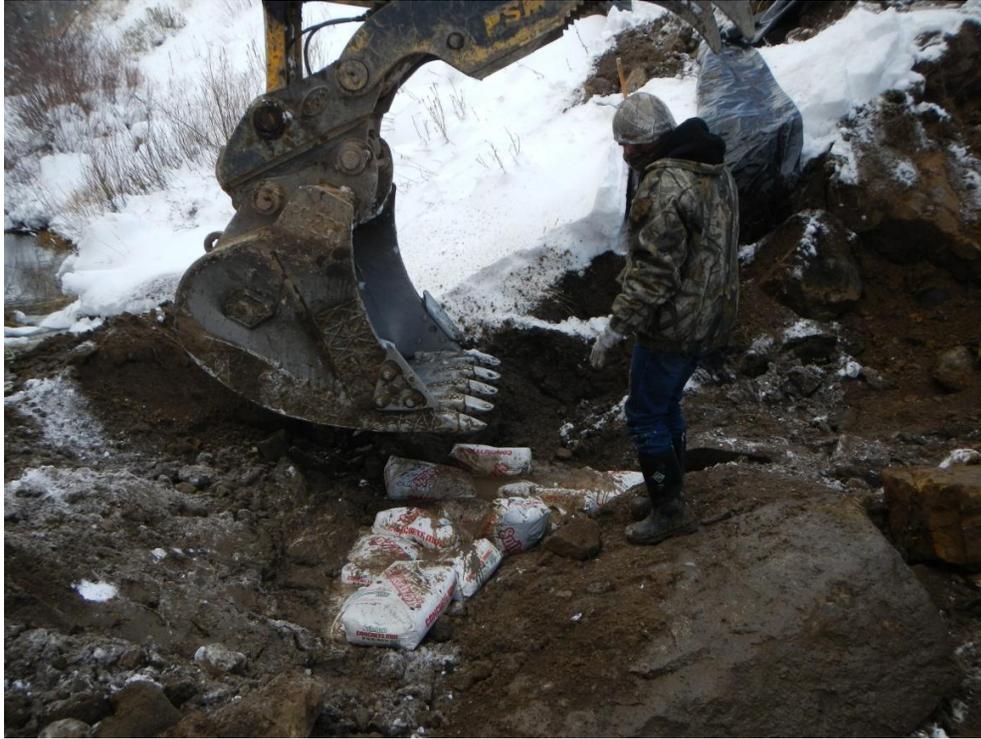
11/18/2015 The culvert inlet is plugged with rock and cement.

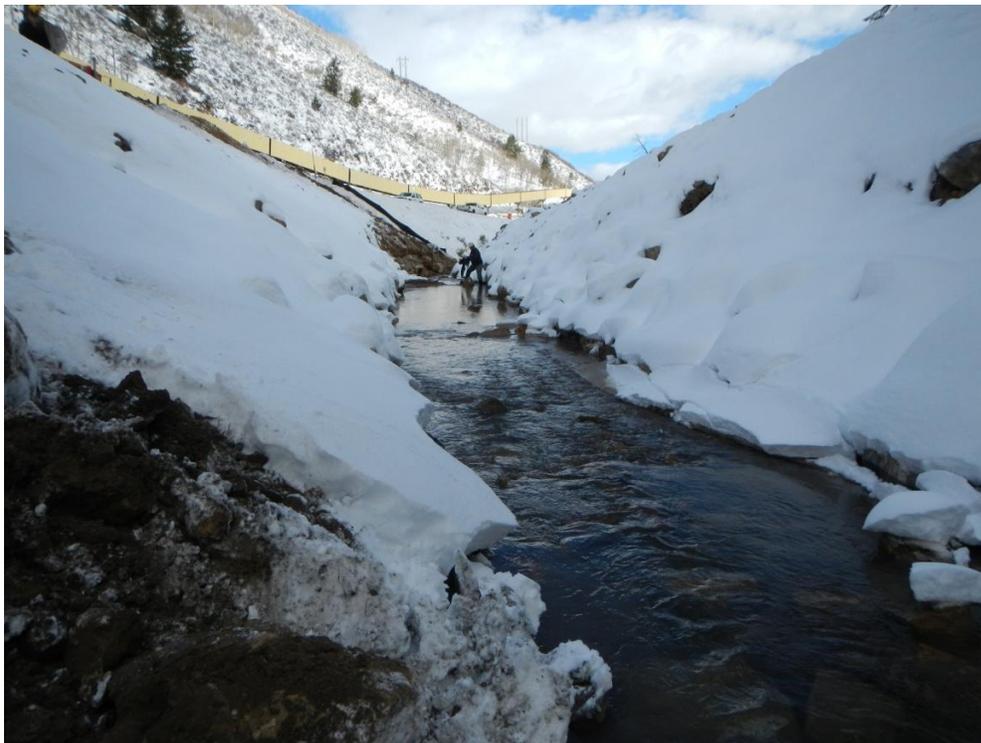
Eccles Creek flows into reconstructed channel 11/18/2015, looking downstream.

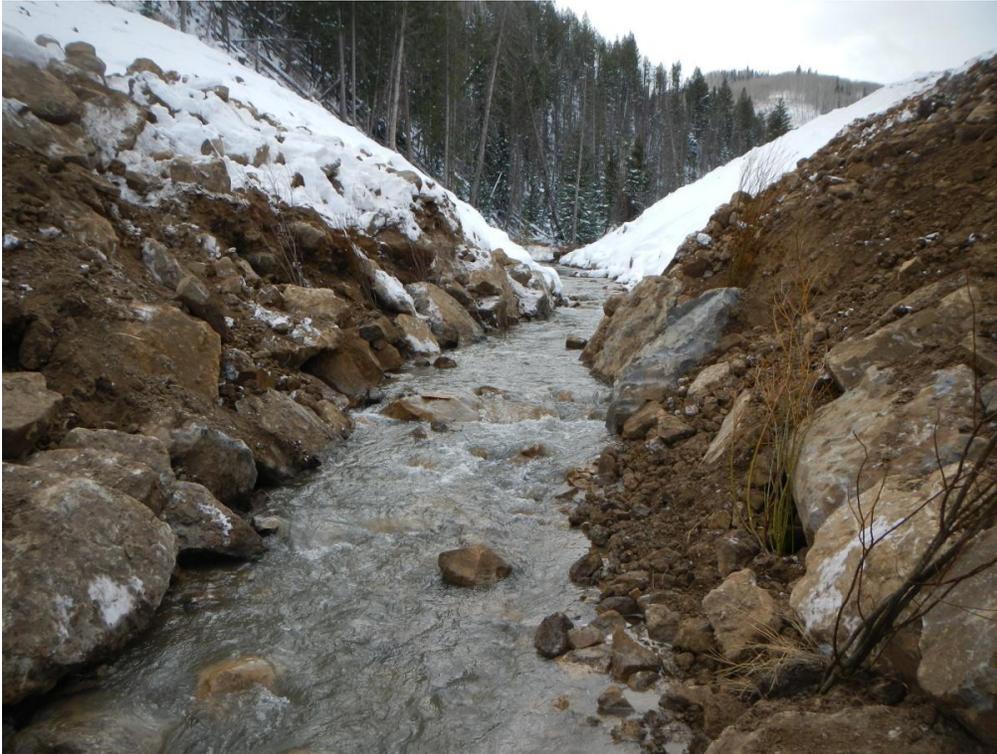
11/18/2015 Looking upstream. Sedges, rushes and willows planted on the north ordinary high water mark (OWHM). Willows only were planted on the south OHWM.

Seven willow bundles were placed around the former inlet and covered the cuttings with backfill. We also planted 10 willow bundles at the outlet (five bundles on each stream bank). One container of sedges and one container of rushes (@ approx 25/container) were planted along the north stream bank where ground was recently worked and therefore not frozen. Snow and frozen soils delayed the planting of the remaining willows (5 bundles) and sedges (125 plugs) and rushes (100 plugs) until the spring. (Unfortunately the rushes and sedges went missing over the winter, but the remaining willow bundles were placed into the water at the toe of the slope in June 2016.)

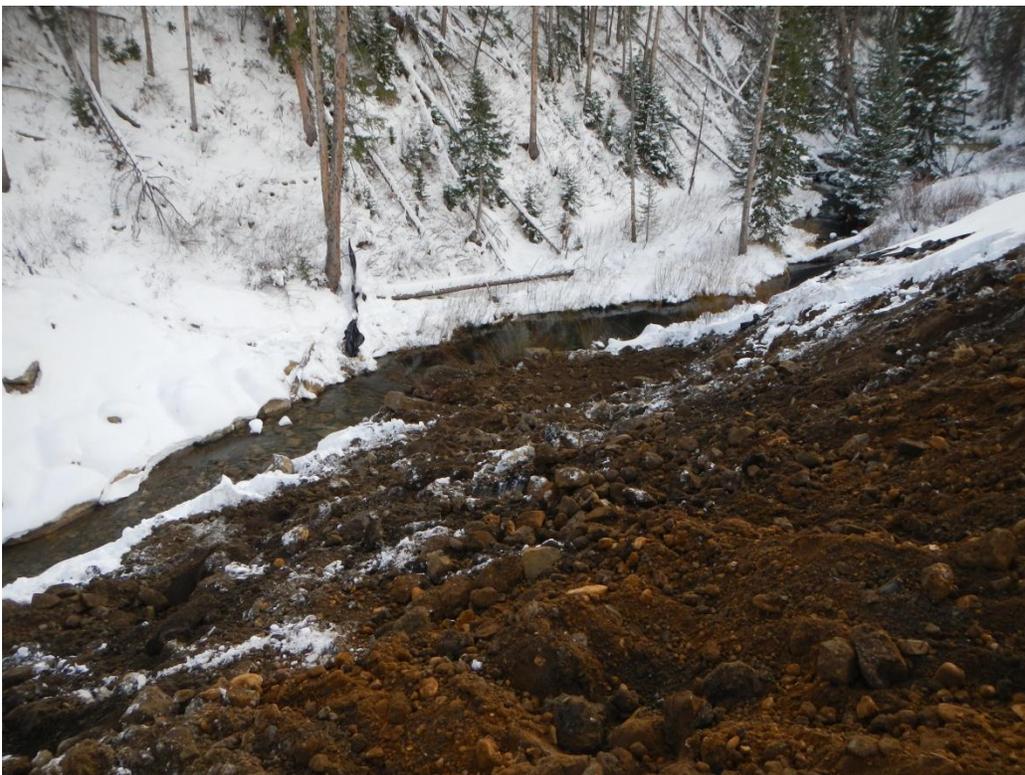
11/18/2015 Former culvert inlet location is planted with willow cuttings.

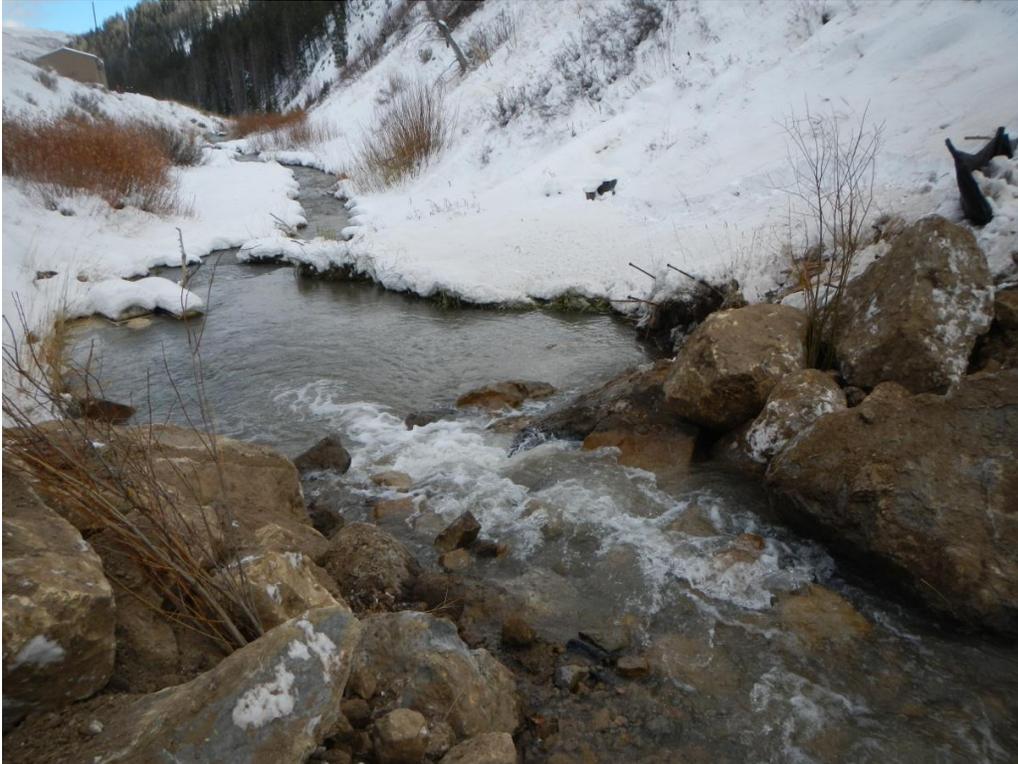
11/18/2015 New outlet with willows planted on each side.

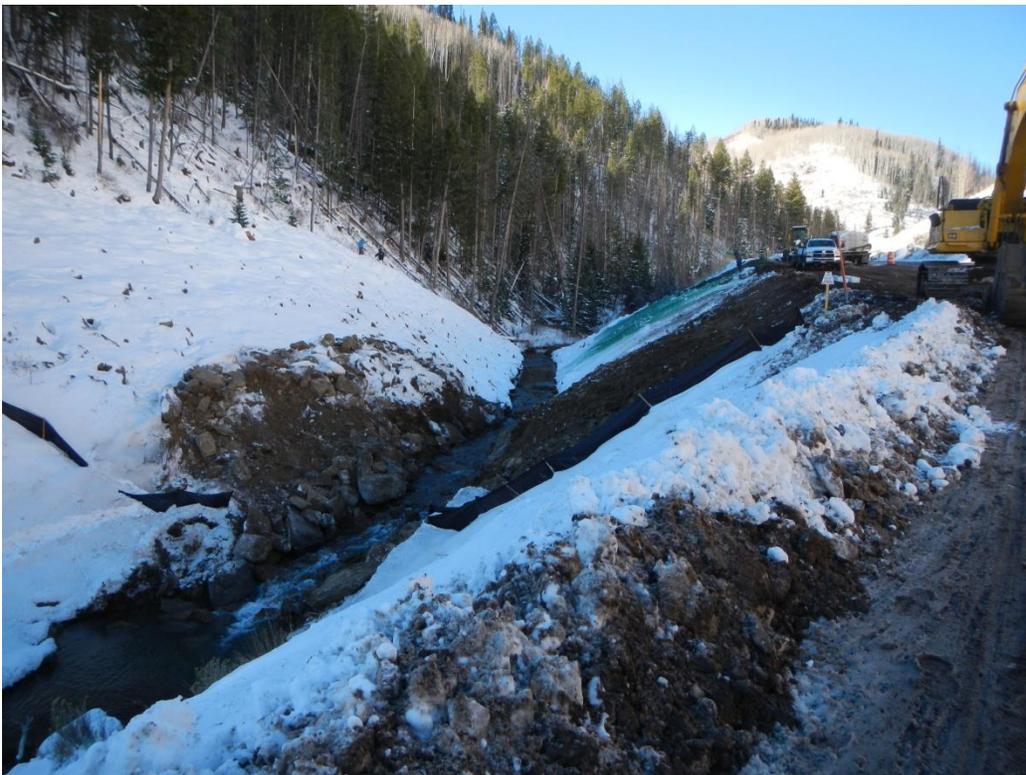
Slopes are seeded by hand and hydromulched, 11/19/2015.

Ward Landscaping was subcontracted to do the hydromulching required on the steep slopes of the stream channel. Ward landscaping hand seeded the site (with a slightly different mix) and then applied hydromulch to the north side, but had difficulty reaching the far slope. Consequently, 10 lbs/ac Triticale were applied over the snow, to provide early spring cover and add a standing mulch the steep slopes. Work was completed November 19, 2015. The stream alteration final compliance report was filed on February 2, 2016.
