Skyline Mine

RE: Swens Canyon Ventilation Facility (SCVF), Canyon Fuel Company, LLC, Skyline Mine,
C/007/0005, Task ID 4777

Title: Swens Canyon Ventilation Facility

Installation of new ventilation facility in Swens Canyon to ventilate SW Reserves. Response to Task 4777

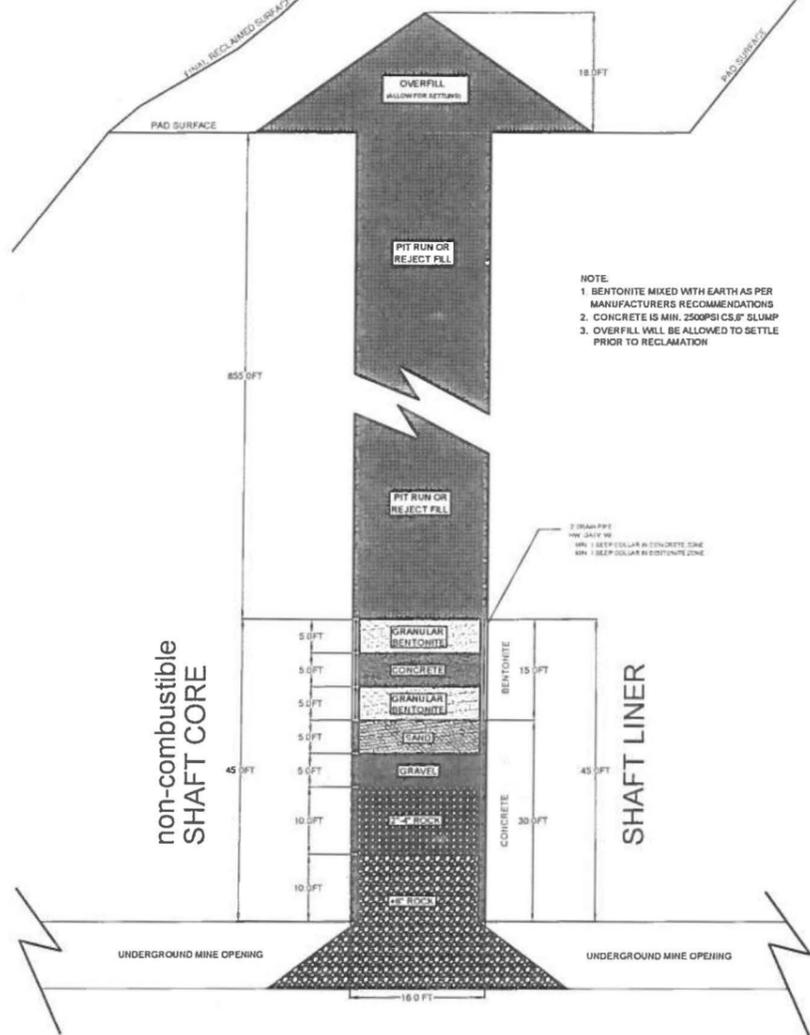
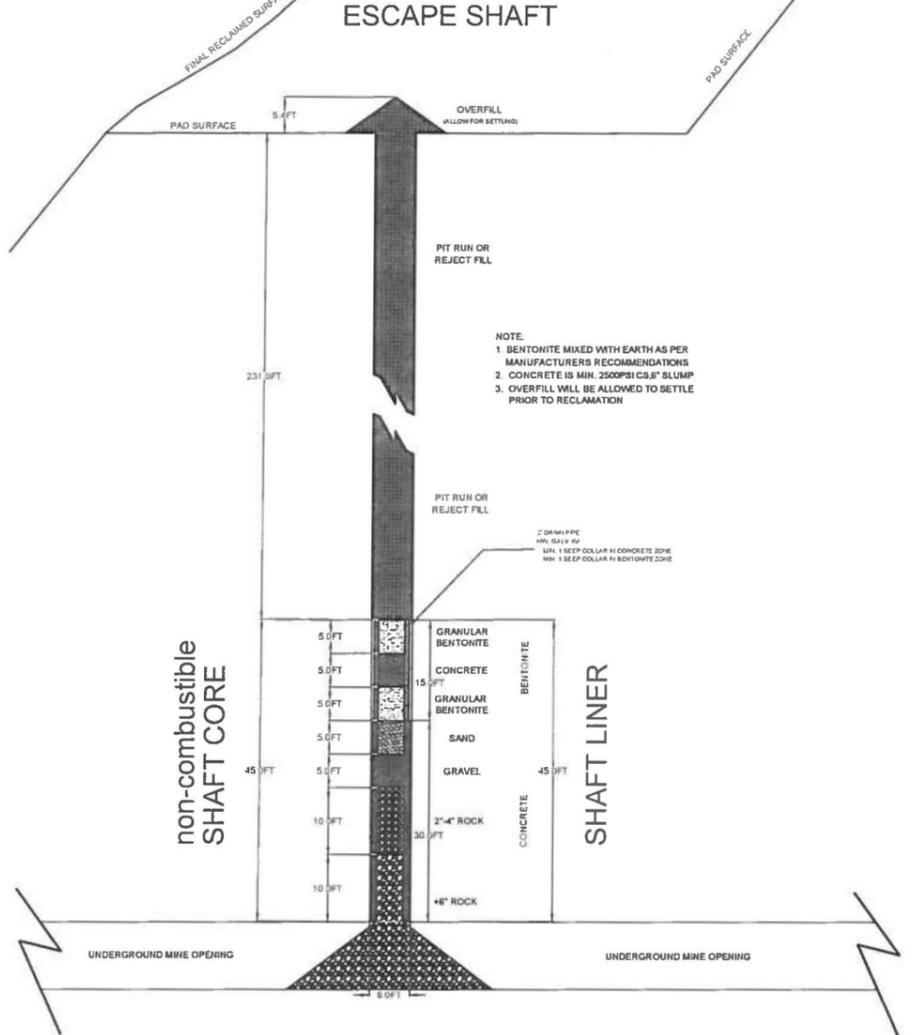
ESCAPE SHAFT

NOTE:
 1. BENTONITE MIXED WITH EARTH AS PER MANUFACTURERS RECOMMENDATIONS
 2. CONCRETE IS MIN. 2500PSI CS.8\"/>

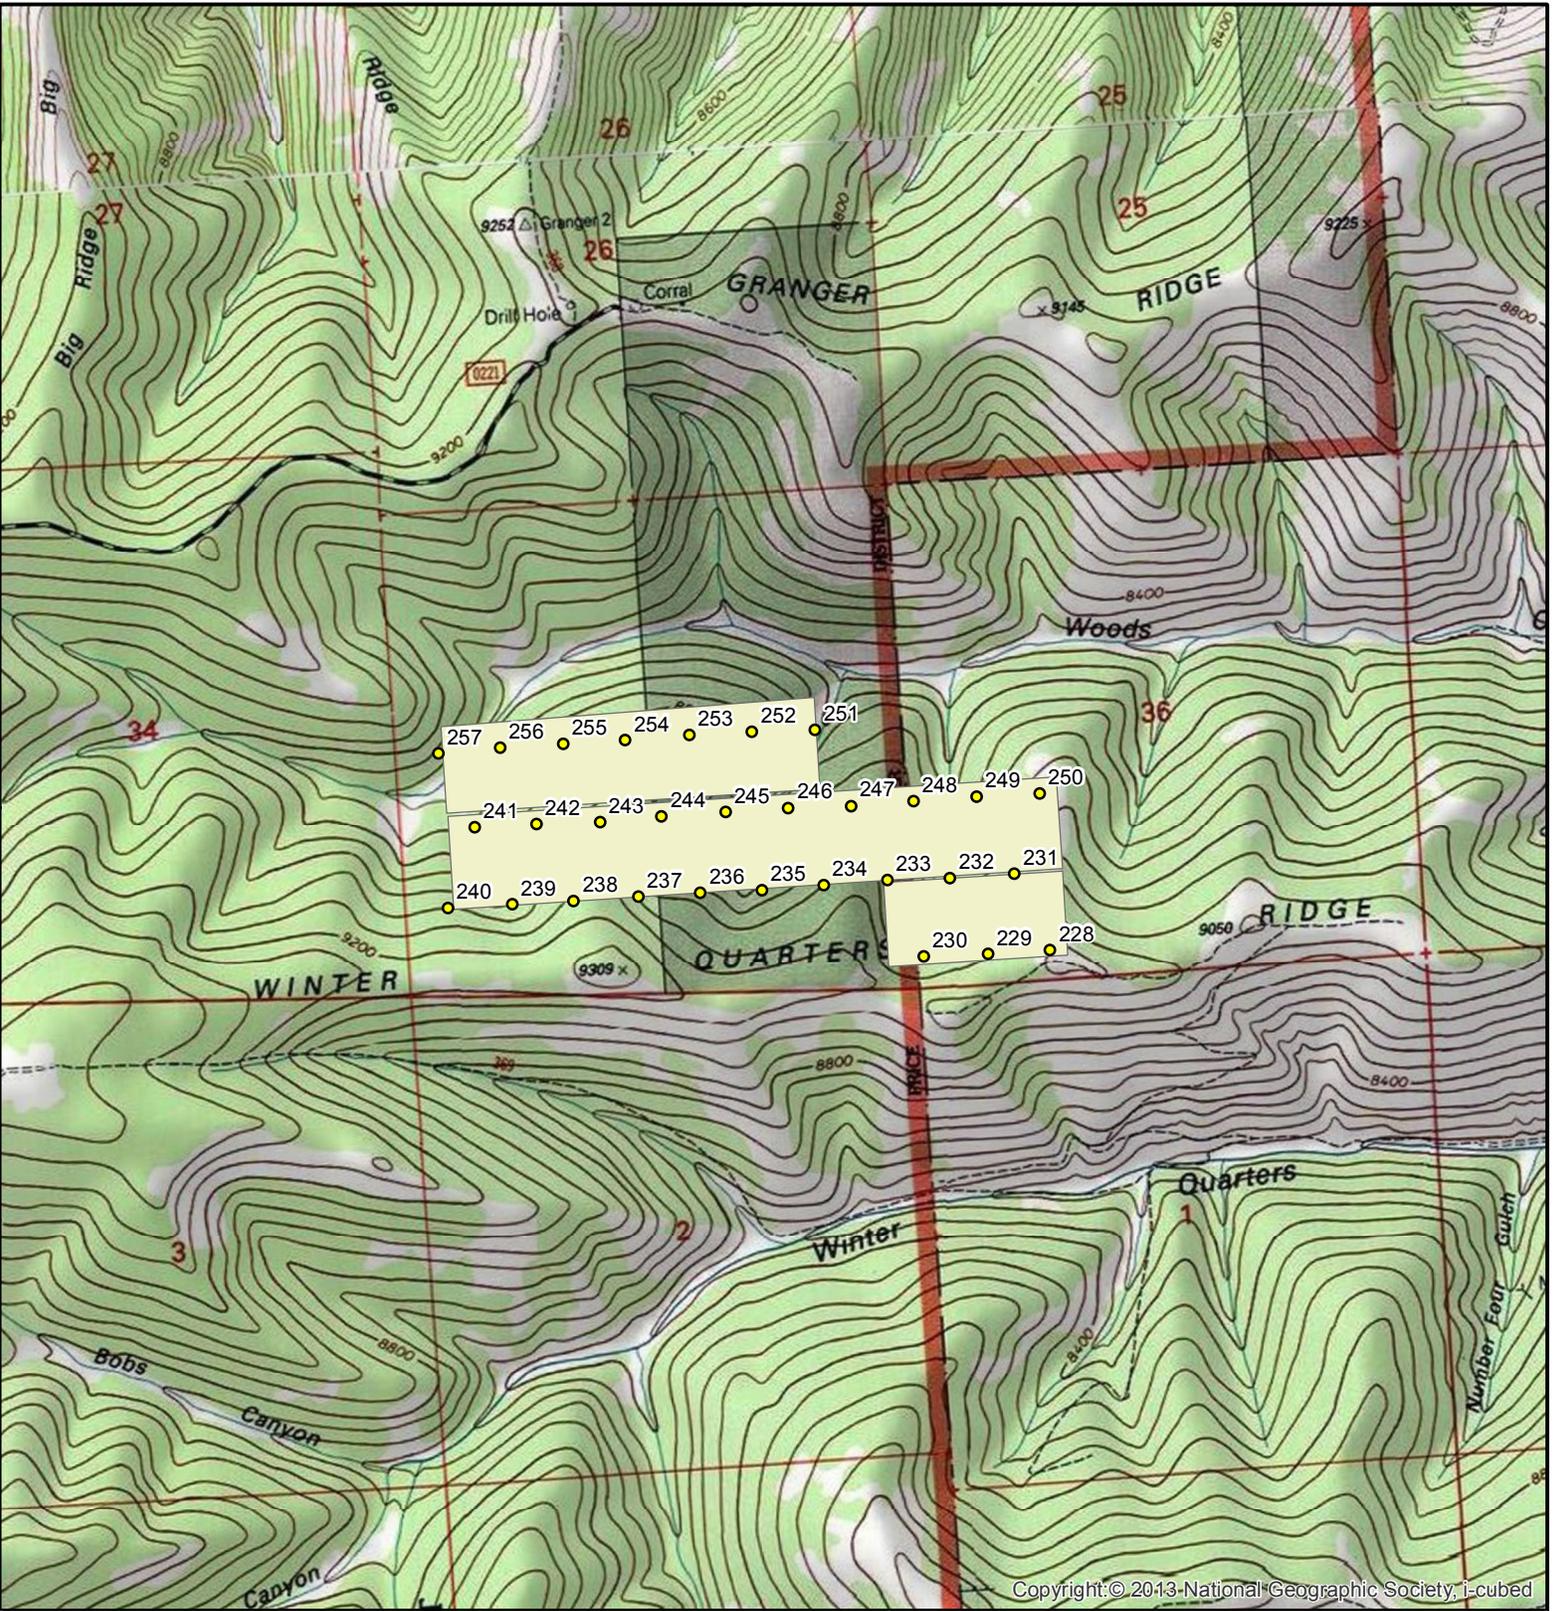
FIGURE 2
Power line, Access Roads,
and Ventilation Shaft

The 2013 wildlife survey included the following areas: a potential power line route, ventilation hole, and access roads (Figure 2); a subsidence survey (Figure 3); and a spring survey (Figure 4). Each survey area is displayed on a map attached hereto in Appendix A as Figure 1. Northern goshawk protocol surveys, general raptor surveys, and general wildlife surveys were conducted in and around the areas displayed on Figure 2 and Figure 3.

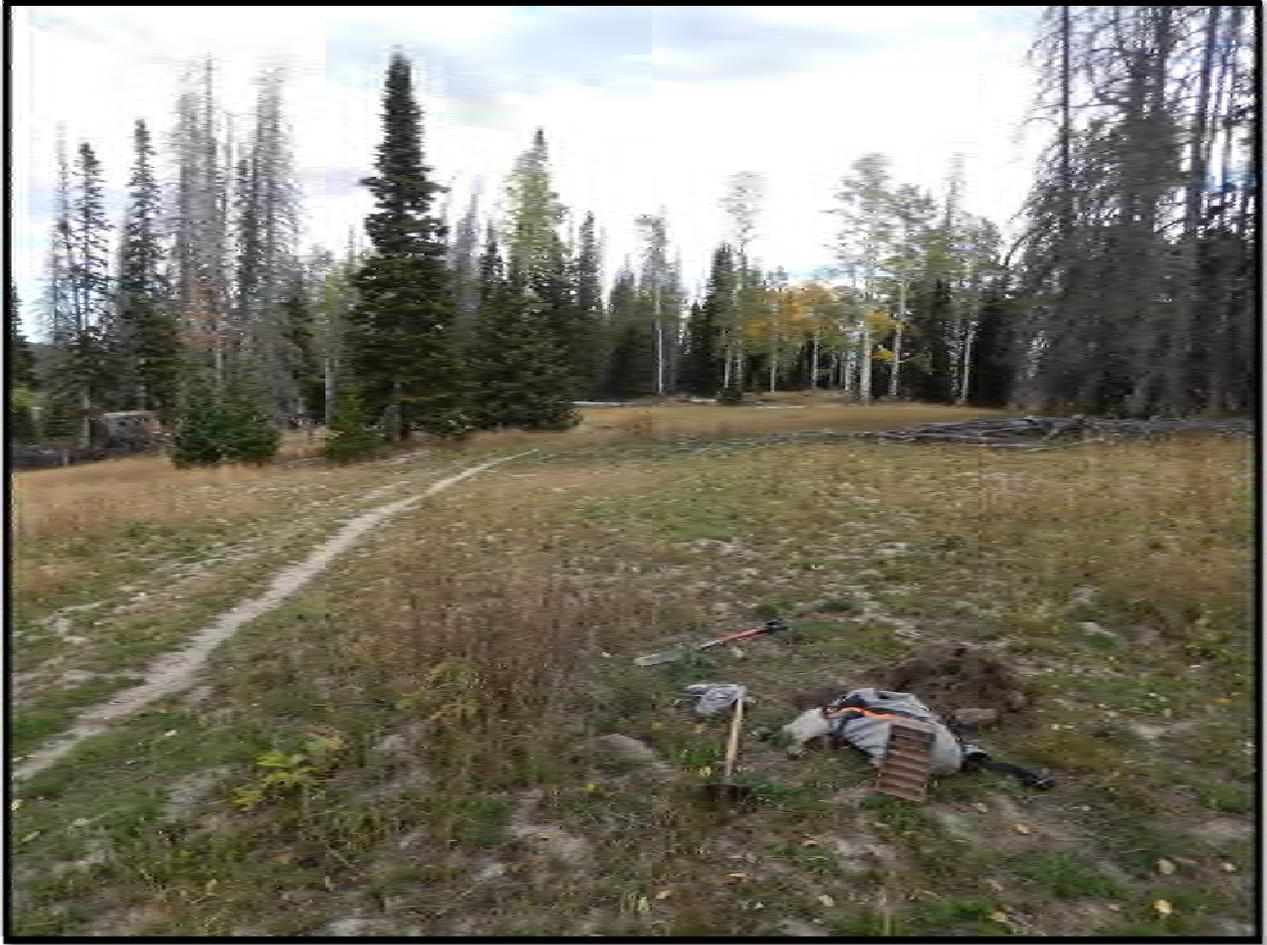
Photo B - 1. Soil profile location 14SKY08, McCadden family soil; loamy-skeletal, mixed, superactive Lithic Haplocryolls. Looking northeast across opening surrounded by quaking aspen and Englemann spruce. Vegetation near profile location includes fescue and coneflower. Extensive rodent activity has mixed the surface horizon. Extensive amount of dead conifers in adjacent stands.

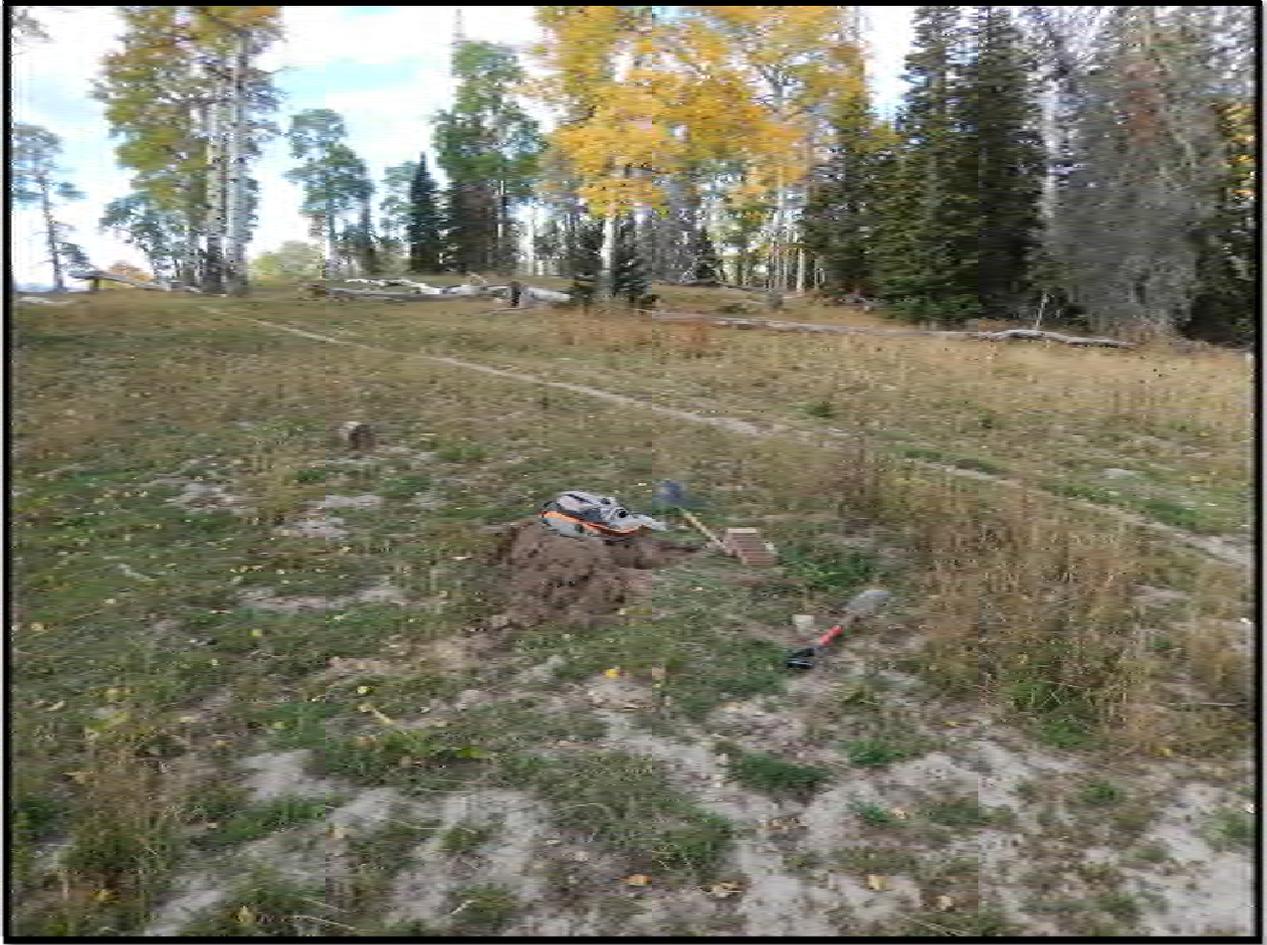
Photo B - 2. Soil profile location 14SKY08, McCadden family soil; loamy-skeletal, mixed, superactive Lithic Haplocryolls. Looking west southwest upslope across ridge. Soil is similar to Lotex (14SKY09), but it has more rock fragments.

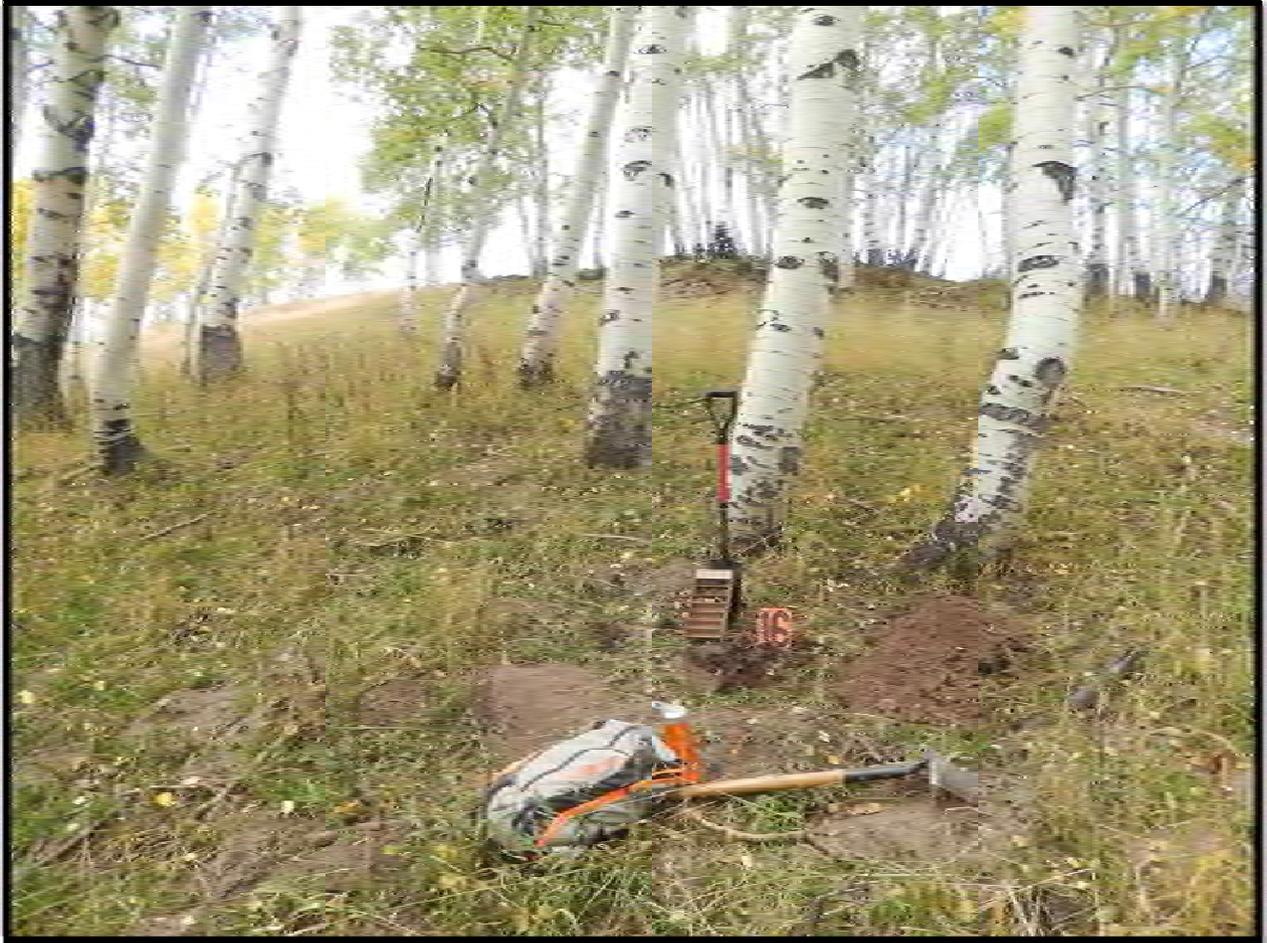
Photo B - 3. Soil profile location 14SKY09, Lotex family; loamy, mixed superactive Lithic Haplocryolls. Looking upslope along ridge. Soil is similar to McCadden (14SKY08), but it has less rock fragments. Soil number in photo is incorrect.

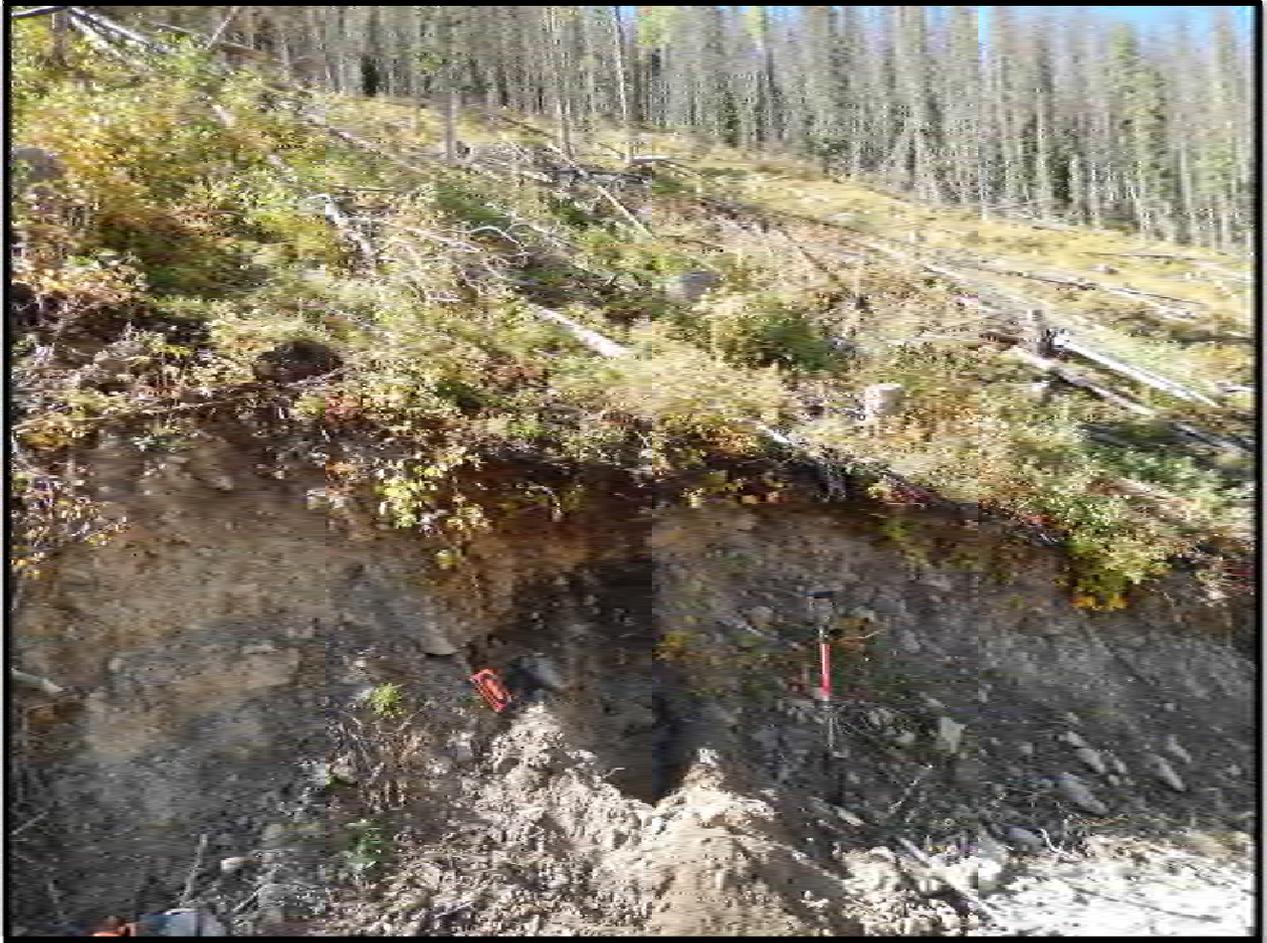
Photo B - 4. Soil profile location 14SKY10, Storm family; loamy-skeletal, mixed, superactive Typic Haplocryepts. Looking west up slope across from Skyline mine surface facilities. Area has been recently logged. Significant amount of dead conifers in adjacent stand in background. Profile is on footslope.

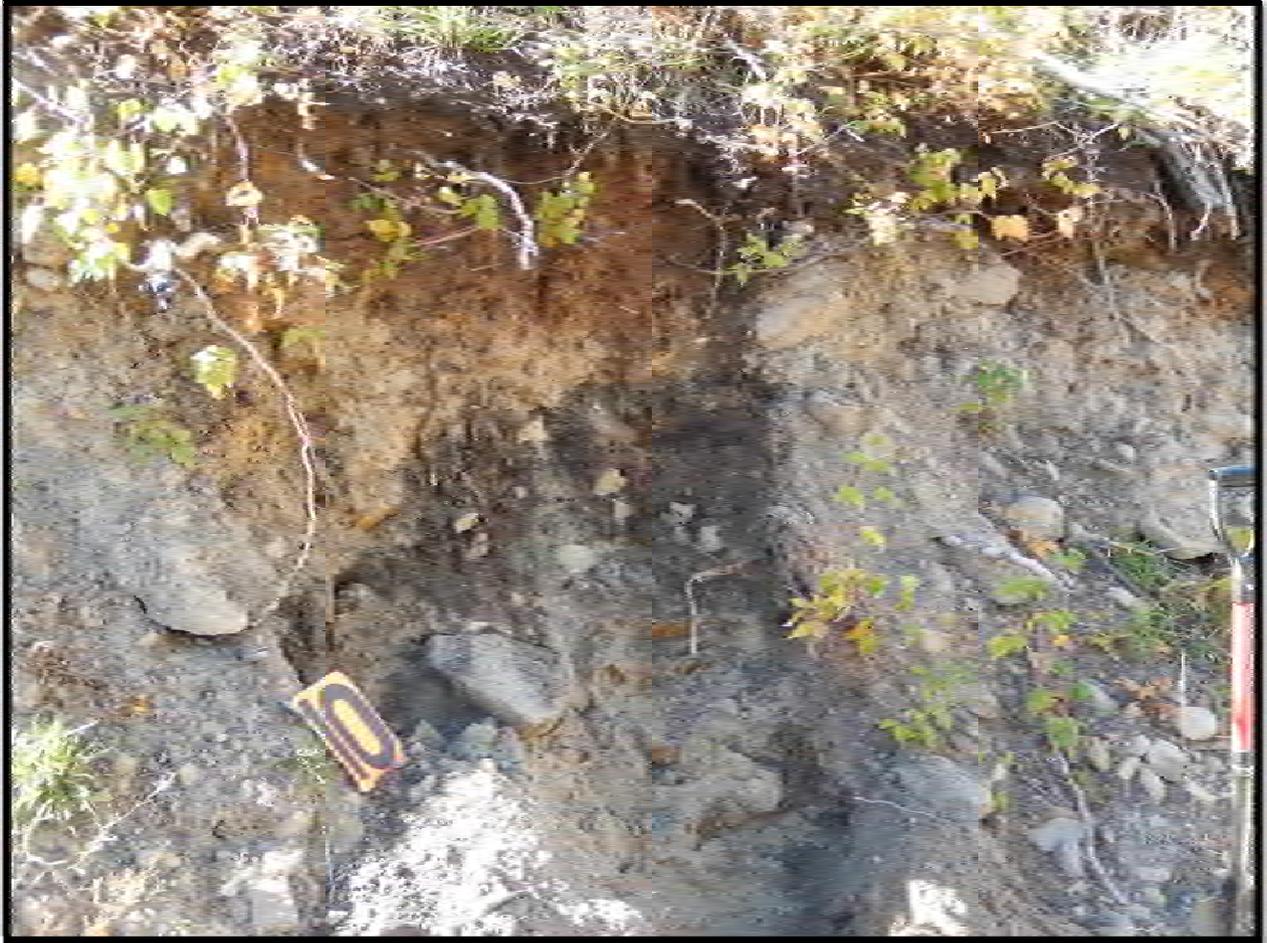
Photo B - 5. Soil profile 14SKY10, Scout family; loamy-skeletal, mixed, superactive Ustic Haplocrypts. Buried surface at 56 cm (22 inches). Scout family soils were mapped by the Manti LaSal National Forest in similar settings including the southwest end of the powerline corridor and south of Swens Pad.

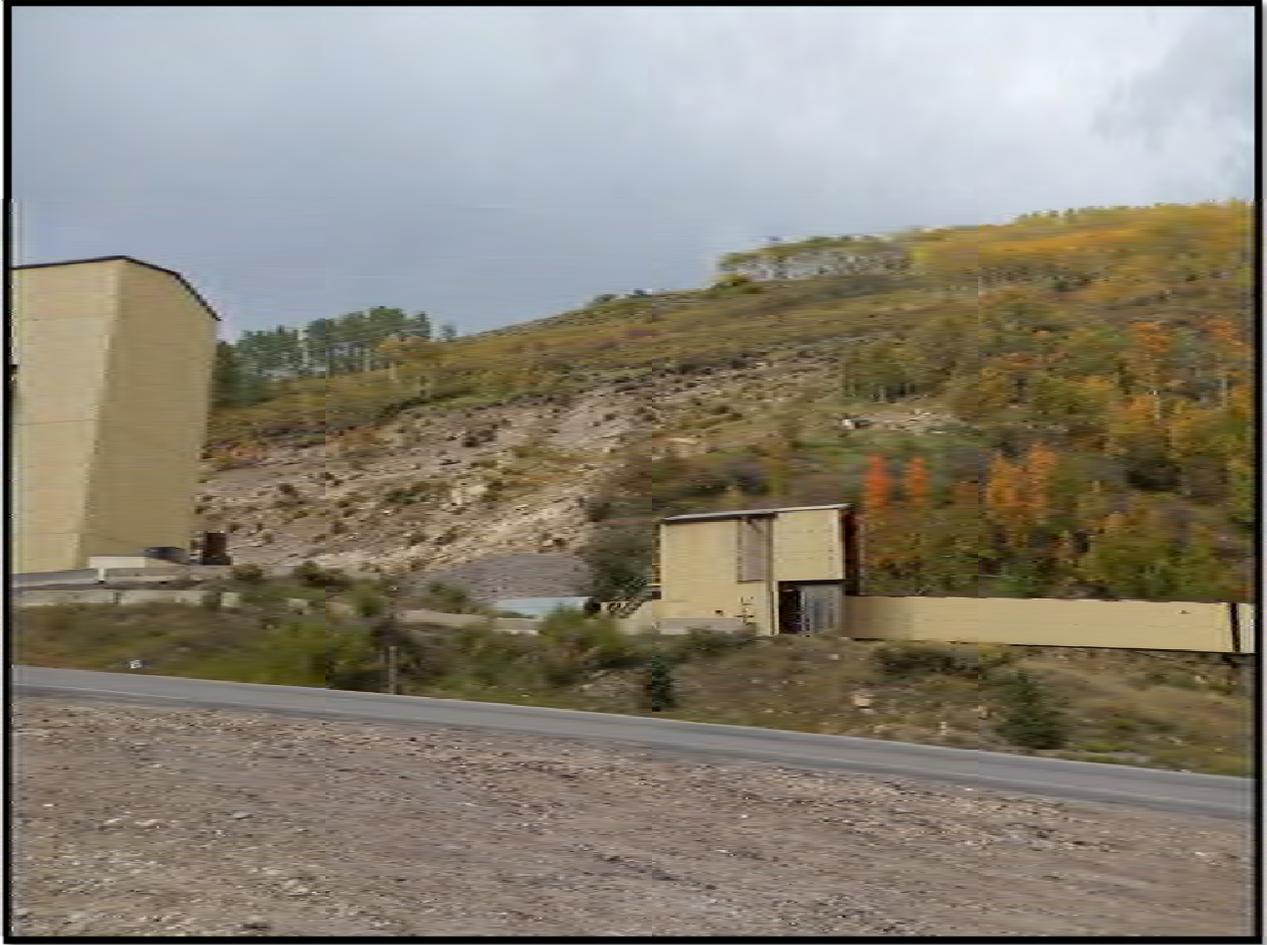
Photo B - 6. Location 14SKY11 is near sandstone outcrop near center of photo (11:00 from small conveyor building). Area has been previously disturbed. Site could not be accessed. Close-up of location can be seen in Photo B-7.

Photo B - 7. Close-up of location 14SKY11 is near exposed sandstone outcrop near center of photo as seen in Photo B-6.

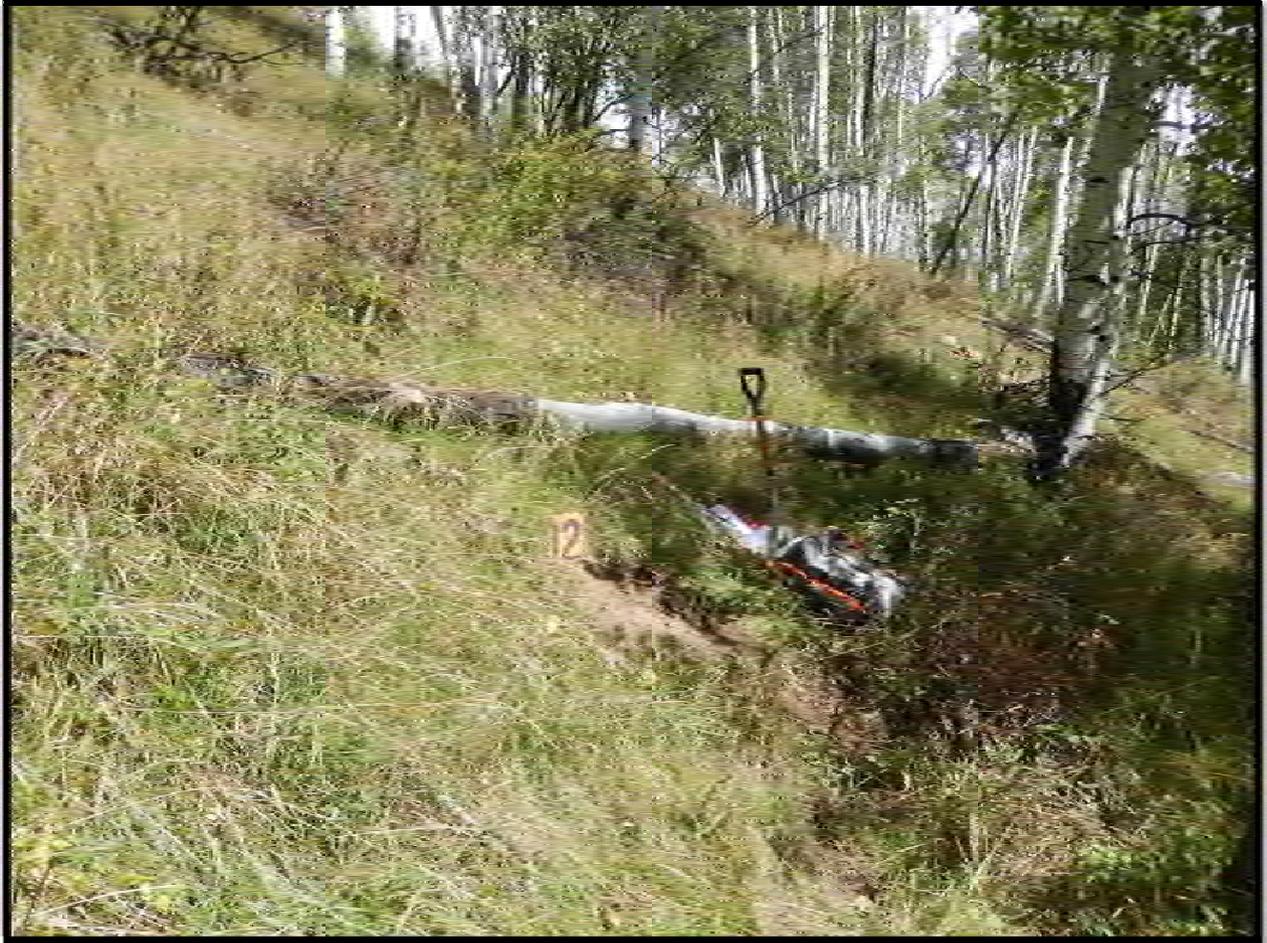
Photo B - 8. Soil profile location 14SKY12, Hailman family; coarse-loamy, mixed, superactive Pachic Haplocryolls. Looking northeast across very steep 60 percent south southeast facing slope. Soil has a thick dark surface (pachic) and a strong cambic horizon. Control section (25-100 cm or 10 to 40 inches) has less than 18 percent clay.

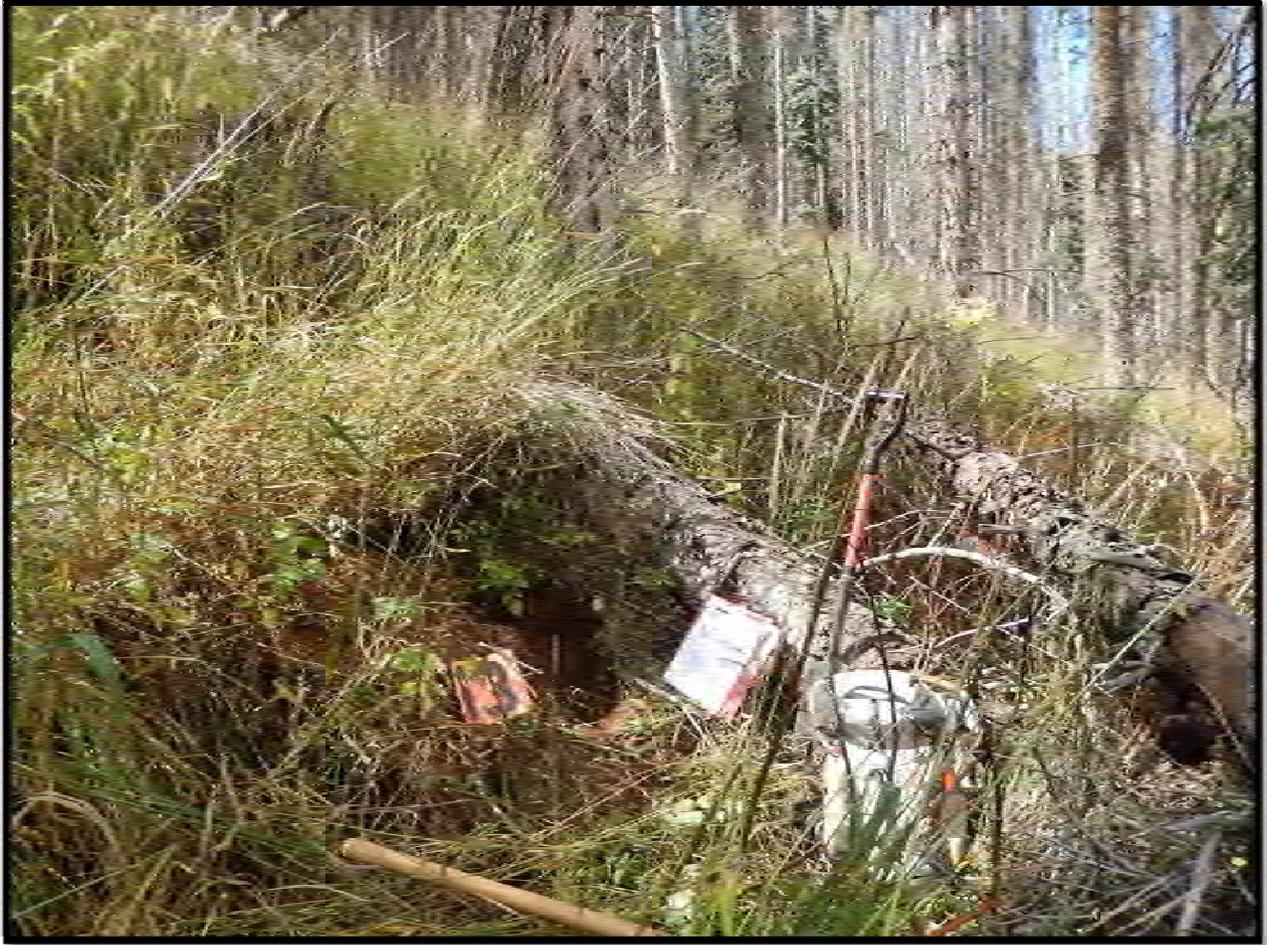
Photo B - 9. Soil profile location 14SKY13, Merino family; loamy-skeletal, mixed, superactive Lithic Haplocryepts. Location is in stand of dead lodgepole pine, subalpine fir, and Englemann spruce on north facing slope. Fallen dead trees can be seen in photo. Soil was described in hole left by fallen tree.

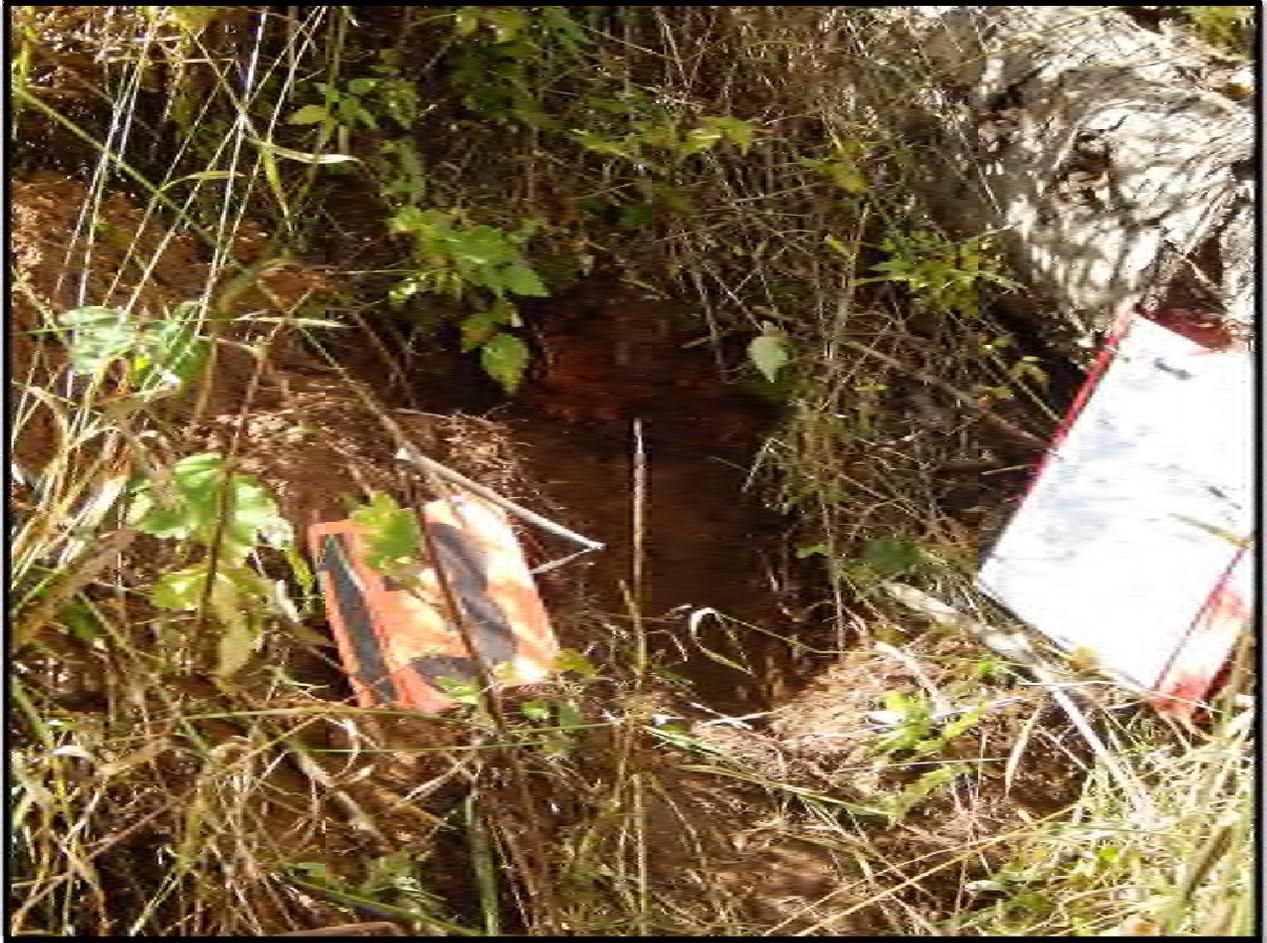
Photo B - 10. Soil profile 14SKY13, Merino family; loamy-skeletal, mixed, superactive Lithic Haplocrypts. Profile had a very thick surface of decomposing needles, twigs, and cones. Merino family soils were mapped by the Manti LaSal National Forest in the area, but primarily on ridges dominated by grasses and shrubs.

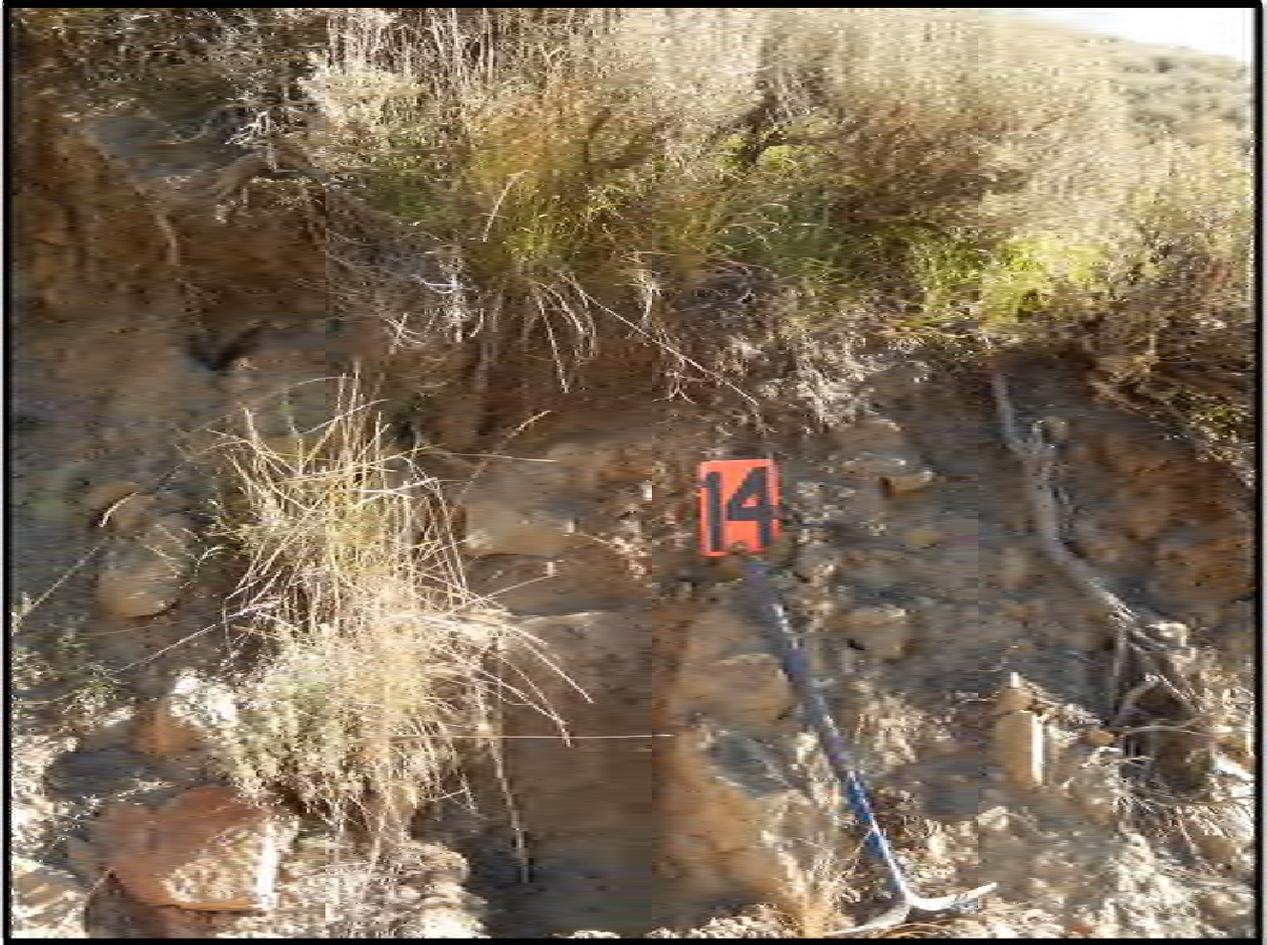
Photo B - 11. Soil profile 14SKY14, Kamack family; loamy-skeletal, mixed, superactive Typic Haplocryolls. Rock fragments are subangular sandstone. The percent clay ranges from 3 to 8 percent in the soil profile. Fractured shale is at 108 cm (42.5 inches) in this profile (dark gray at bottom of hole in photo). Profile described in roadcut along Swens Canyon road on south side of proposed "Swens Pad."

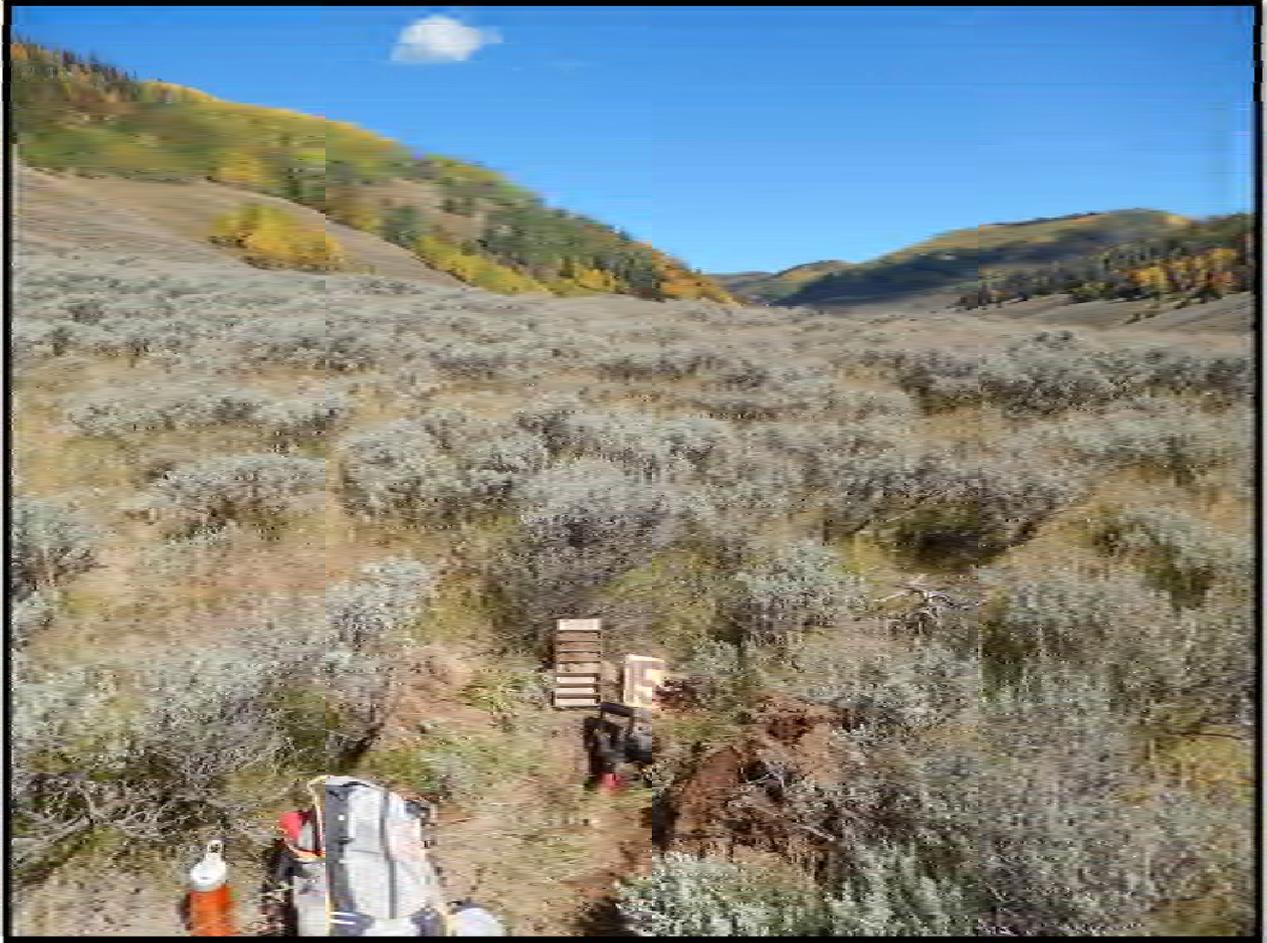
Photo B - 12. Soil profile location 14SKY15, Hailman family; coarse-loamy, mixed, superactive Pachic Haplocryolls. Looking north across proposed "Swens Pad" location. Soil is similar to the Toze family soil mapped at this location, but 14SKY15 has an weighted average 4 percent clay in the control section (25 to 100 cm or 10 to 40 inches).

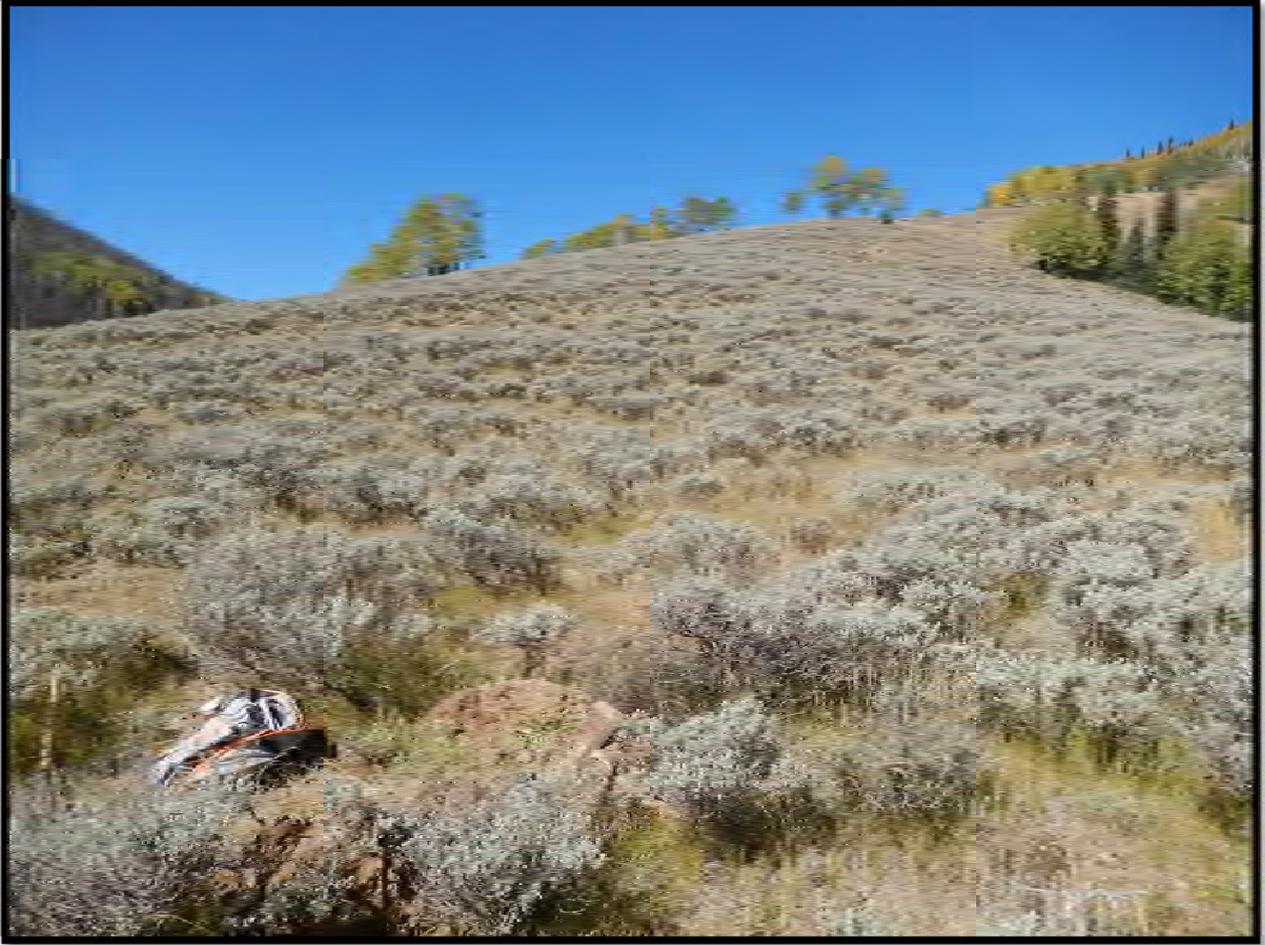
Photo B - 13. Soil profile location 14SKY15, Hailman family; coarse-loamy, mixed, superactive Pachic Haplocryolls. Looking west upslope from across profile (lower left in photo) in soil map unit S1 into the steeper S2 map unit at the proposed "Swens Pad" location.

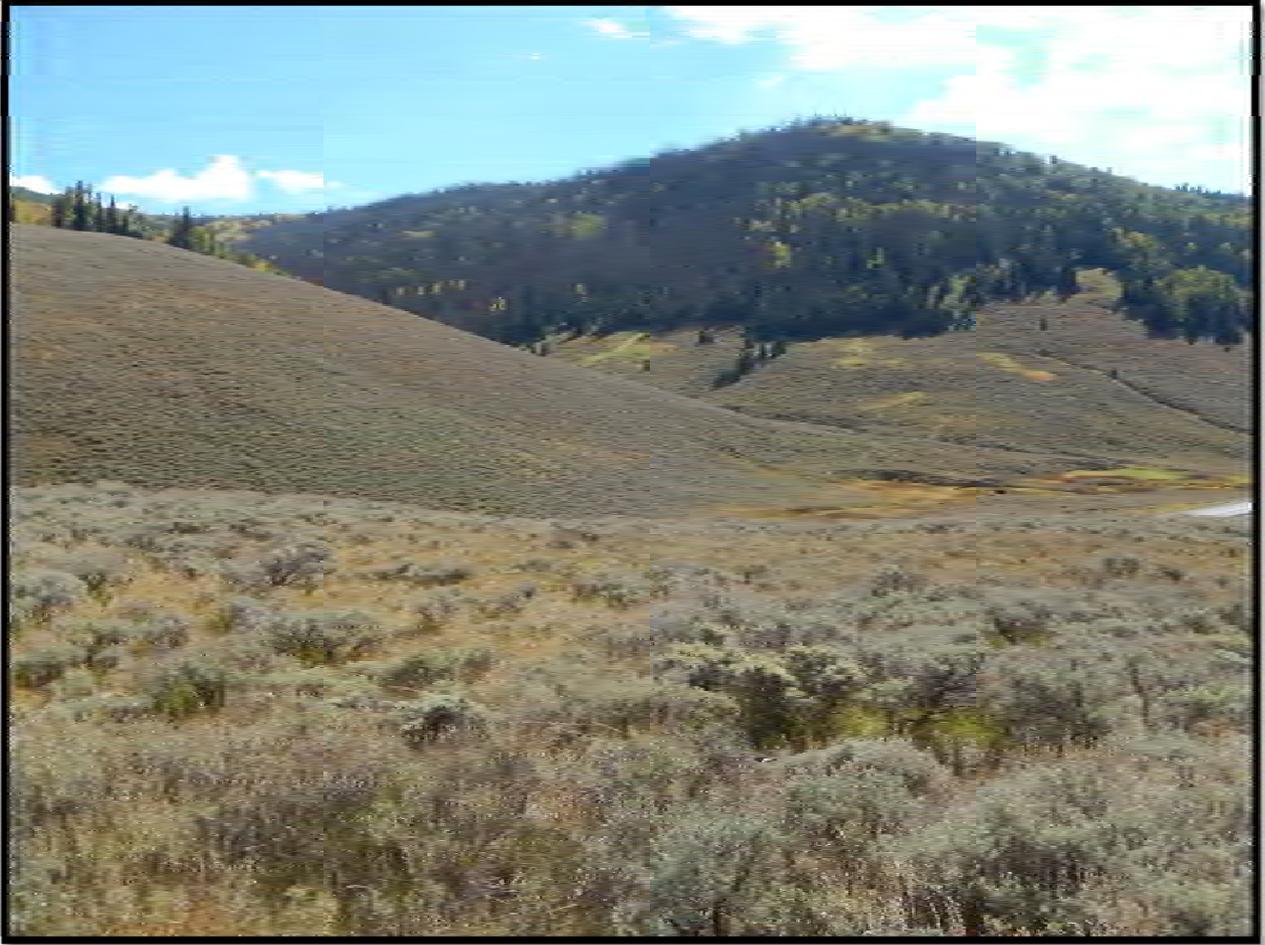
Photo B - 14. Soil profile location 14SKY15, Hailman family; coarse-loamy, mixed, superactive Pachic Haplocryolls. Looking southeast from center of proposed Swens Pad" location across Upper Huntington Canyon. Proposed powerline route will cross Upper Huntington Creek and highway (light gray on right center of photo) through an underground bore.

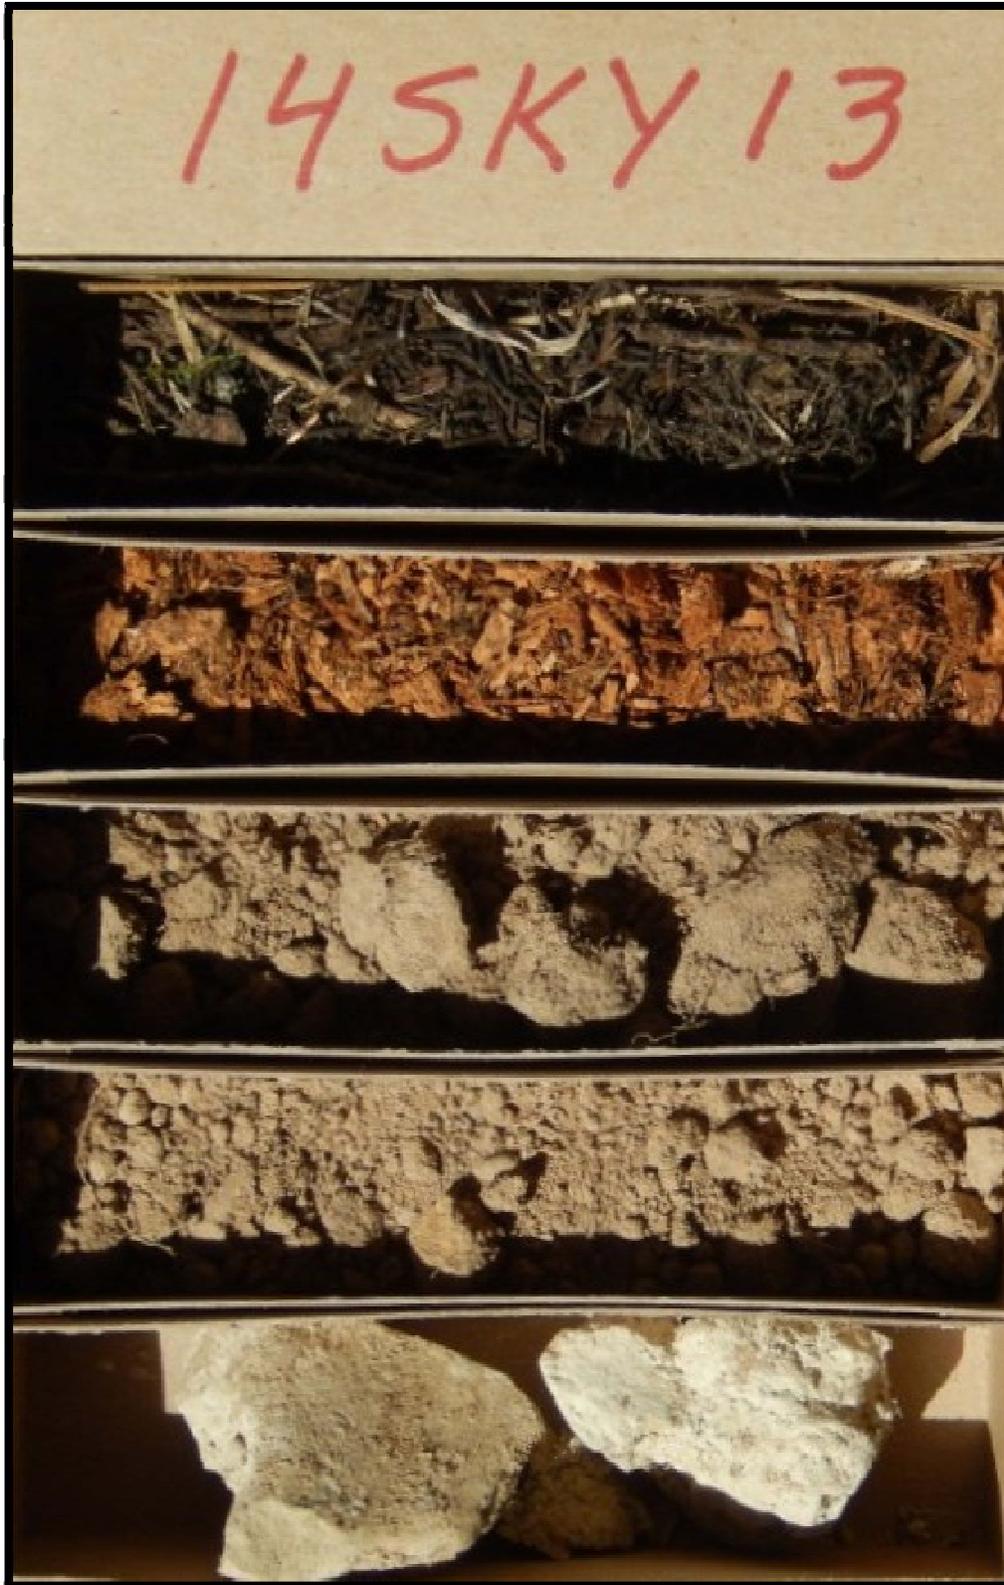
Photo C - 5. Soil profile 14SKY13, Merino family; loamy-skeletal, mixed, superactive Lithic Haplocrypts.
