Skyline Mine

RE: Swens Canyon Ventilation Facility (SCVF), Canyon Fuel Company, LLC, Skyline Mine,
C/007/0005, Task ID 4777

Title: Swens Canyon Ventilation Facility

Installation of new ventilation facility in Swens Canyon to ventilate SW Reserves. Response to Task 4777

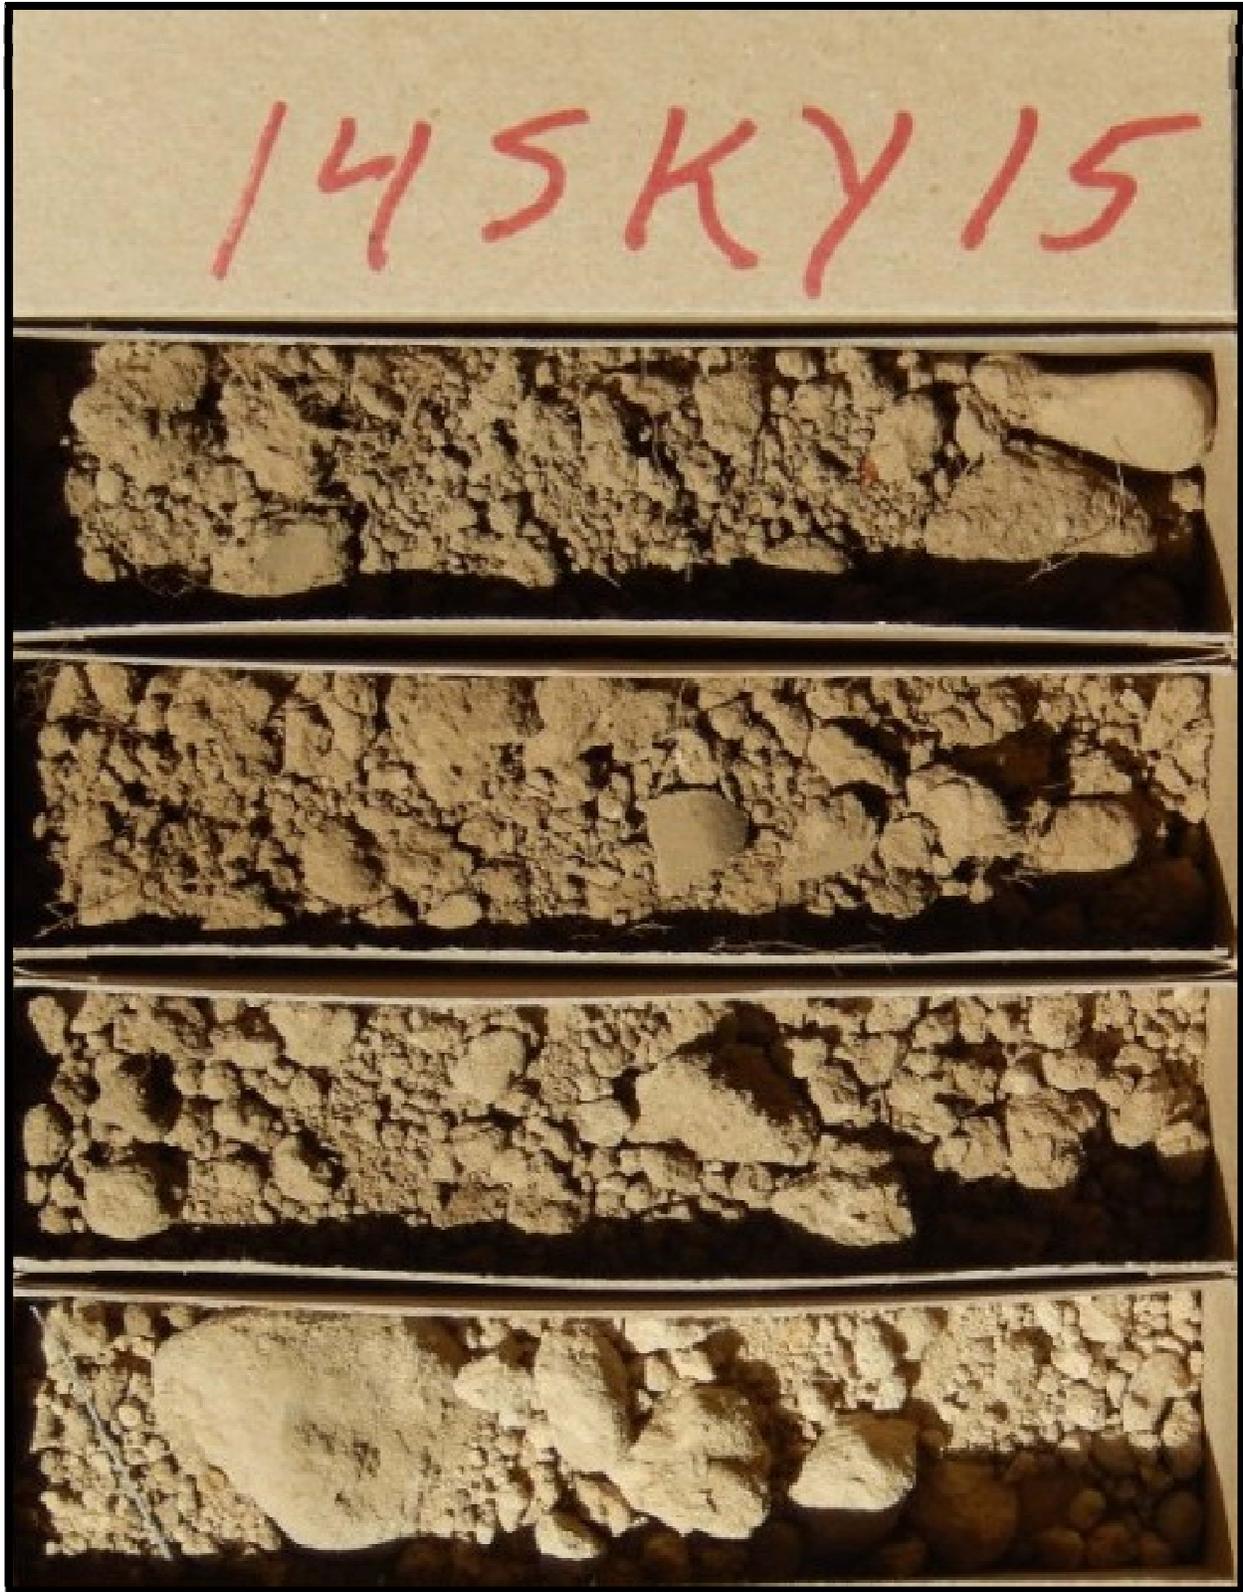
Photo C - 7. Soil profile 14SKY15, Hailman family; coarse-loamy, mixed, superactive Pachic Haplocryolls.

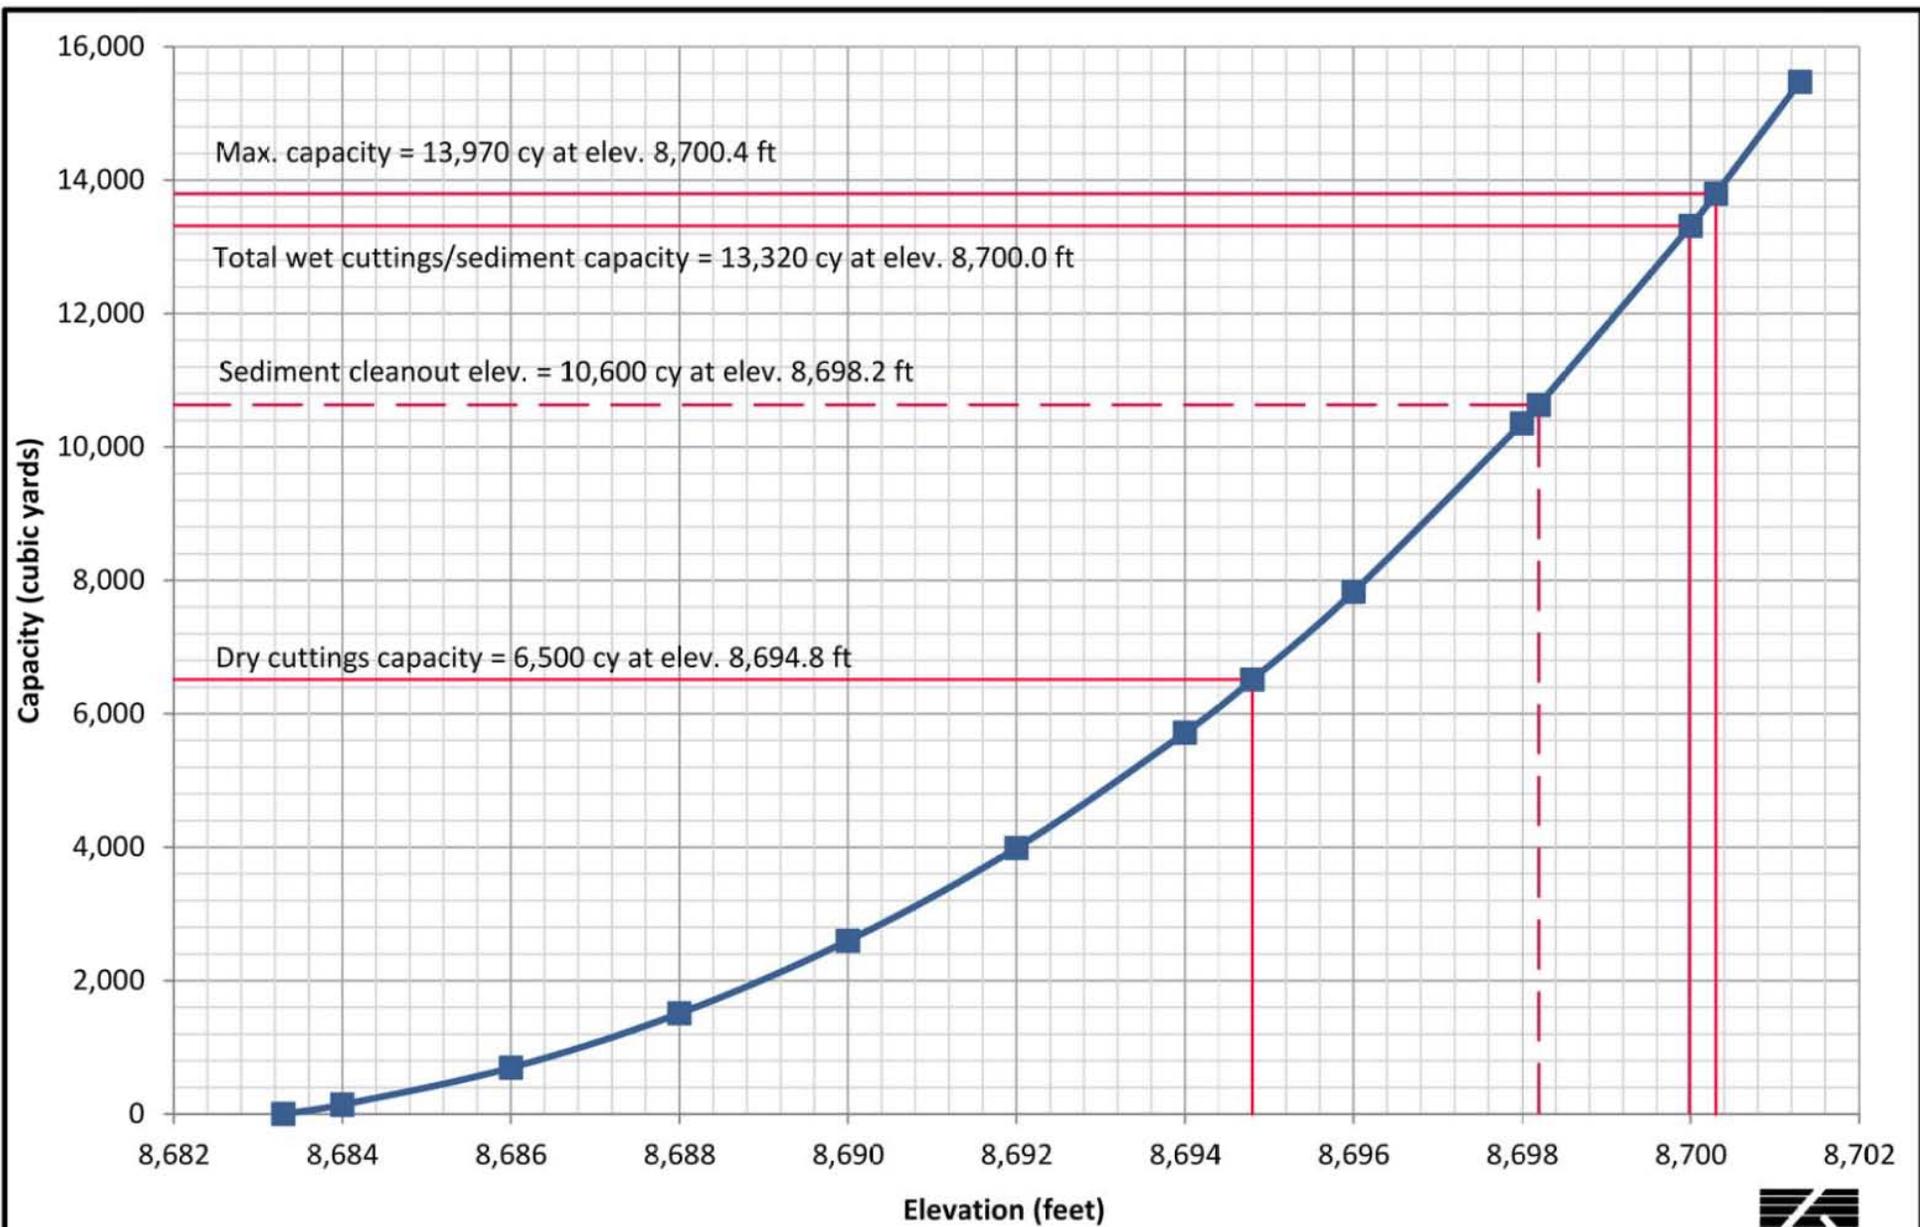
FIGURE 2. POND STAGE-CAPACITY CURVE

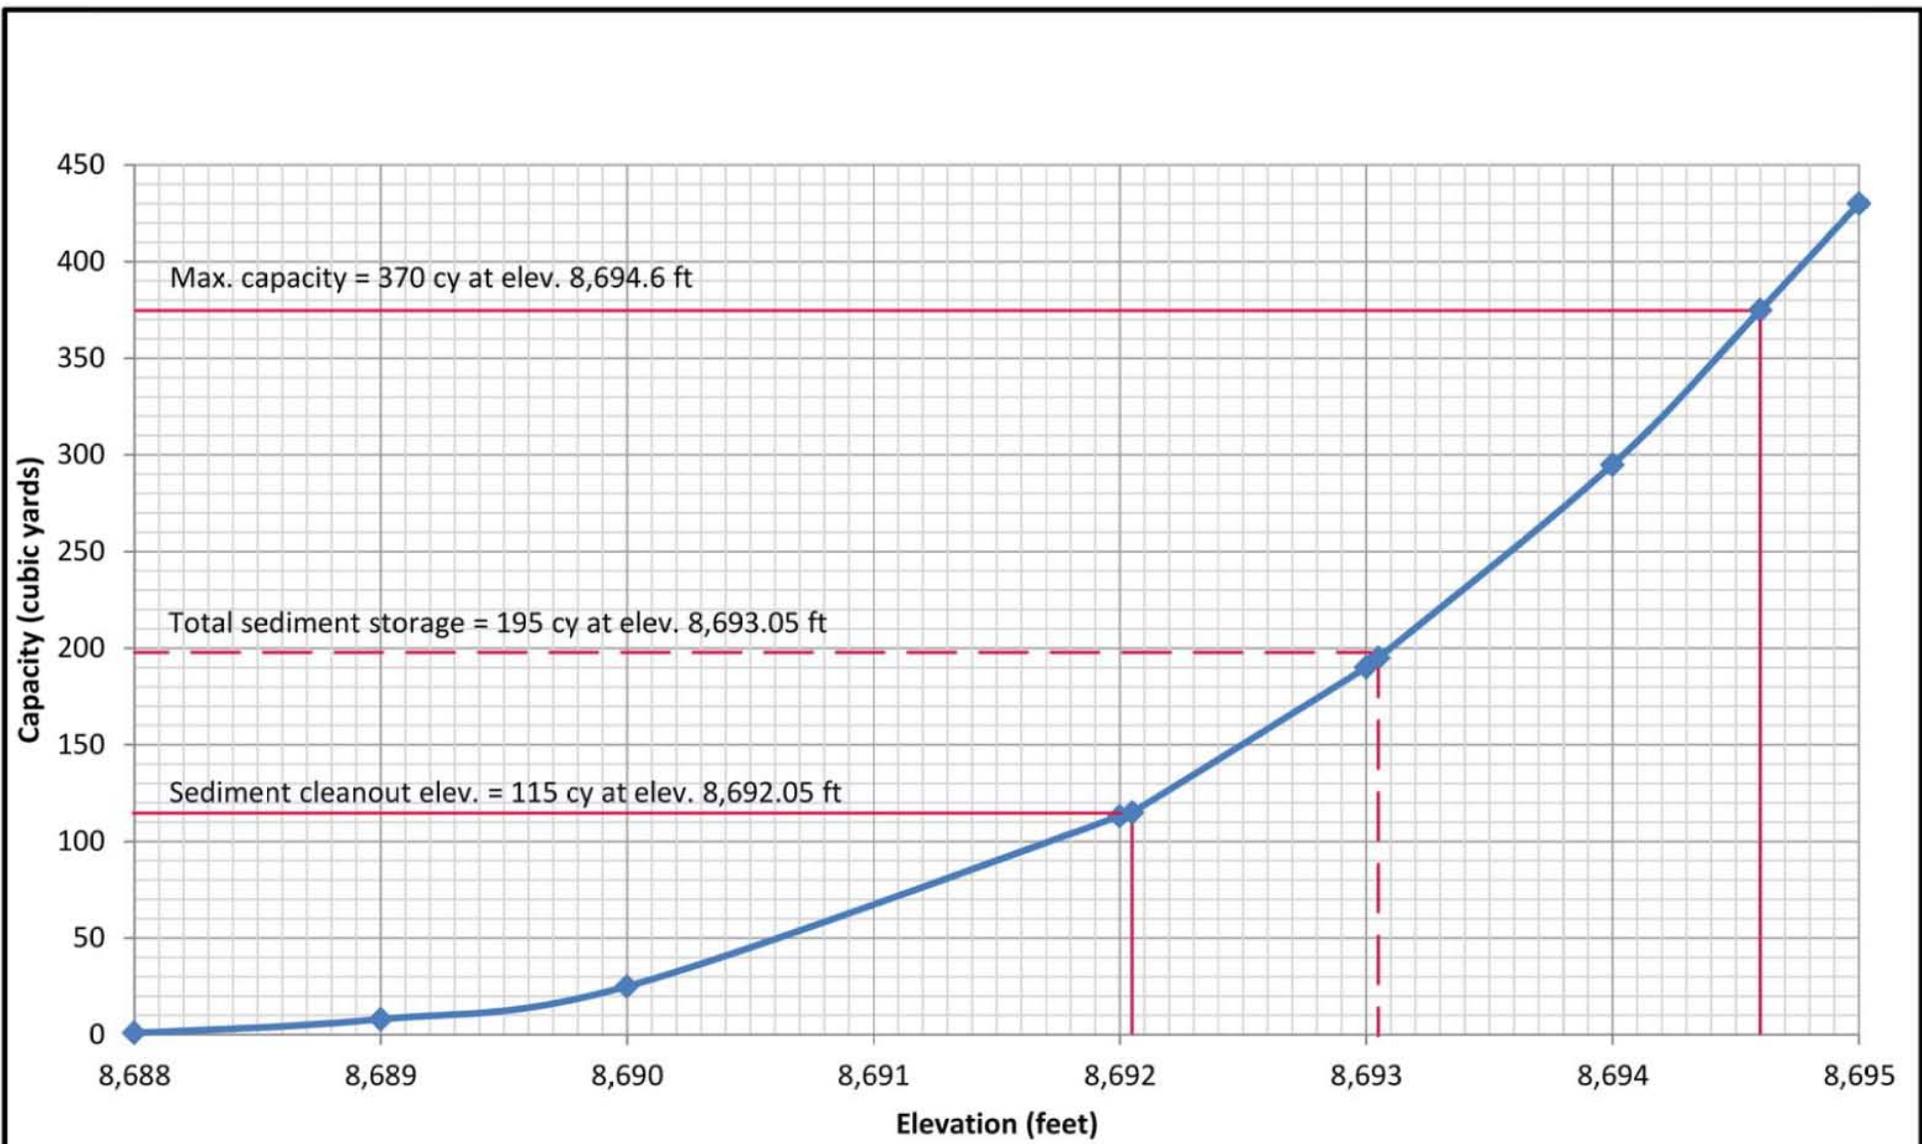
FIGURE 3. SEDIMENT BASIN STAGE-CAPACITY CURVE

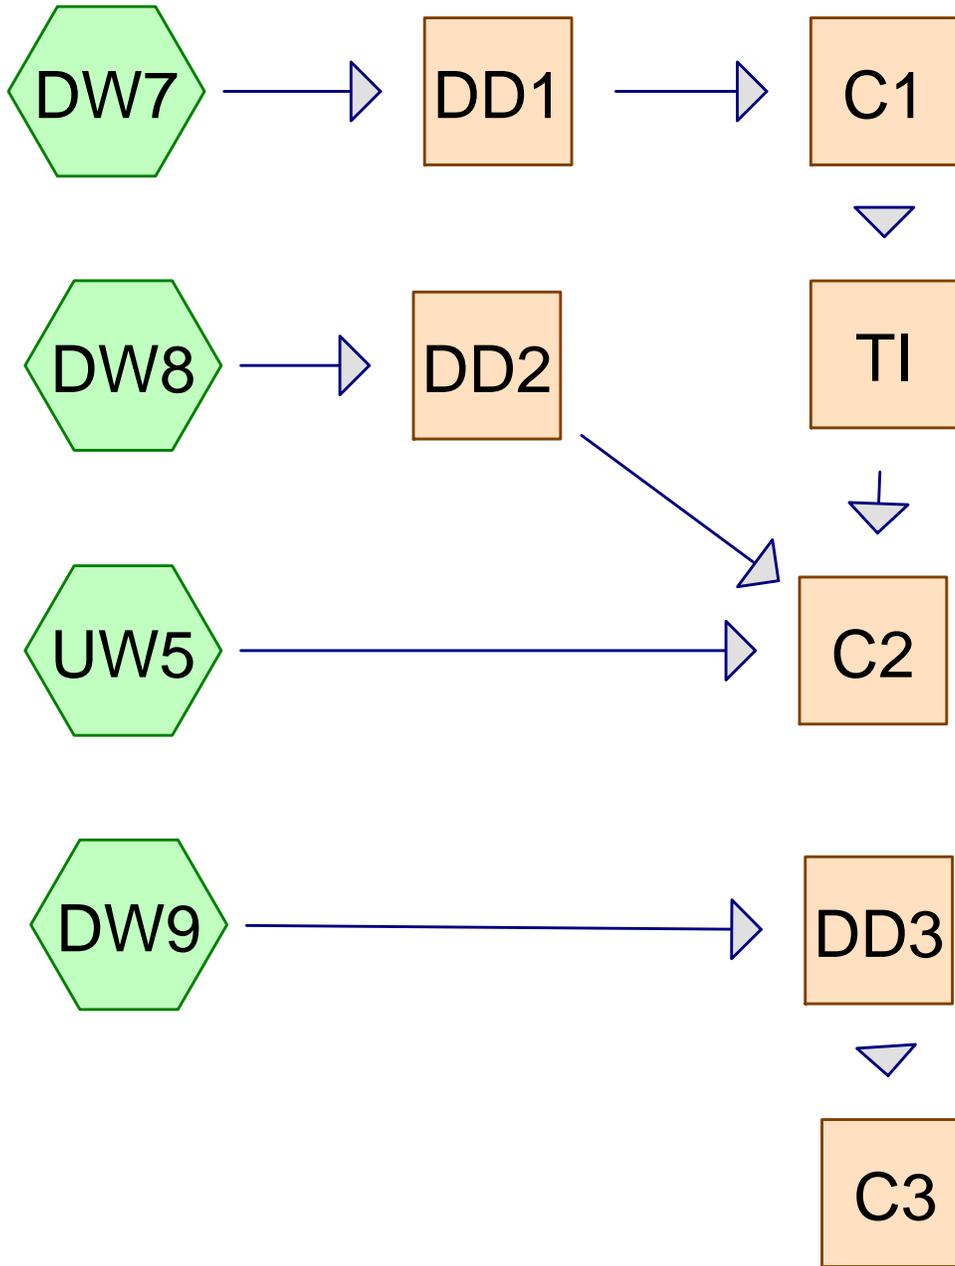
Routing Diagram for Swen Canyon Diversions
 Prepared by EarthFax Engineering Group, LLC, Printed 11/14/2014
 HydroCAD® 10.00 s/n 03900 © 2013 HydroCAD Software Solutions LLC

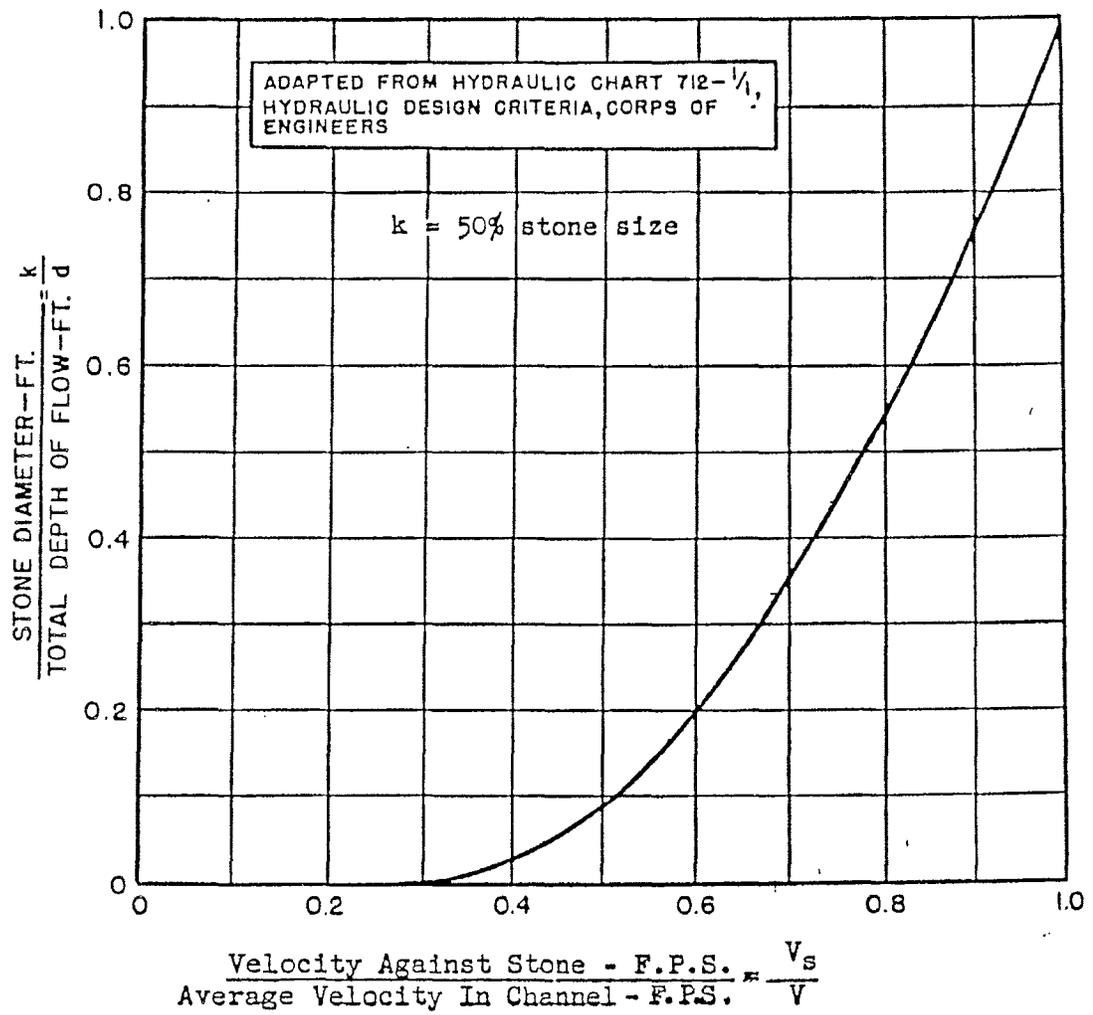
FIGURE 5-1 Velocity Against Stone on Channel Bottom (U.S. Department of Transportation, 1978).

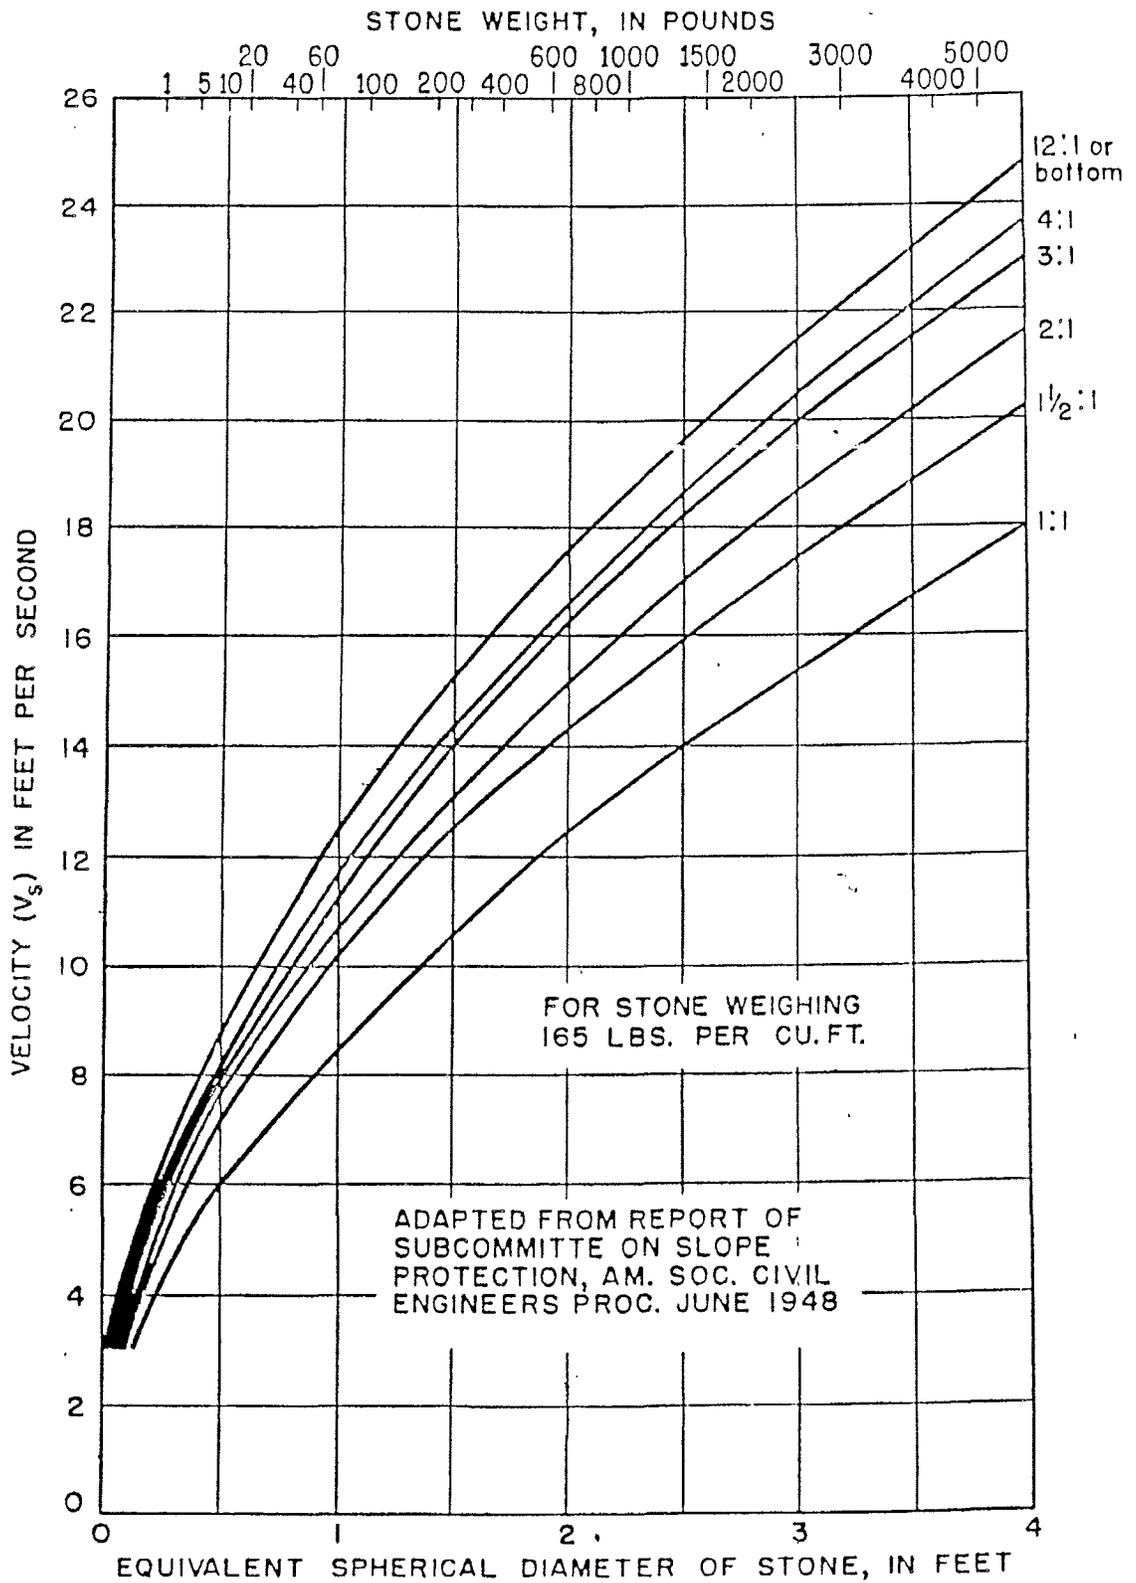
FIGURE 5-2 Size of Stone that will Resist Displacement for Various Velocities and Side Slopes (U.S. Department of Transportation, 1978).
