RE: Demonstration of abatement for Citation # 21182, Skyline Mine, Canyon Fuel Company, LLC, C/007/0005

RE: Notice of Noncompliance Report, Canyon Fuel Company, LLC., Skyline Mine, UPDES Permit UT0023540

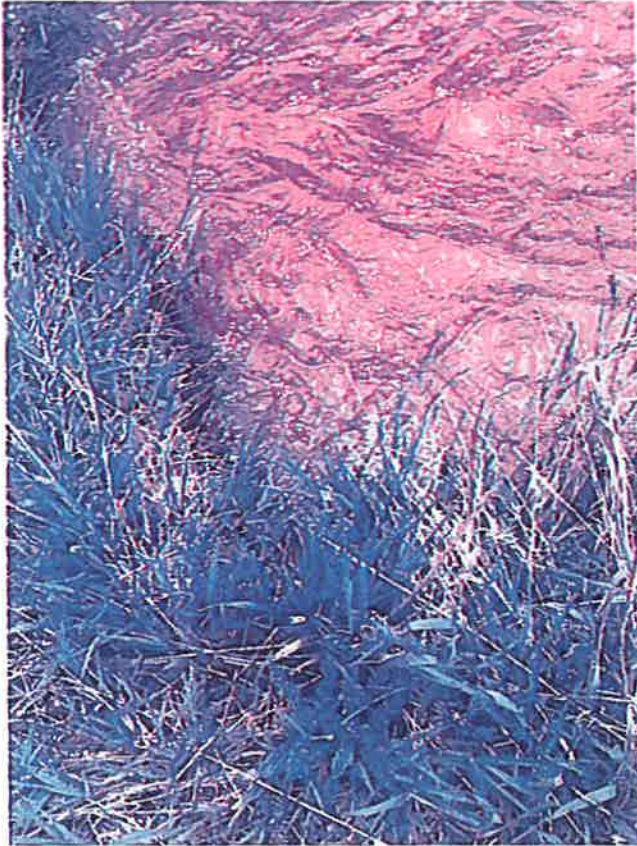
Eccles Creek @ water quality sample site ~ 20-minutes after sample was collected (5/18/16 @14:39)

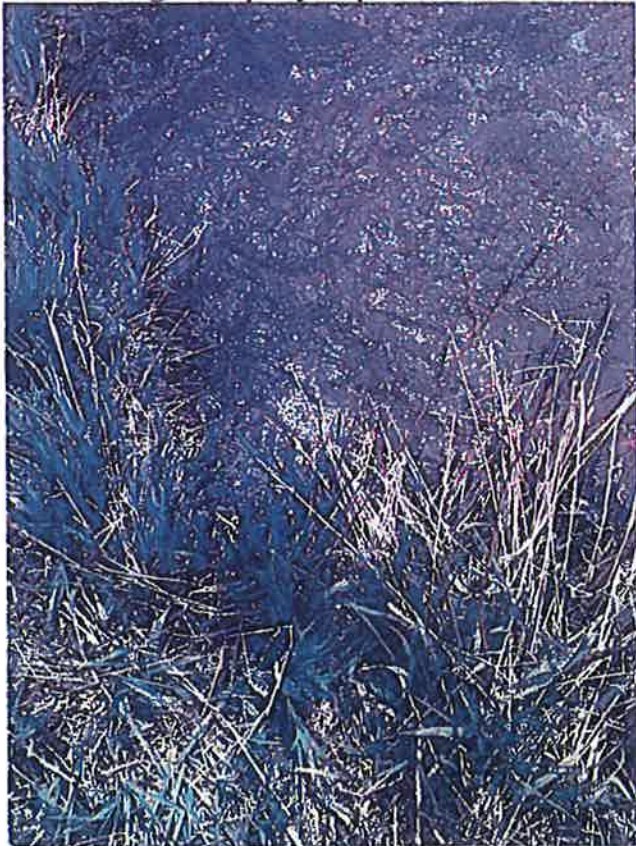
Eccles Creek @ water quality sample site (5/19/16 @ 14:55) Note: water is slightly turbid due to recent rain and snow-melt events

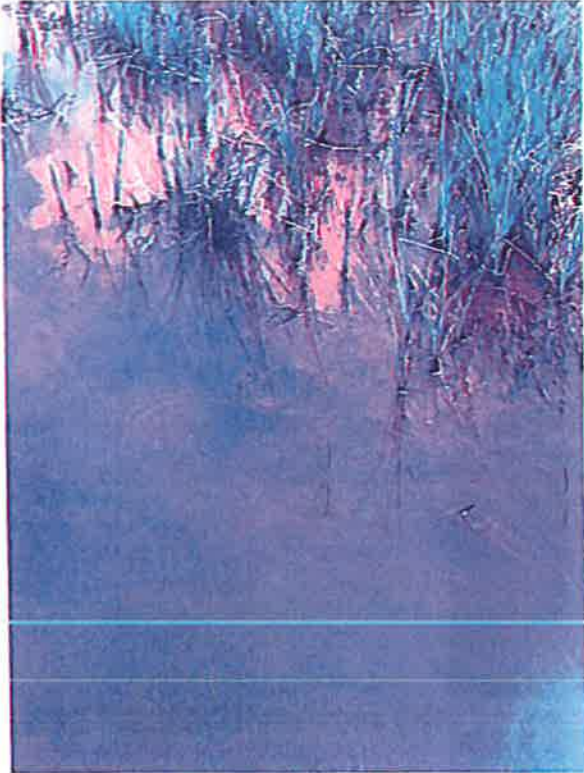
3.a. Description of Noncompliance and its cause; a volume of mine water containing iron was discharged from Discharge Point UPDES 001 into Eccles Creek. The steel pipe carrying the water apparently contained some residual iron/rust that was not completely flushed out of the pipe prior to discharging. The total estimate of iron loading to the stream was calculated to be 0.48 pounds based on the estimated discharge volume and water quality lab analysis.

Eccles Creek @ S. Fork; calm pool with residual iron approximately 1.5 hours after event (5/18/16 @ 15:22)

3.d. Steps taken to prevent a reoccurrence of the noncompliance; an in-house investigation of the personnel involved in the incident was conducted within two days of the occurrence. The 'tap-root' investigation of the incident determined: 1) All pipe sections will be thoroughly cleaned/back-flushed prior to being put into service; 2) the discharge line/pipe will be tested in its entirety prior to discharging to the creek; 3) personnel will be positioned at the outfall during initial discharge; and 4) if water containing iron is observed, personnel manning the outfall will divert the water into the sediment pond while the water is in the process of being turned off.

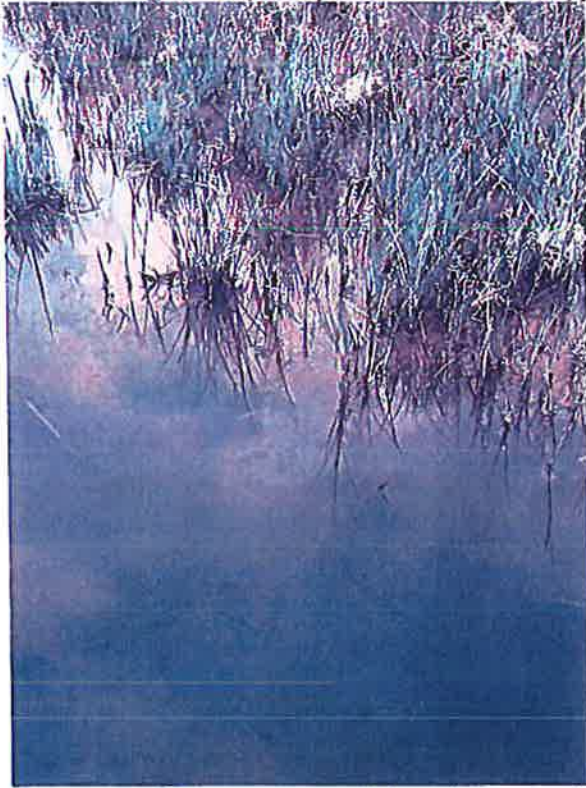
Eccles Creek @ S. Fork; same pool cleared of residual iron (5/19/16 @ 14:58) Note: water is slightly turbid due to recent rain and snow-melt events
