Inspection Report

Permit Number:	C0070005
Inspection Type:	PARTIAL
Inspection Date:	Monday, August 10, 2020
Start Date/Time:	8/10/2020 8:30:00 AM
End Date/Time:	8/10/2020 3:00:00 PM
Last Inspection:	Monday, July 13, 2020

Permitee: **CANYON FUEL COMPANY**
 Operator: **CANYON FUEL COMPANY**
 Site: **SKYLINE MINE**
 Address: **HC 35 BOX 380, HELPER UT 84526**
 County: **CARBON**
 Permit Type: **PERMANENT COAL PROGRAM**
 Permit Status: **ACTIVE**

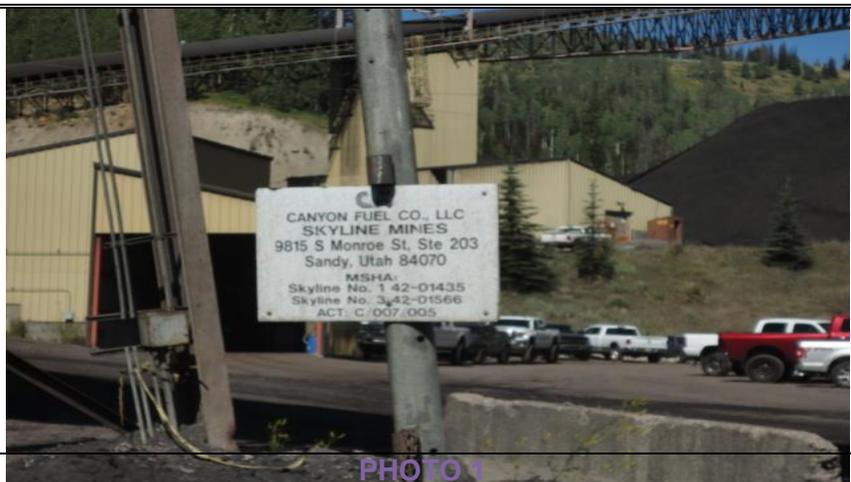
The identification sign was inspected and it meets the requirements of the R645 Coal Rules. See Photo

PHOTO 1
Identification Sign

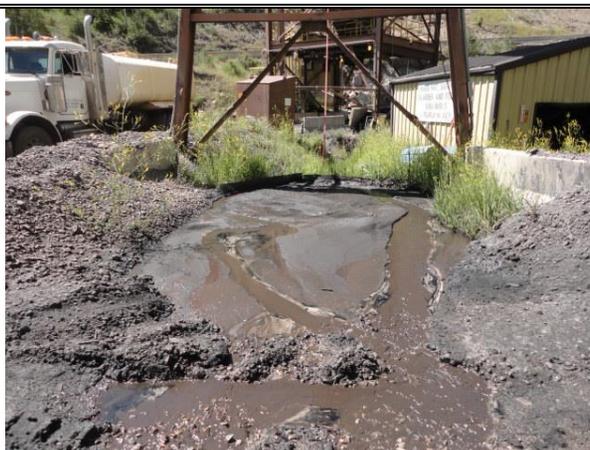
I inspected diversions and culverts throughout the property. They were open and would function as design in a storm event. See Photos.

The mine site sediment pond #001 is schedule to be clean out in the next couple of weeks. No sediment pond was discharging during the inspection. The mine water at Winterquarters is plumb/pump into discharge pipe of the sediment pond #004. I did not see any hazardous conditions to the sediment ponds. The embankments appear to be stable. The permittee conducted a second quarter sediment pond inspection on June 29, 2020. No hazardous conditions were reported.

PHOTO 2
Catch Basin by pond #001

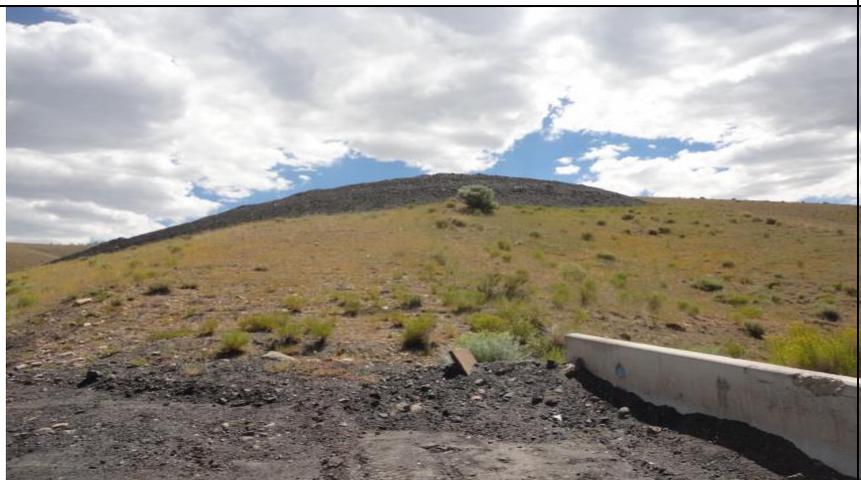
I inspected the refuse pile and it appears to be stable. I did not notice any hazardous conditions to the embankments. The refuse pile is inactive. The permittee conducted a second quarter refuse pile inspection June 23, 2020. This document is P.E. certified. No hazardous conditions were reported. See Photos

PHOTO 3
Refuse Pile

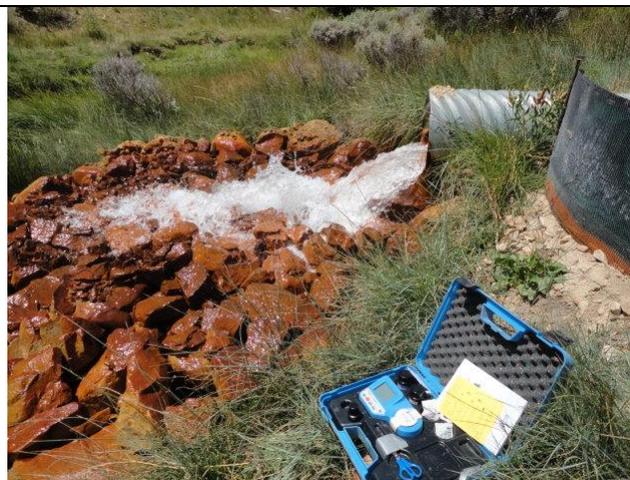
The permittee was in compliance with the UPDES permit for the second quarter. The permittee and I took a water sample of the sediment #004 at Winterquarters. It is most likely this sample will be above the maximum allowable level for total iron of 1.0 mg/l. The permittee took a portable field tester and tested the water. Twice the sample was above 1.0 mg/l. It was later determine that one of the pumps underground was not working properly. This is believed to be the cause of the higher total iron coming from the mine.

PHOTO 4
Winter Quarters Discharge at 004
