State of Utah
DEPARTMENT OF NATURAL RESOURCES
DIVISION OF OIL, GAS AND MINING

Re: Technical Field Visit to the Mudwater Canyon Fan Portals, Plateau Mining Corporation, Star Point Mine, C/007/006

Date & Time: November 27, 2000, 10:00 AM to 12:00 PM

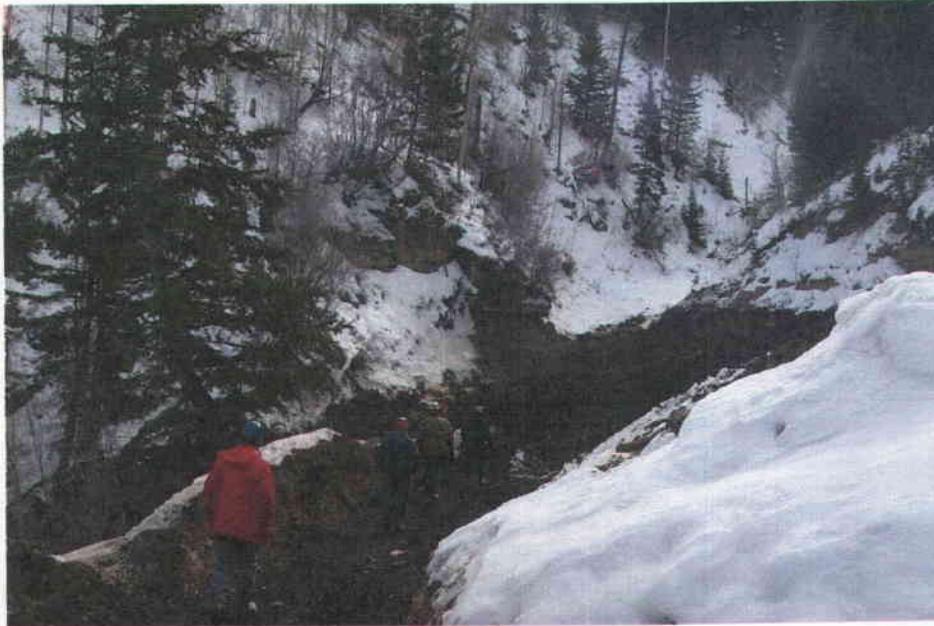
Demolition of the fan and associated buildings was complete, and the area where these structures once stood has been regraded (Figure 1). We felt the grading blends fairly well with the area uphill (Figure 2).

Figure 1. General area of the fan portal.

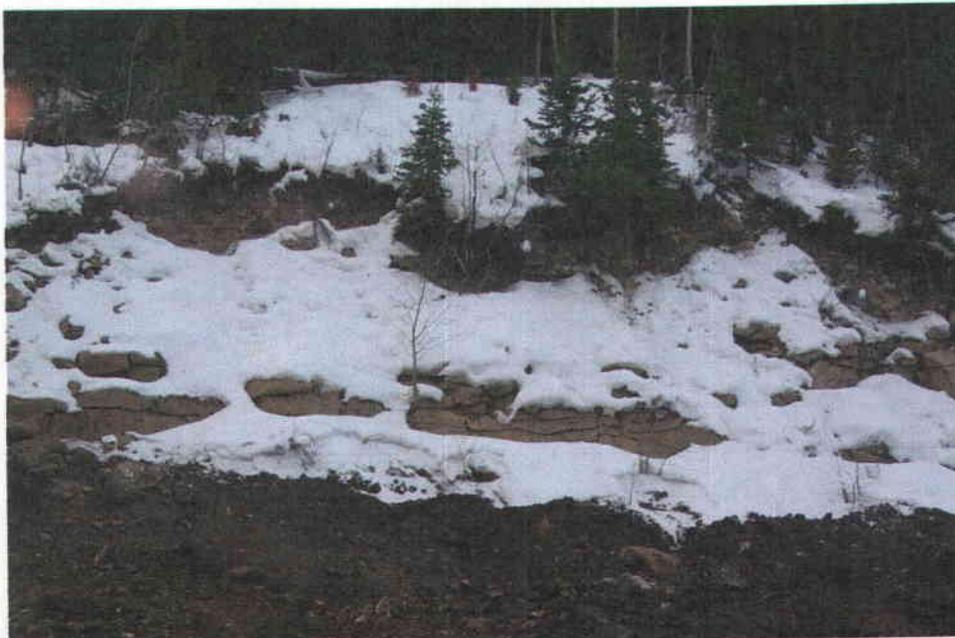
Figure 2. Area uphill from fan portal.

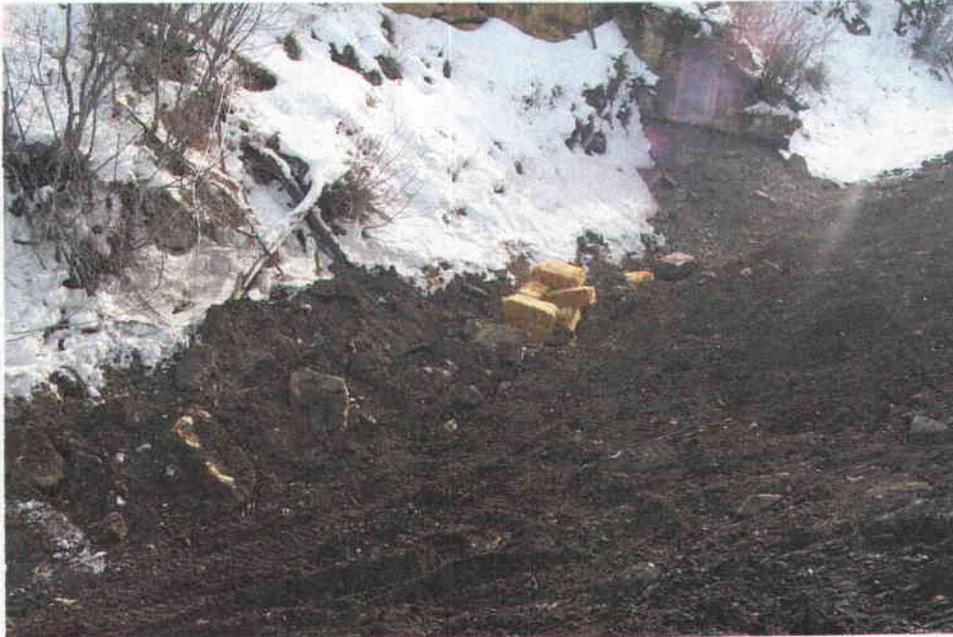
There is an old portal that Plateau backfilled ~~it~~ to make the area safer (Figure 3). They are not responsible for this area under Title V of SMCRA.

Figure 3. Backfilled abandoned portal (upper right).

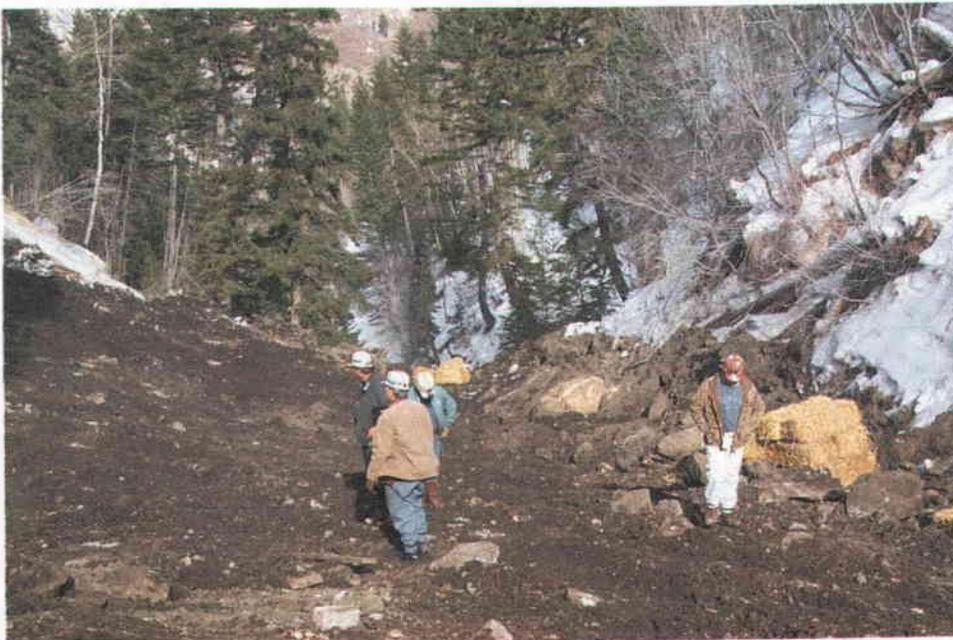
Through most of the regraded area, the channel is not very steep, but it drops off rather suddenly (Figures 4 and 5). According to Mr. Burggraf, this transition area is at a location where bedrock is near the surface. The channel was not designed, but there is a lot of rock that was put in the steep part. We asked the operator to place additional rock at the transition area between the steep and not-so-steep areas.

Figure 4. Area just above the steep slope going down to the undisturbed channel.

The operator needs to place rock at the top of the reclaimed channel in an effort to prevent a nickpoint where erosion can begin. Also, the break in slope between the disturbed and undisturbed areas needs to be reduced as much as possible.

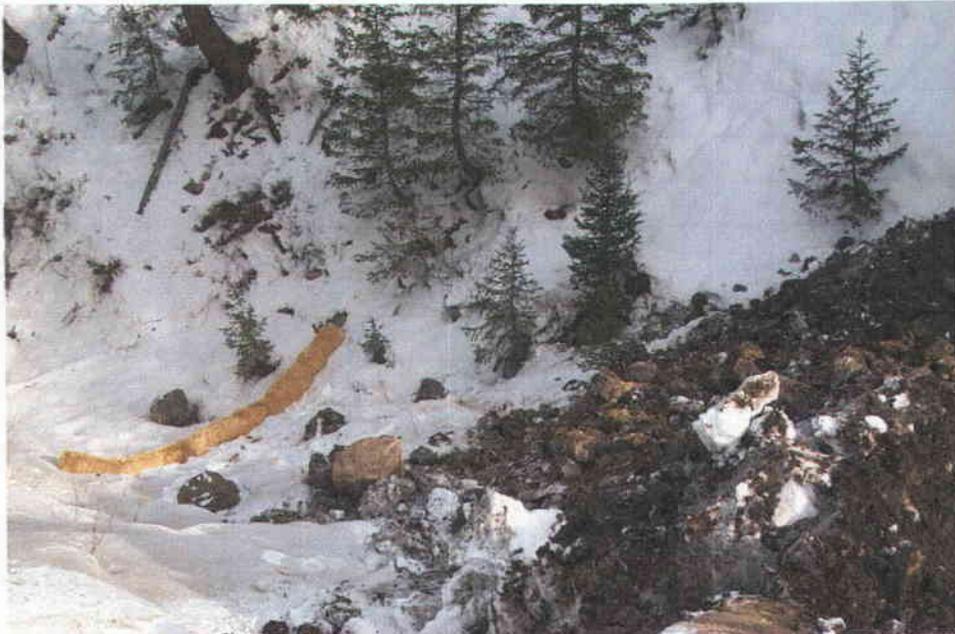
Figure 5. Steep slope going down to the undisturbed channel.

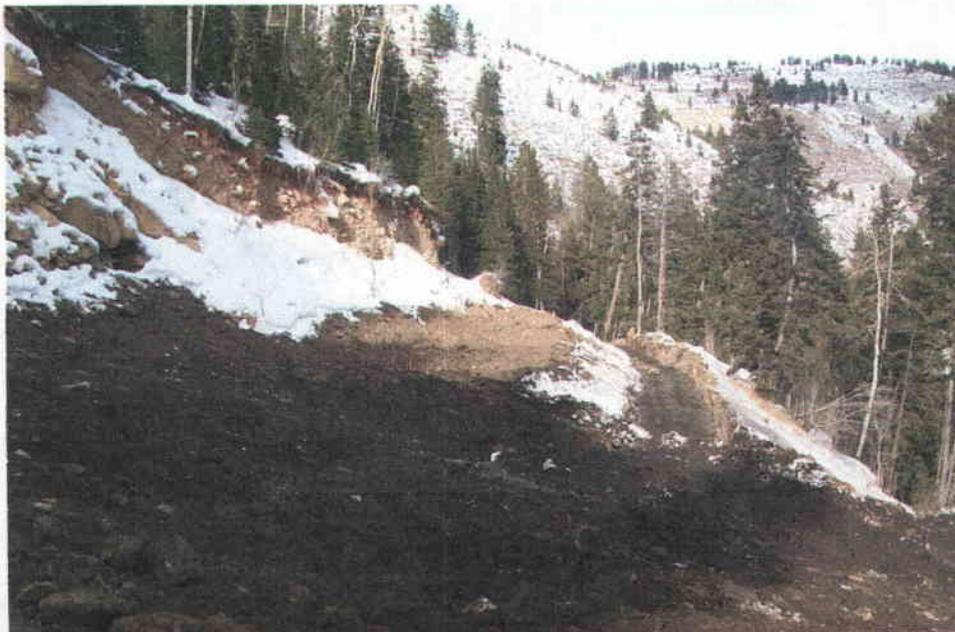
We expressed some concern about the break in the slope from the disturbed to the undisturbed areas (Figure 6). Although the operator plans to reduce this as much as possible, it will not be possible to completely eliminate it. There is a potential for some erosion in this area, but because we expect rapid vegetation establishment, the erosion should not be excessive.

Figure 6. Break in the slope between the disturbed and undisturbed areas.
