Inspection Report

Table with 2 columns: Field, Value. Fields include Permit Number (C0070012), Inspection Type (PARTIAL), Inspection Date (Wednesday, May 11, 2005), Start Date/Time (5/11/2005 12:00:00 PM), End Date/Time (5/11/2005 2:30:00 PM), Last Inspection (Thursday, April 28, 2005).

Permittee: NEVADA ELECTRIC INVESTMENT CO
Operator: NEVADA ELECTRIC INVESTMENT CO
Site: WELLINGTON PREPARATION PLANT
Address: 330 E 400 S STE 6, PO BOX 337 SPRINGVILLE UT 84663
County: CARBON
Permit Type: PERMANENT COAL PROGRAM
Permit Status: ACTIVE

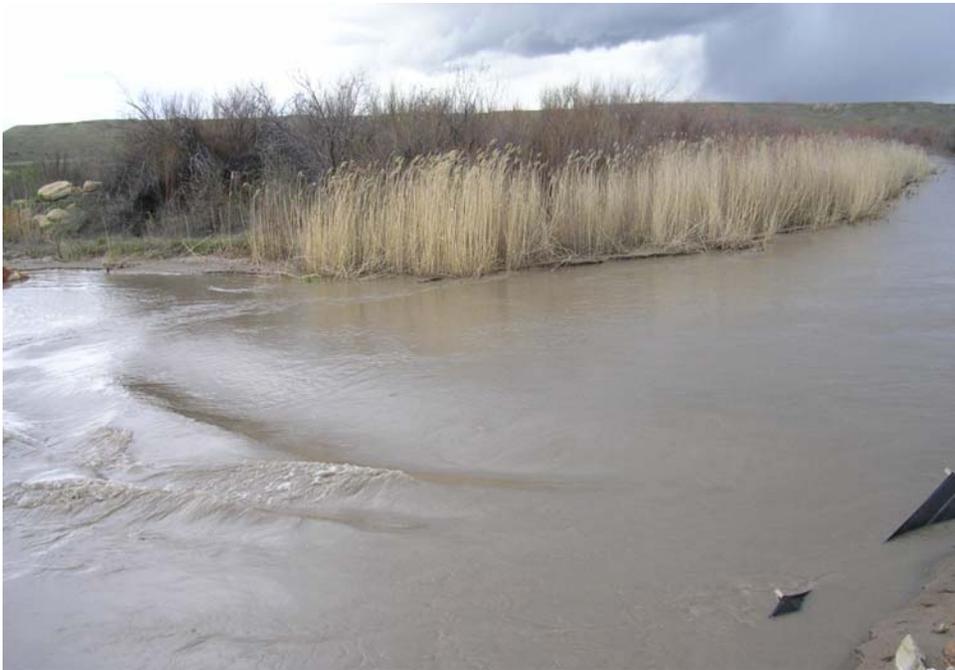
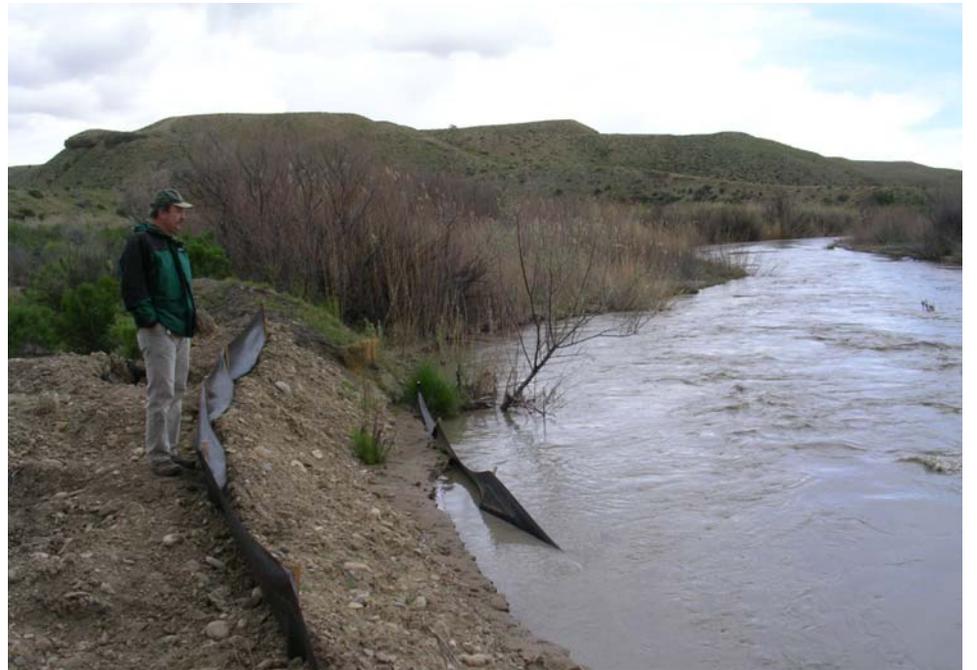
Rain previous night has swollen the Price River and overtopped the silt fence at the recently reclaimed river pumphouse. Ironically, recently seeded areas were dry.

Price River had overtopped the silt fence at the river's edge in the vicinity of the river pumphouse reclamation. This silt fence will be repaired as soon as the river subsides (photo attached)
