## Inspection Report

Permit Number:	C0070013
Inspection Type:	PARTIAL
Inspection Date:	Tuesday, July 29, 2008
Start Date/Time:	7/29/2008 8:50:00 AM
End Date/Time:	7/29/2008 10:15:00 AM
Last Inspection:	Tuesday, July 15, 2008

Permittee: **UTAHAMERICAN ENERGY INC**  
 Operator: **UTAHAMERICAN ENERGY INC**  
 Site: **HORSE CANYON MINE**  
 Address: **PO BOX 986, PRICE UT 84501**  
 County: **CARBON**  
 Permit Type: **PERMANENT COAL PROGRAM**  
 Permit Status: **ACTIVE**

The Permittee reported an illegal trespass through a reclaimed area (sediment pond #1) to the Division on July 28, 2008. The trespass occurred on or about July 19, 2008. Approximately 1175 feet of road was established through the reclaimed area which is being considered as part of the Phase III bond release application. The road width is approximately eleven feet; this equates to 0.3 acres of re-disturbance. The trespass was developed as part of the ATV trail being developed through this area.

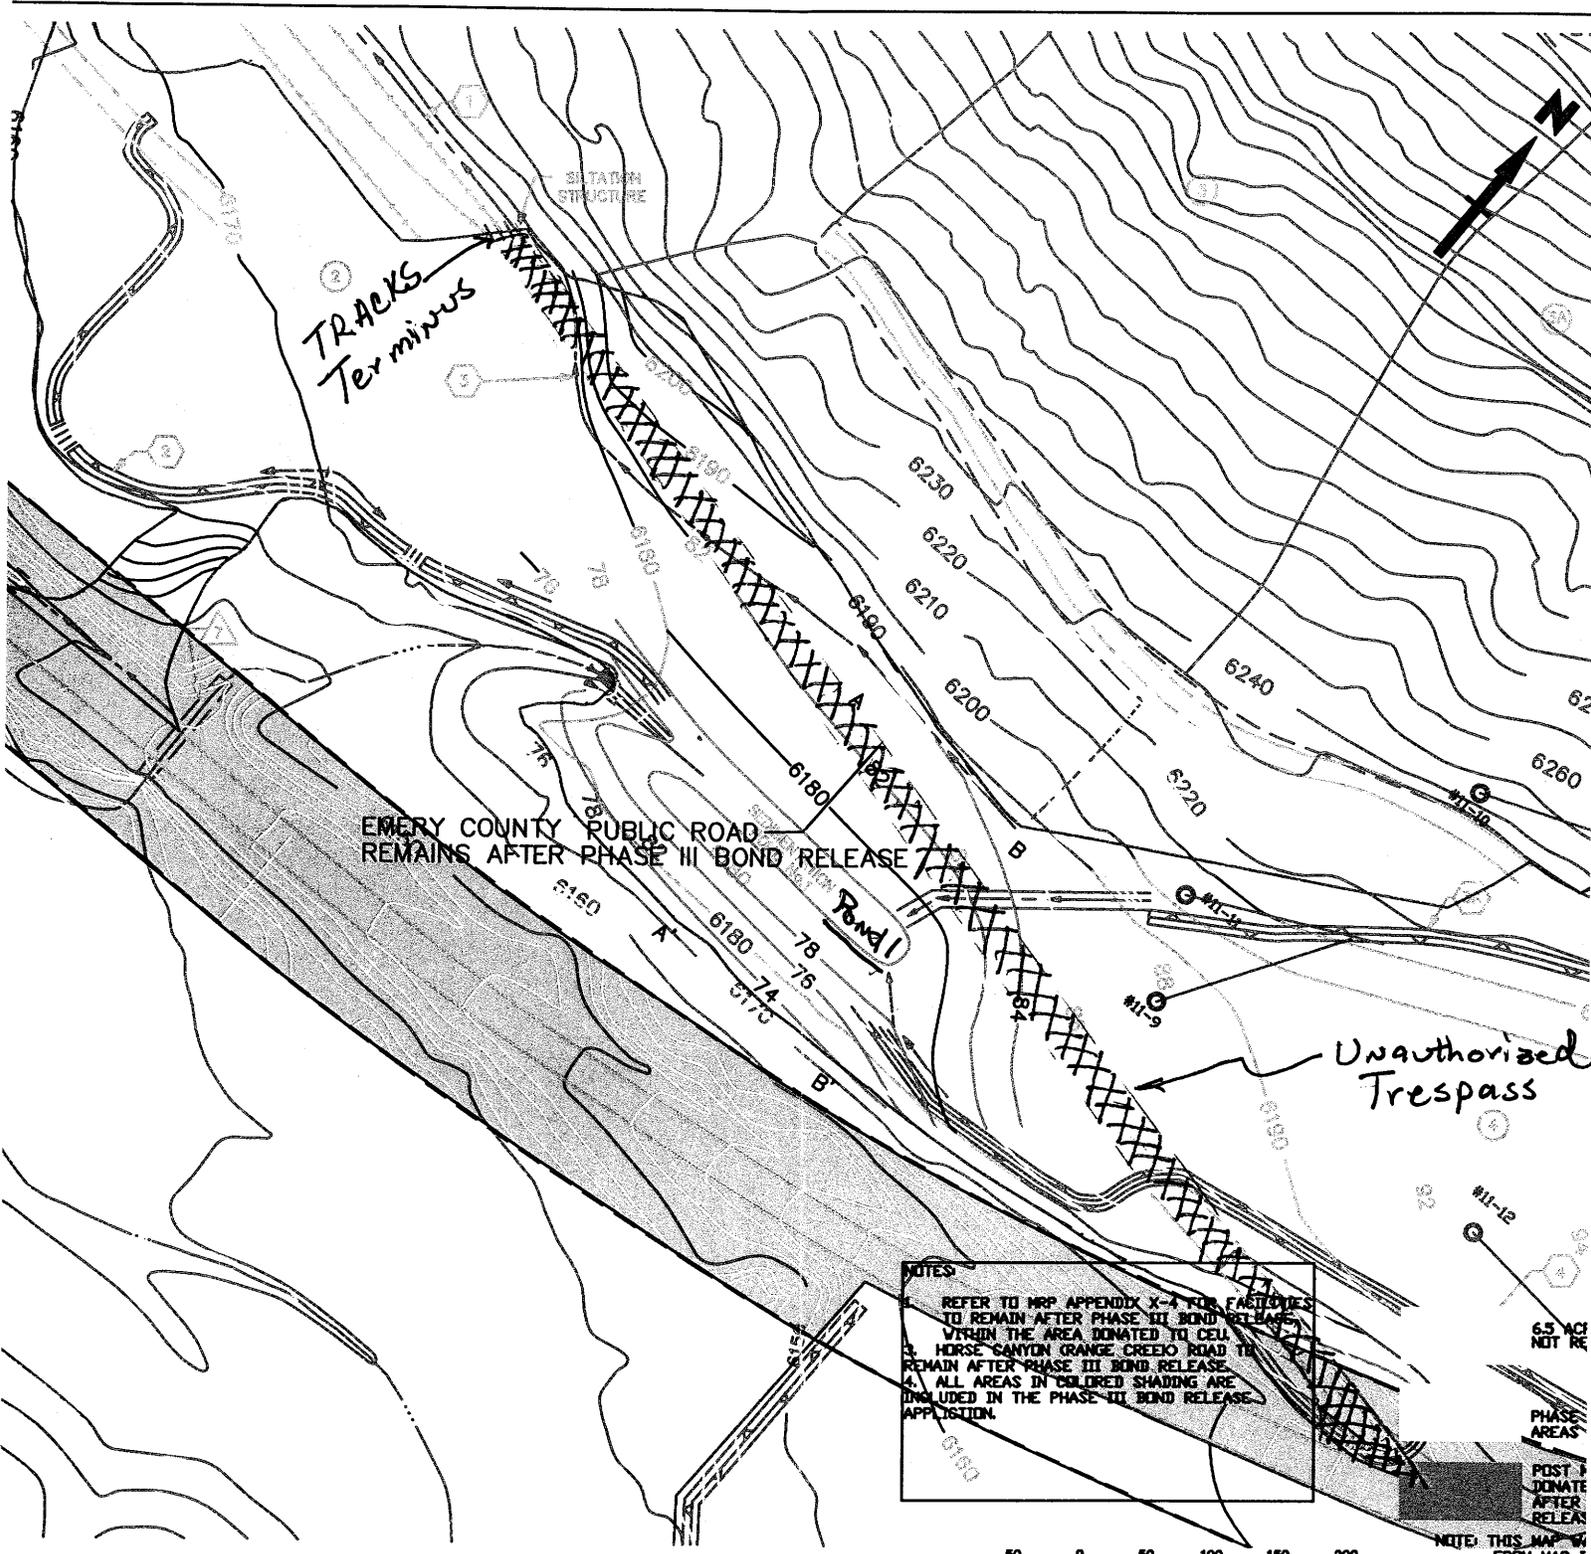
NOTES  
 REFER TO MRP APPENDIX X-4 FOR FACILITIES TO REMAIN AFTER PHASE III BOND RELEASE WITHIN THE AREA DONATED TO CELL HORSE CANYON CREEK ROAD TO REMAIN AFTER PHASE III BOND RELEASE. ALL AREAS IN DOTTED SHADING ARE INCLUDED IN THE PHASE III BOND RELEASE APPLICATION.

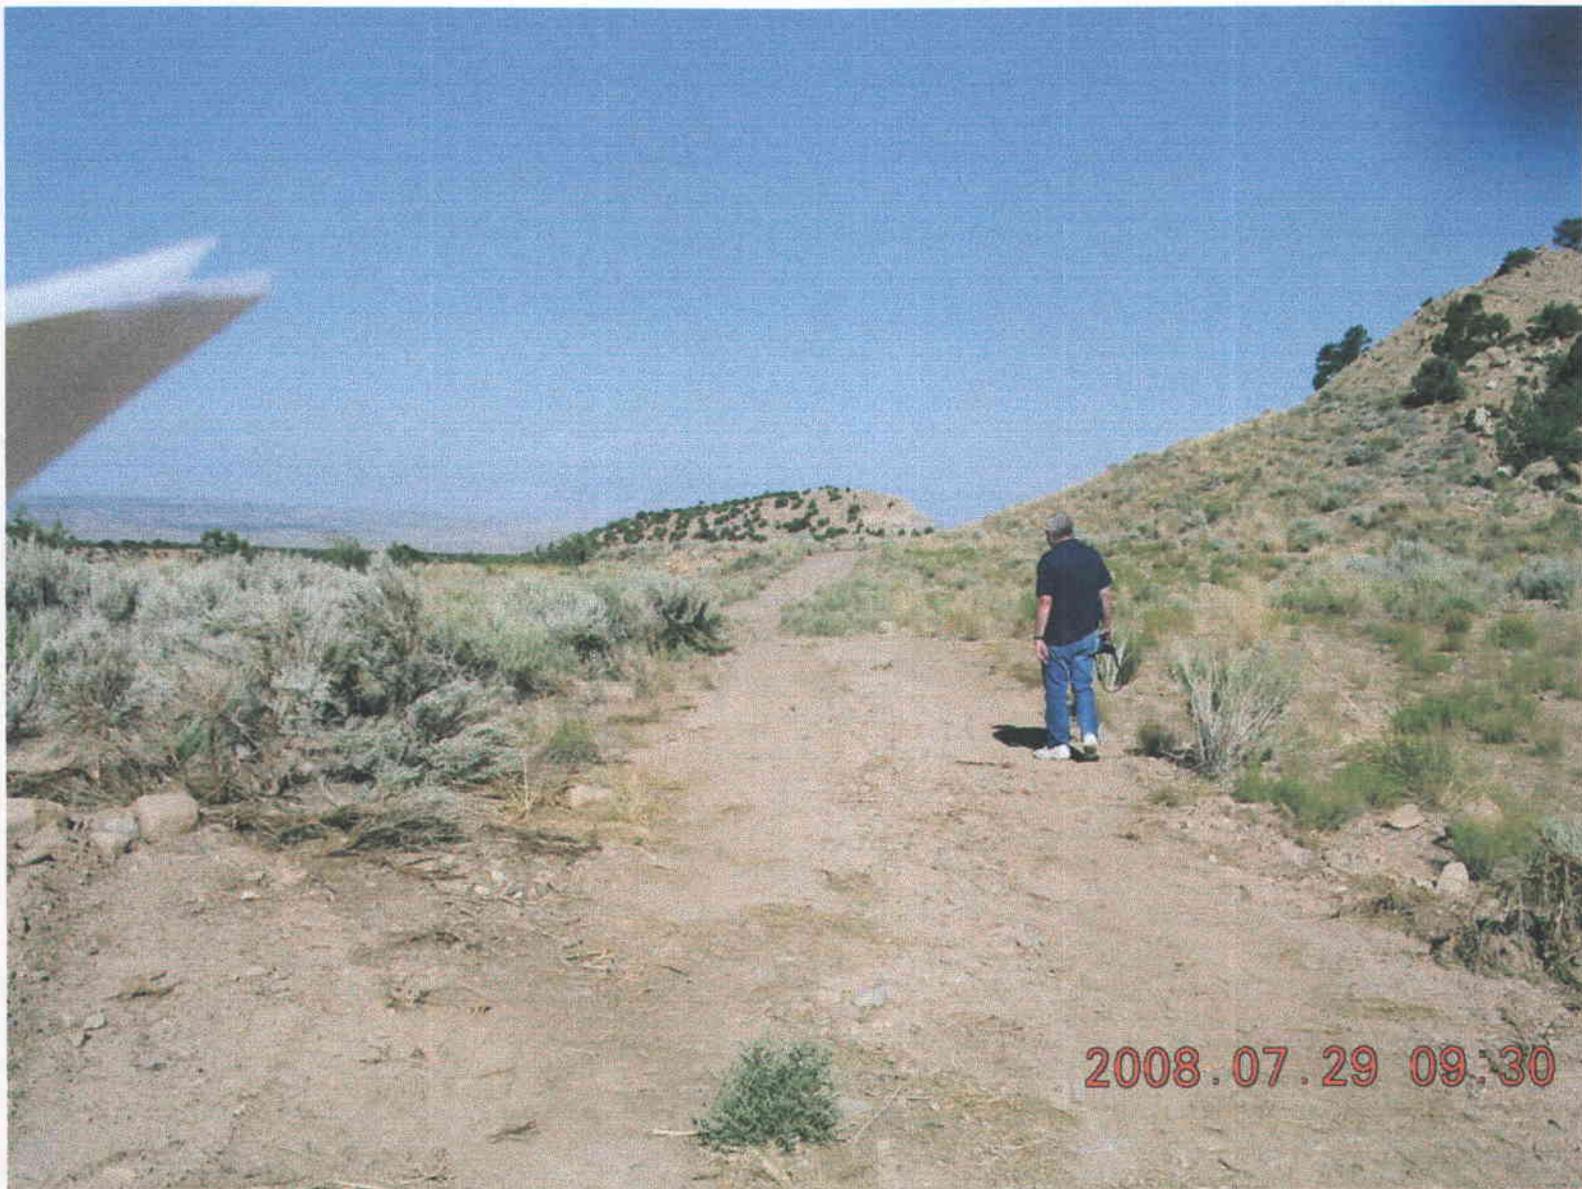
#1 Horse Canyon Trespass Road

The trespass road was made by blading off the vegetation for its length. It will remain a dirt surface road until reclamation.

UtahAmerican Energy intends to make the trespasser roughen and re-seed the 0.3 acres associated with the trespass.

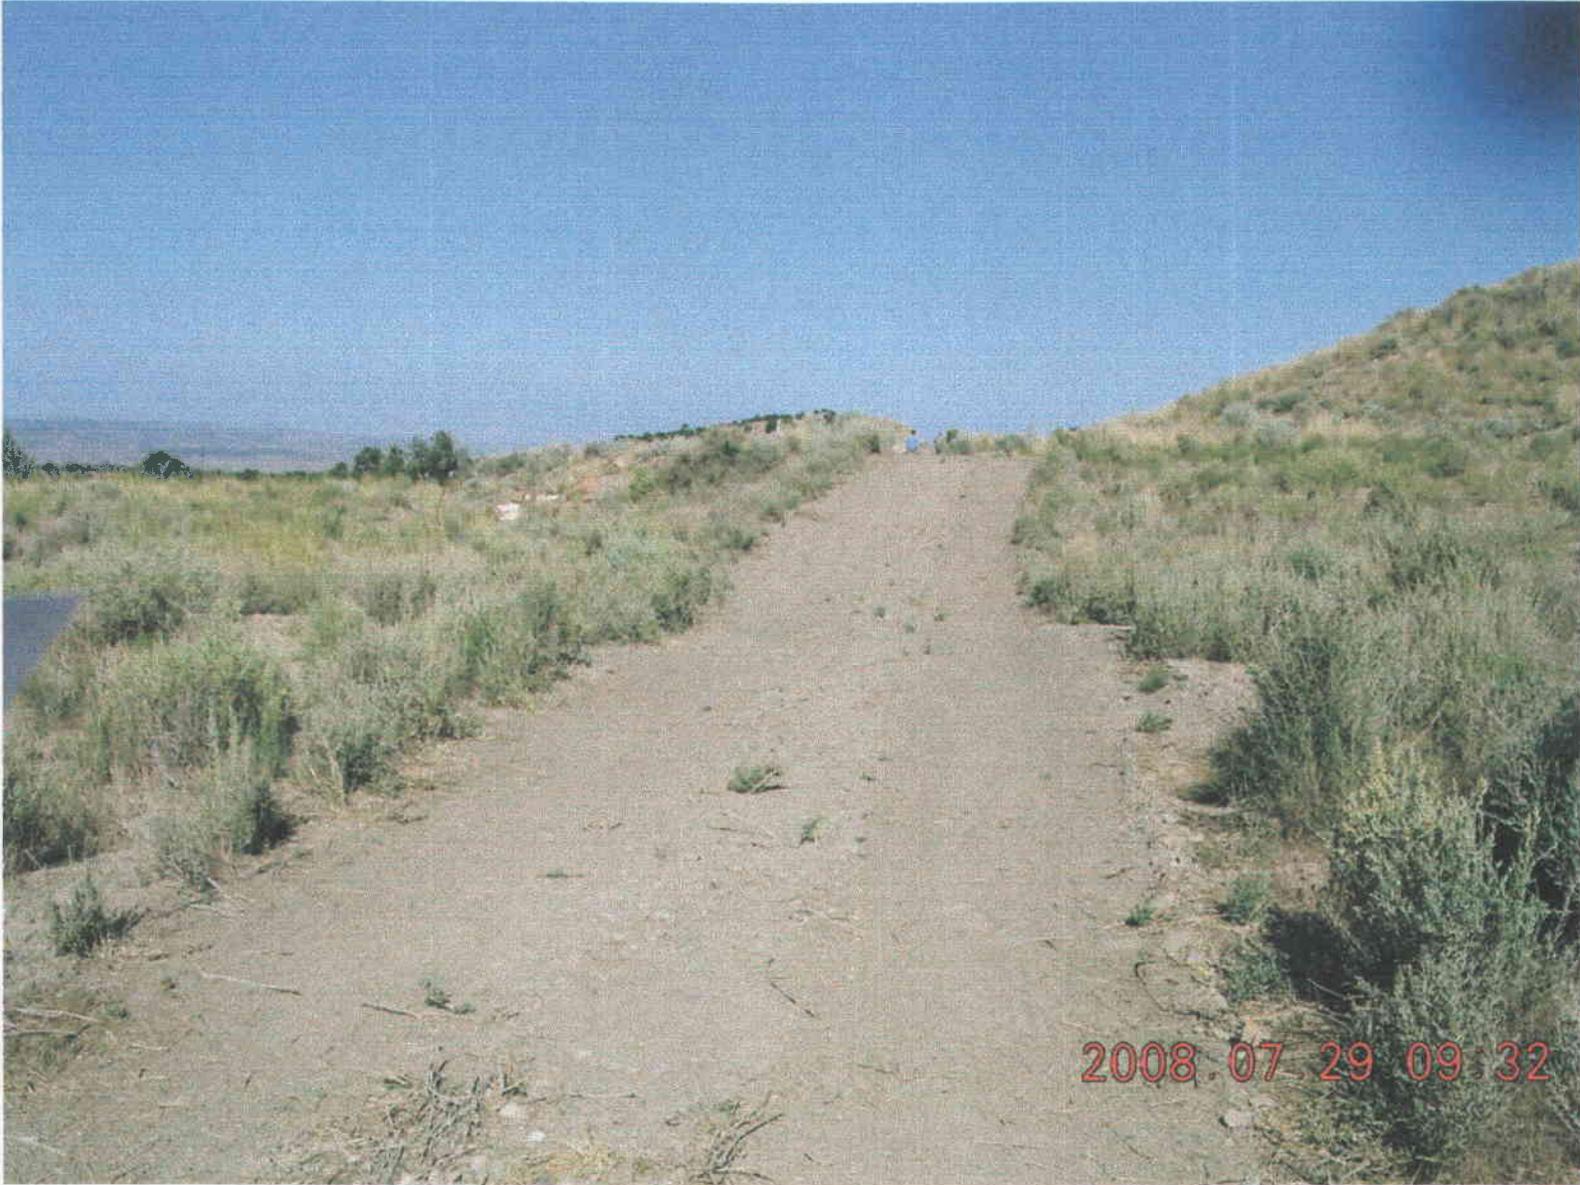
#2

The re-established vegetation lying along the trespass road has not been damaged and appears to be doing well in spite of the hot dry summer in this area.
