Inspection Report

Permit Number:	C0070013
Inspection Type:	COMPLETE
Inspection Date:	Wednesday, March 04, 2015
Start Date/Time:	3/4/2015 8:00:00 AM
End Date/Time:	3/4/2015 11:45:00 AM
Last Inspection:	Tuesday, February 03, 2015

Permittee: **UTAHAMERICAN ENERGY INC**
 Operator: **UTAHAMERICAN ENERGY INC**
 Site: **HORSE CANYON MINE**
 Address: **PO BOX 910, EAST CARBON UT 84520-0910**
 County: **CARBON**
 Permit Type: **PERMANENT COAL PROGRAM**
 Permit Status: **ACTIVE**

RE: Horse Canyon Mine Portal

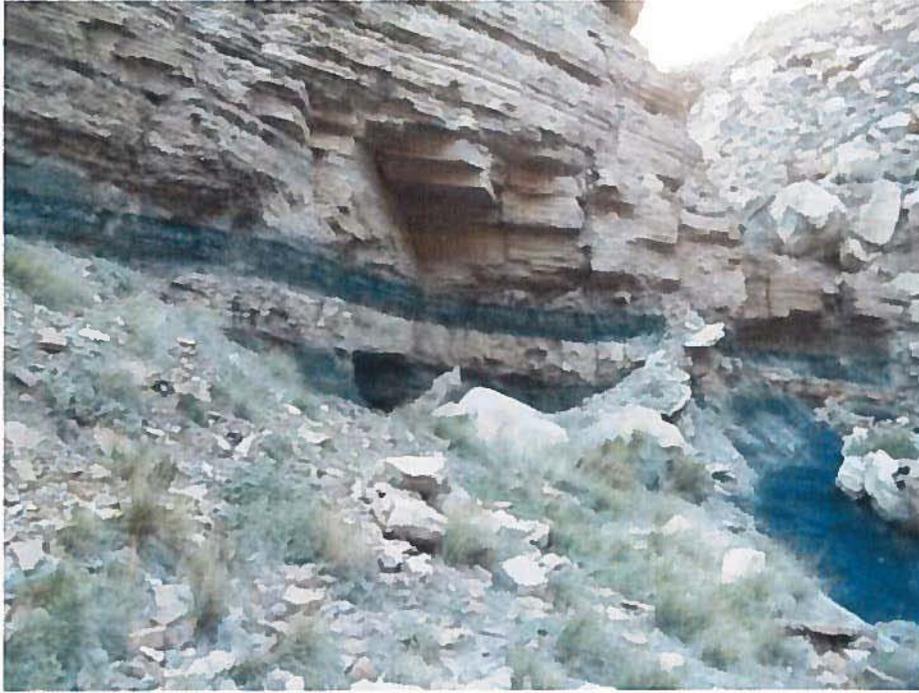
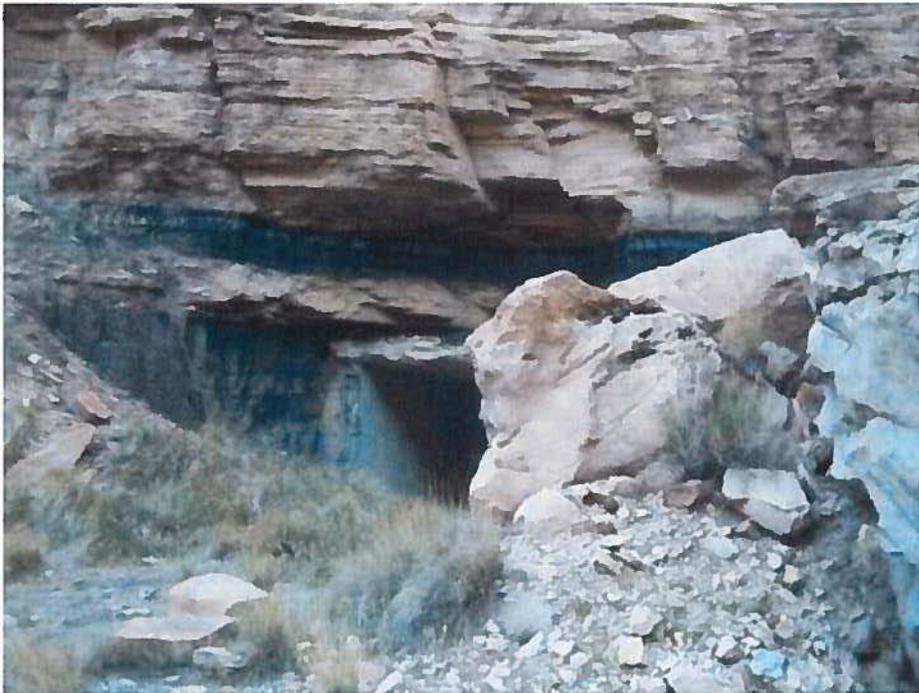
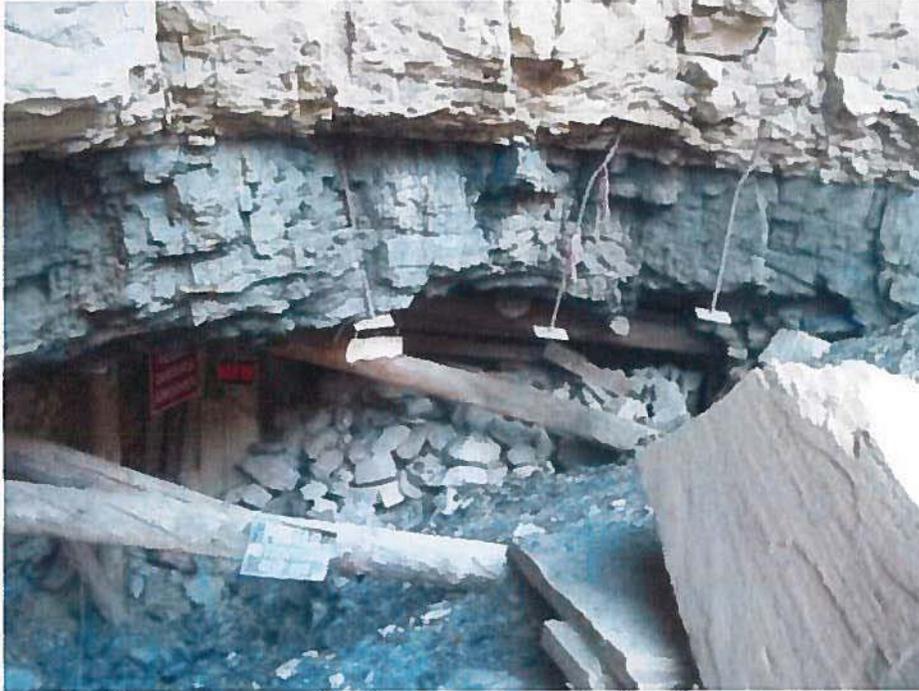
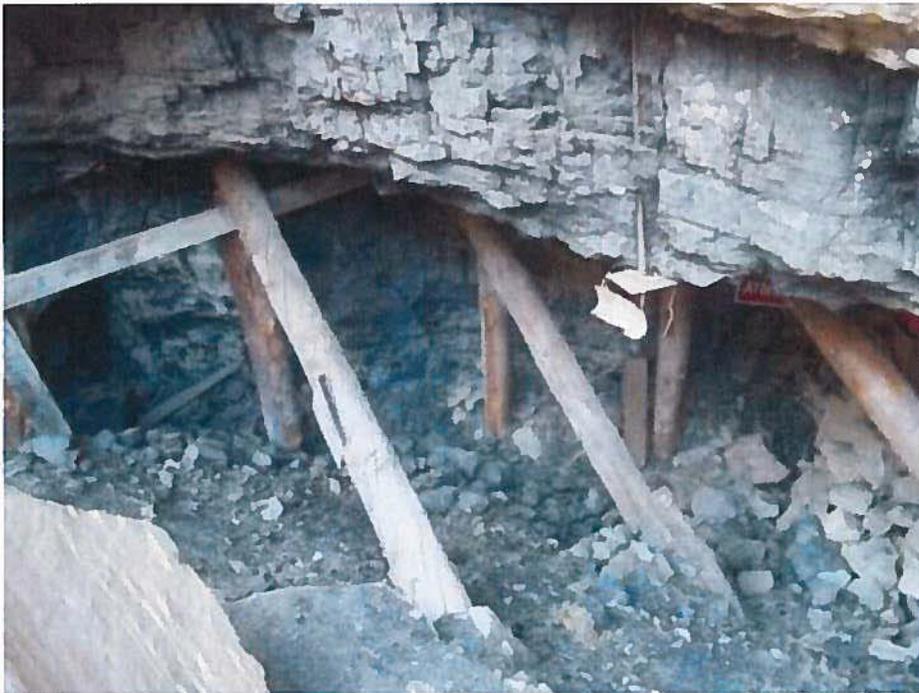
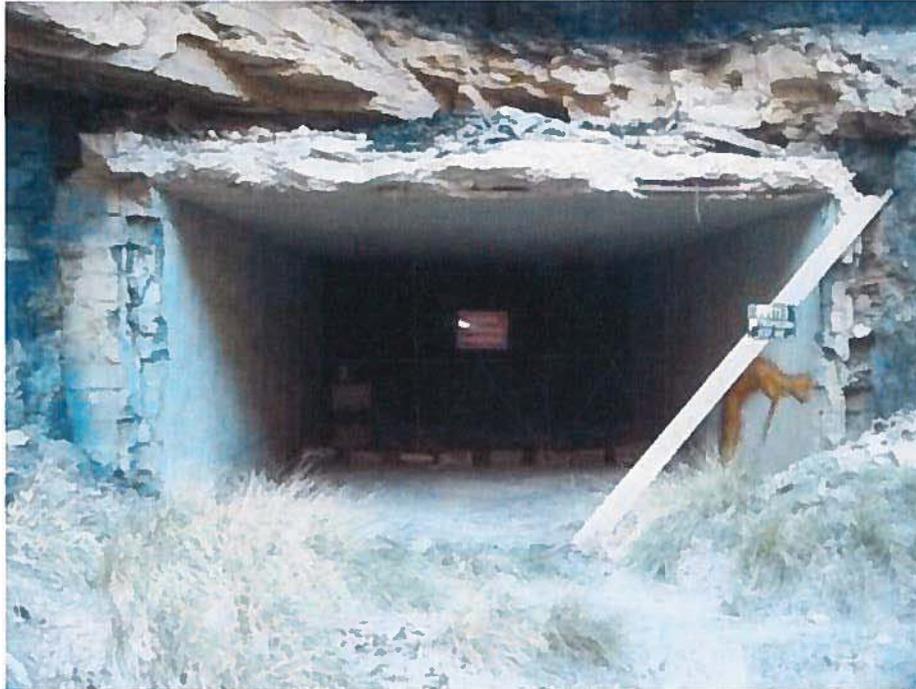
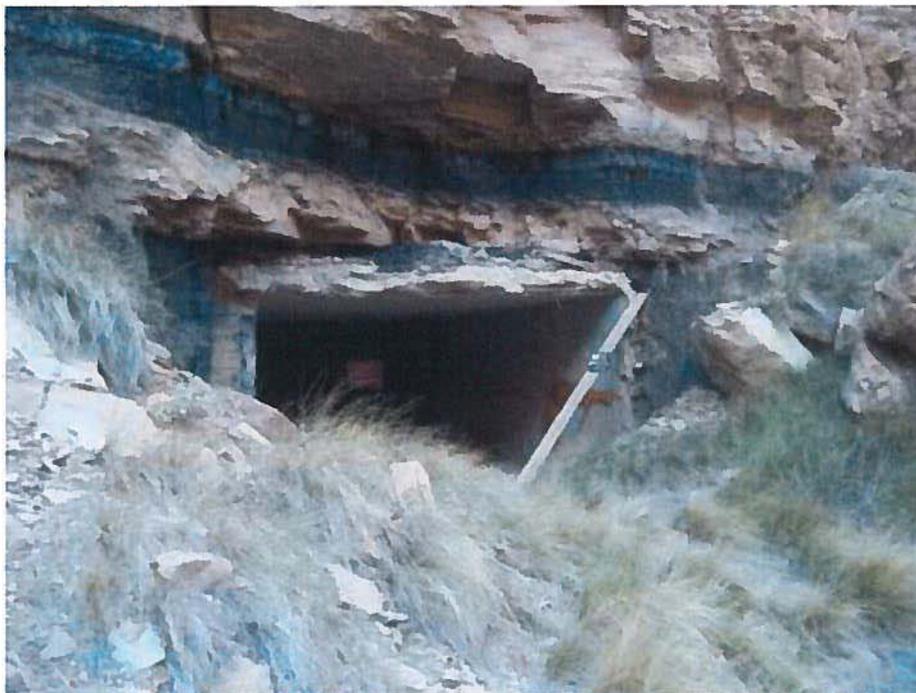
All Photographs Taken October 24, 2014

On October 24, 2014, Joe Via from EIS Environmental and Engineering Consulting visited the closed Horse Canyon Mine portals in Lila Canyon to inspect the portal fence and closures for signs of vandalism and general status. Several photographs were taken of the portals.

There was no evidence of vandalism or tampering to the southern portal fence and there were no openings or structural damage to the fence. There was no evidence of vandalism to the northern portal. The northern portal was sealed with rock and could not be entered. The signs at both portals remain posted.
