Inspection Report

Permit Number:	C0070013
Inspection Type:	COMPLETE
Inspection Date:	Tuesday, June 23, 2020
Start Date/Time:	6/23/2020 10:00:00 AM
End Date/Time:	6/23/2020 3:00:00 PM
Last Inspection:	Wednesday, May 13, 2020

Permittee: **UTAHAMERICAN ENERGY INC**
 Operator: **UTAHAMERICAN ENERGY INC**
 Site: **HORSE CANYON MINE**
 Address: **PO BOX 910, EAST CARBON UT 84520-0910**
 County: **CARBON**
 Permit Type: **PERMANENT COAL PROGRAM**
 Permit Status: **ACTIVE**

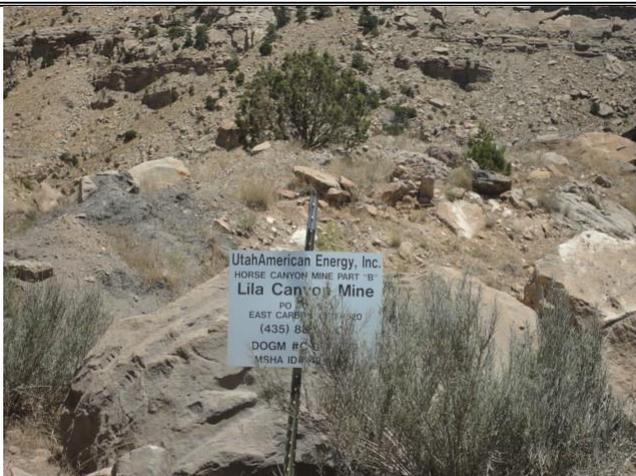
PHOTO 1

The mine identification signs is posted at the entrance into the mining permit area. The sign displays the name, address, phone number and Utah Mining Permit Number as required by law. The sign was found to meet the requirements of the law.

Lila Canyon Identification Sign

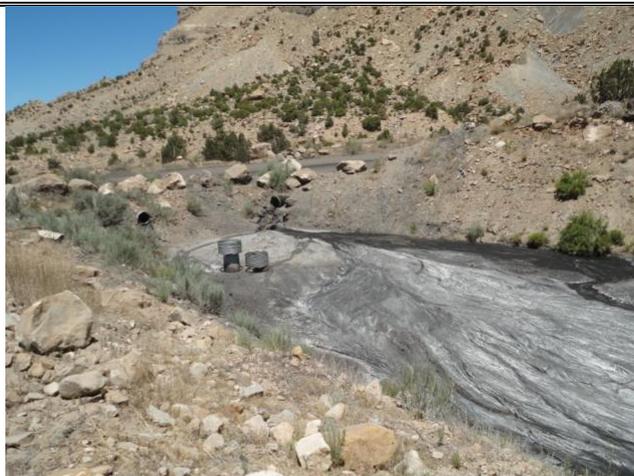
PHOTO 2

Sediment pond #2 the smaller sediment pond near the mine identification sign needs to be cleaned. According to the last sediment pond inspection the pond is scheduled to be cleaned this construction season.

Sediment Pond #1 60% elevation 5843.6'. Existing sediment elevation 5838.1'.
Sediment Pond #2 60% elevation 5847.0'. Existing Sediment elevation 5848.0'.
(Pond Scheduled to be Cleaned).

Lila Canyon Sediment Pond #2 (Smaller Pond)

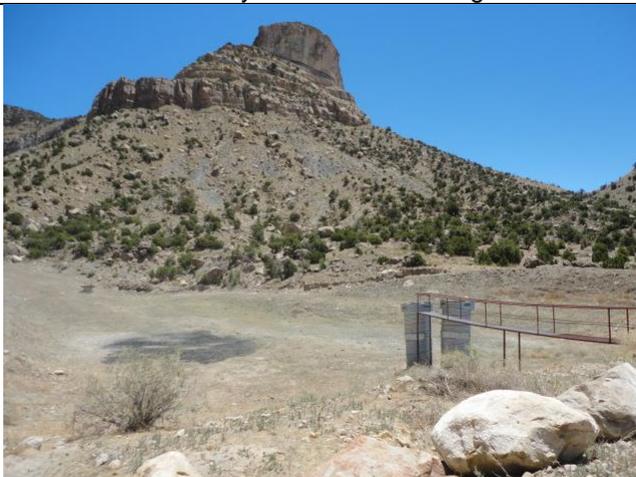
PHOTO 3

Lila Canyon Sediment Pond #1 (Larger Pond)

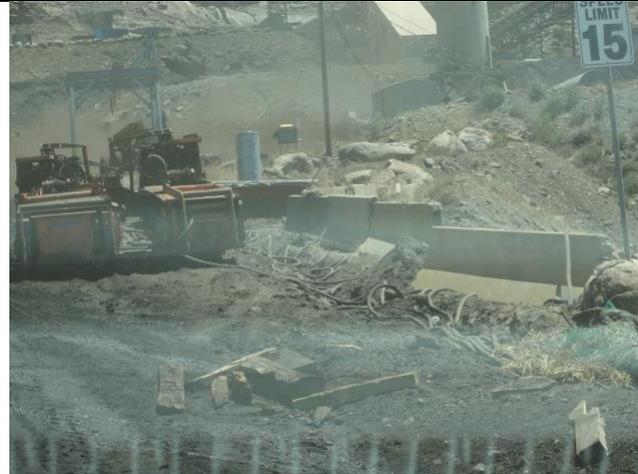
PHOTO 6

The diversions were checked throughout the mine site. Two sections of diversions need maintenance. The first area is along the road diversion near the bath house area. This diversion has cable in its reaches from a shuttle car that is parked in this area (See Photos 6 & 7)

Lila Canyon Cable in Diversion (Up-Canyon View)

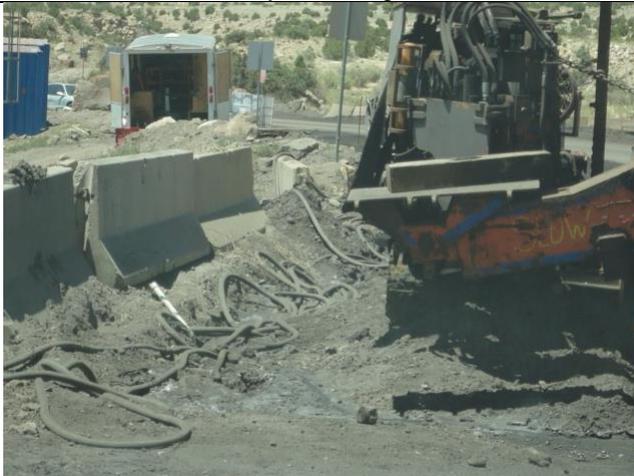
PHOTO 7

Lila Canyon Cable in Diversion (Down-Canyon View)
