# Inspection Report

Permit Number:	C0070013
Inspection Type:	COMPLETE
Inspection Date:	Tuesday, March 9, 2021
Start Date/Time:	3/9/2021 9:00:00 AM
End Date/Time:	3/9/2021 1:00:00 PM
Last Inspection:	Wednesday, February 10, 2021

Permittee: **UTAHAMERICAN ENERGY INC**  
 Operator: **UTAHAMERICAN ENERGY INC**  
 Site: **HORSE CANYON MINE**  
 Address: **PO BOX 910, EAST CARBON UT 84520-0910**  
 County: **CARBON**  
 Permit Type: **PERMANENT COAL PROGRAM**  
 Permit Status: **ACTIVE**

**ATTACHMENT A – Photos Lila Canyon March 9, 2021 site visit**

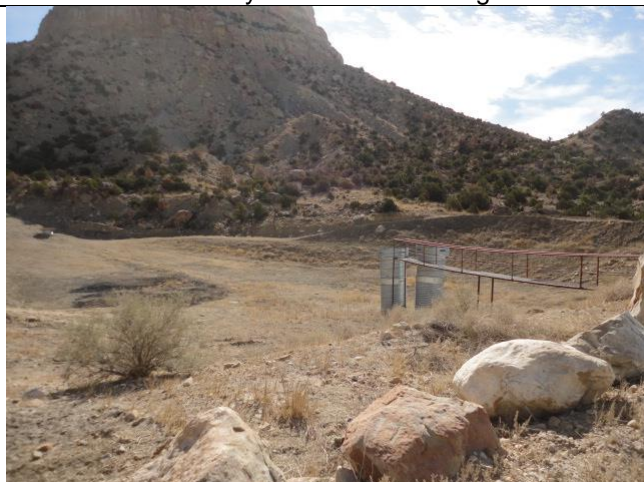
**PHOTO 3**

There are two sediment ponds that service the Lila Canyon Mine. A smaller sediment pond adjacent to the main road, Sediment pond #2 and a larger sediment pond, sediment pond #1.

Both ponds were stable. Dikes were checked and no problems were found.

Lila Canyon Large Sediment Pond
