# Inspection Report

Permit Number:	<b>C0070013</b>
Inspection Type:	COMPLETE
Inspection Date:	Tuesday, March 9, 2021
Start Date/Time:	3/9/2021 9:00:00 AM
End Date/Time:	3/9/2021 1:00:00 PM
Last Inspection:	Wednesday, February 10, 2021

Permittee: **UTAHAMERICAN ENERGY INC**  
 Operator: **UTAHAMERICAN ENERGY INC**  
 Site: **HORSE CANYON MINE**  
 Address: **PO BOX 910, EAST CARBON UT 84520-0910**  
 County: **CARBON**  
 Permit Type: **PERMANENT COAL PROGRAM**  
 Permit Status: **ACTIVE**

**ATTACHMENT A – Photos Lila Canyon March 9, 2021 site visit**

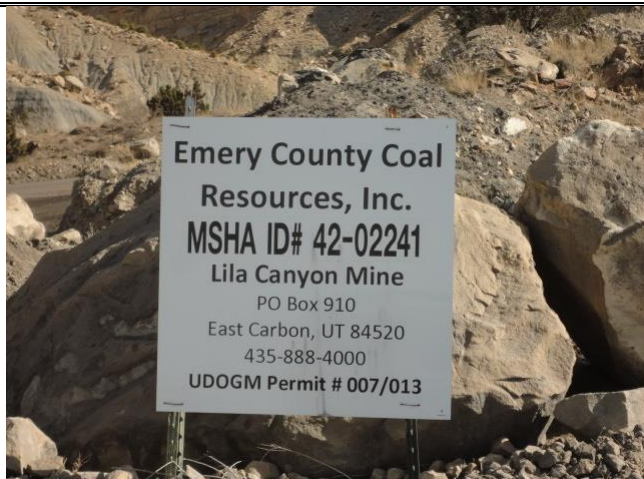
**PHOTO 1**

There is one mine identification sign associated with this site. The sign is posted at the access point from the county road into the mining permit area.

Regulations require that certain information be posted on the identification sign. These requirements are the name, address, phone number and permit number. All of these items were posted on the identification sign for the Lila Canyon Mine.

The sign is in compliance.

Lila Canyon Identification Sign

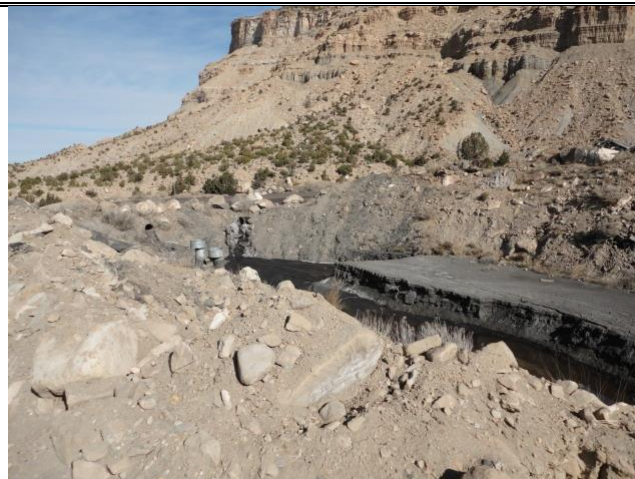
**PHOTO 2**

There are two sediment ponds that service the Lila Canyon Mine. A smaller sediment pond adjacent to the main road, Sediment pond #2 and a larger sediment pond, sediment pond #1.

Sediment Pond #2 was recently cleaned. A sediment delta is still presetn at the back of the pond. The equipimnet used to clean the pond could not reach this area.

Both ponds were stable. Dikes were checked and no problems were found.

Lila Canyon Small Sediment Pond

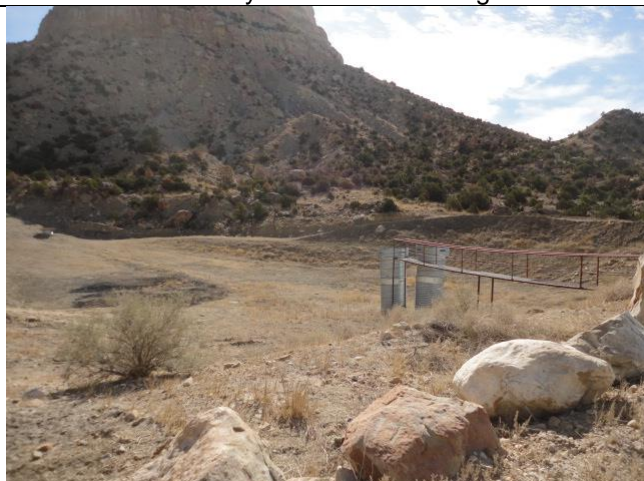
**PHOTO 3**

Lila Canyon Large Sediment Pond

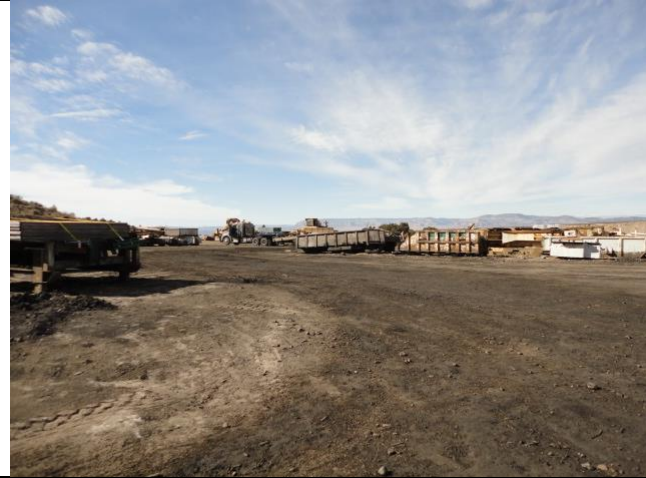
**PHOTO 6**

Construction on the new warehouse that was approved in 2019 still has not taken place. A pad area was built and soils savaged. No structure has been erected. The pad is currently being used to store equipment. Construction of the new warehouse is currently scheduled for 2022.

Lila Canyon Warehouse Pad

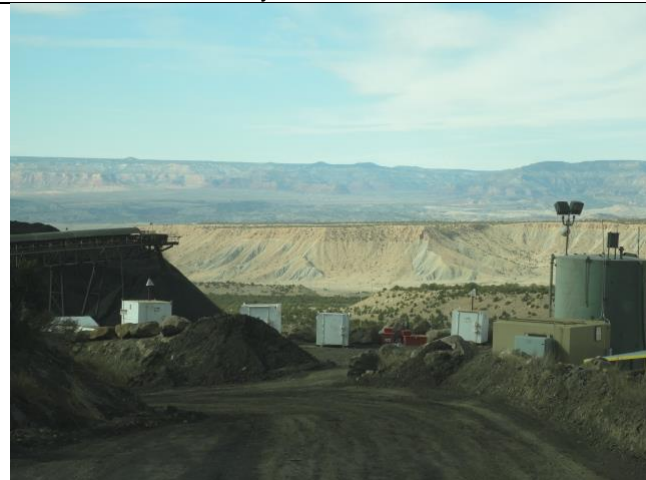
**PHOTO 8**

The powder and cap magazines are separated form each other. The magazines are grounded against a lighting strike. Signs are placed in accordance with the directions given in the regulations.

Lila Canyon Explosive Storage Area
