Inspection Report

Permit Number:	C0070013
Inspection Type:	PARTIAL
Inspection Date:	Tuesday, July 13, 2021
Start Date/Time:	7/13/2021 9:00:00 AM
End Date/Time:	7/13/2021 12:30:00 AM
Last Inspection:	Wednesday, June 2, 2021

Permittee: **EMERY COUNTY COAL RESOURCES, INC.**
 Operator: **EMERY COUNTY COAL RESOURCES, INC.**
 Site: **LILA CANYON MINE**
 Address: **PO BOX 910, EAST CARBON UT 84520-0910**
 County: **CARBON**
 Permit Type: **PERMANENT COAL PROGRAM**
 Permit Status: **ACTIVE**

ATTACHMENT A – LILA Canyon

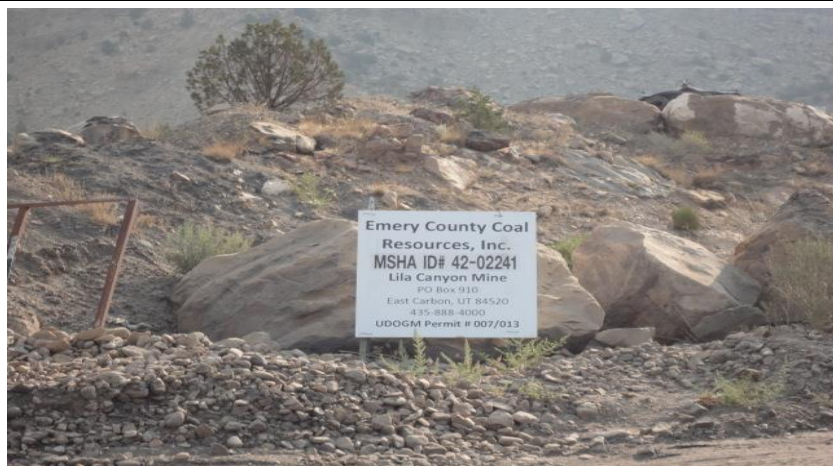
PHOTO 1
Identification Sign

The identification sign was inspected and it meets the requirements of the R645 Coal Rules. See Photo

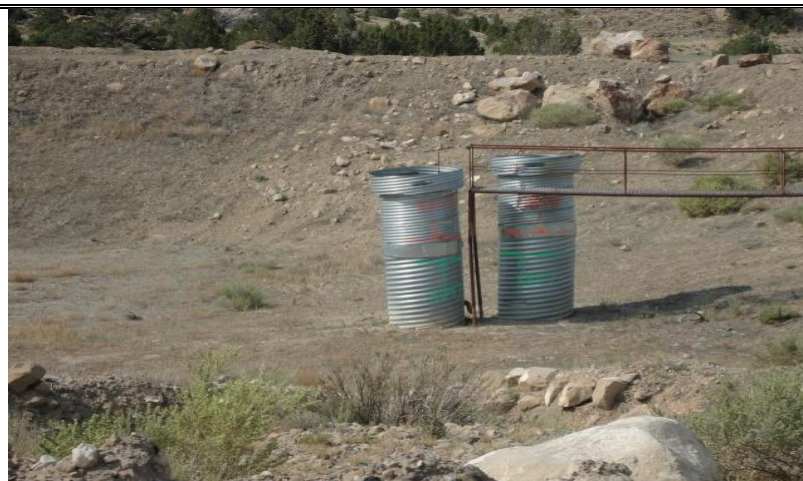
PHOTO 2
Sediment Pond #1

Inspected both sediment ponds. Pond #2 had a minor amount of water that was used for washing equipment. Pond #1 was totally dry. The permittee has given the 60% sediment level on the standpipe. The sediment level is several feet below the marker. See photo

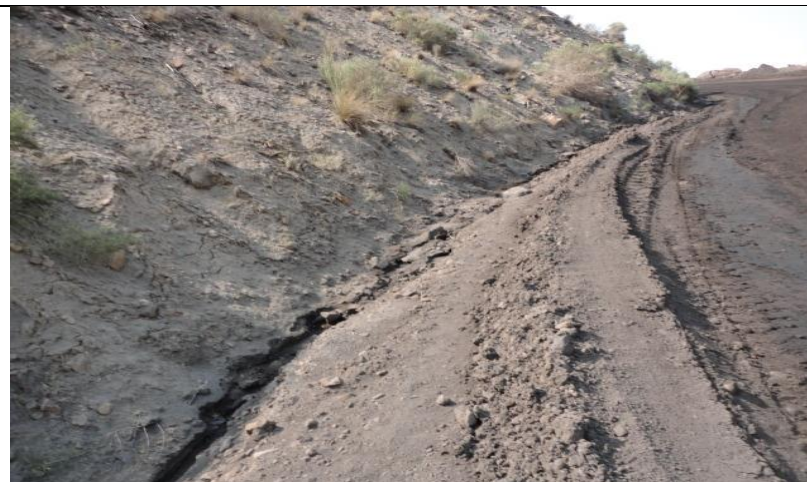
PHOTO 4
Diversion DD-1

The diversions and culverts were open and functioning as design. Sediment has started to fill within these structures. The permittee had cleaned out several diversions since the last inspection. See Photos

I inspected the road diversions and culverts throughout the property. Some of the diversions have some sediment build-up within. Diversions will need cleaning out in the near future.
