# Inspection Report

Permit Number:	C0070013
Inspection Type:	PARTIAL
Inspection Date:	Thursday, September 2, 2021
Start Date/Time:	9/2/2021 9:30:00 AM
End Date/Time:	9/2/2021 2:00:00 PM
Last Inspection:	Wednesday, August 18, 2021

Permittee: **EMERY COUNTY COAL RESOURCES, INC.**  
 Operator: **EMERY COUNTY COAL RESOURCES, INC.**  
 Site: **LILA CANYON MINE**  
 Address: **PO BOX 910, EAST CARBON UT 84520-0910**  
 County: **CARBON**  
 Permit Type: **PERMANENT COAL PROGRAM**  
 Permit Status: **ACTIVE**

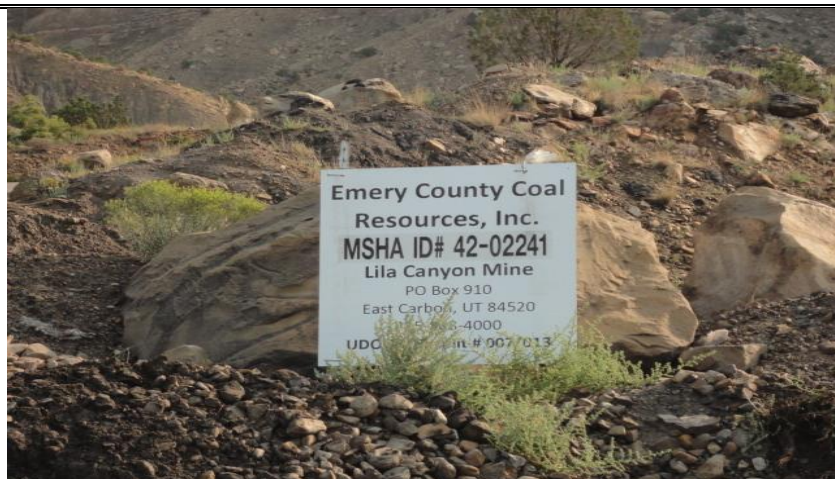
**PHOTO 1**  
Identification Sign

I inspected the identification signs and they meet the requirements of the R645 Coal Rules. The rock storage and reclamation site are the location of the identification signs. See Photo

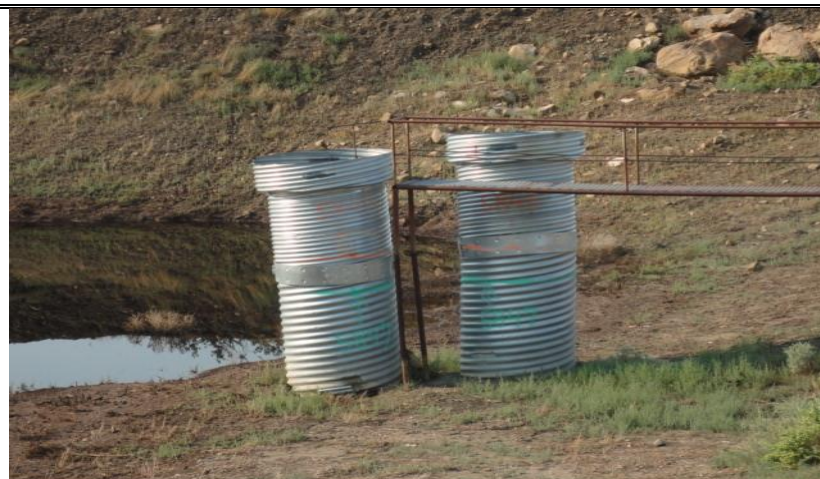
**PHOTO 2**  
Sediment Pond #1

I inspected both sediment ponds. Both contain some water from recent rainstorms in August. Sediment pond #2 needs repair work to the inner embankments of the pond. Erosion has occurred due to rainstorms. The pond is incised and therefore no hazardous condition existed. Water could enter the pond that it is not designed to do.

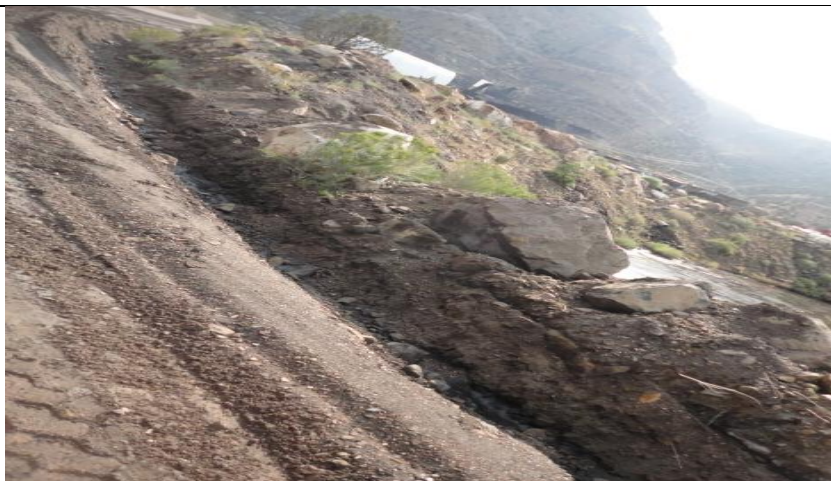
**PHOTO 4**  
Diversion DD-3

I inspected diversions and culverts throughout the property. They were open and would function during a storm event. The structures were recently re-graded and clean out of sediment. See photos
