# Inspection Report

Permit Number:	<b>C0070019</b>
Inspection Type:	PARTIAL
Inspection Date:	Thursday, April 13, 2017
Start Date/Time:	4/13/2017 9:00:00 AM
End Date/Time:	4/13/2017 12:00:00 PM
Last Inspection:	Thursday, April 06, 2017

Permitee: **ANDALEX RESOURCES INC**  
 Operator: **ANDALEX RESOURCES INC**  
 Site: **CENTENNIAL MINE**  
 Address: **PO BOX 910, EAST CARBON UT 84520-0910**  
 County: **CARBON**  
 Permit Type: **PERMANENT COAL PROGRAM**  
 Permit Status: **INACTIVE**

The site is inactive except for the shop building, which repairs mining equipment for the Lila Mine. It is also used as a mining equipment storage area.

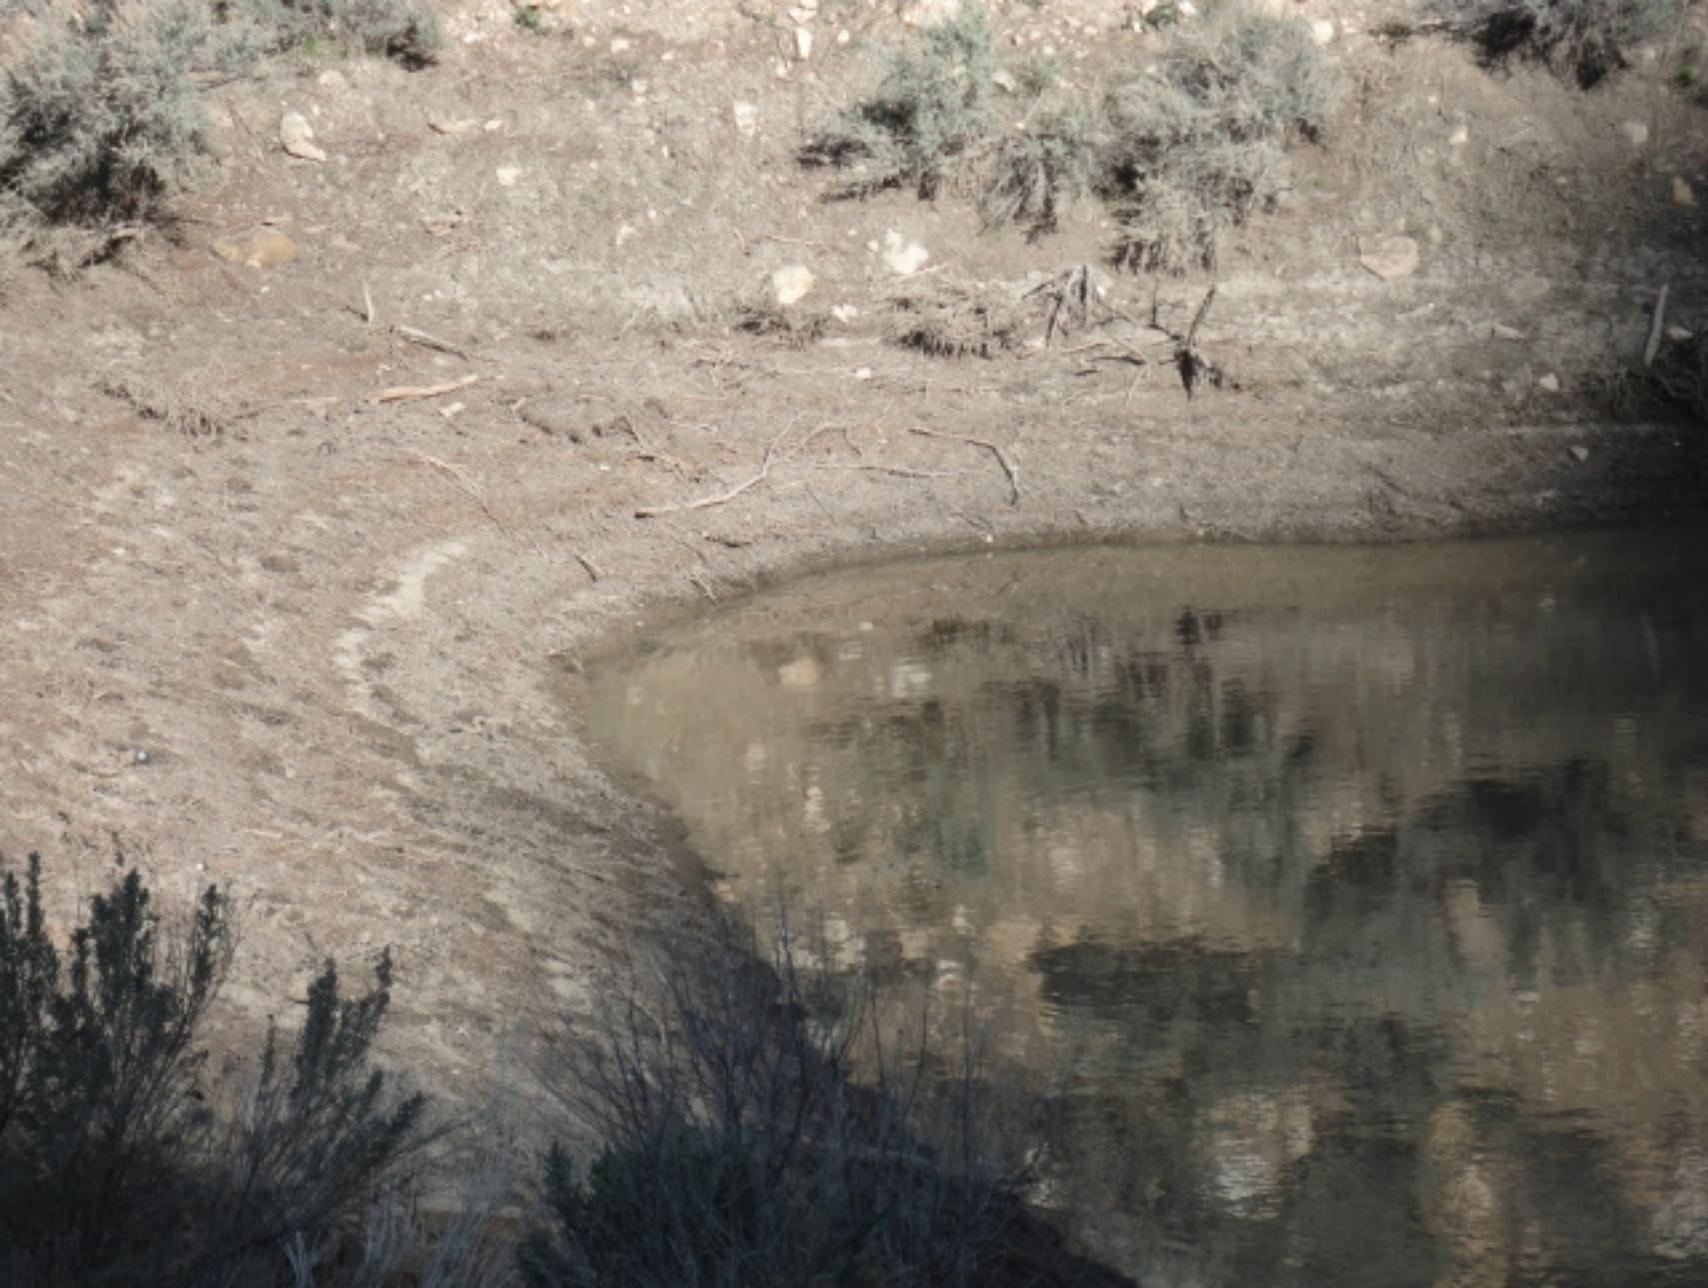
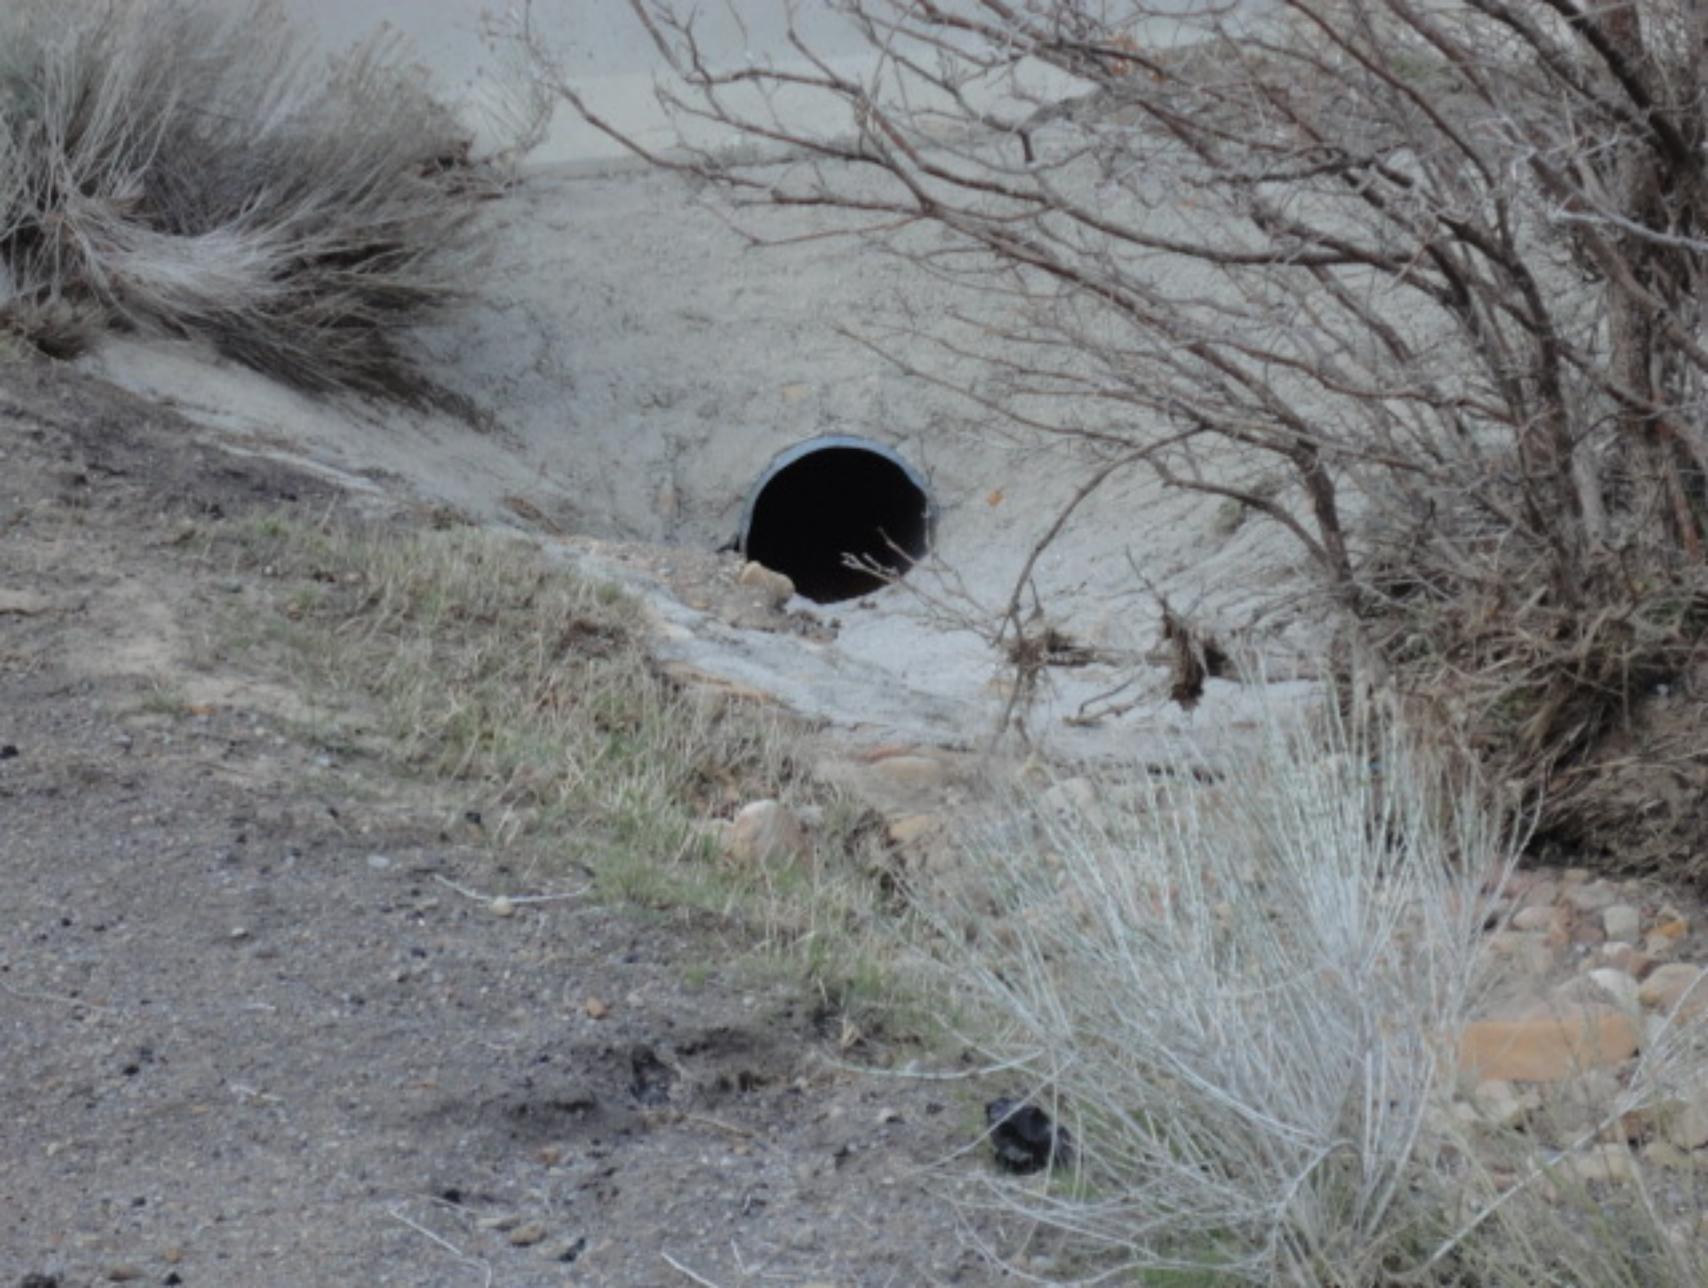
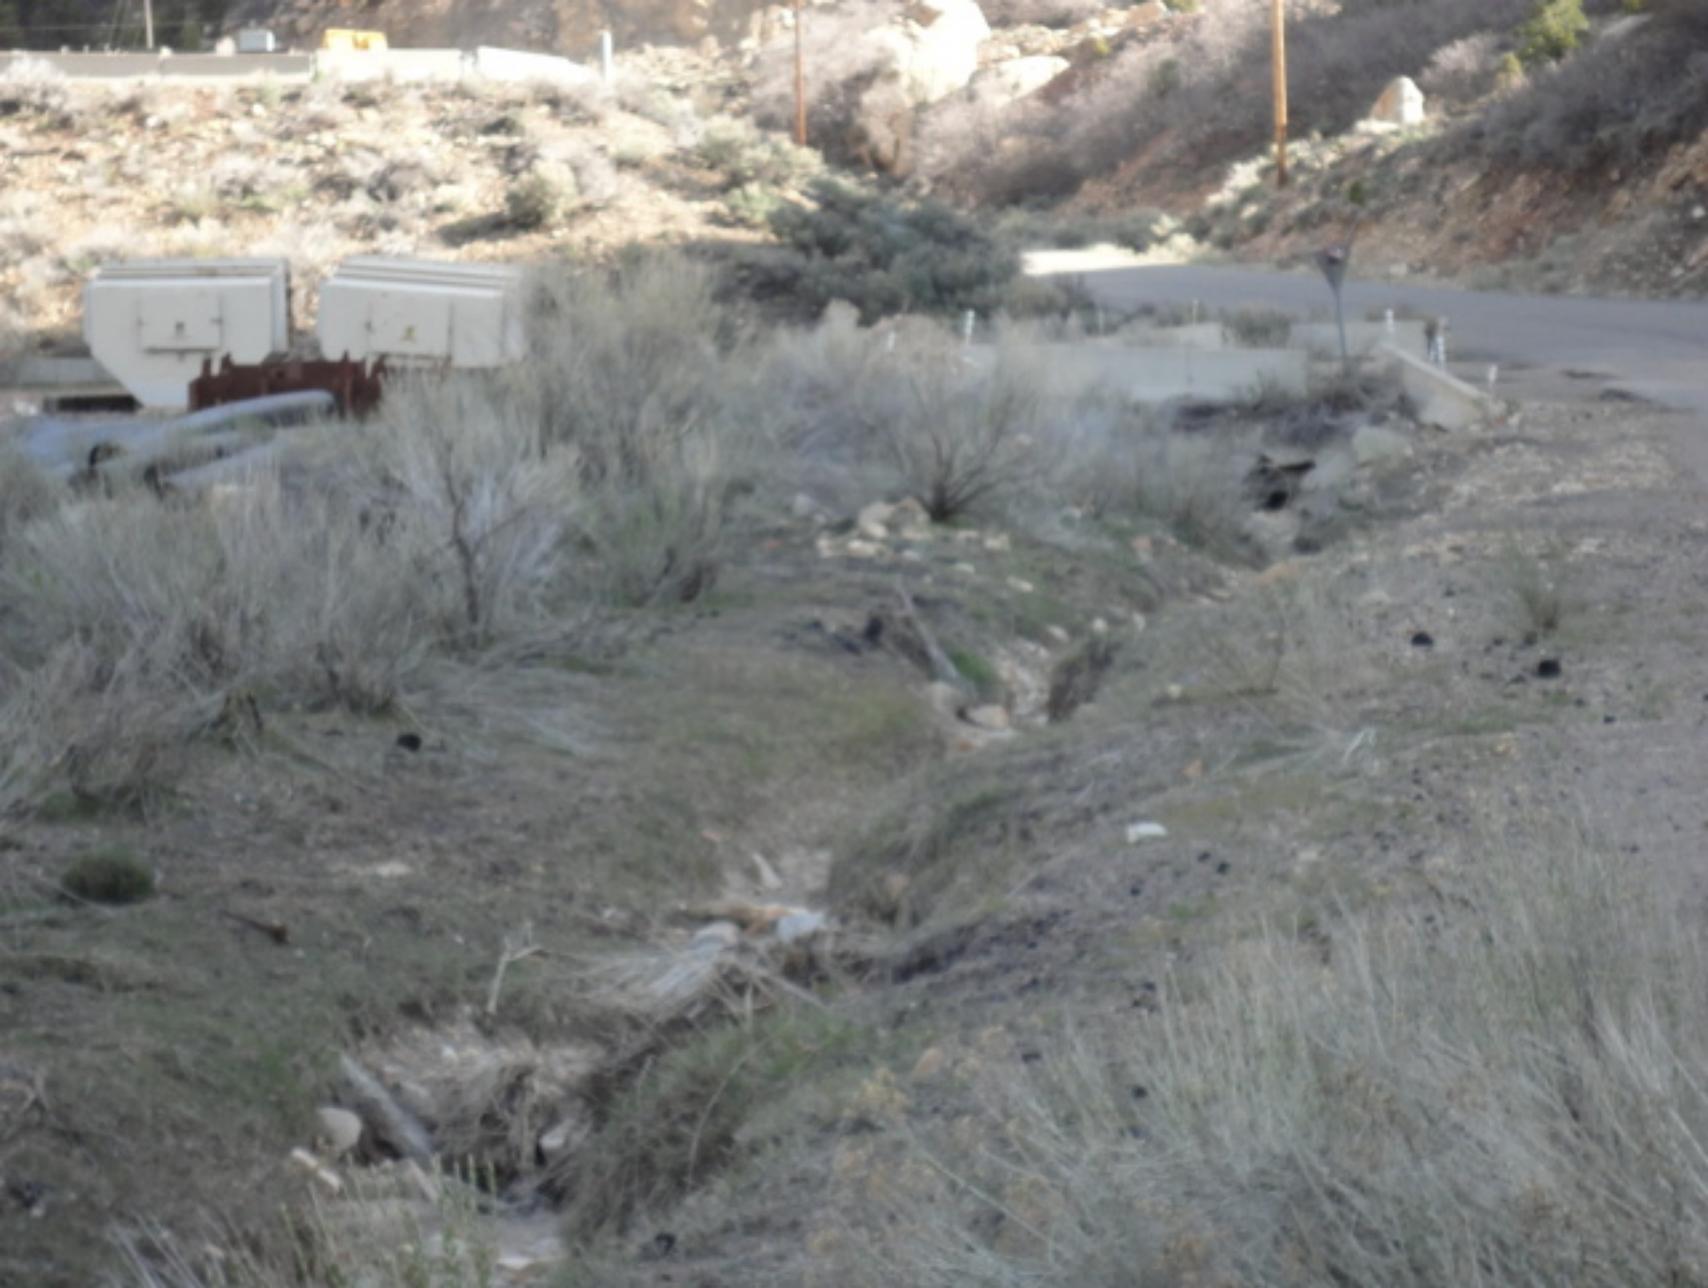
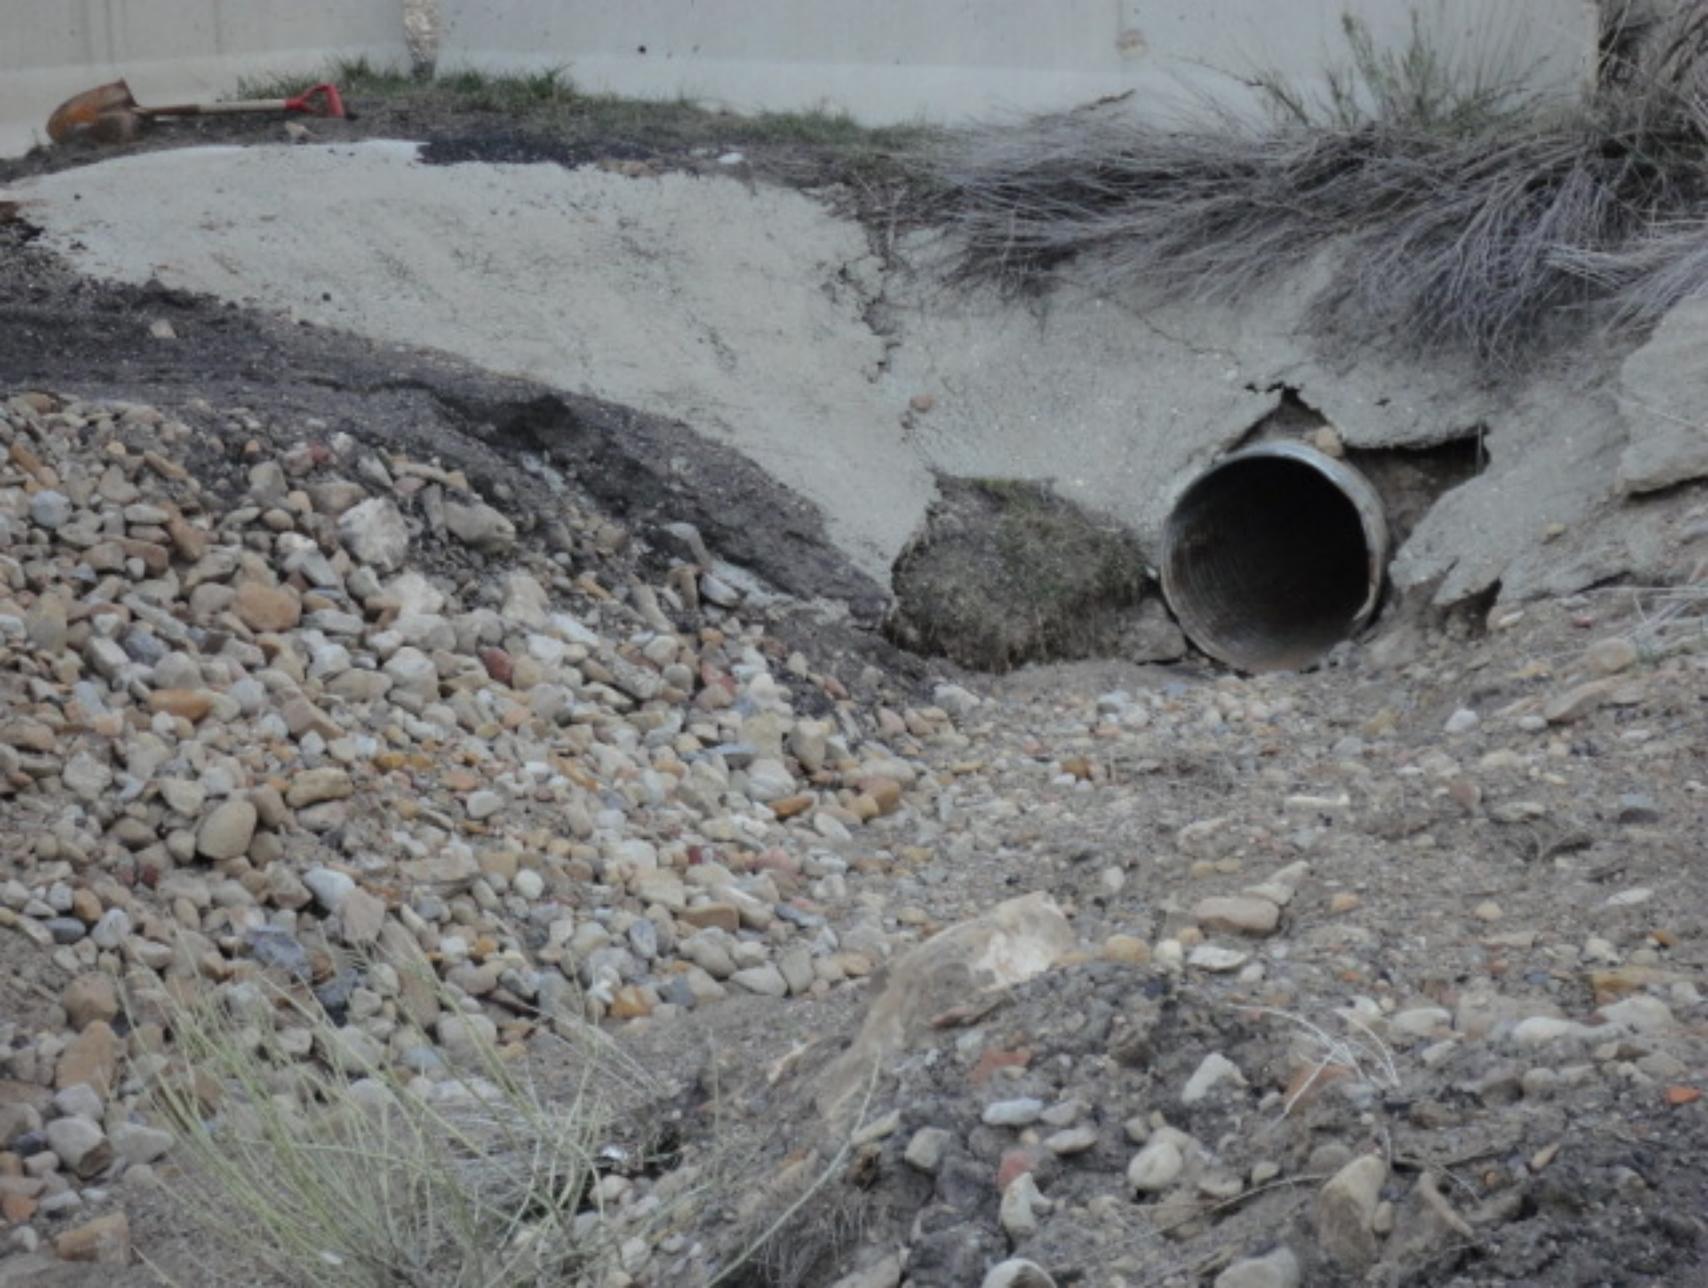
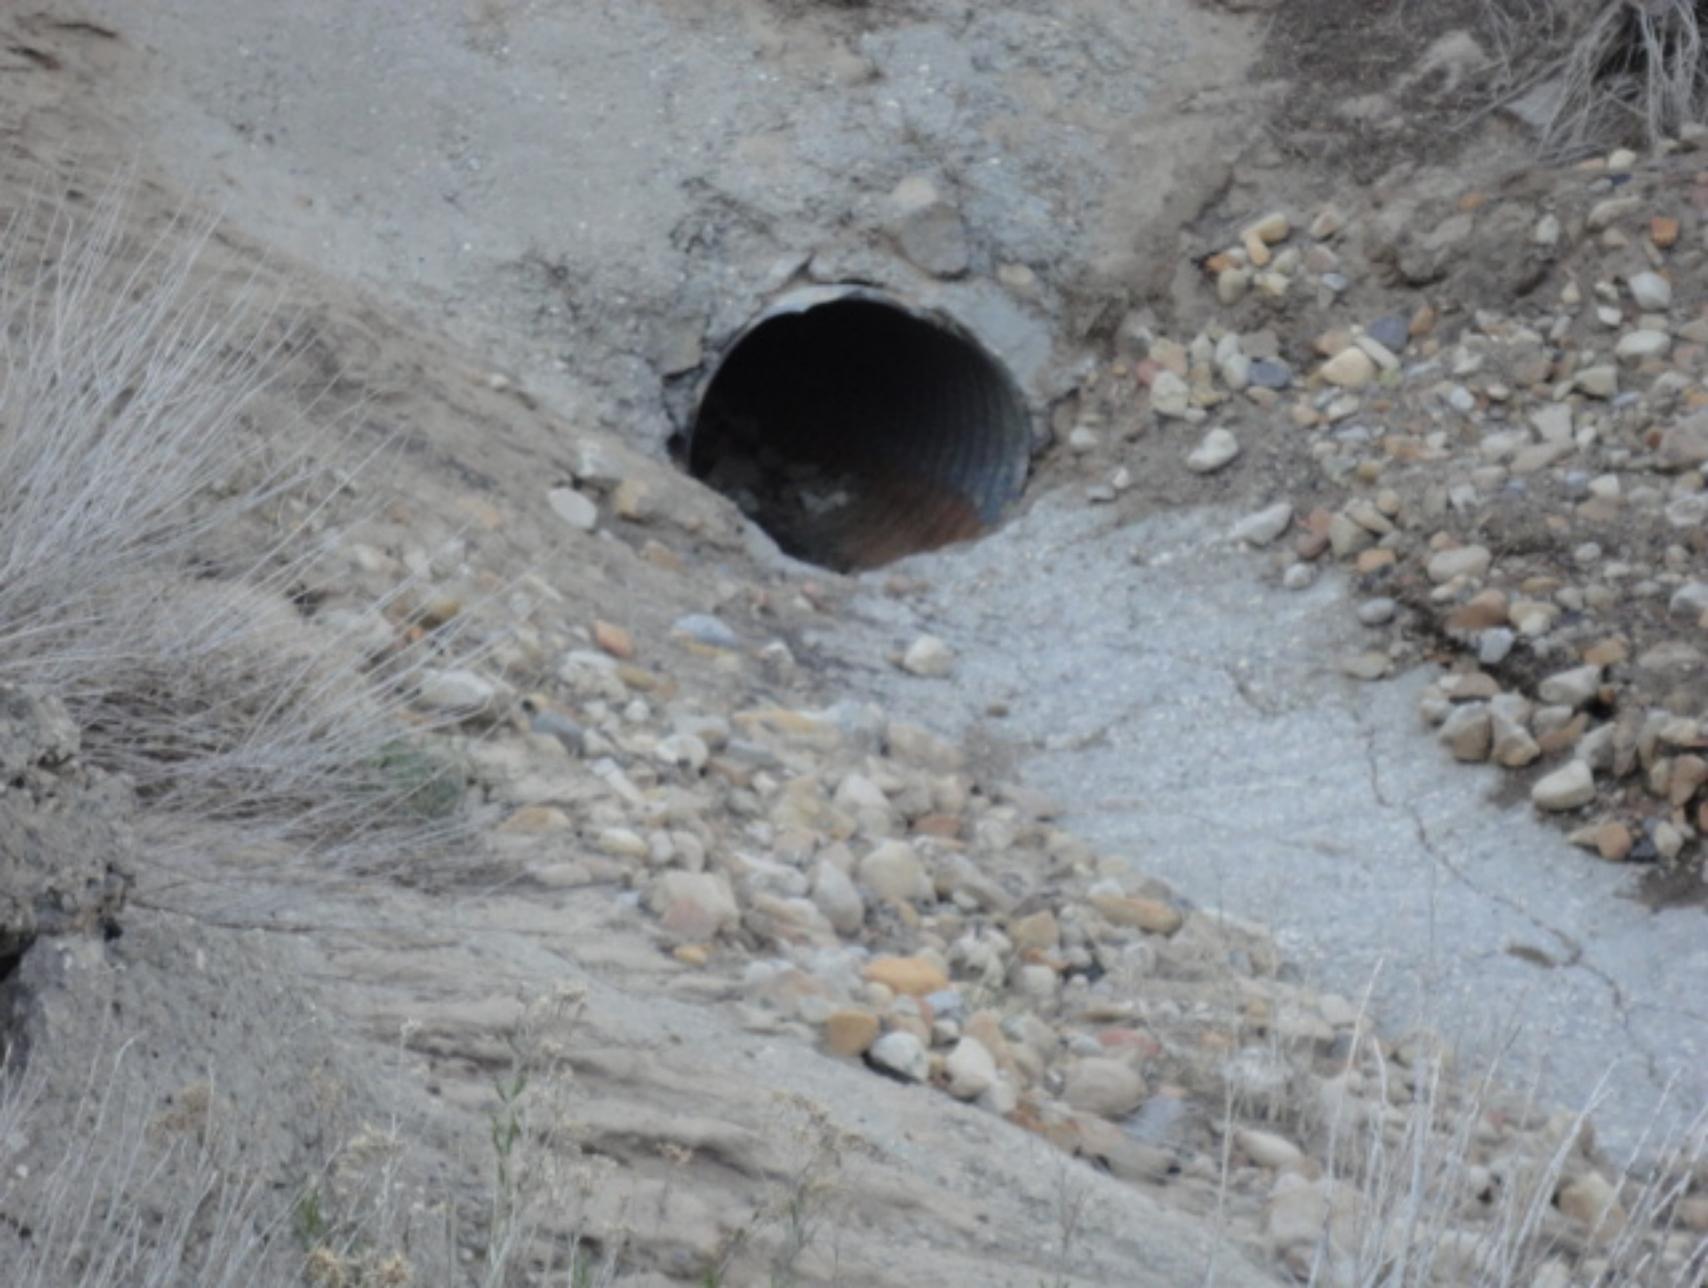
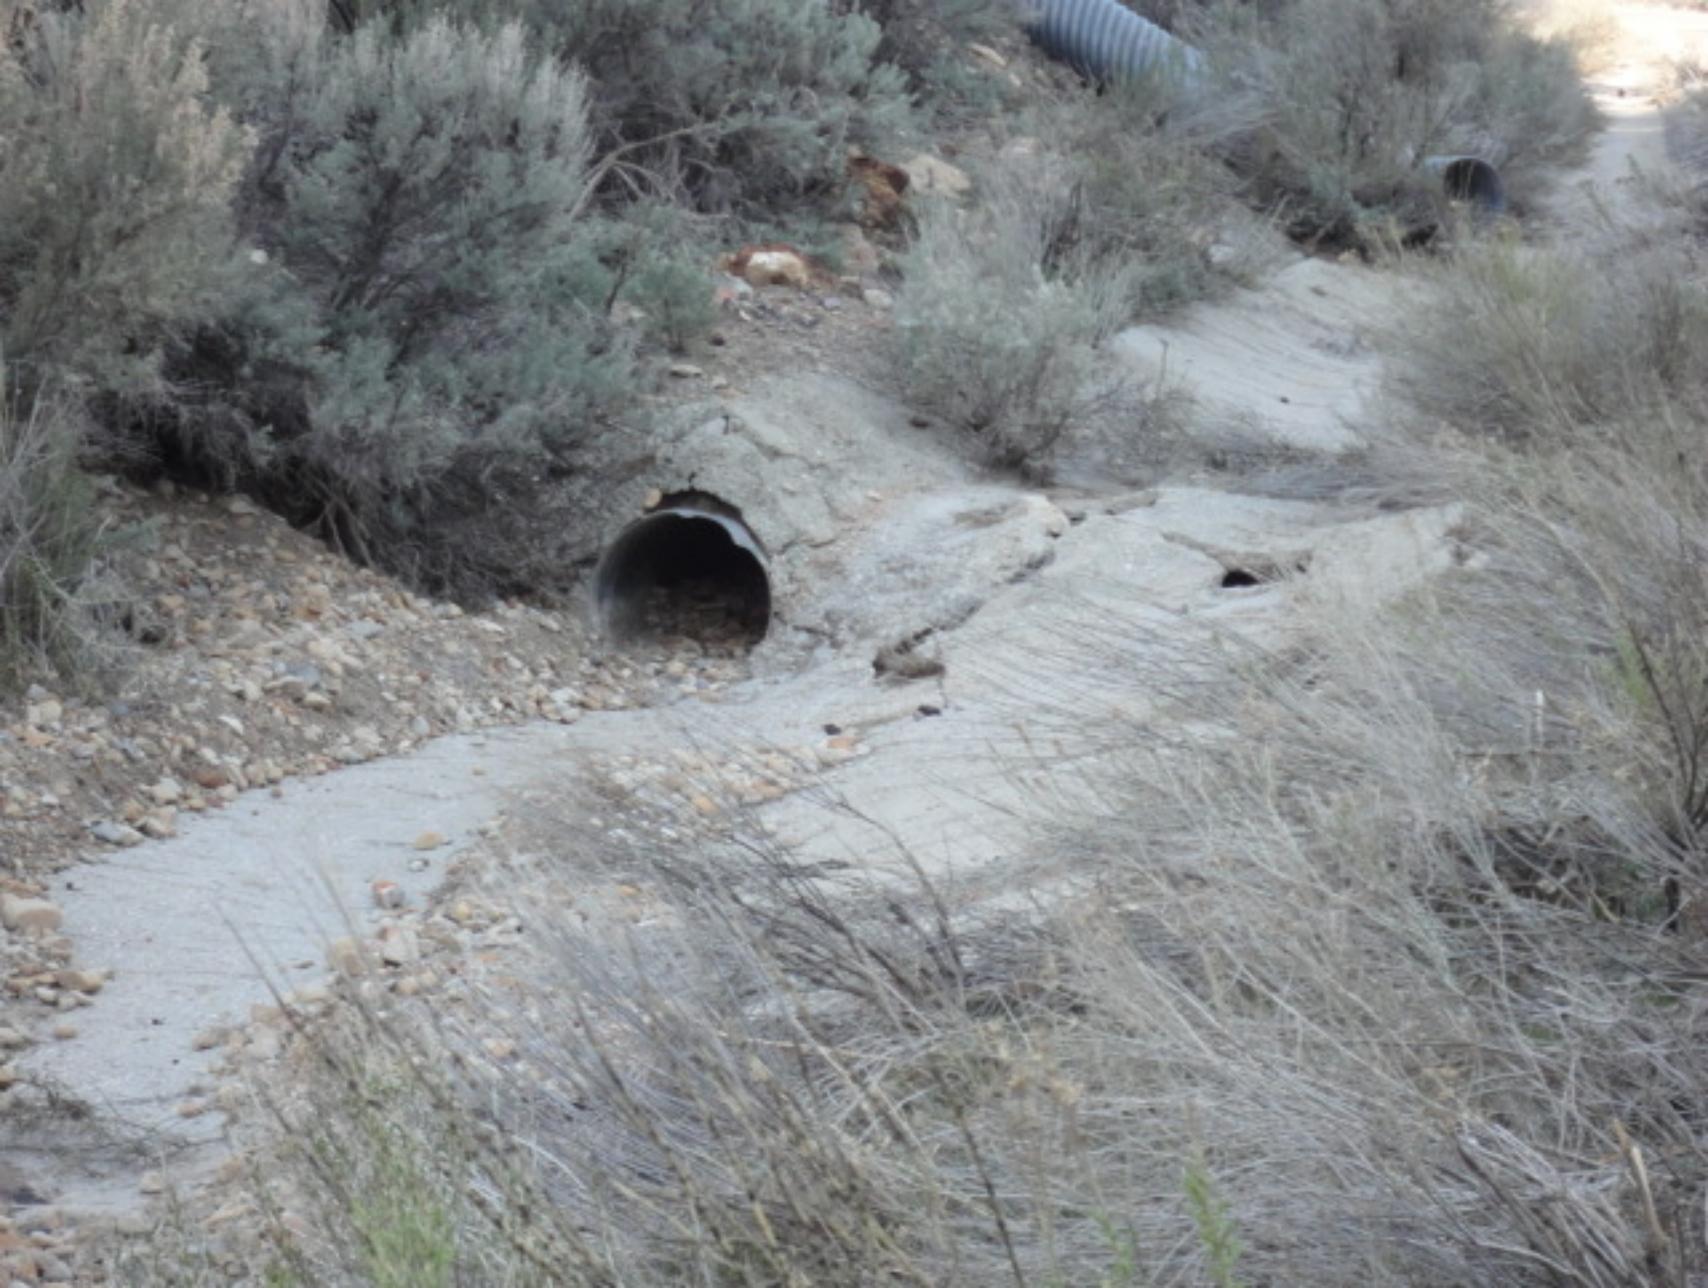
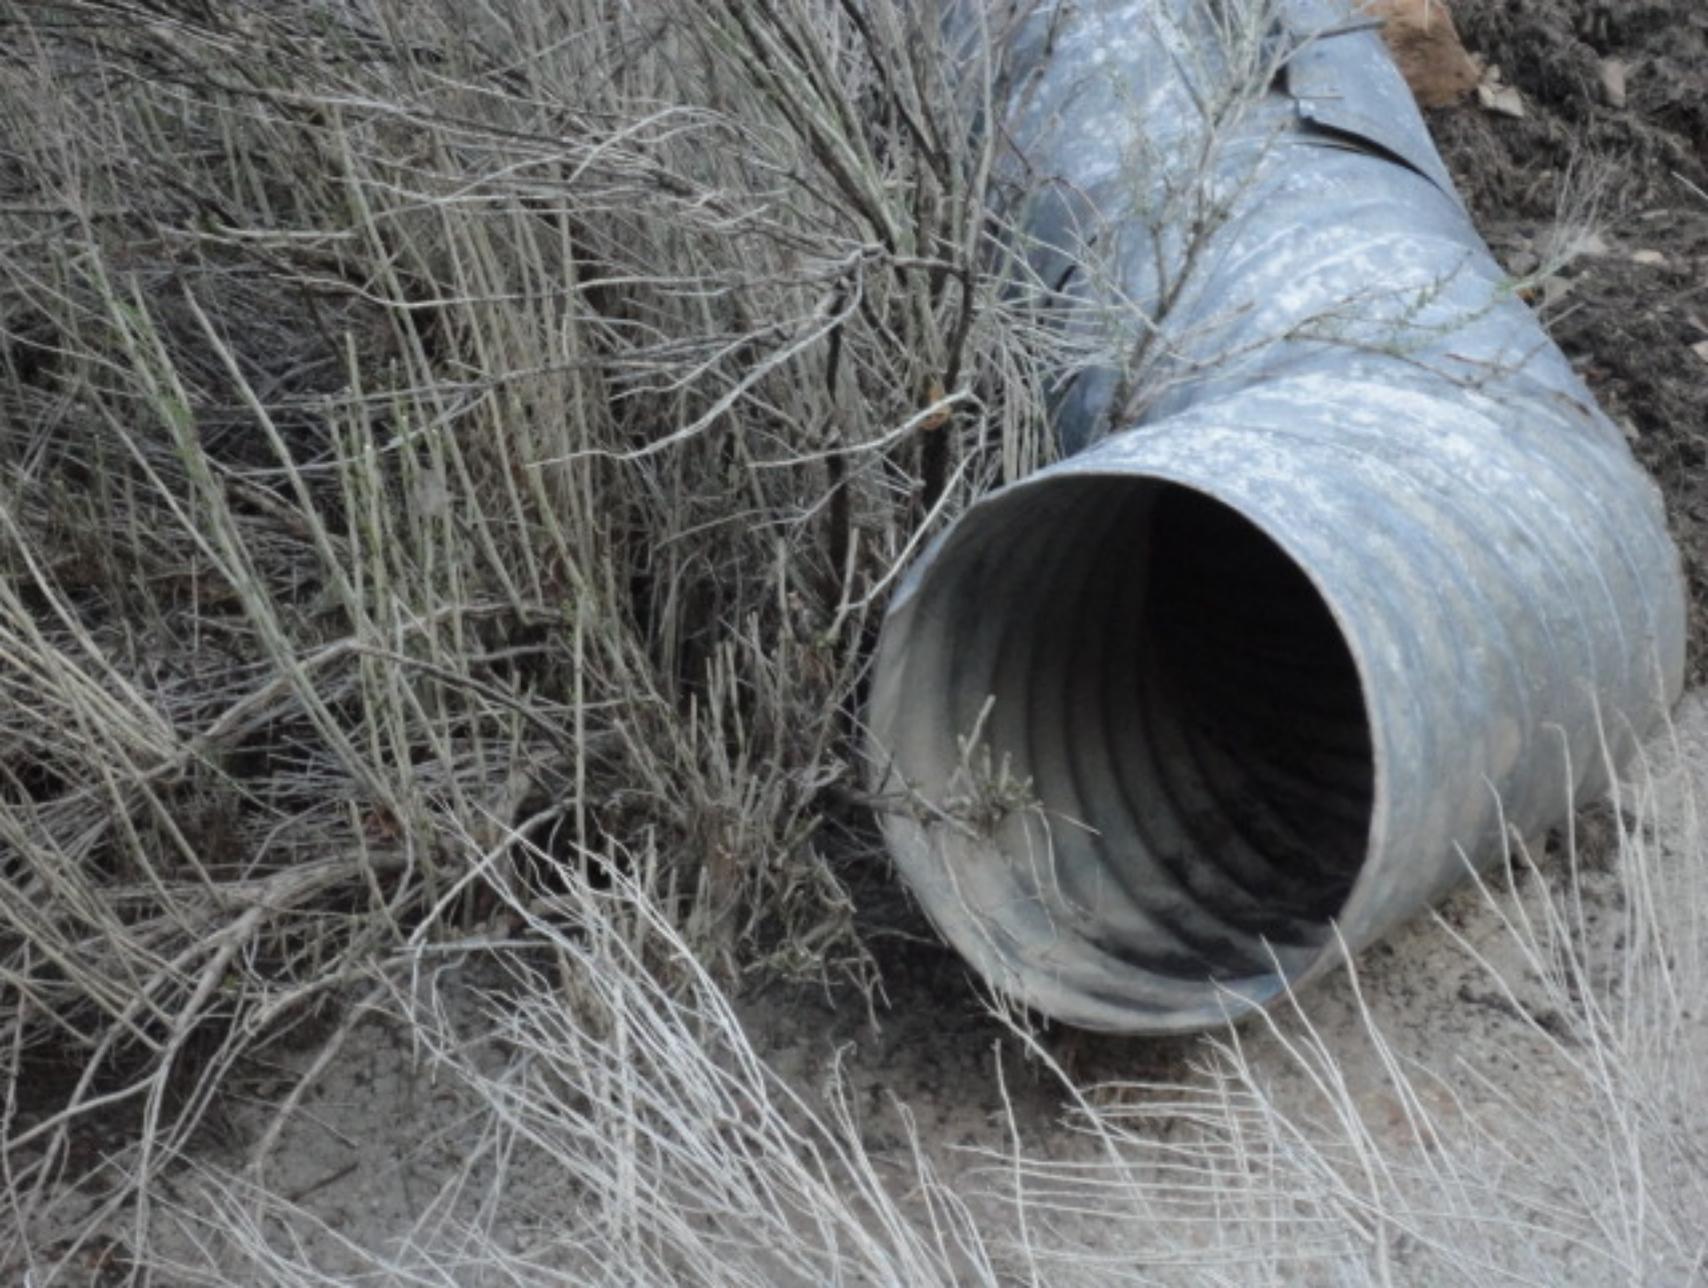
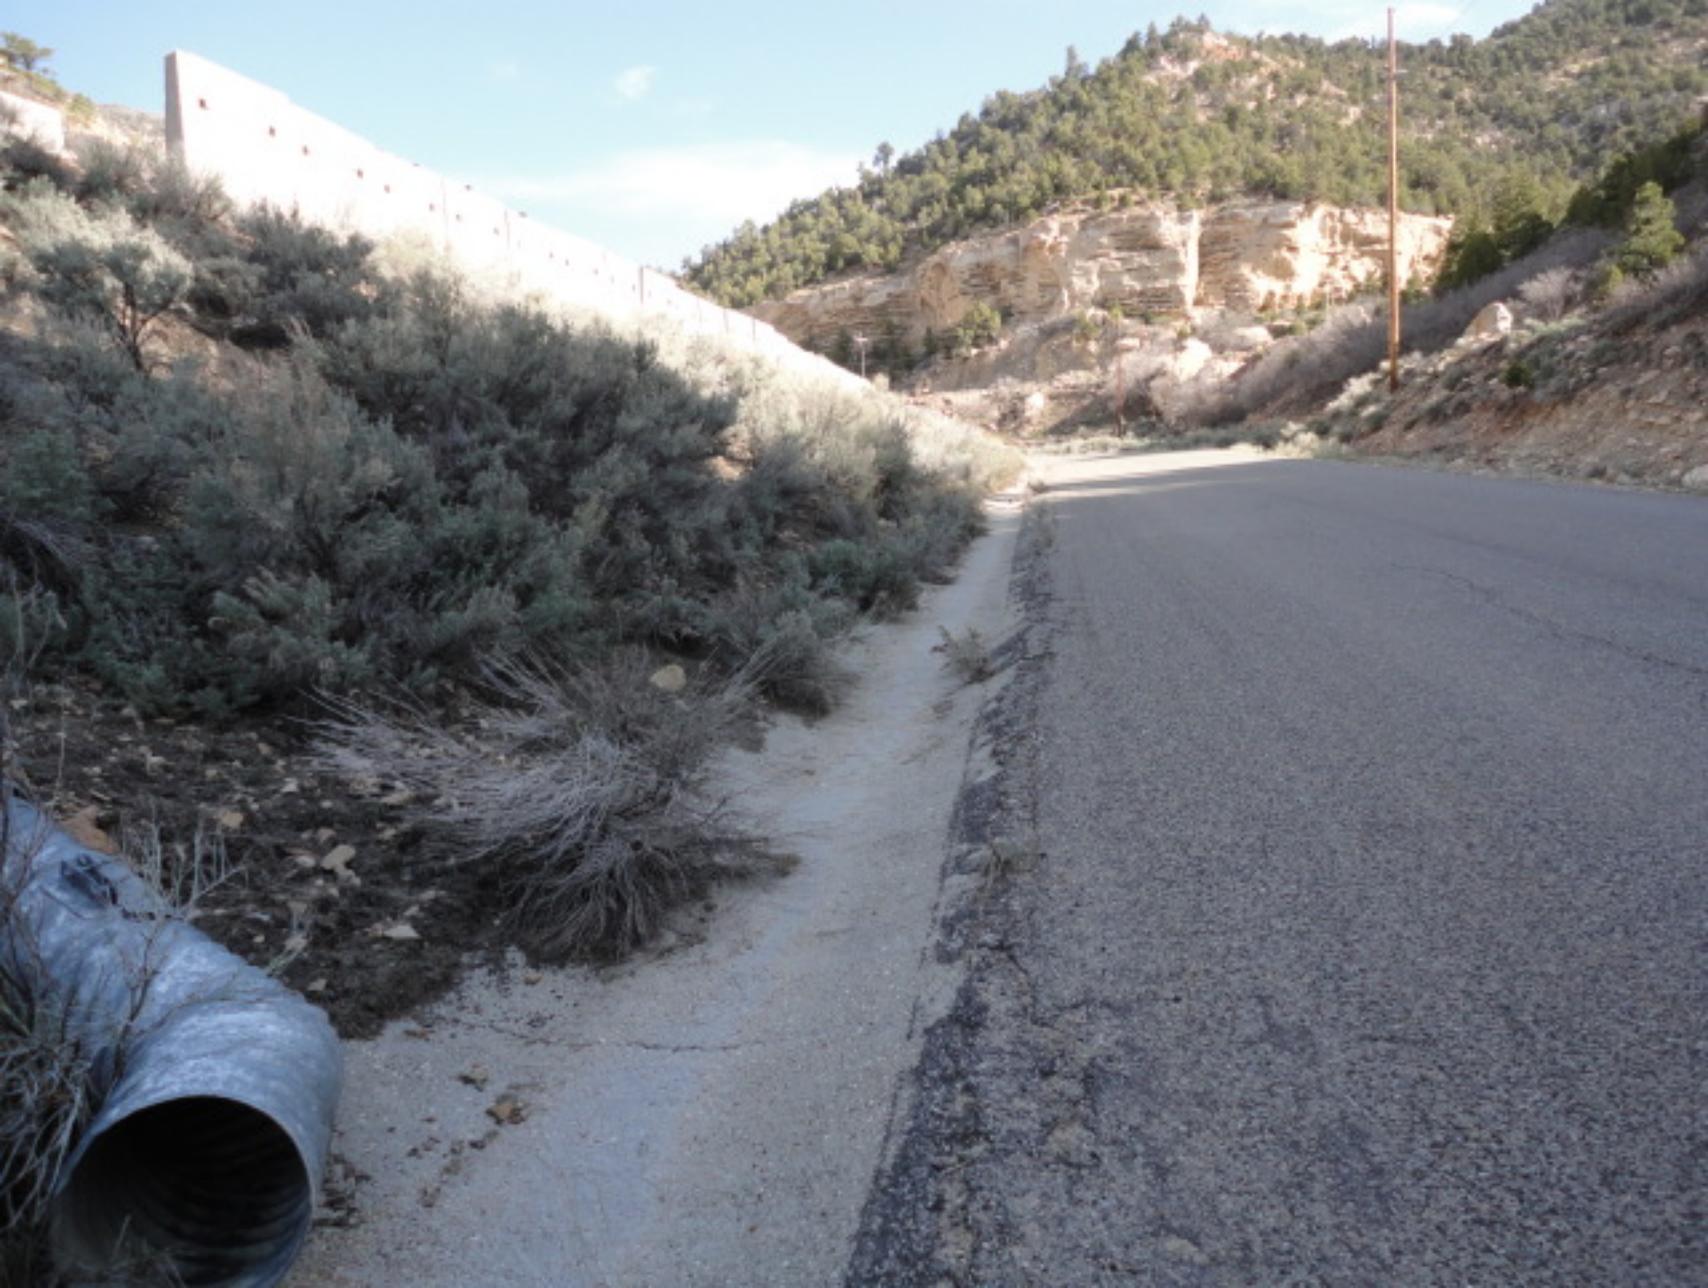
I inspected the sediment ponds throughout the property. They contained some water but were not discharging. It is unlikely these structures will discharge in the near future. The embankments appear to be stable. Inlets and outlets would function as designed. I did not see any hazardous conditions to these structures. See Photos
