Inspection Report

Permit Number:	C0070020
Inspection Type:	PARTIAL
Inspection Date:	Wednesday, May 25, 2016
Start Date/Time:	5/25/2016 9:30:00 AM
End Date/Time:	5/25/2016 10:30:00 AM
Last Inspection:	Thursday, April 28, 2016

Permittee: **HIDDEN SPLENDOR RESOURCES**
 Operator: **HIDDEN SPLENDOR RESOURCES**
 Site: **HORIZON MINE**
 Address: **57 WEST 200 SOUTH, SUITE 400, SALT LAKE CITY UT 84101**
 County: **CARBON**
 Permit Type: **PERMANENT COAL PROGRAM**
 Permit Status: **ACTIVE**

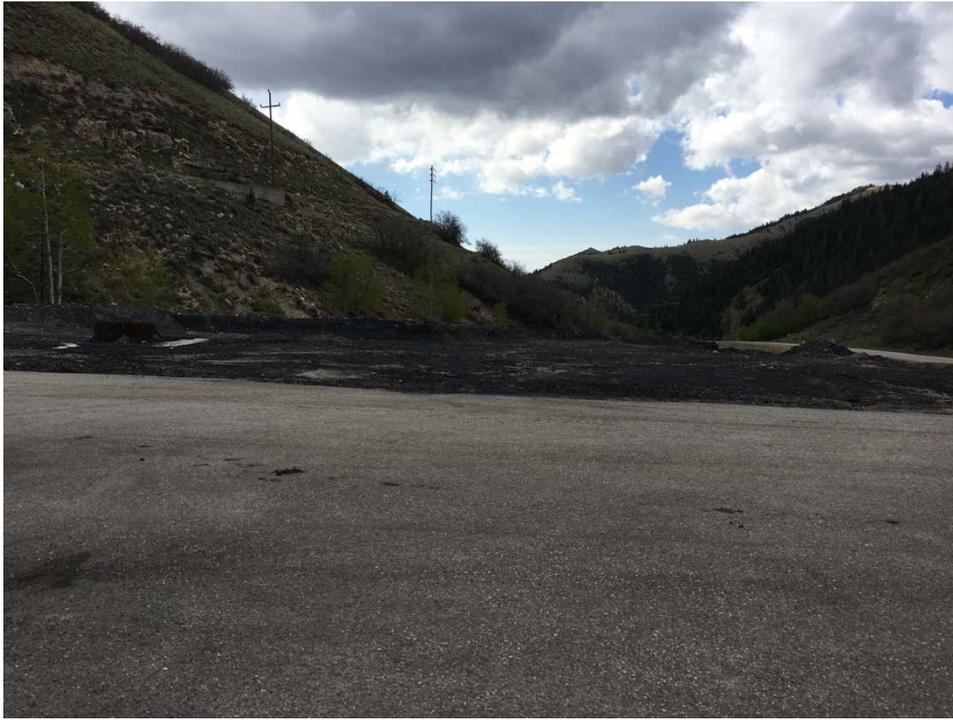
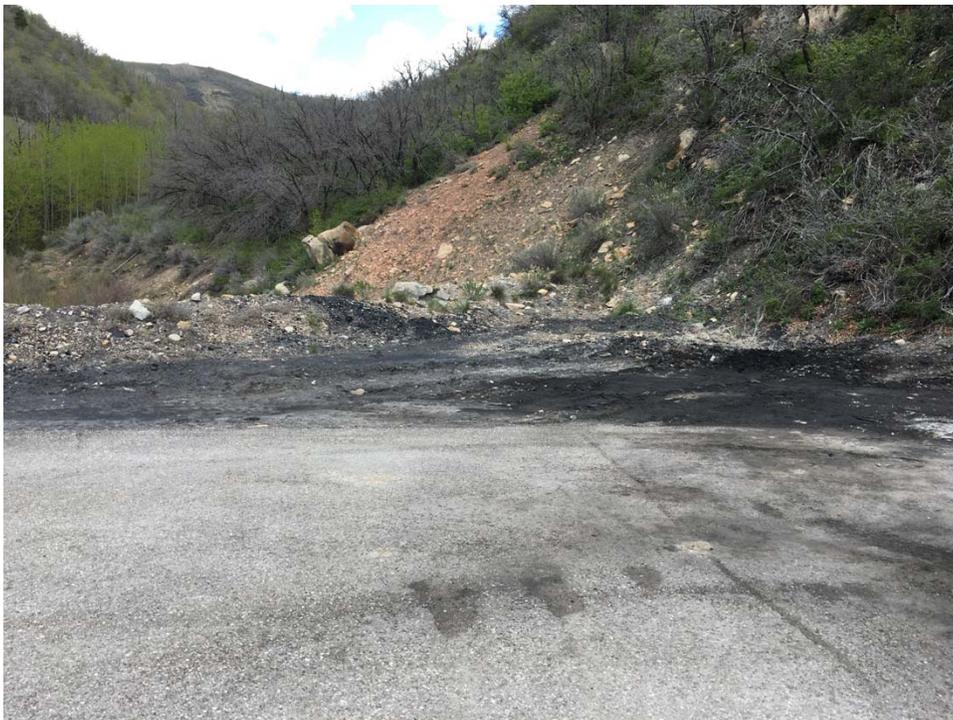
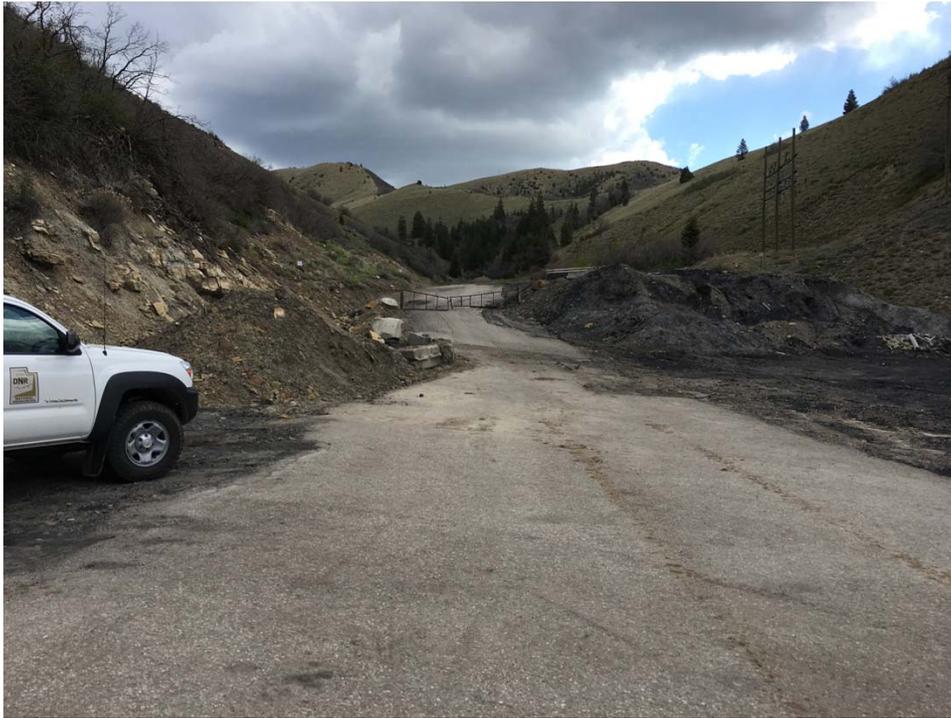
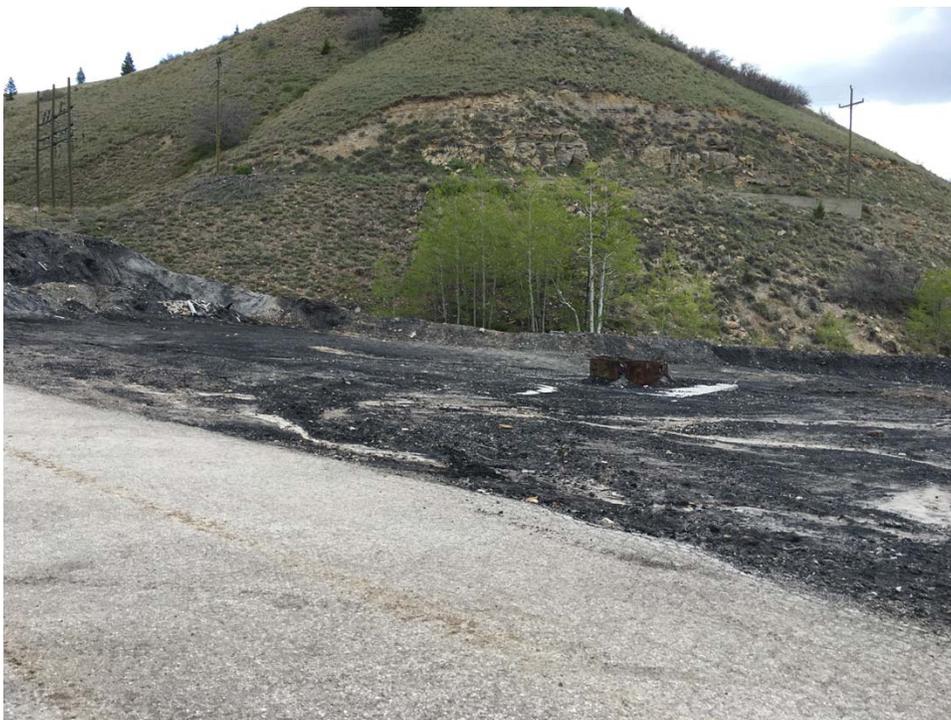
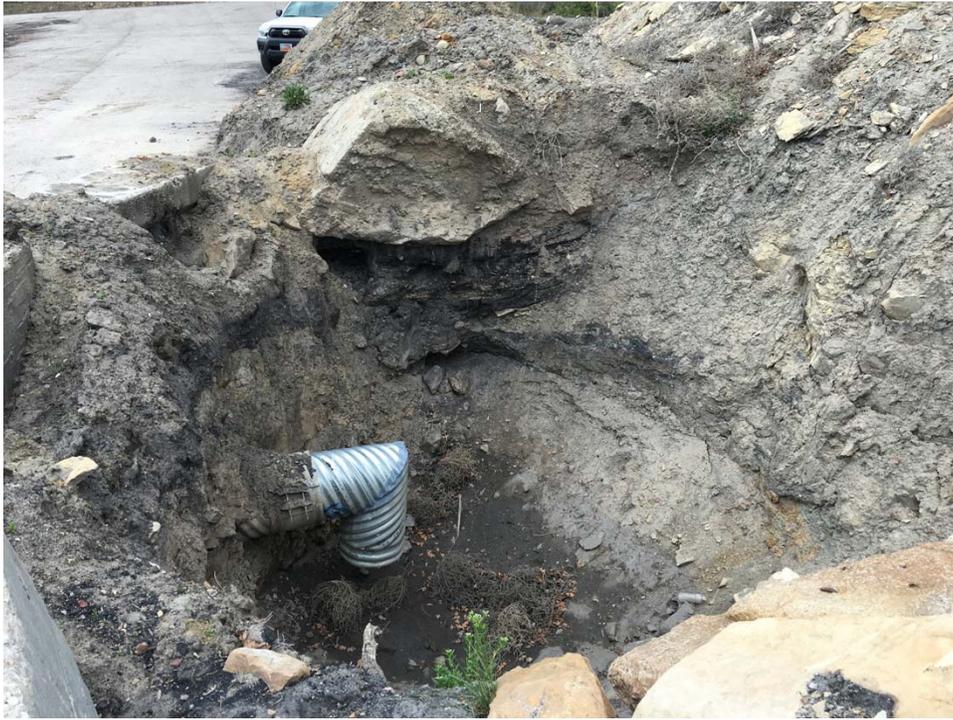
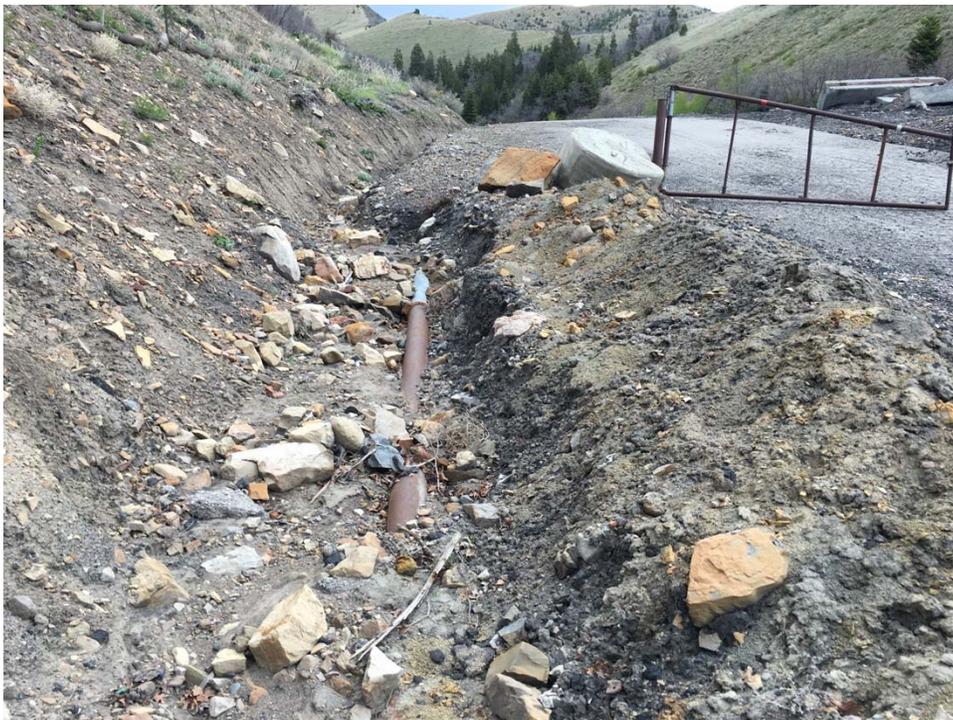
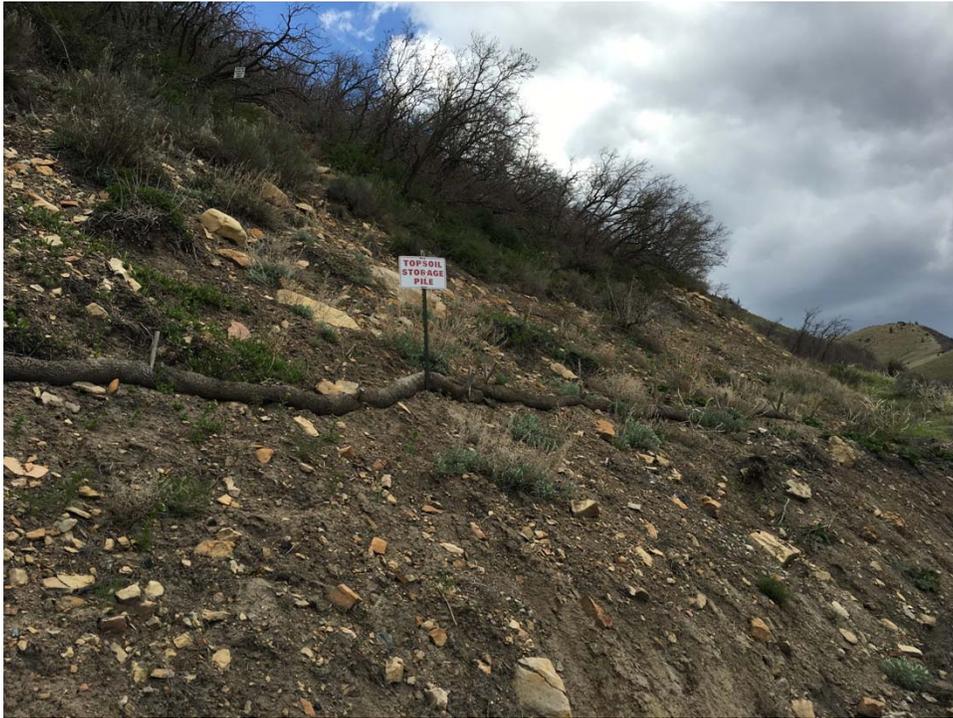
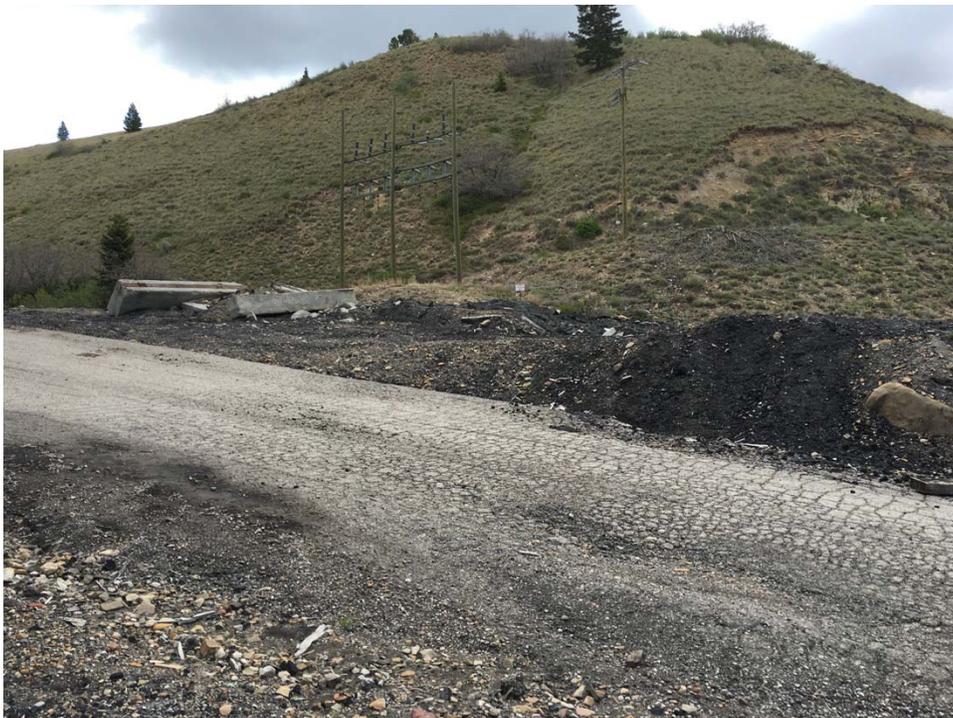
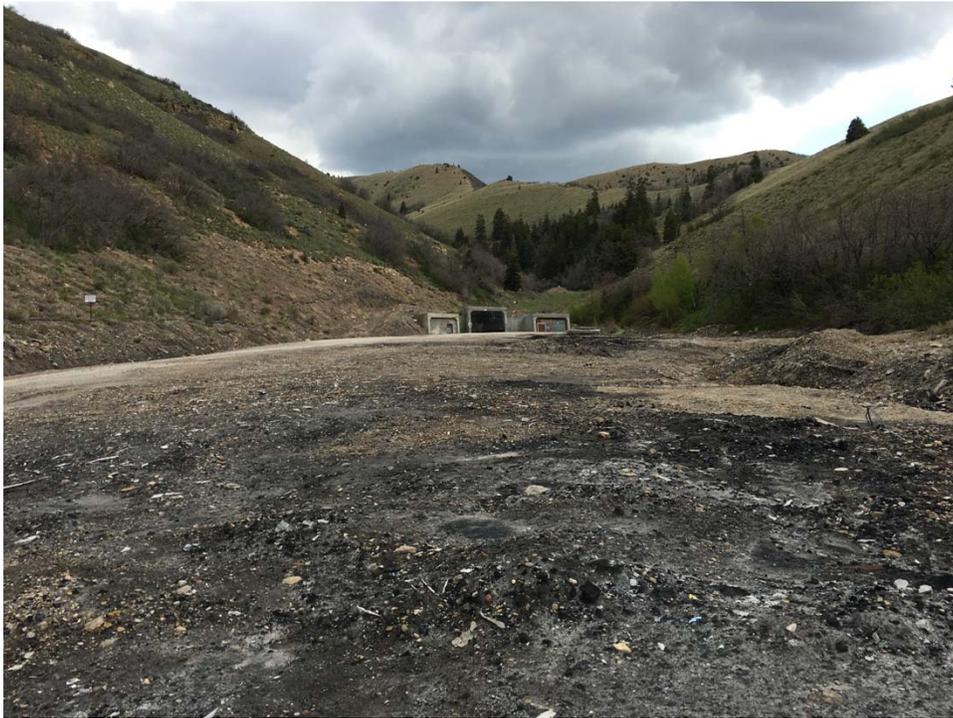
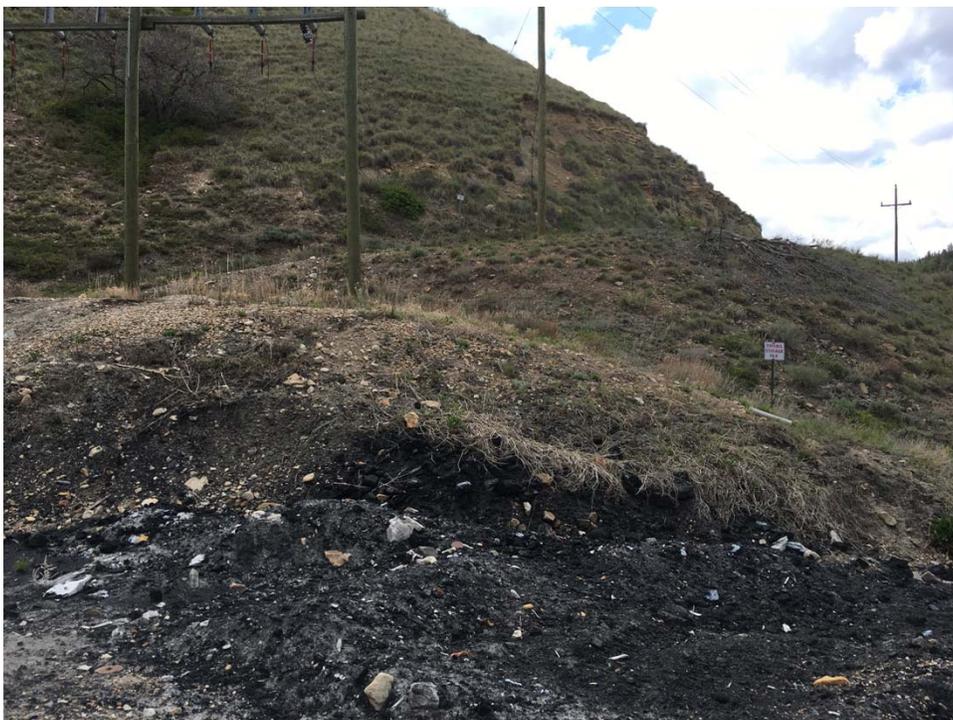
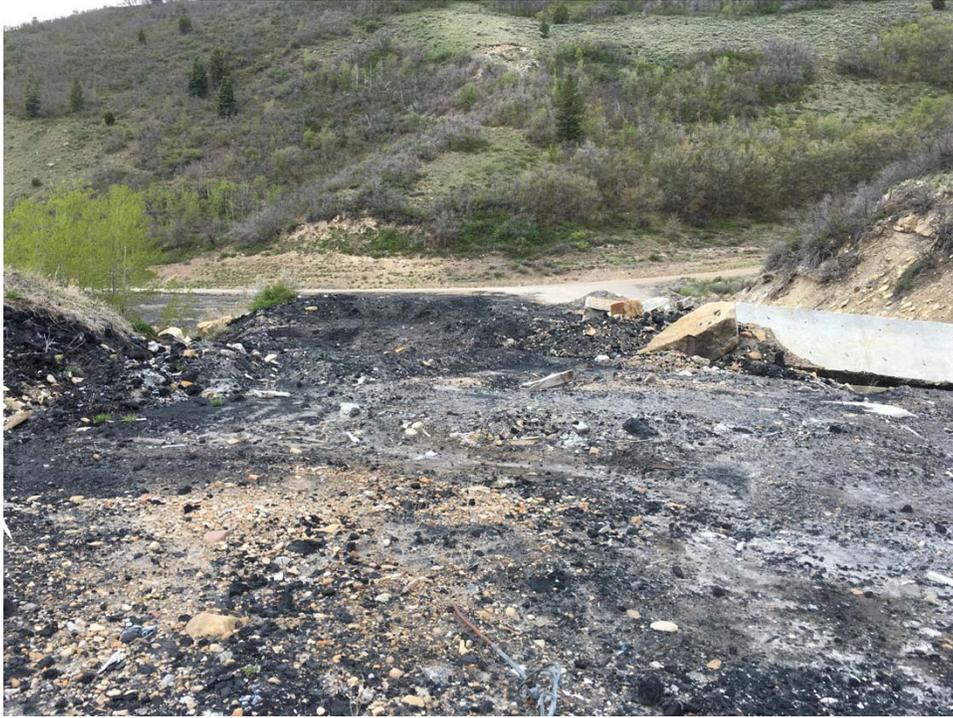
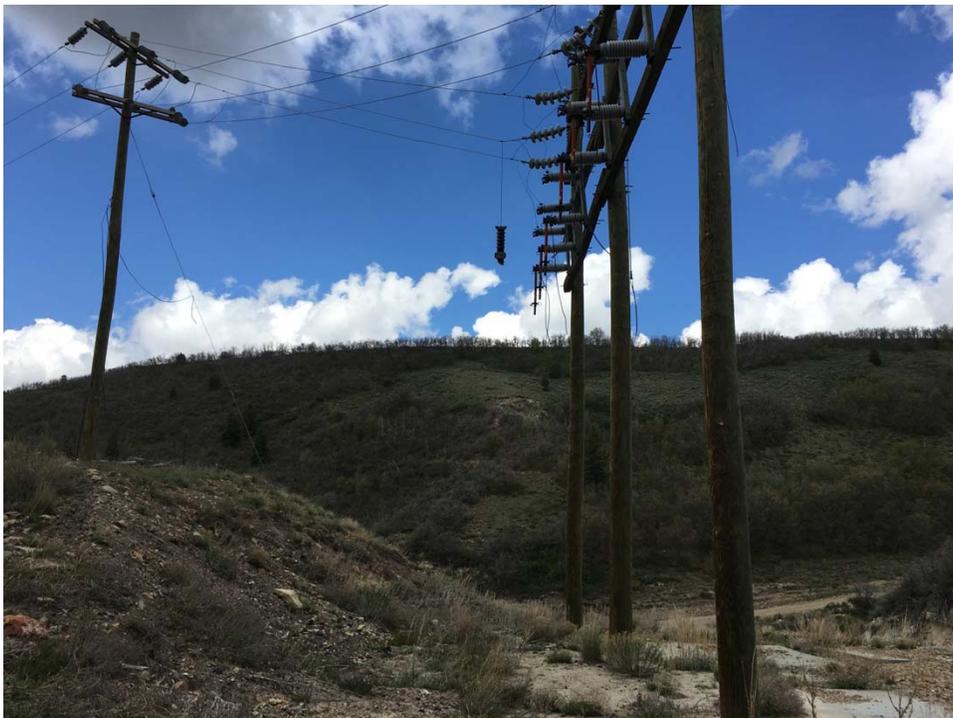
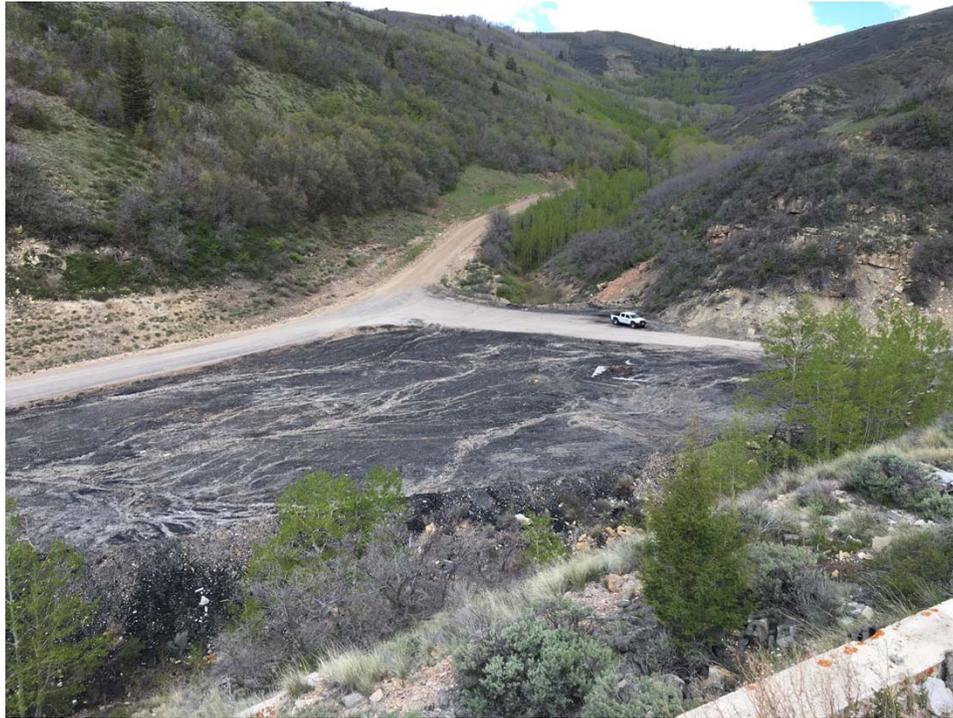
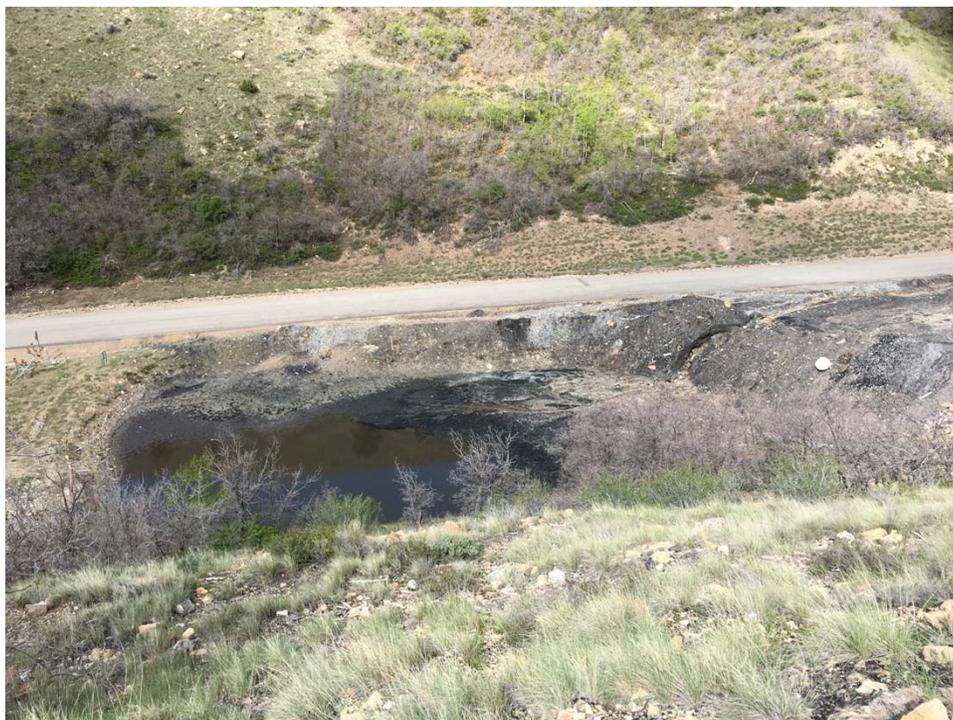
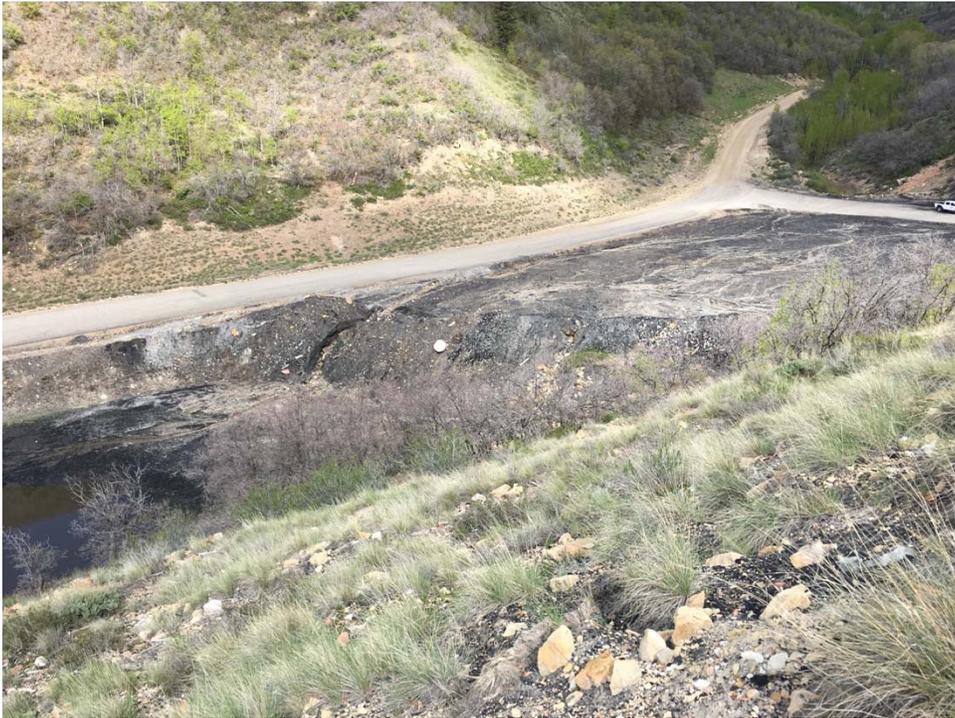
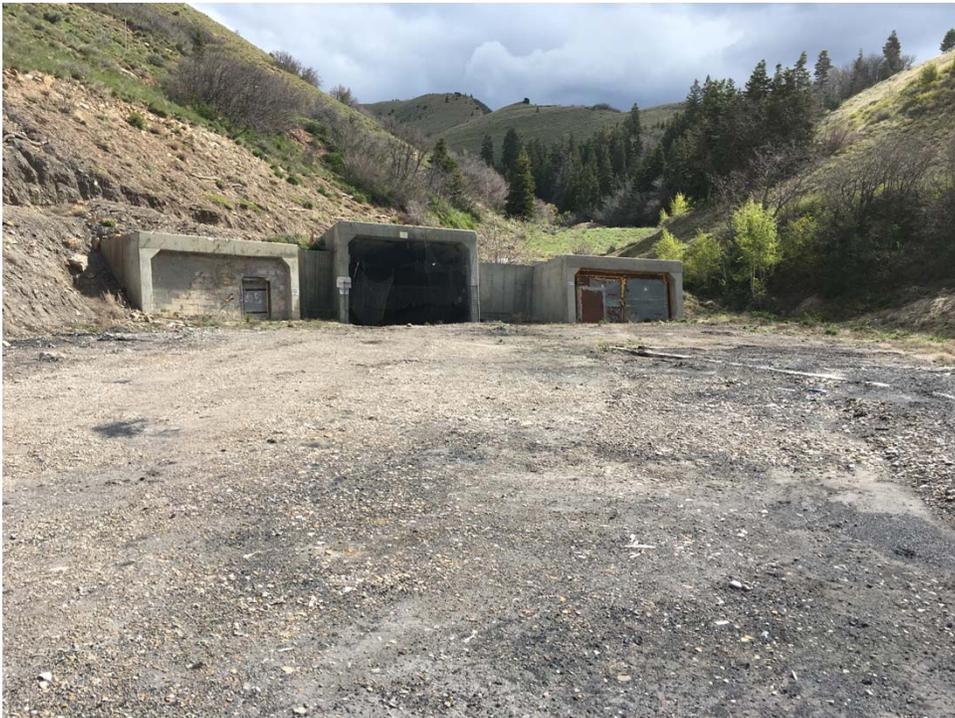
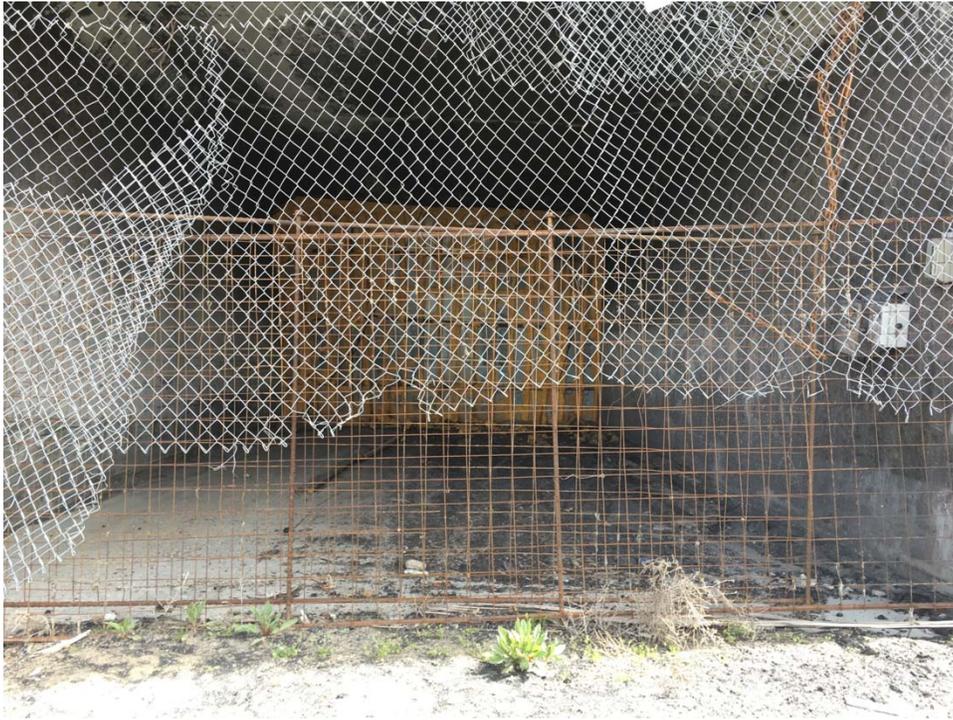
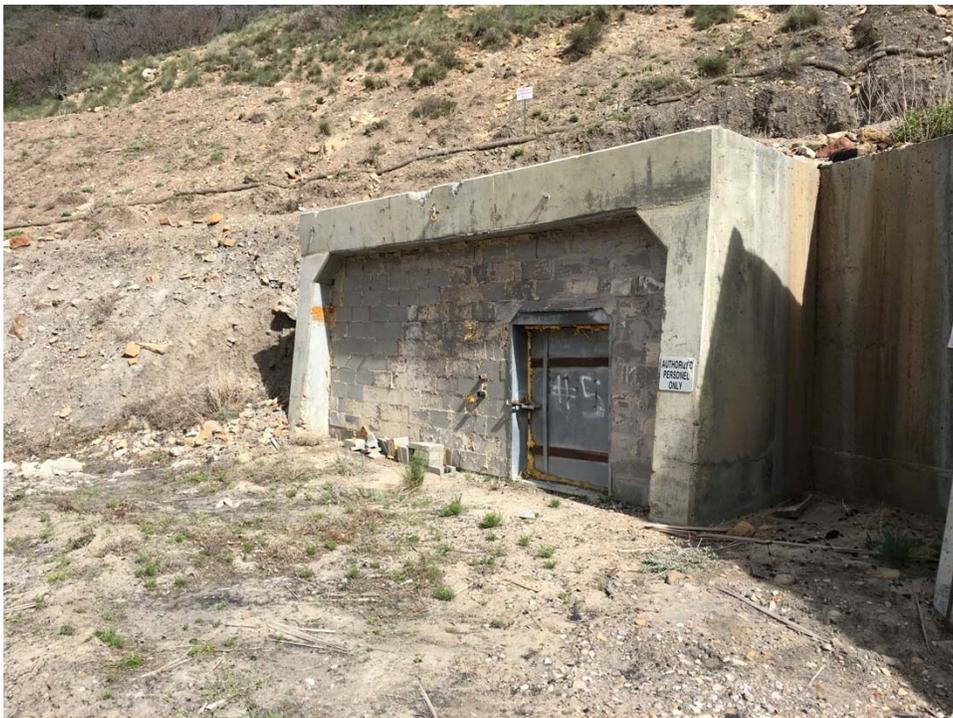
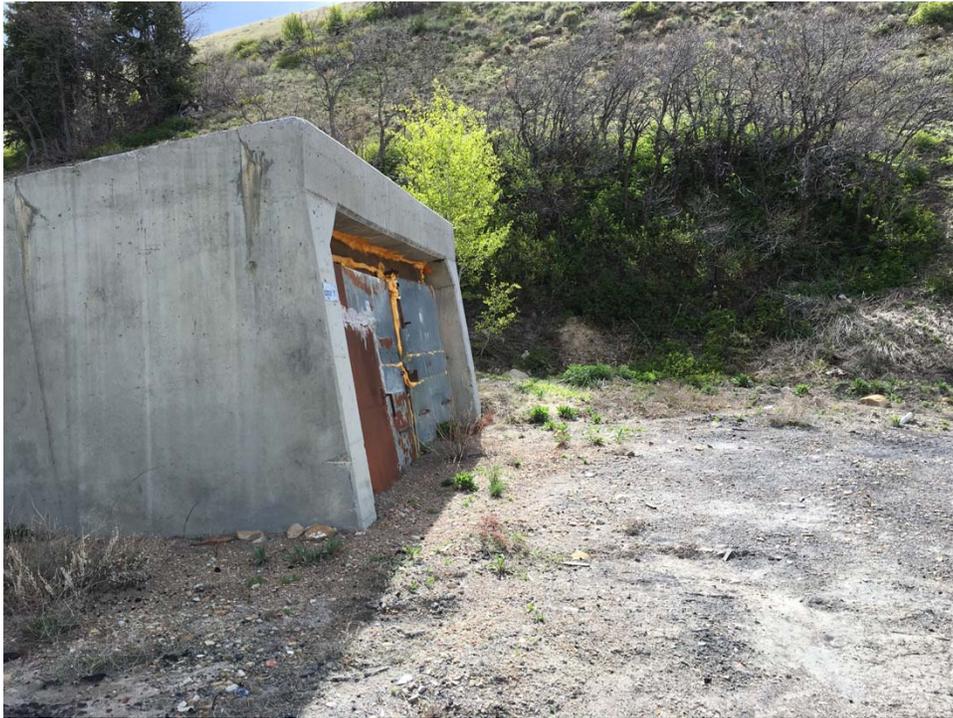
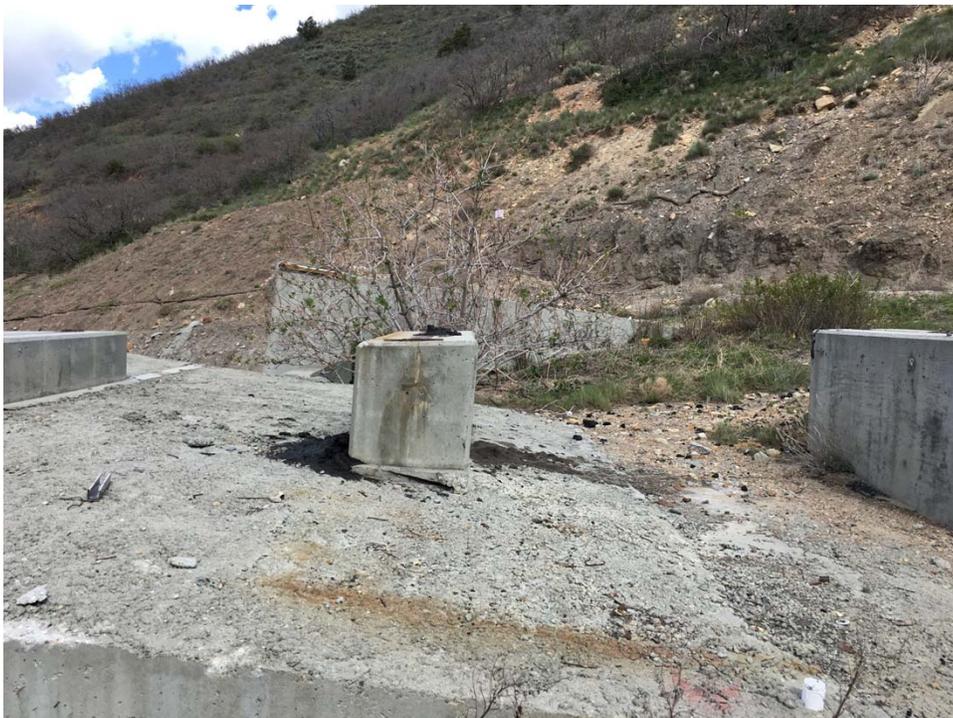
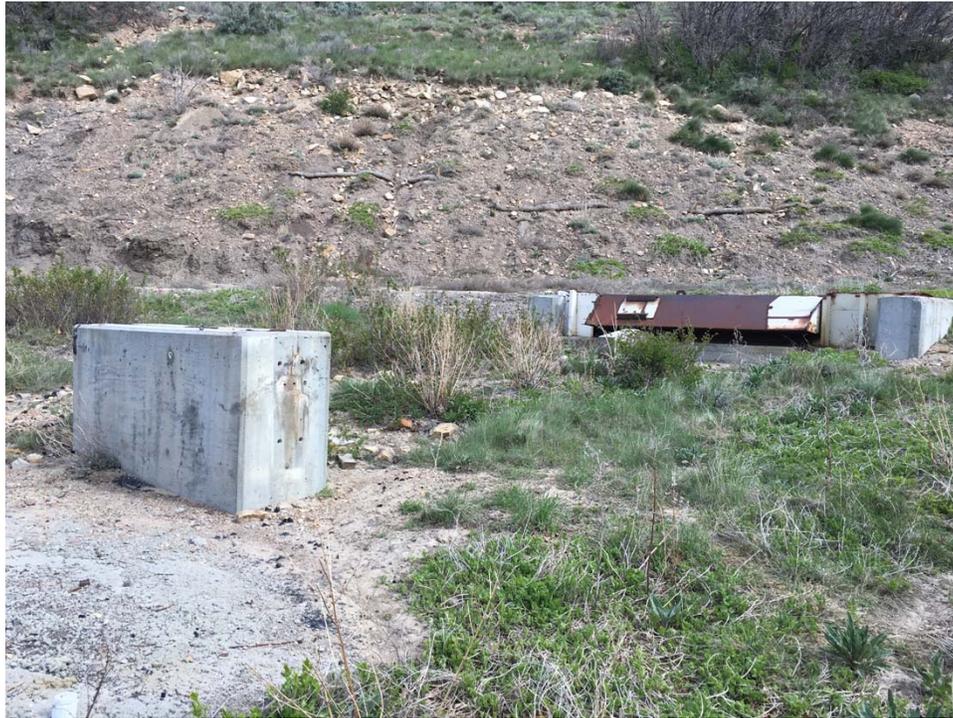
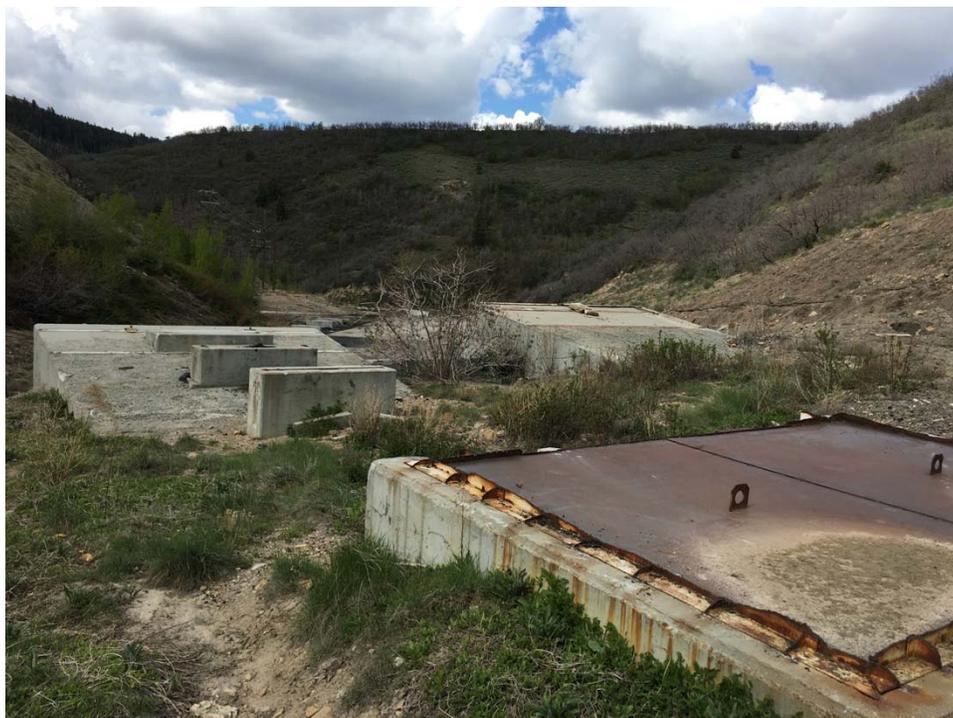
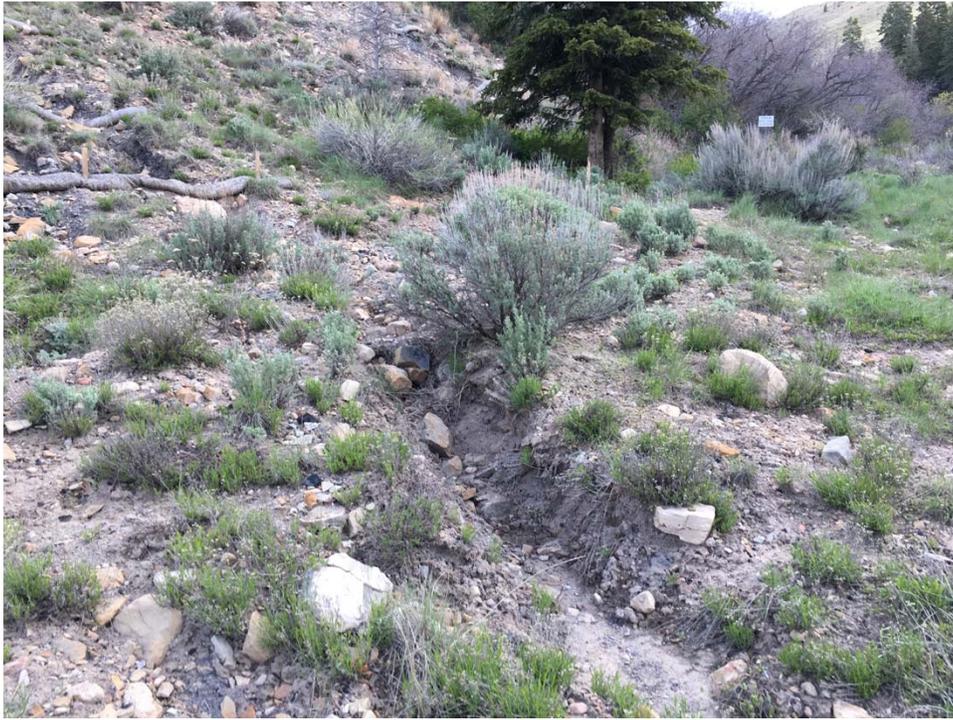
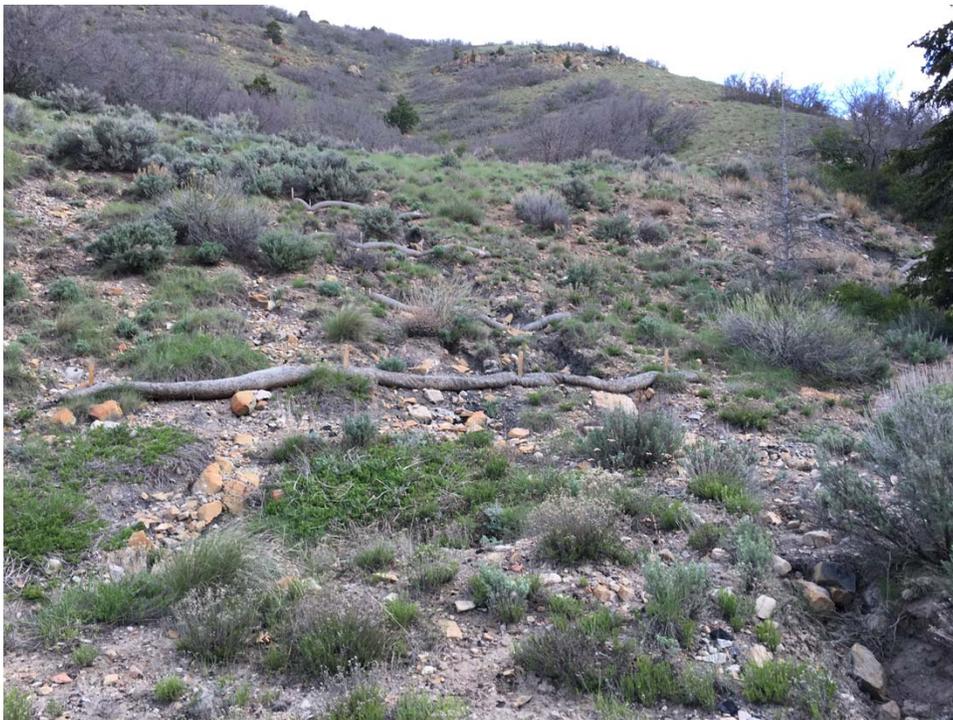
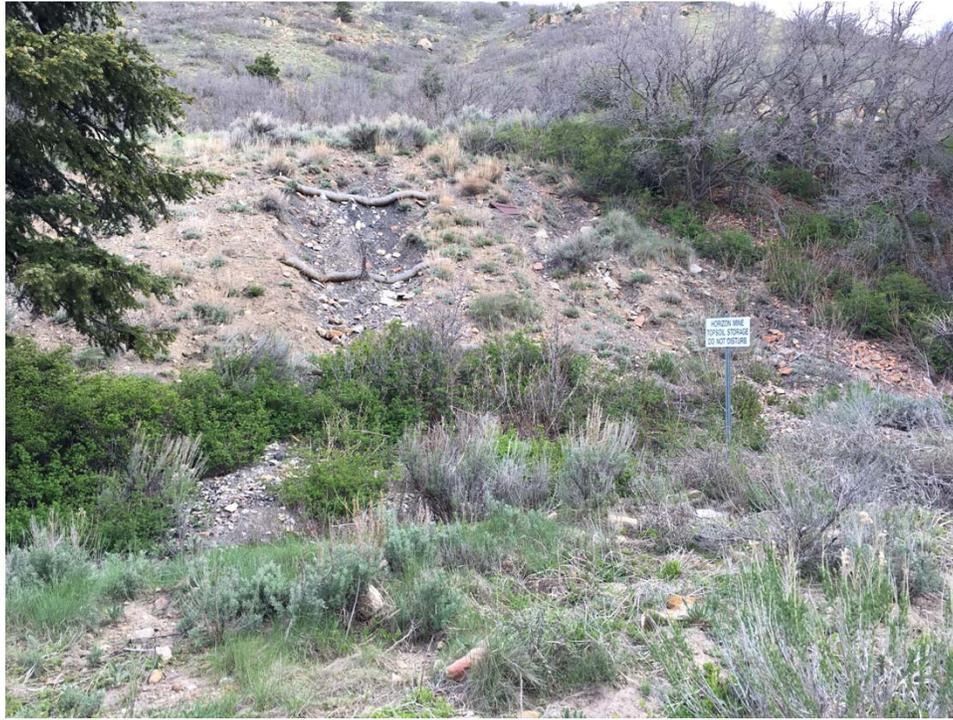
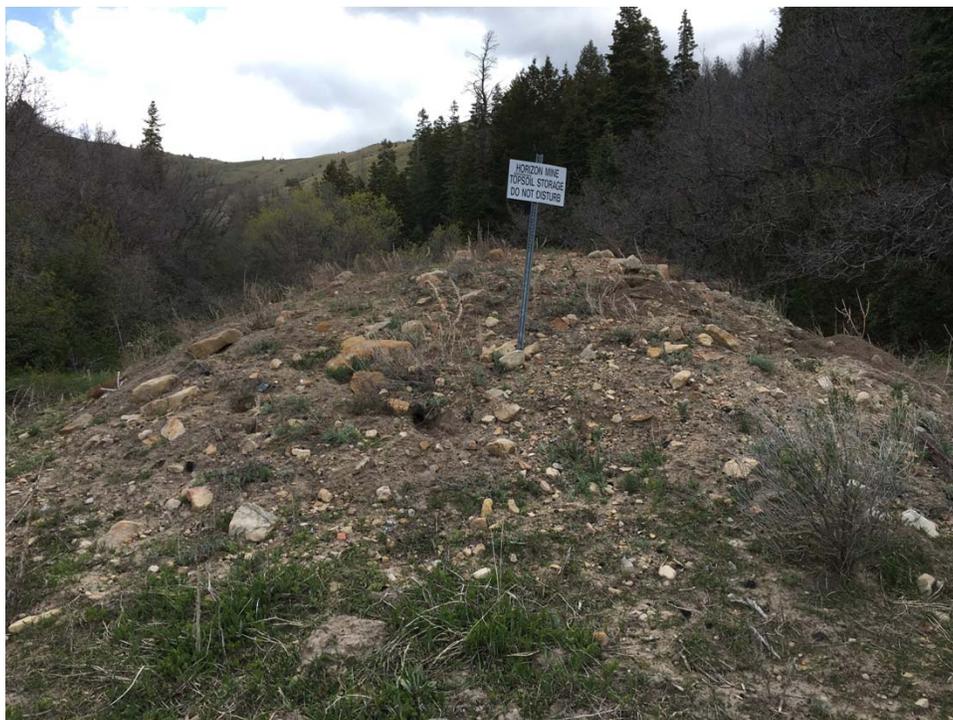
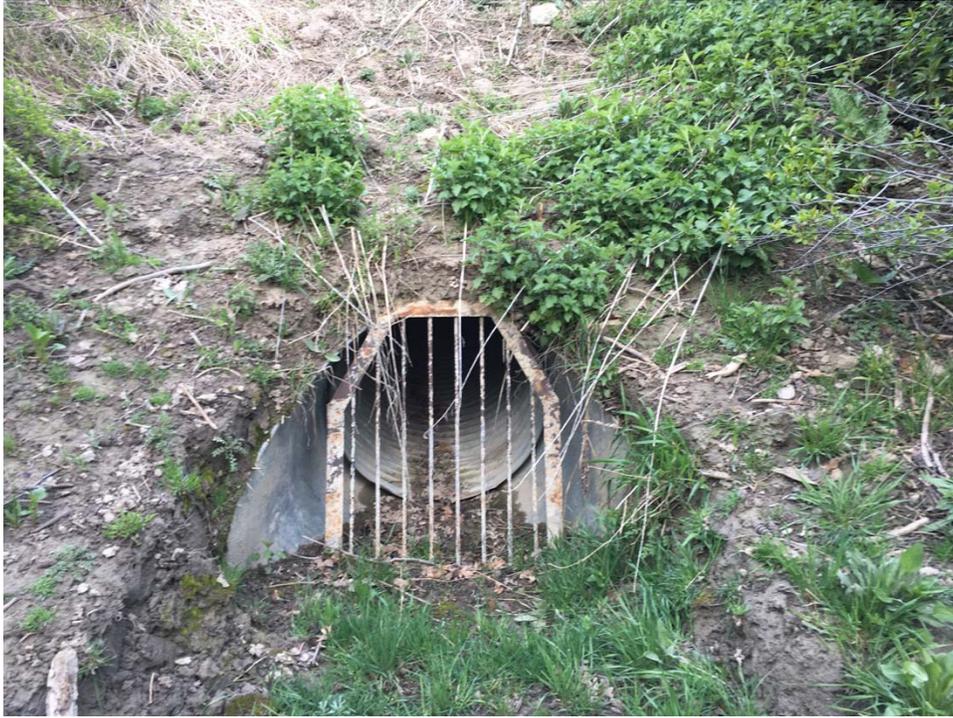
There appears to be settling taking place just above the far left portal (when looking up canyon). See attached pictures. During conversations with Kit Pappas, the Division was informed that there was an opening above this portal that was used during mining to facilitate mine ventilation through a connection with the fan located above the far right portal. This opening was backfilled when the portals were closed and now appears to be settling. This will be watched during subsequent inspections.
