# Inspection Report

Permit Number:	<b>C0070022</b>
Inspection Type:	PARTIAL
Inspection Date:	Thursday, March 09, 2017
Start Date/Time:	3/9/2017 8:00:00 AM
End Date/Time:	3/9/2017 1:30:00 AM
Last Inspection:	Thursday, February 02, 2017

Permittee: **SAVAGE SERVICES CORP**  
 Operator: **SAVAGE SERVICES CORP**  
 Site: **SAVAGE COAL TERMINAL**  
 Address: **2025 EAST 5000 SOUTH, PRICE UT 84051**  
 County: **CARBON**  
 Permit Type: **PERMANENT COAL PROGRAM**  
 Permit Status: **ACTIVE**

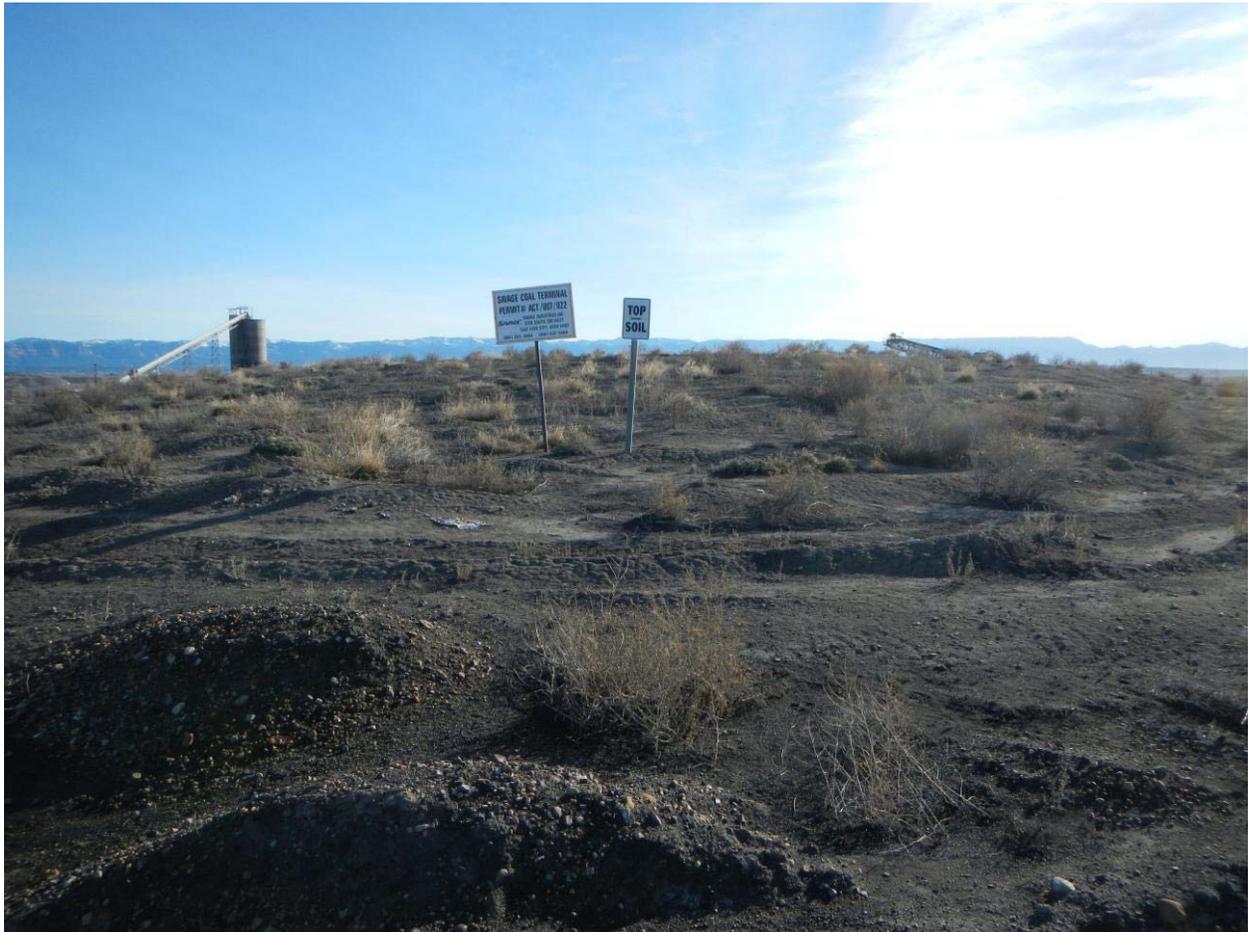
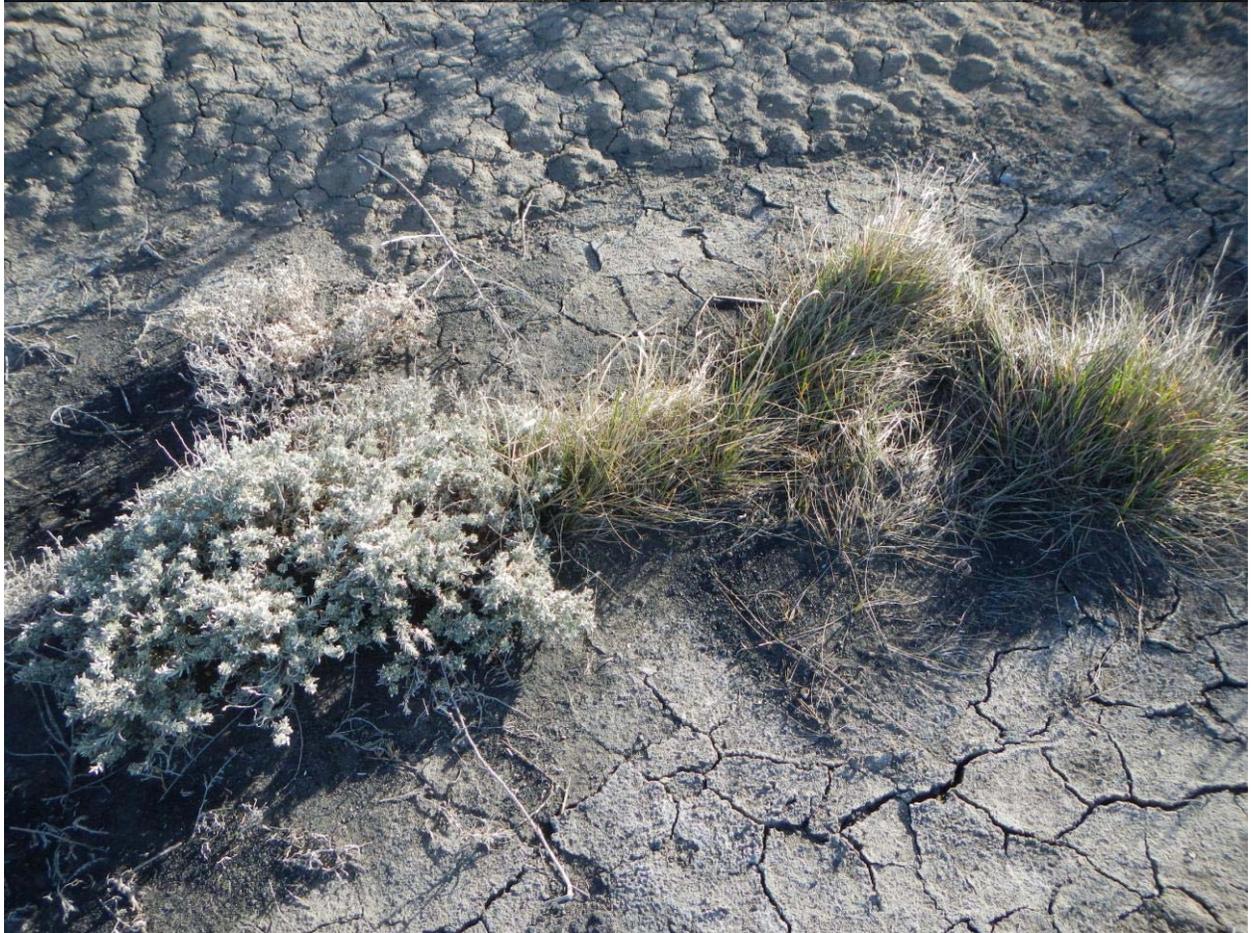
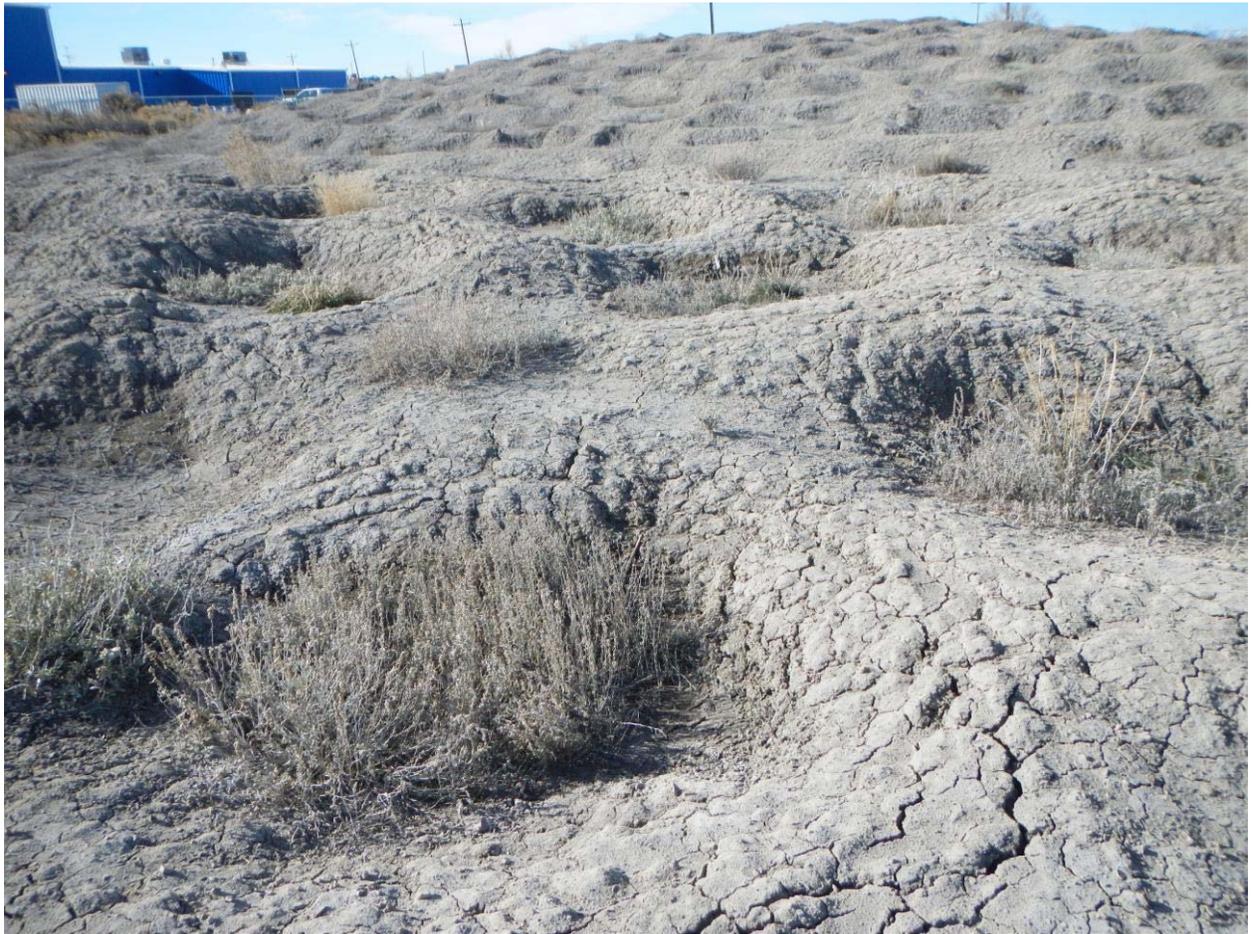
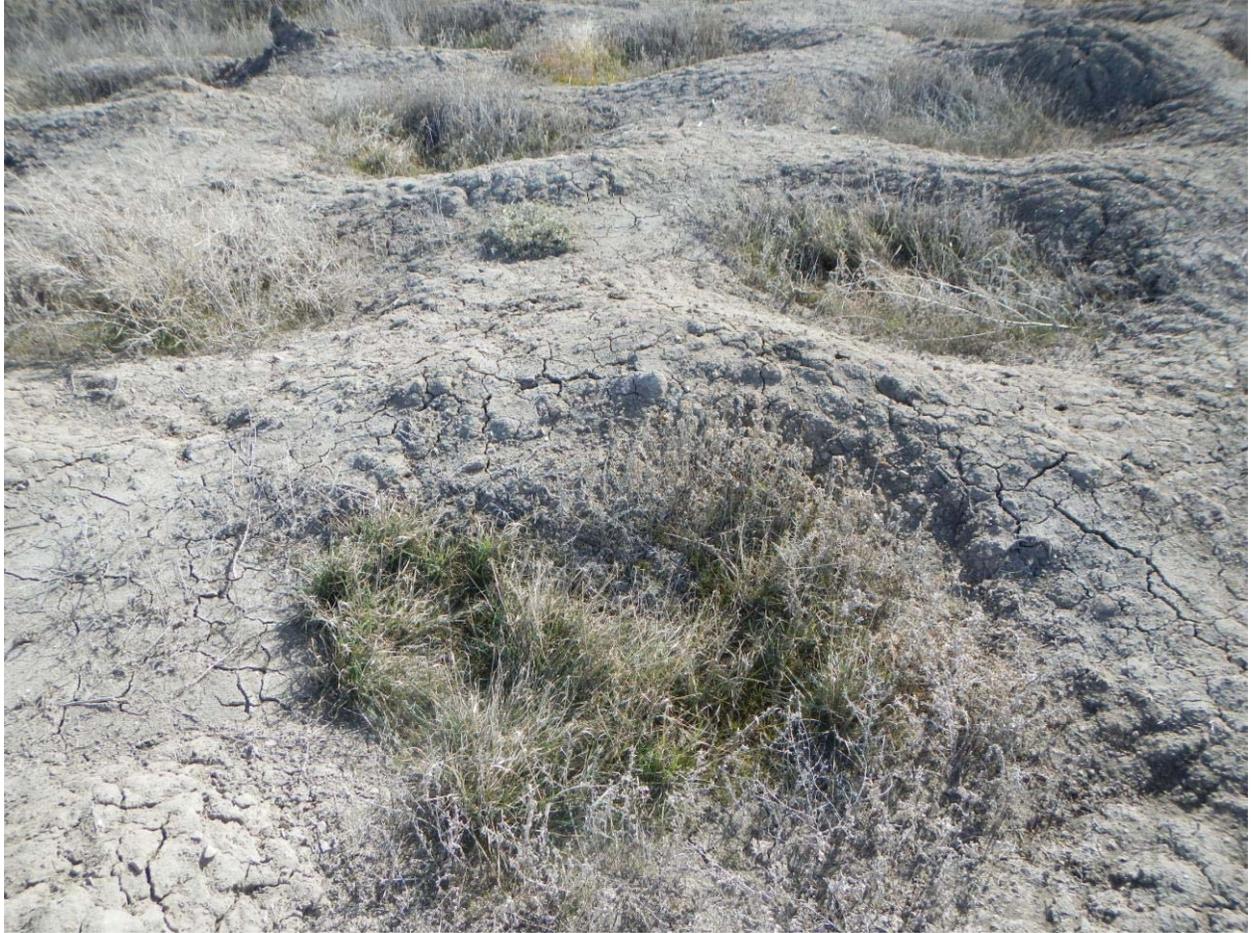
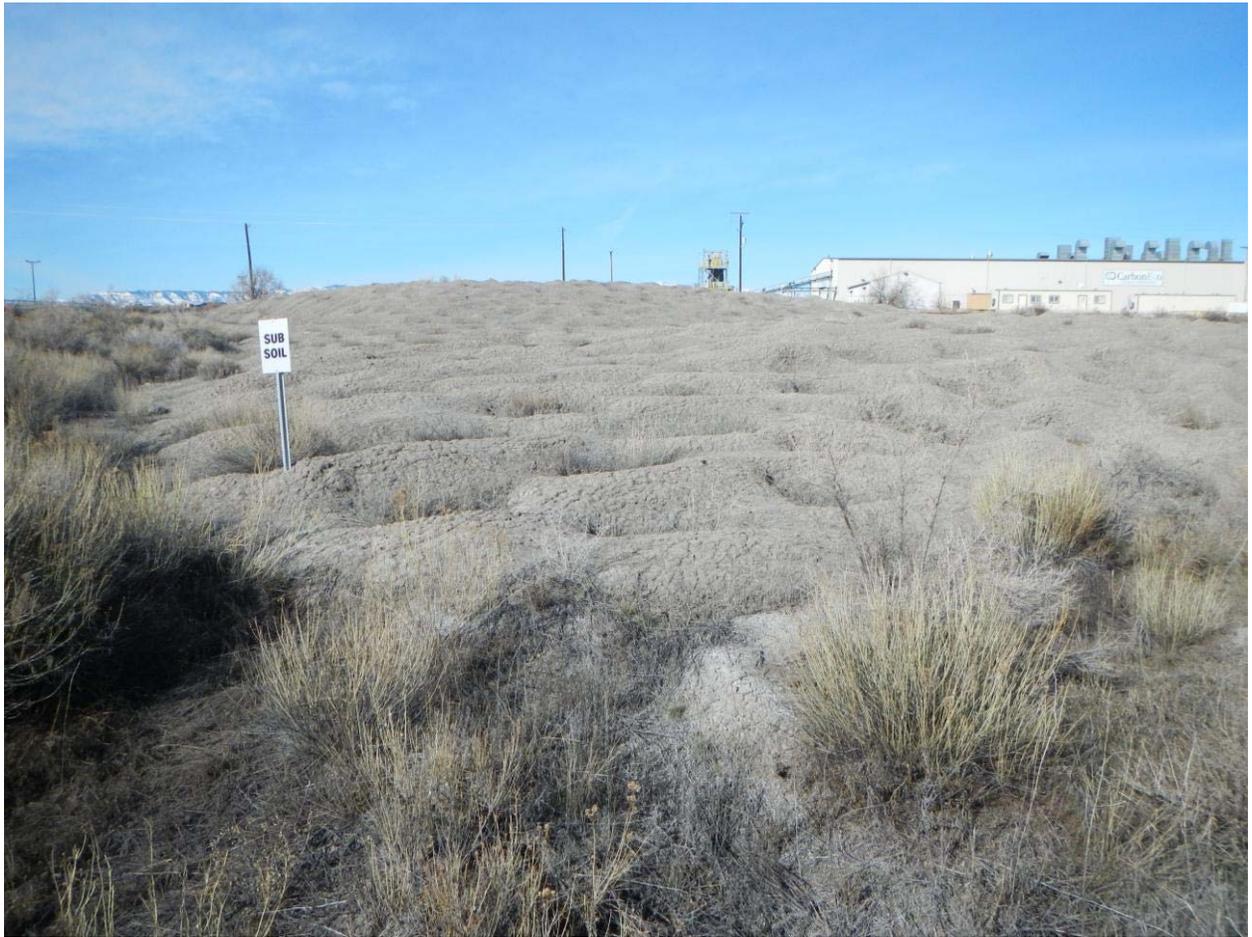
Revegetation on topsoil and subsoil stockpiles was photographed (see attached photos). There were no noxious weeds noted on site. The revegetation test plot is no longer active, but was photographed (see image folder for March 9, 2017).
