# Inspection Report

Permit Number:	C0070033
Inspection Type:	COMPLETE
Inspection Date:	Wednesday, March 12, 2014
Start Date/Time:	3/12/2014 12:30:00 PM
End Date/Time:	3/12/2014 1:30:00 PM
Last Inspection:	Wednesday, February 26, 2014

Permitee: **INTERMOUNTAIN POWER AGENCY**  
 Operator: **AMERICA WEST RESOURCES, INC.**  
 Site: **WILDCAT LOADOUT**  
 Address: **3266 SOUTH 125 WEST, PRICE UT 84501**  
 County: **CARBON**  
 Permit Type: **PERMANENT COAL PROGRAM**  
 Permit Status: **ACTIVE**

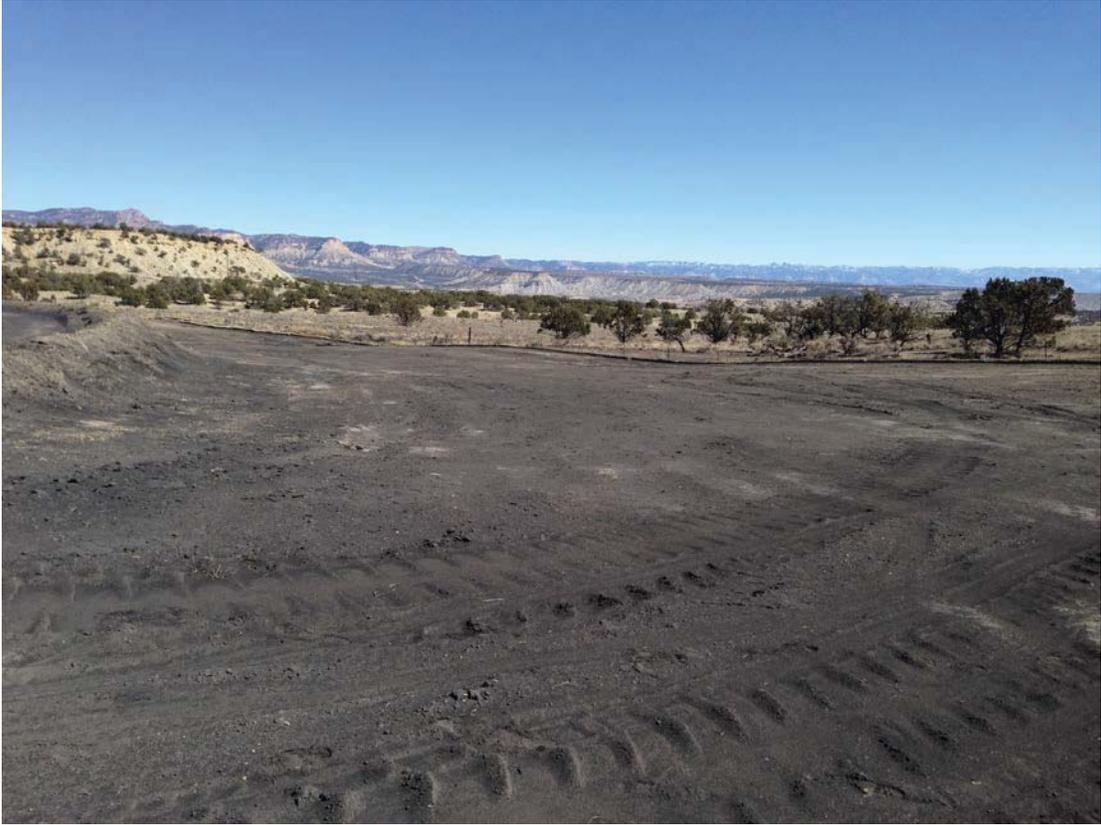
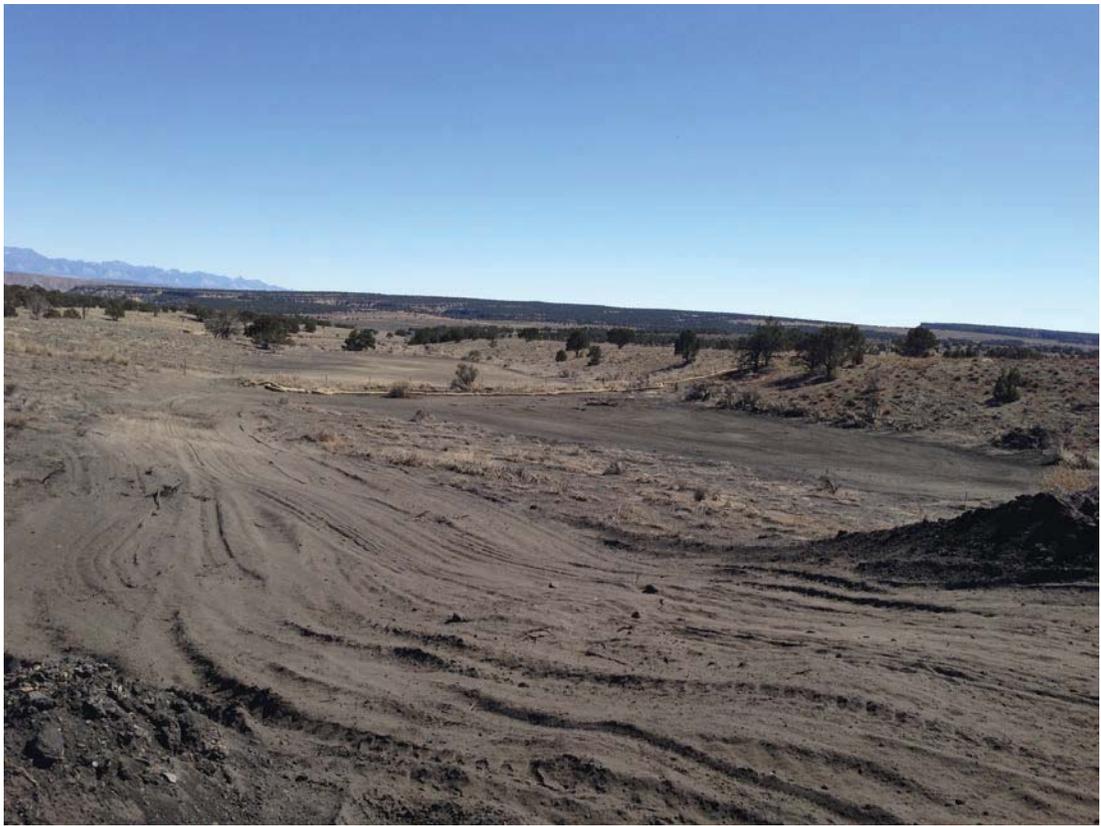
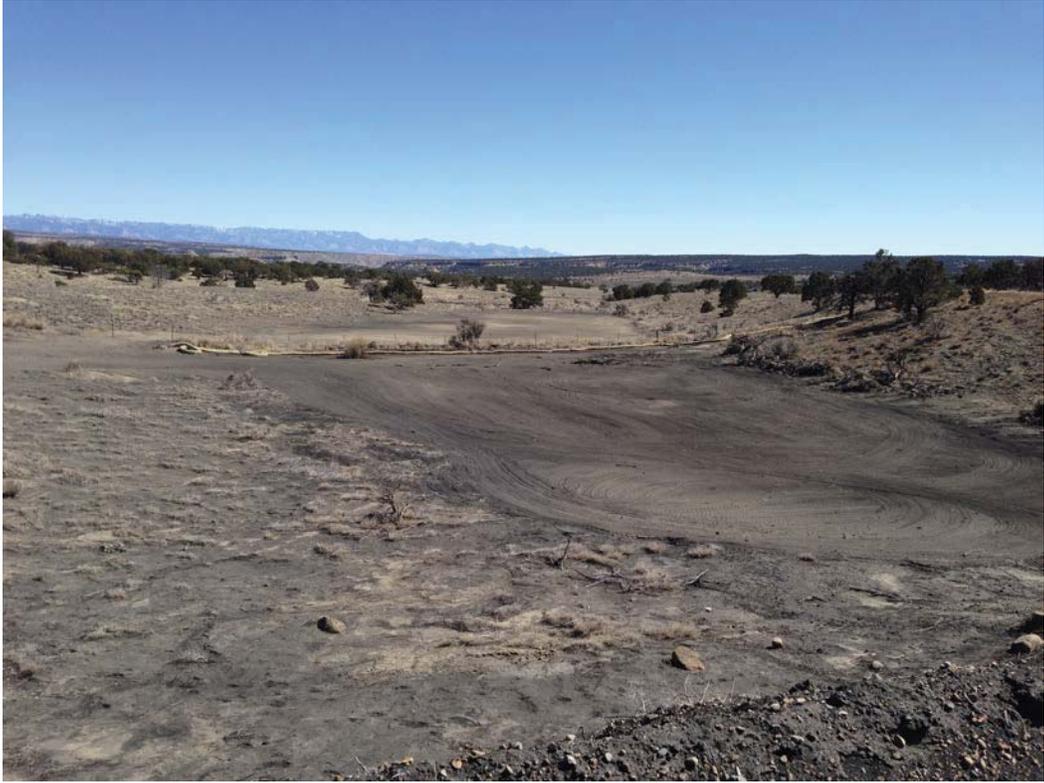
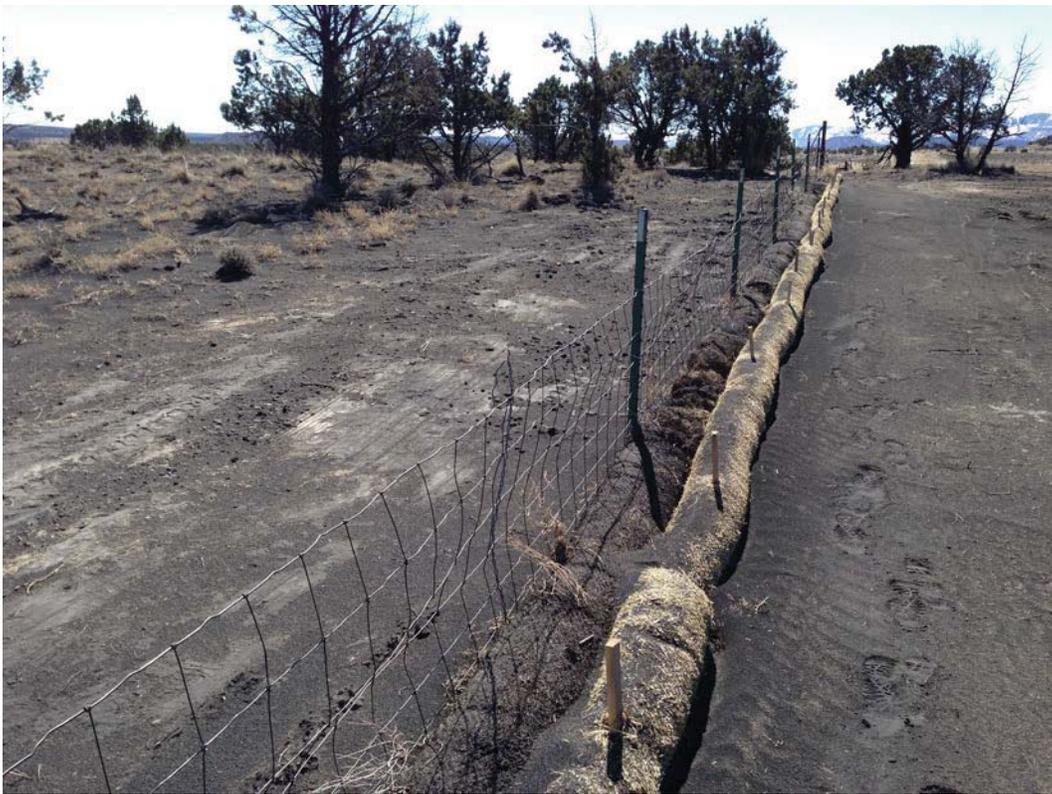
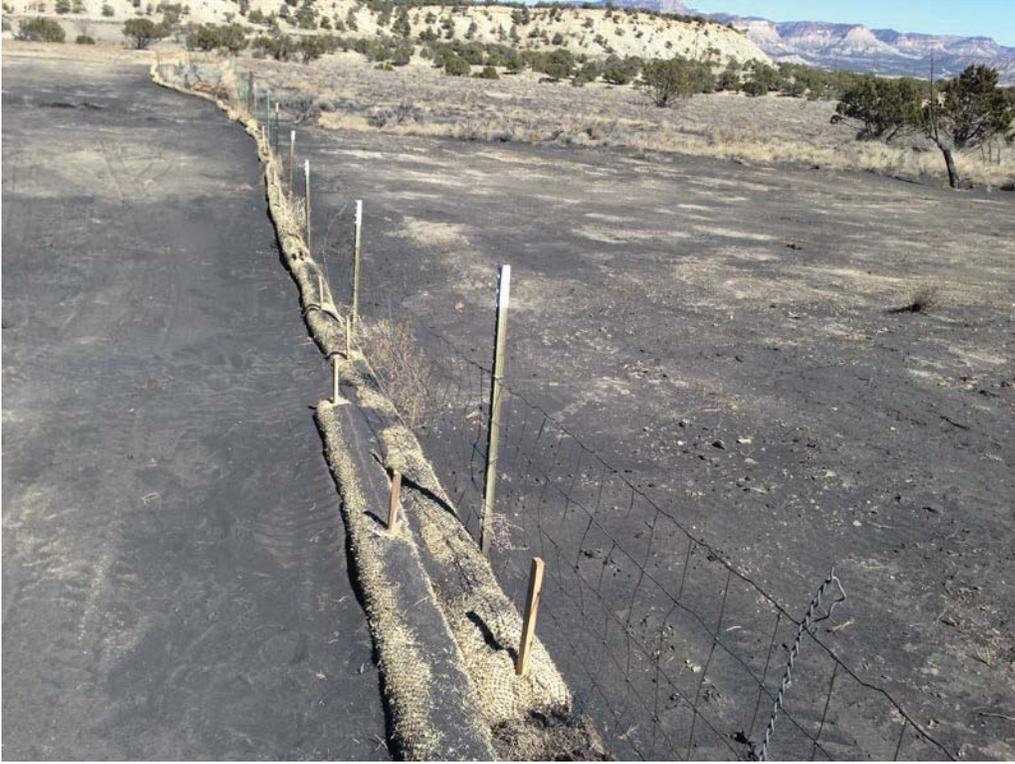
A complete inspection was done at the Wildcat Loadout. During the inspection seeding was taking place on the areas to the east of the facility where coal fines had been removed. New waddles were installed to replace existing sediment control measures along the east side as well. Seeding was going to continue into the next day. The Division has received an amendment to the MRP in response to NOV10132 and with the completion of coal fine clean-up work, the NOV will be terminated.

The areas where coal fines have been removed by mechanical methods are being seeded. The seed is being turned into the topsoil by use of a drag harrow.
