Inspection Report

Permit Number:	C0070033
Inspection Type:	COMPLETE
Inspection Date:	Thursday, November 12, 2015
Start Date/Time:	11/12/2015 9:00:00 AM
End Date/Time:	11/12/2015 2:00:00 PM
Last Inspection:	Wednesday, October 14, 2015

Permittee: **INTERMOUNTAIN POWER AGENCY**
 Operator: **WILD WEST EQUIPMENT & HAULING, LLC**
 Site: **WILDCAT LOADOUT**
 Address: **PO BOX 1, PRICE UT 84501**
 County: **CARBON**
 Permit Type: **PERMANENT COAL PROGRAM**
 Permit Status: **ACTIVE**

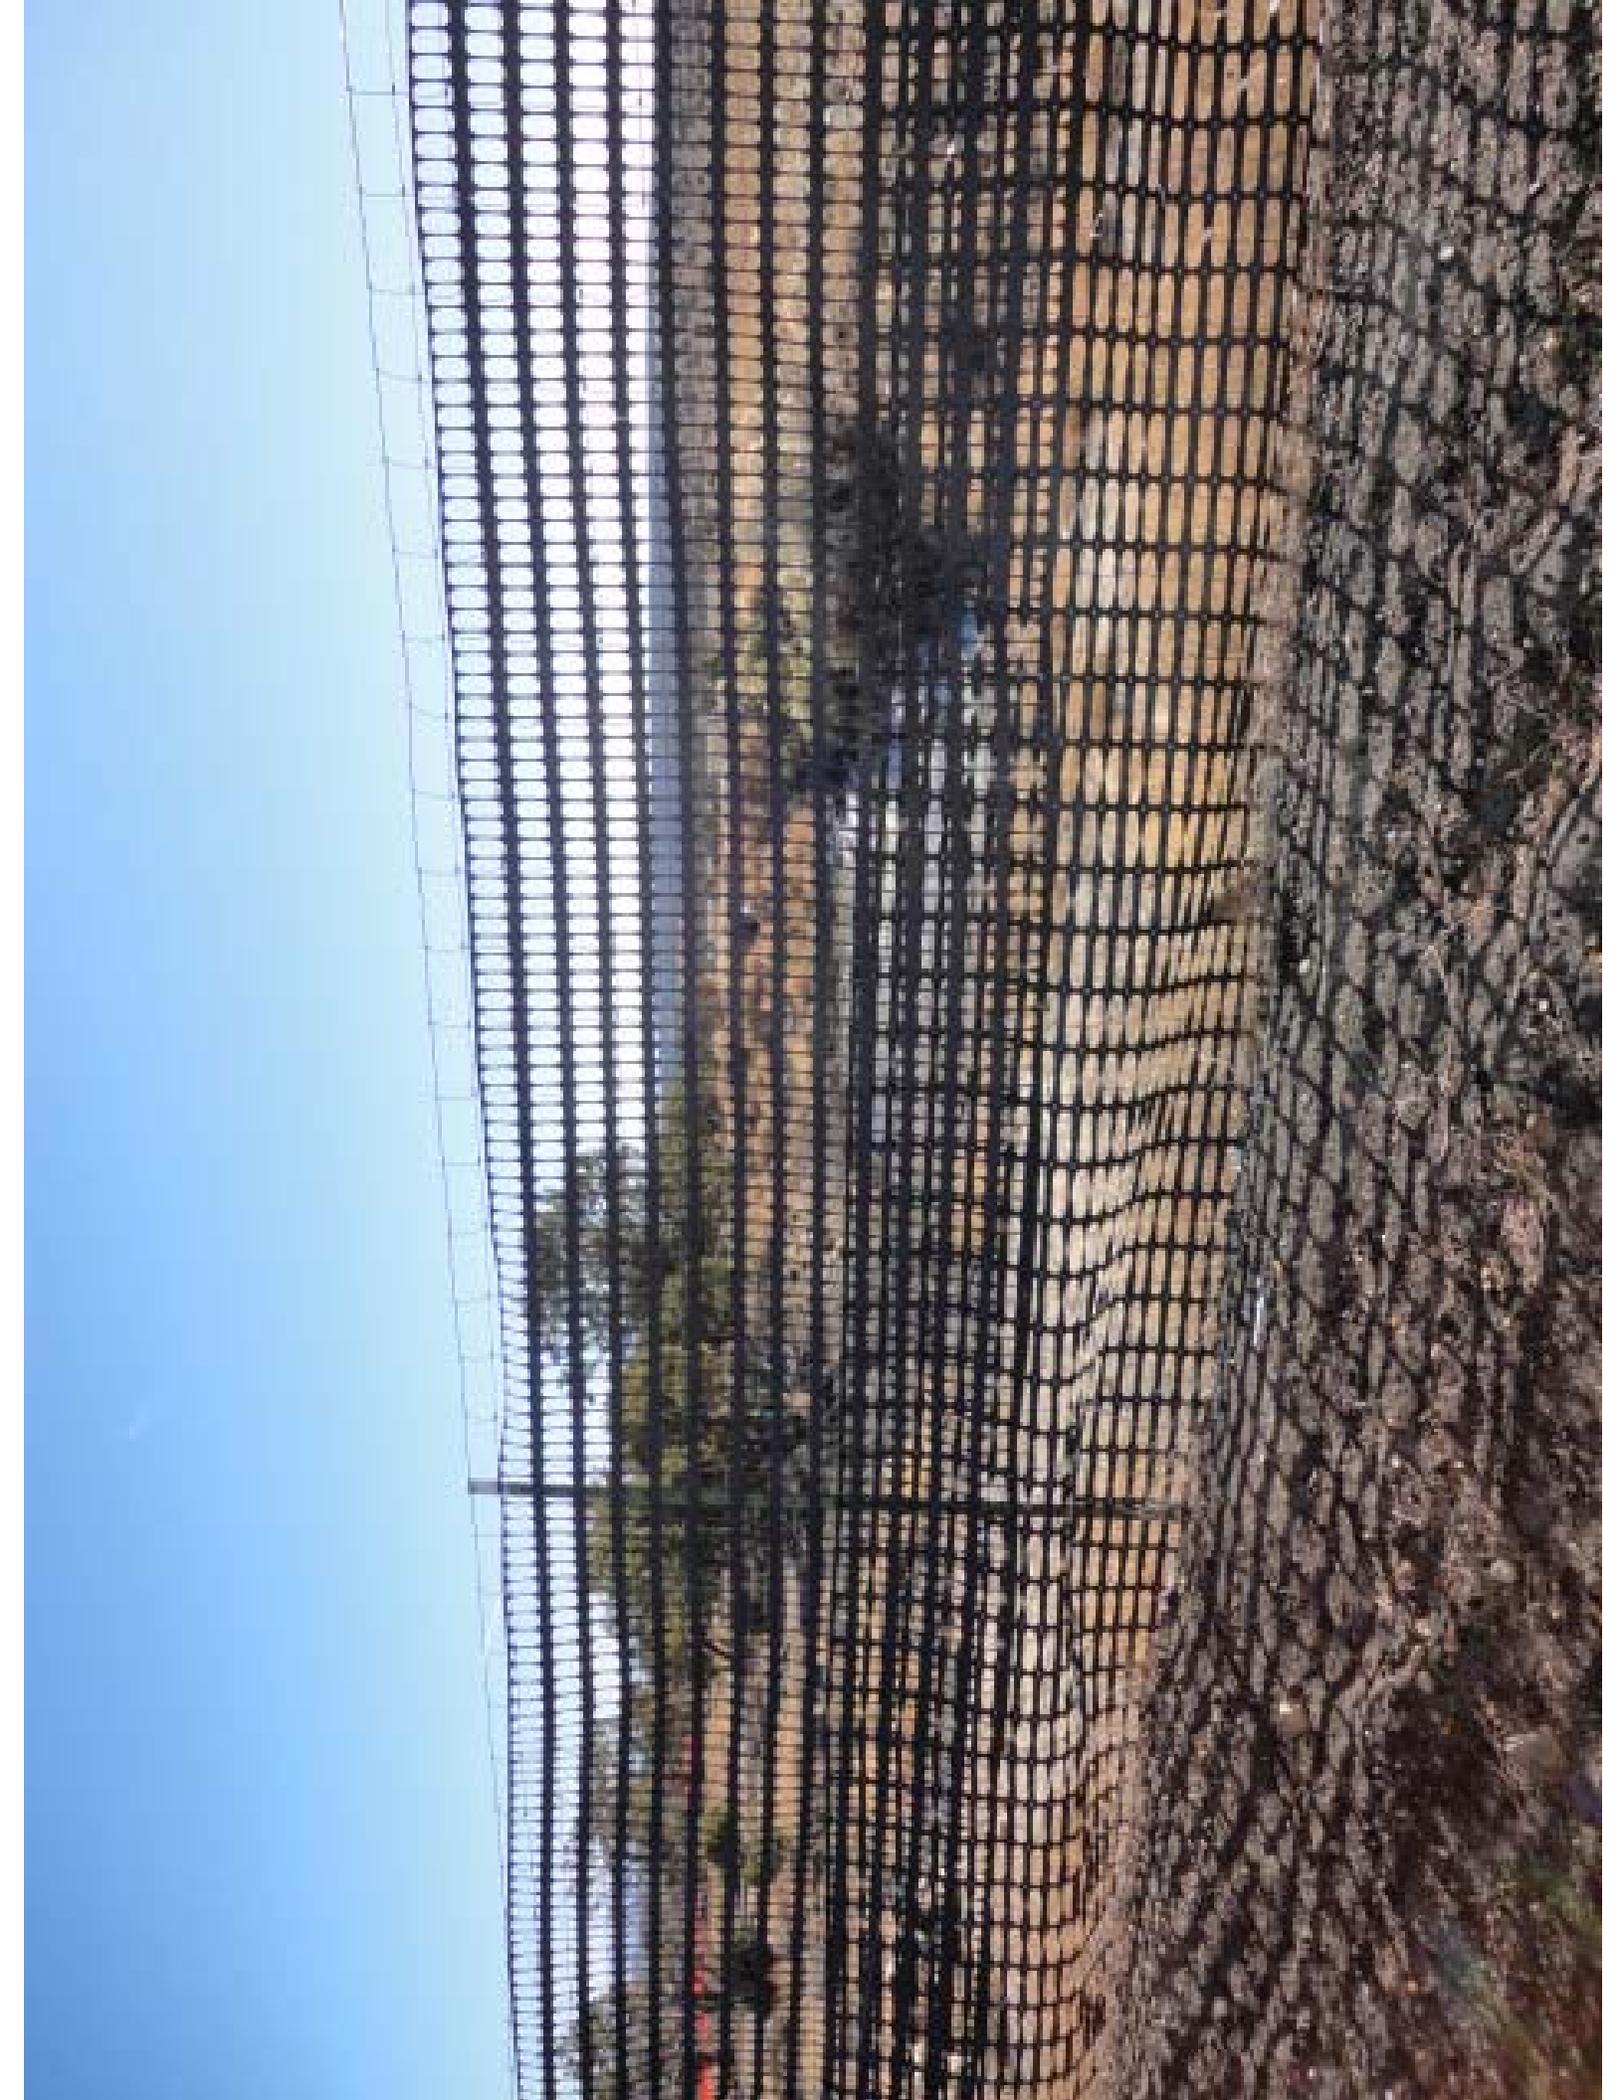
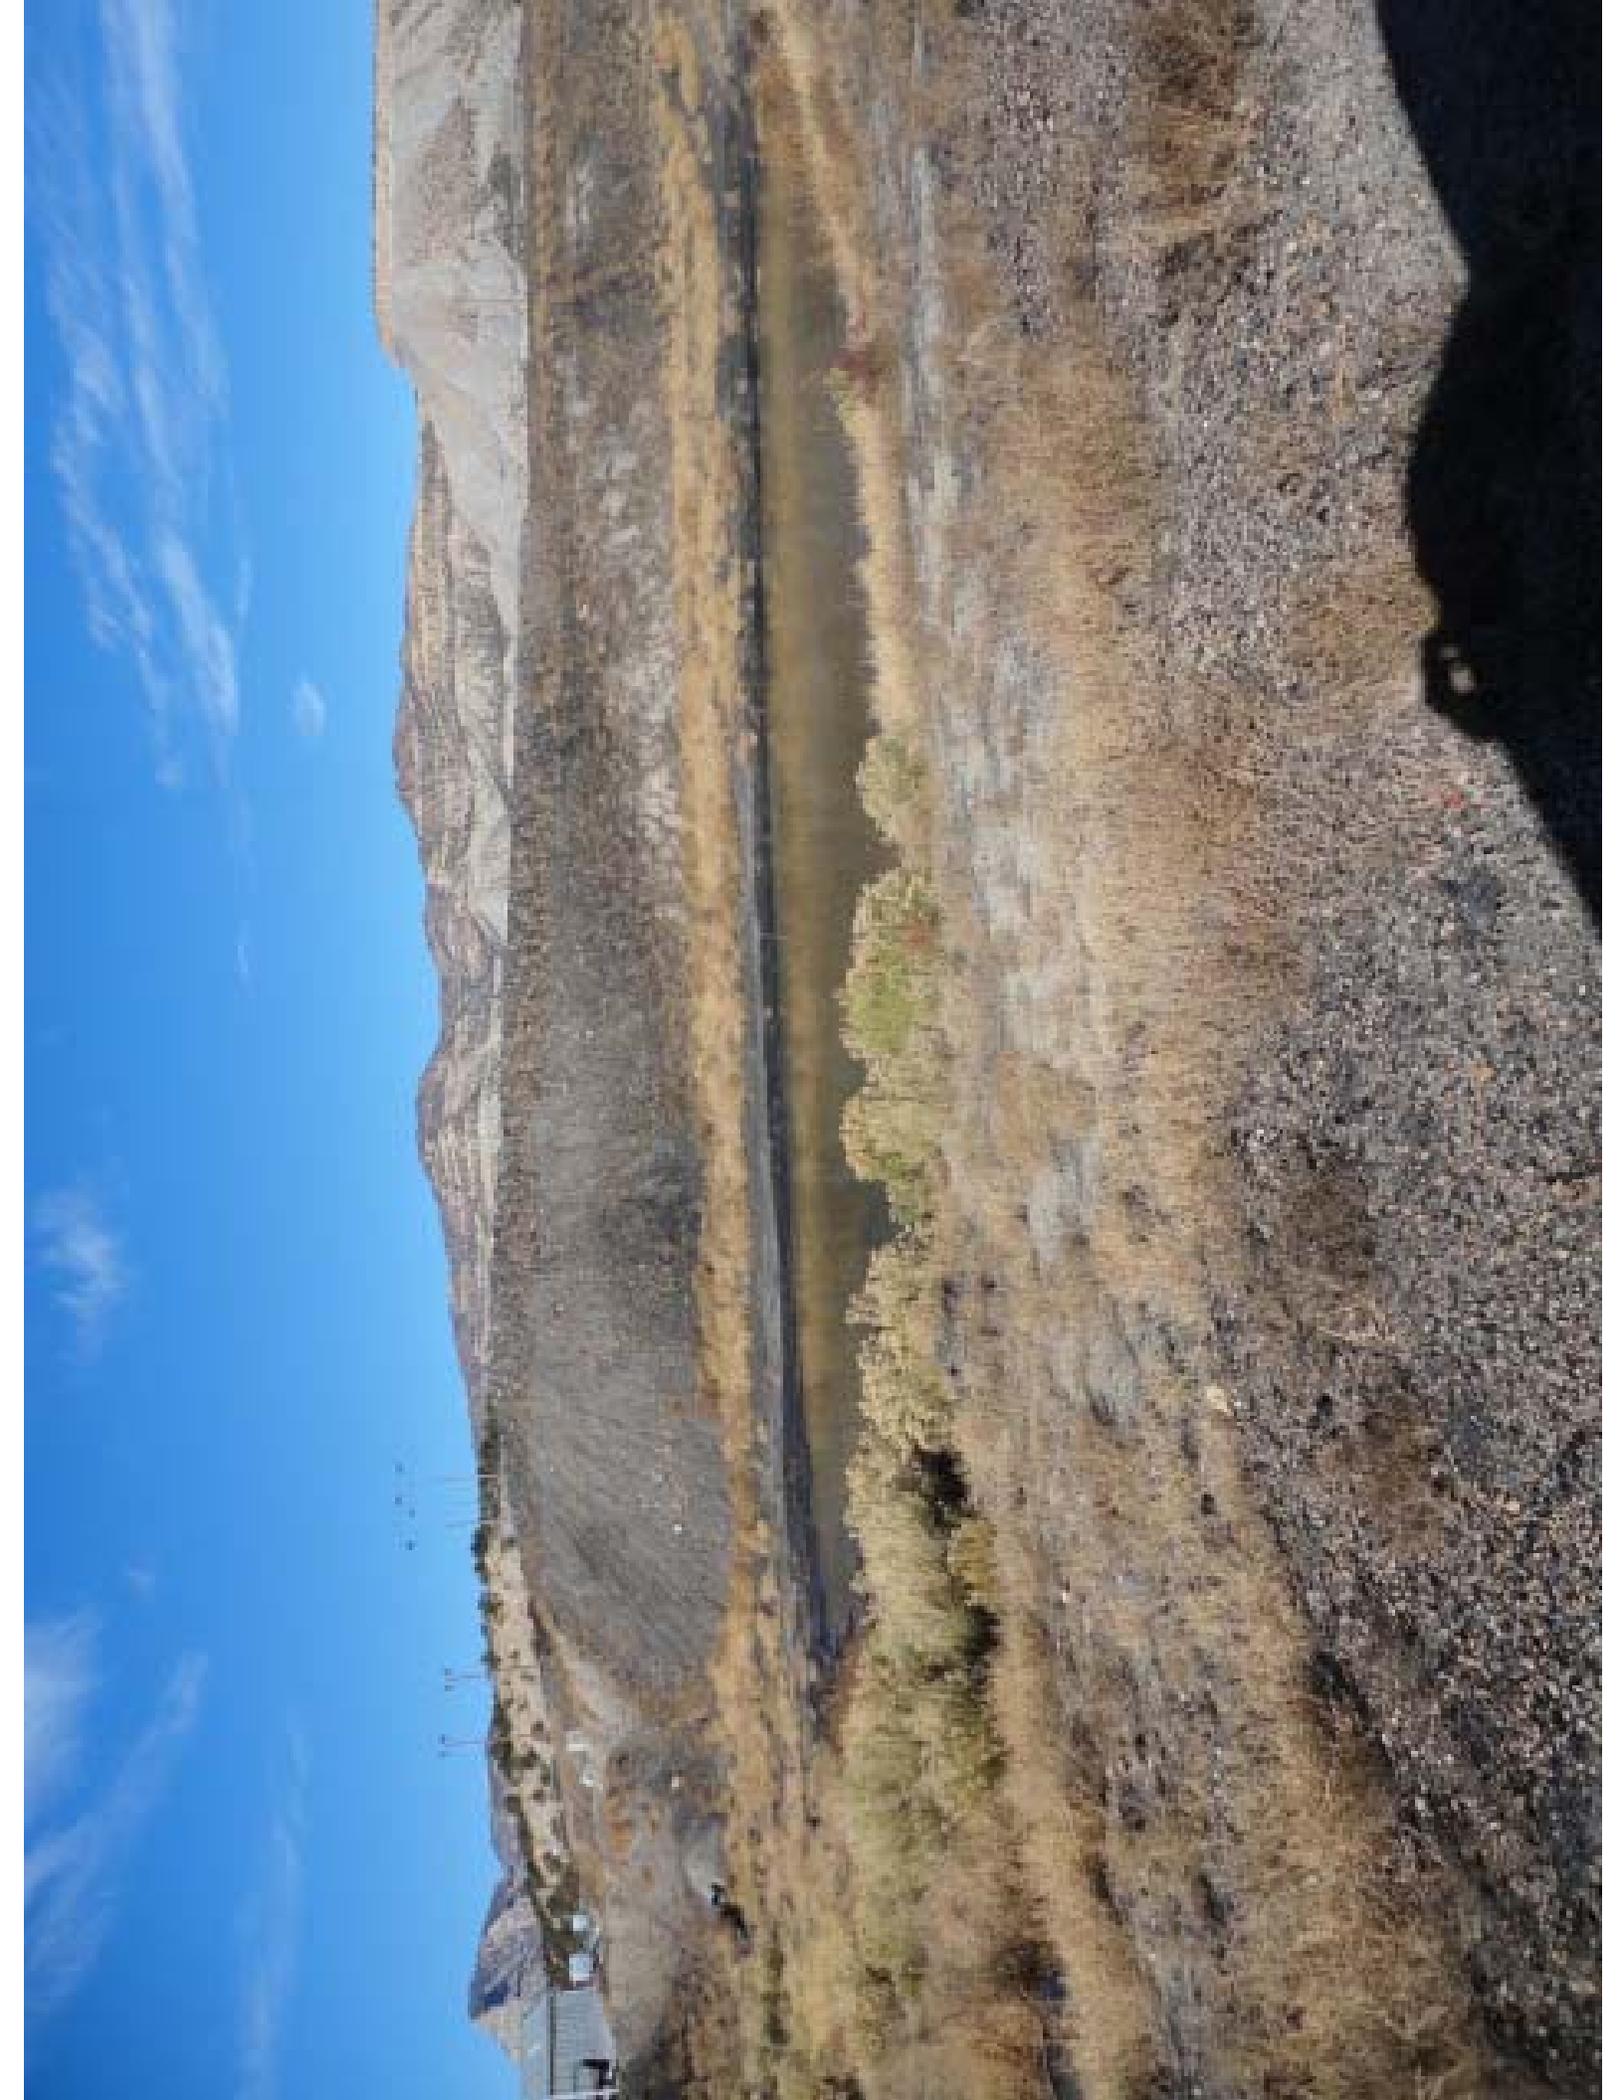
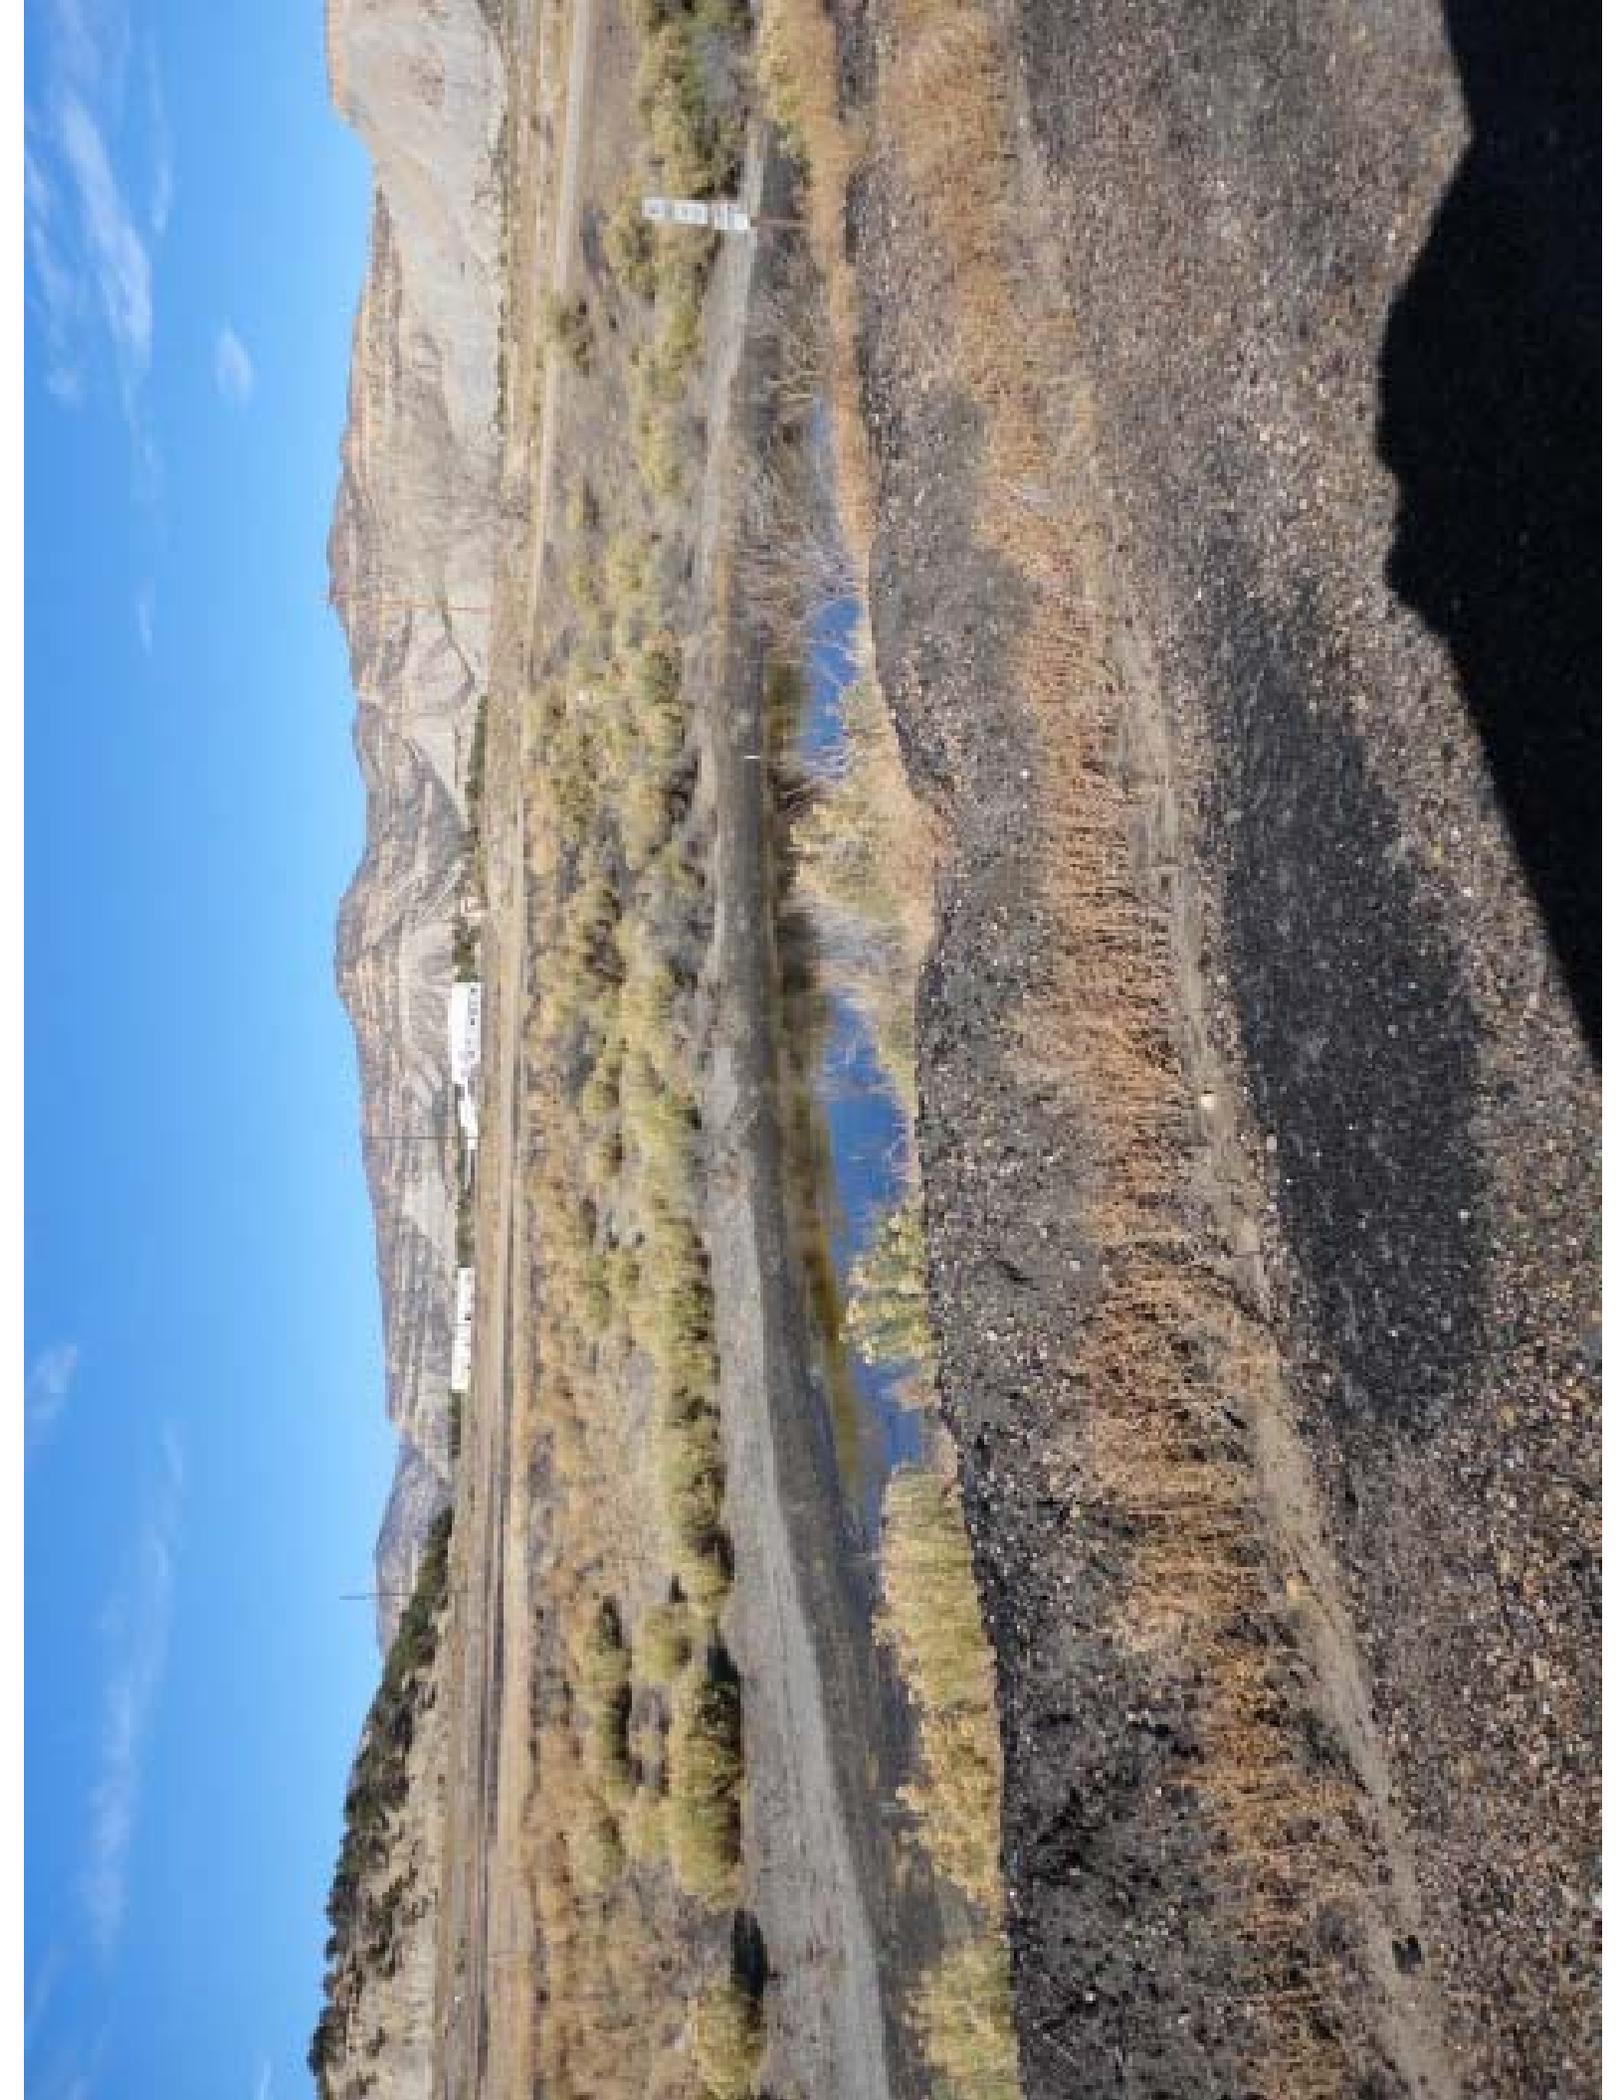
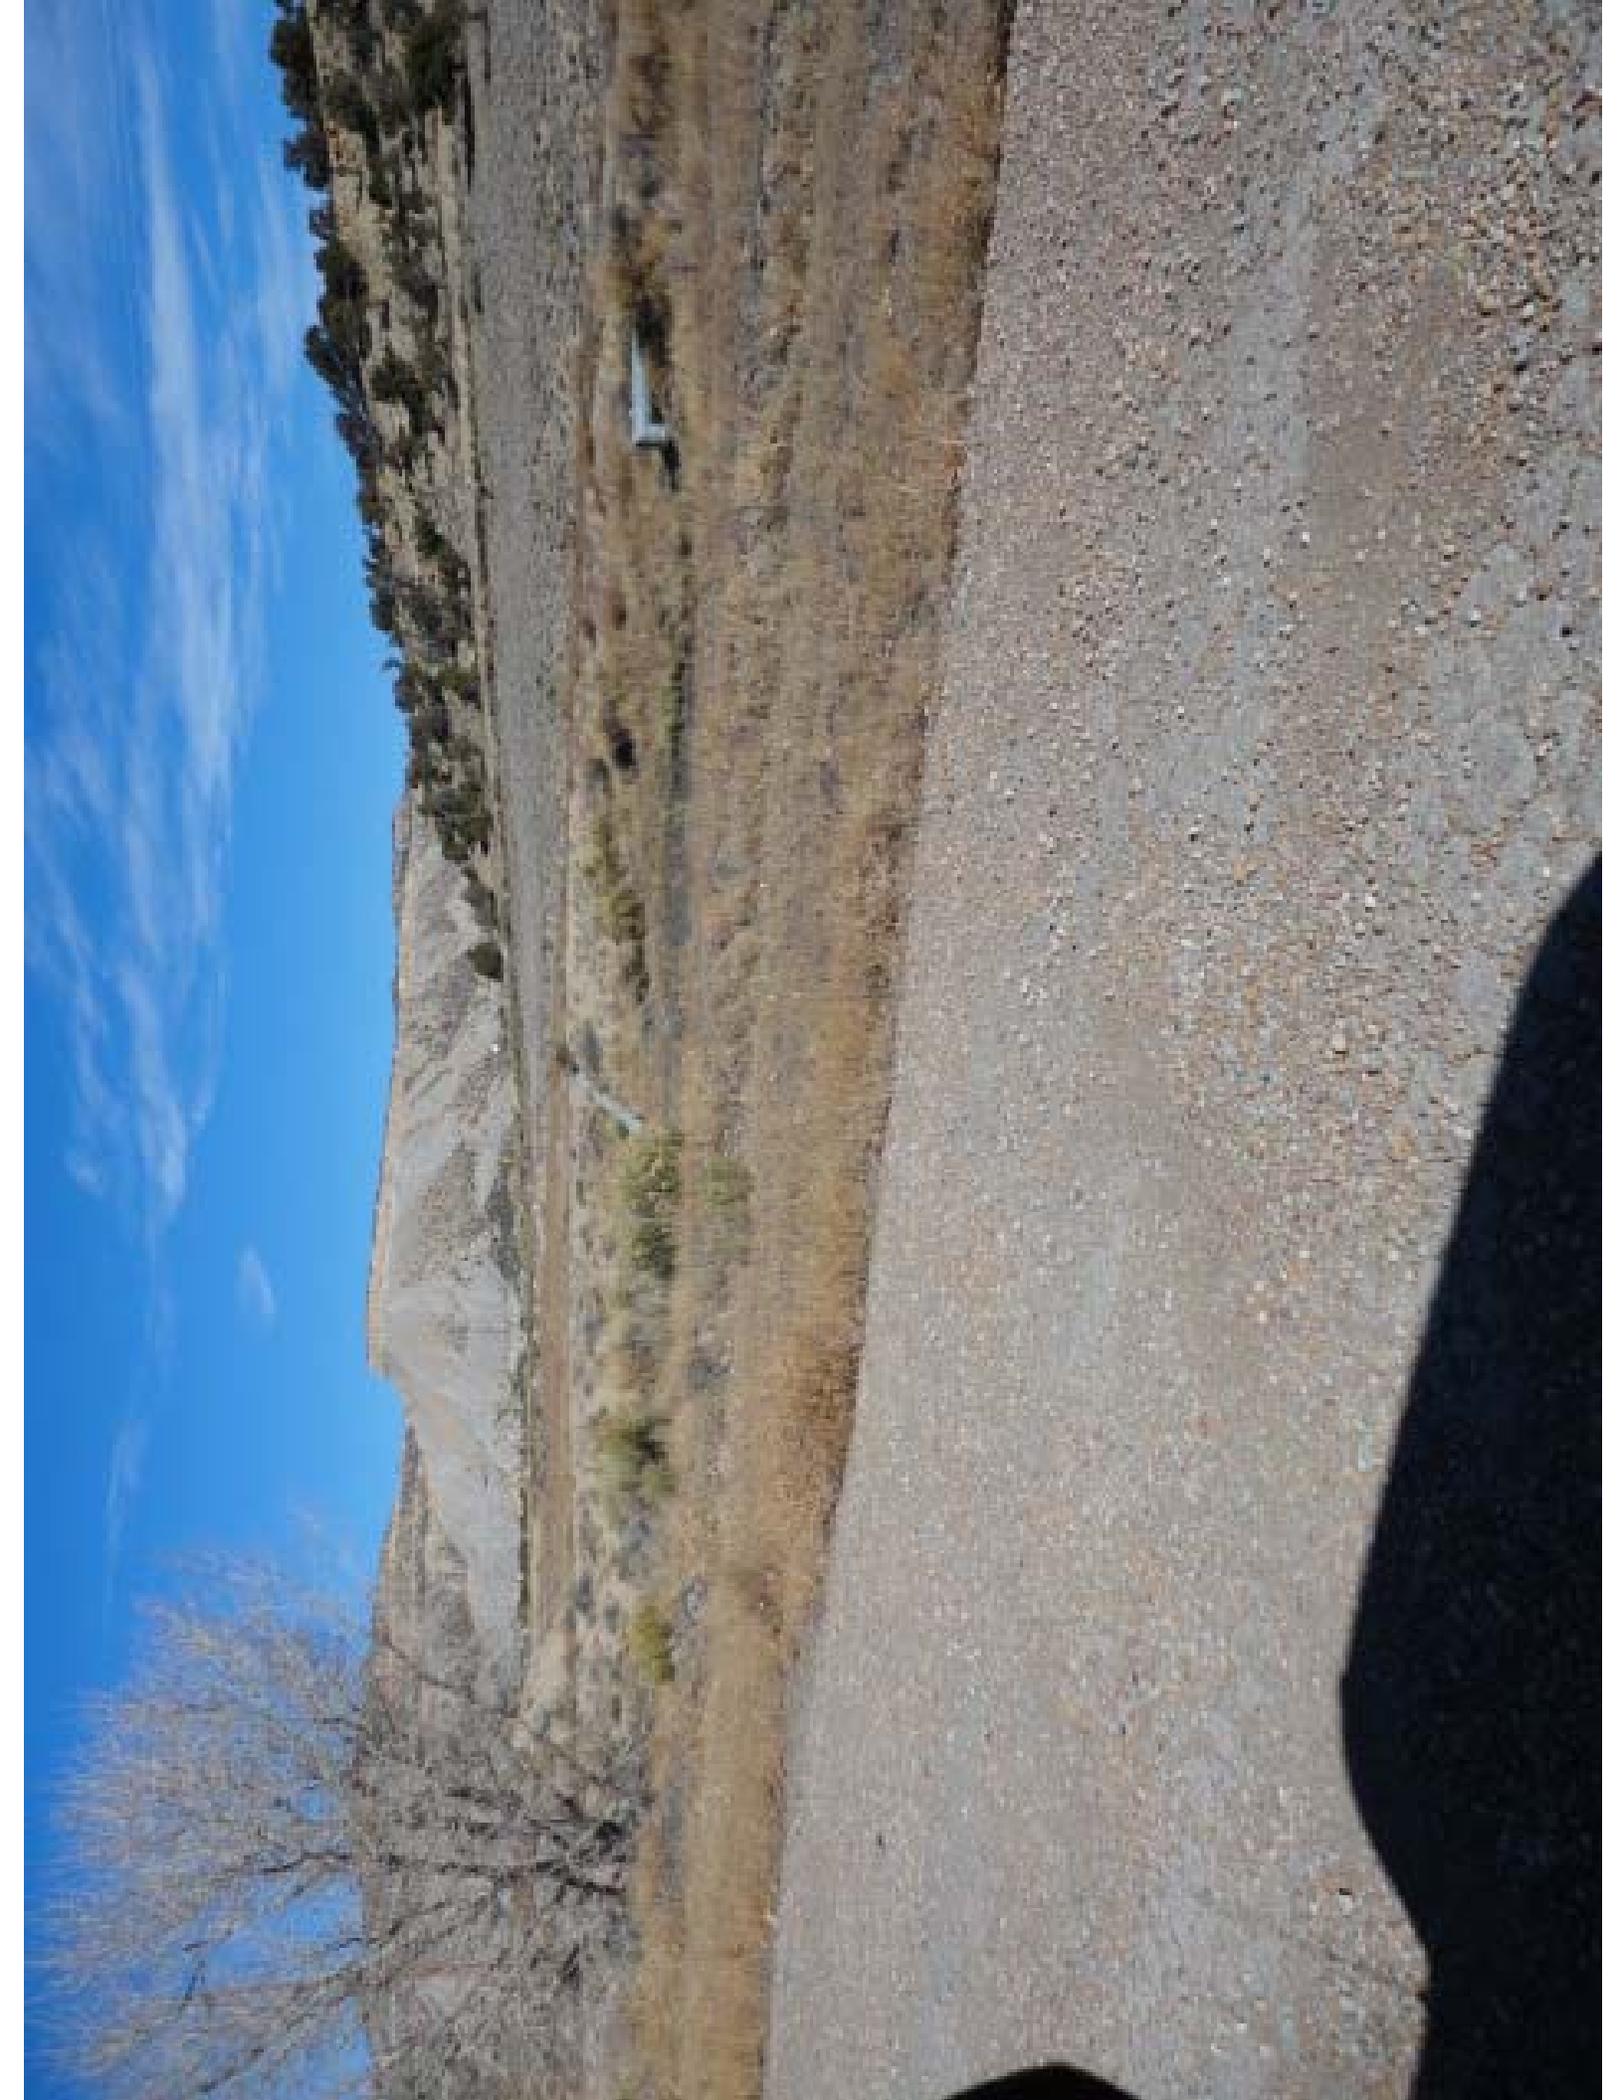
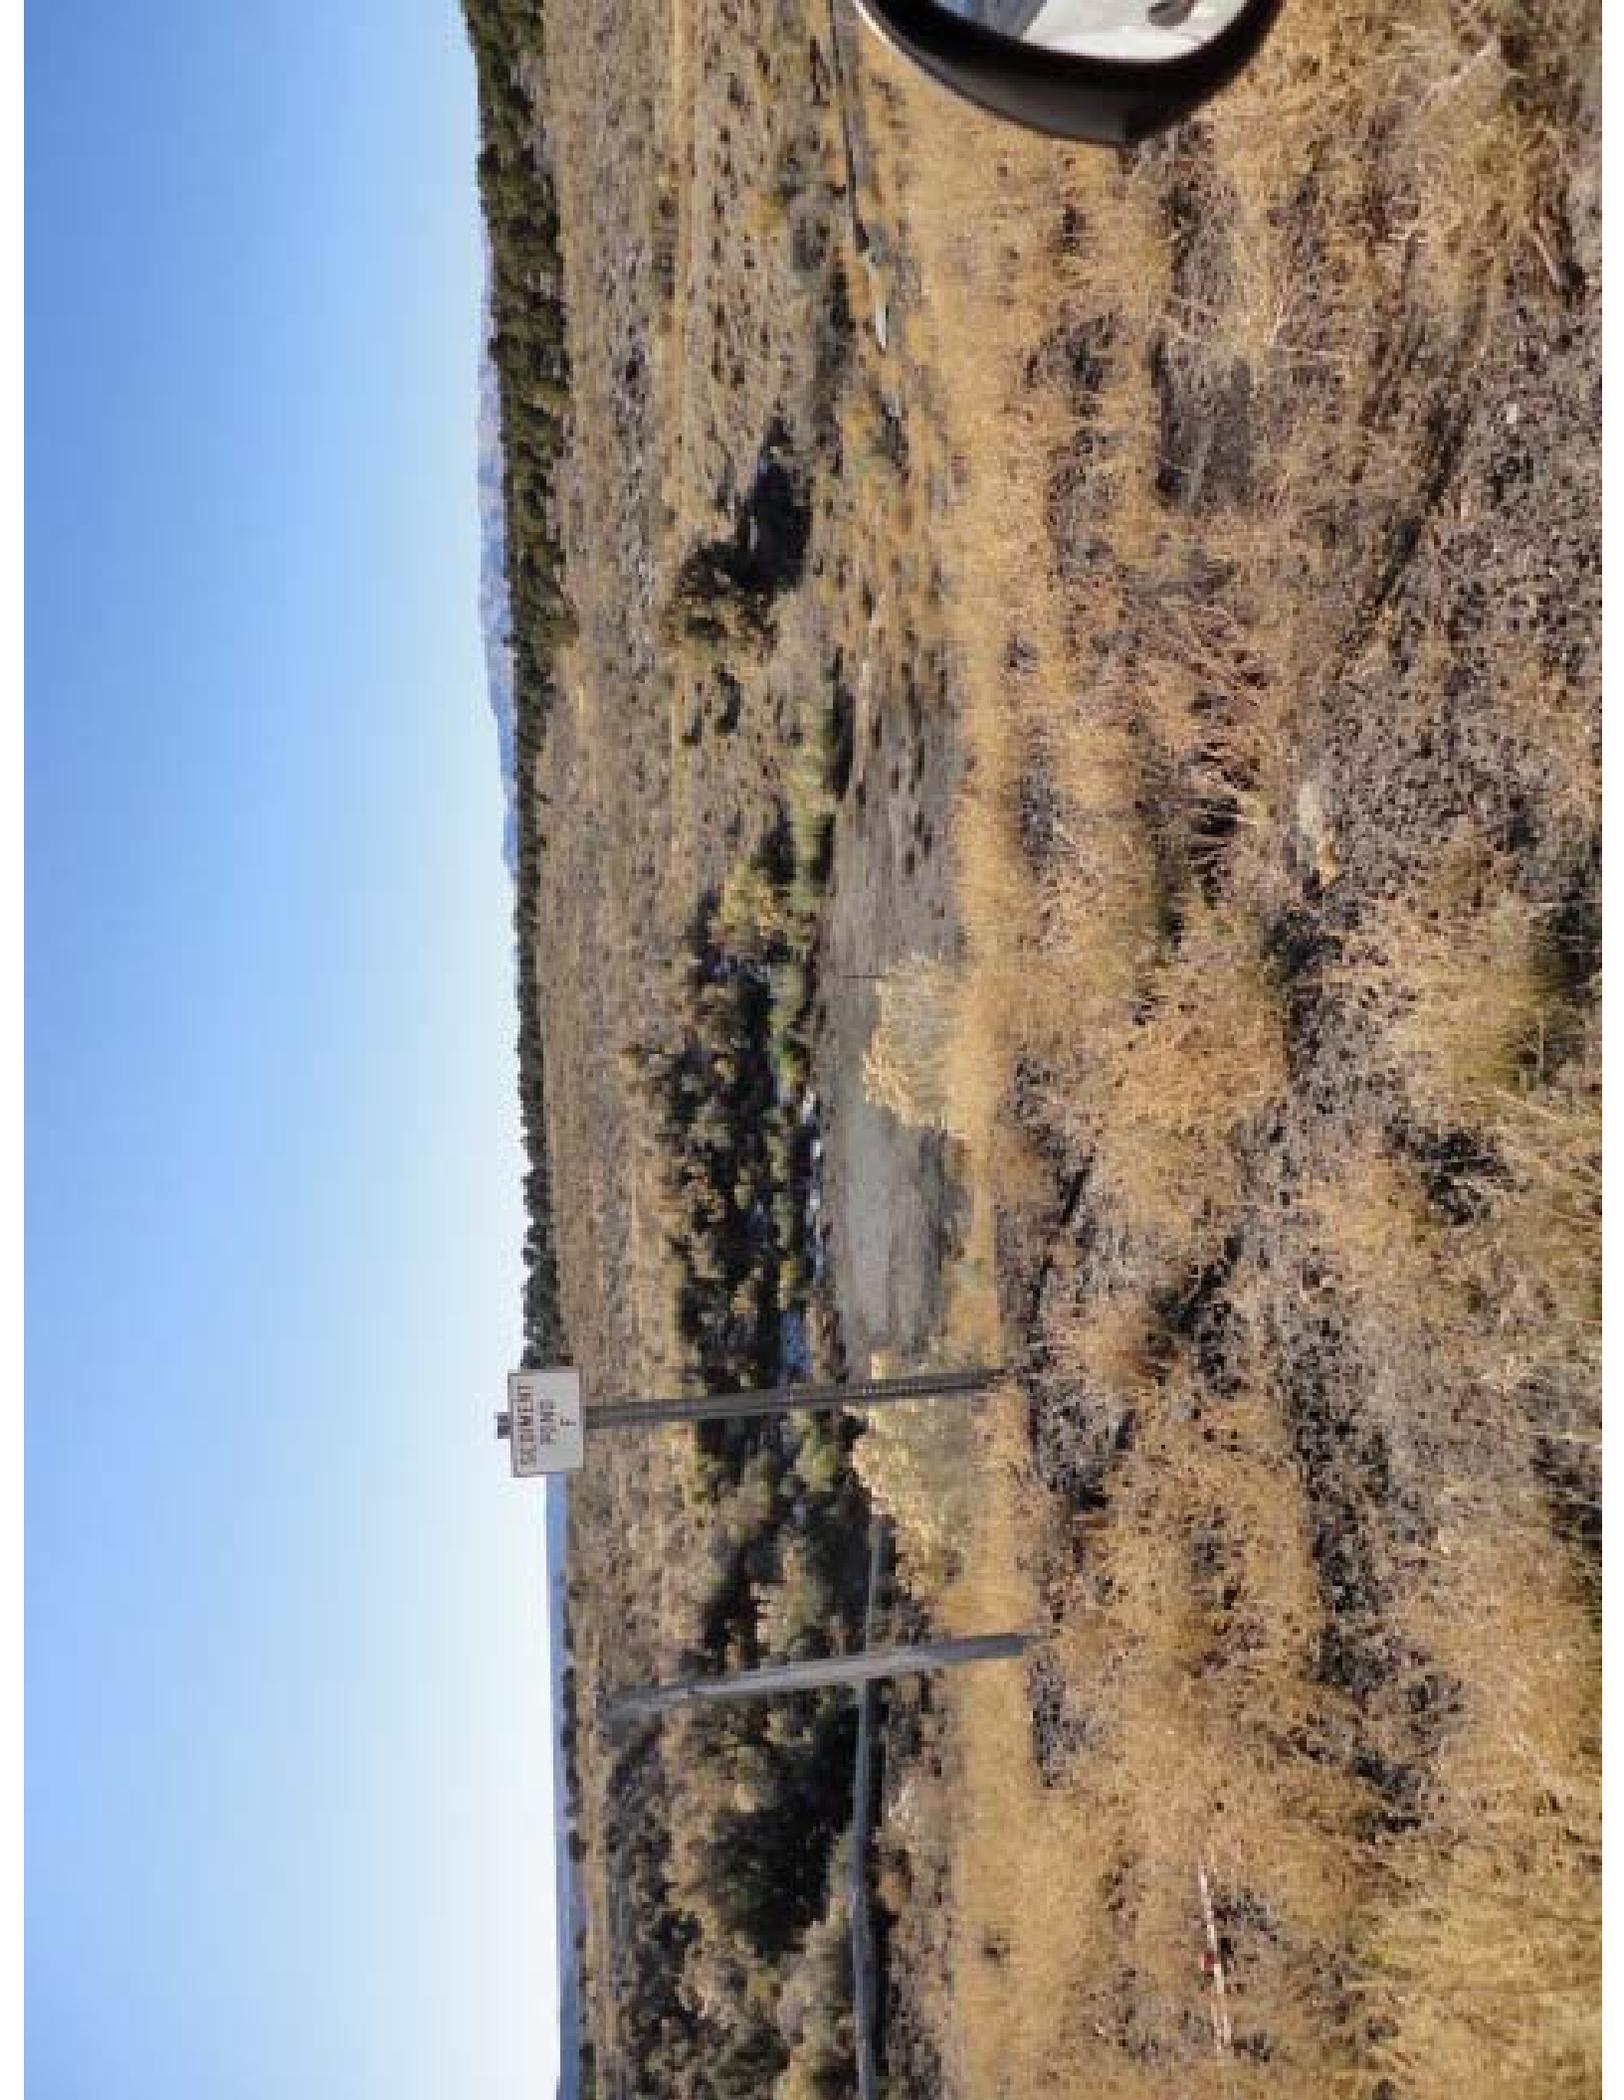
The permittee conducted a third quarter sediment pond inspection on Sept. 18, 2015. . No hazardous conditions were reported. I inspected the sediment ponds and they appear to be stable with no hazardous conditions. The sediment ponds contain little to no water. See Pictures
