# Inspection Report

Permit Number:	C0070033
Inspection Type:	COMPLETE
Inspection Date:	Tuesday, February 16, 2016
Start Date/Time:	2/16/2016 10:00:00 AM
End Date/Time:	2/16/2016 1:00:00 PM
Last Inspection:	Thursday, January 14, 2016

Permitee: **INTERMOUNTAIN POWER AGENCY**  
 Operator: **WILD WEST EQUIPMENT & HAULING, LLC**  
 Site: **WILDCAT LOADOUT**  
 Address: **PO BOX 1, PRICE UT 84501**  
 County: **CARBON**  
 Permit Type: **PERMANENT COAL PROGRAM**  
 Permit Status: **ACTIVE**

### WILDCAT LOAD OUT

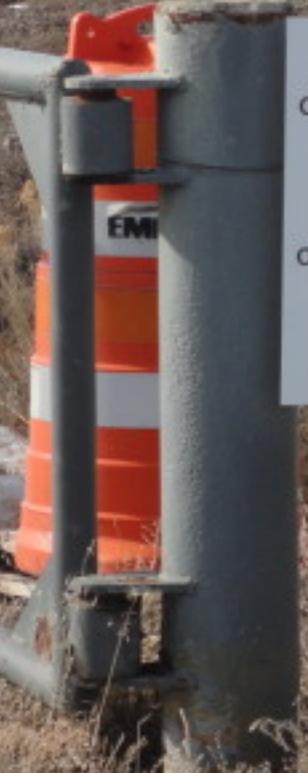
I inspected the identification sign at the main gate to the property. The information complies with the requirements of the R645 Coal Rules. See Picture

OWNER: INTERMOUNTAIN POWER AGENCY  
P.O. BOX 51111 - ROOM 1263  
LOS ANGELES, CALIFORNIA 90051  
PHONE: 213-367-0289  
UDOGM PERMIT NO. C/007/033

OPERATOR:  
WILD WEST EQUIPMENT & HAULING, LLC  
P.O. BOX 1  
PRICE, UTAH 84501  
PHONE: 435-472-3988  
MSHA ID NO. 42-01864

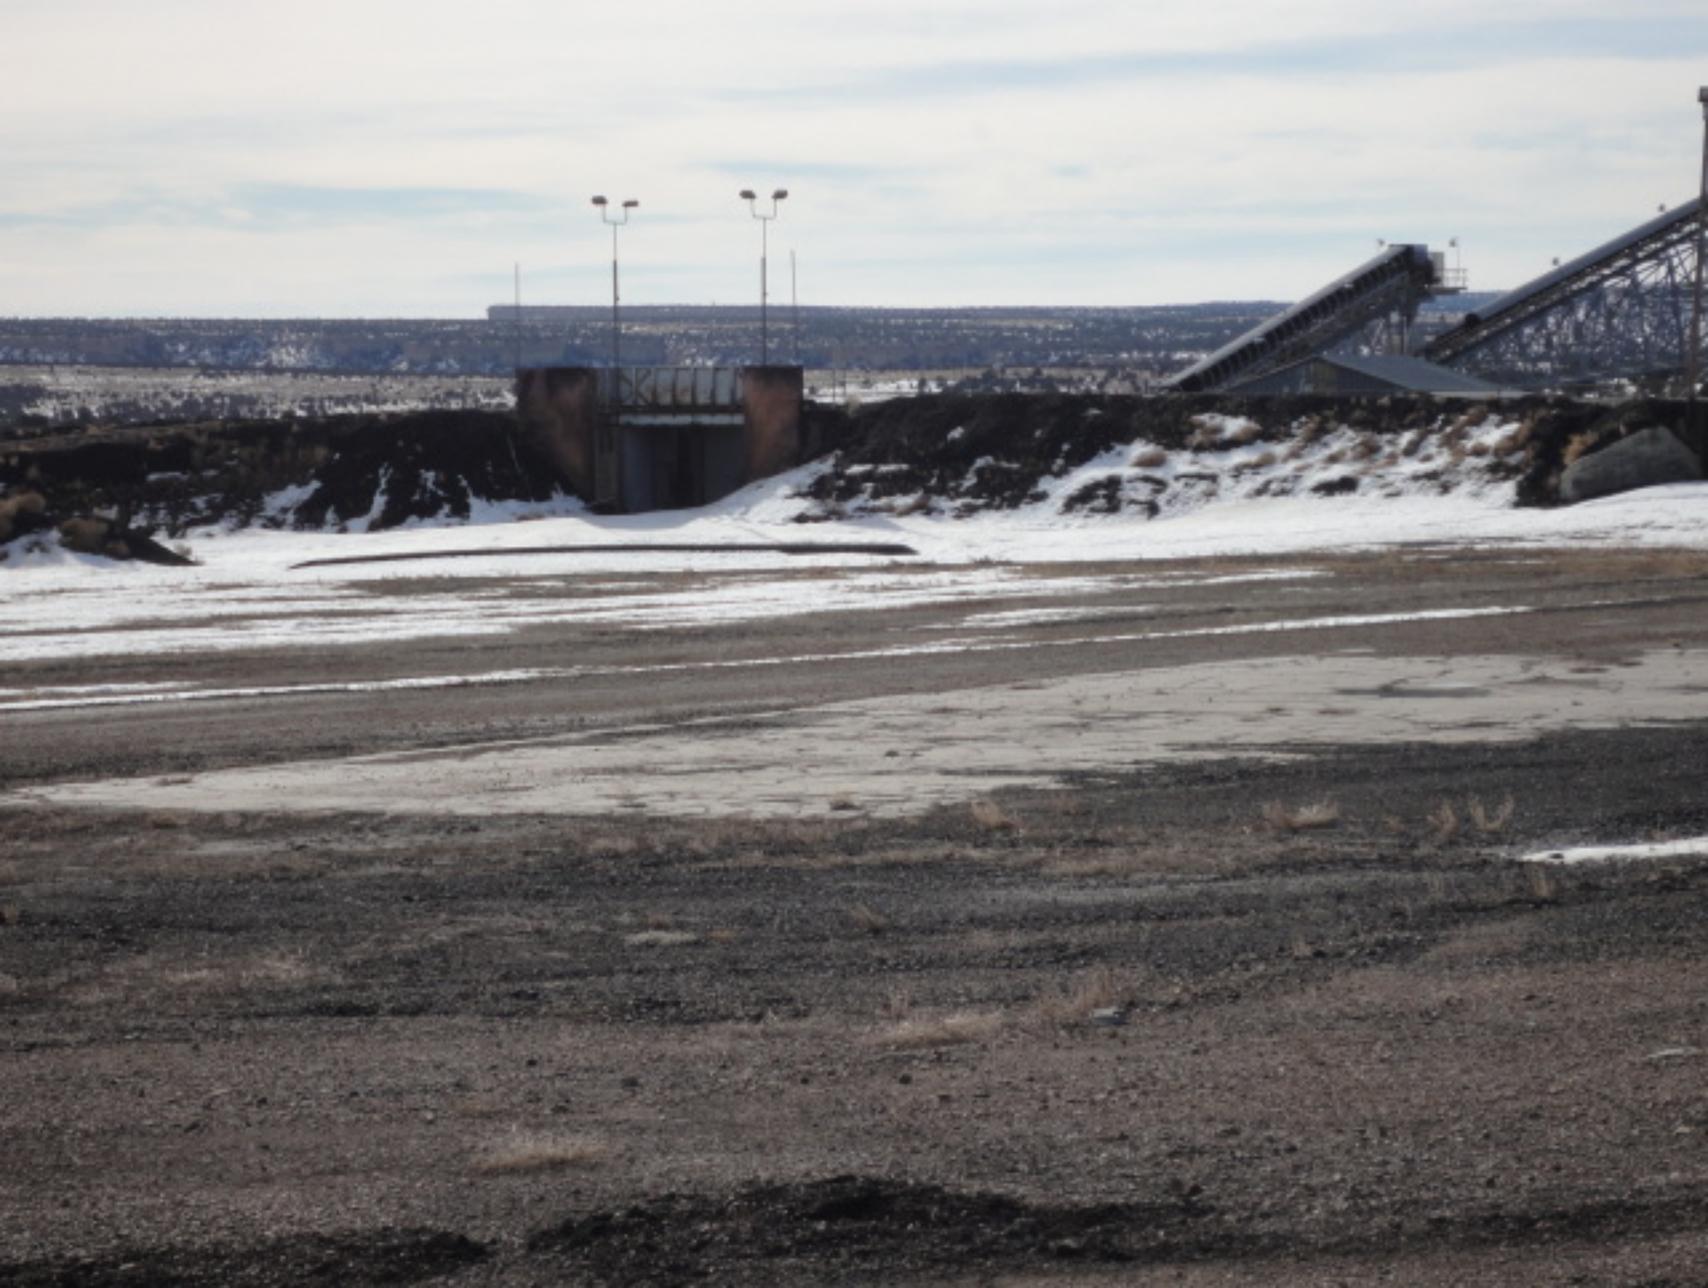
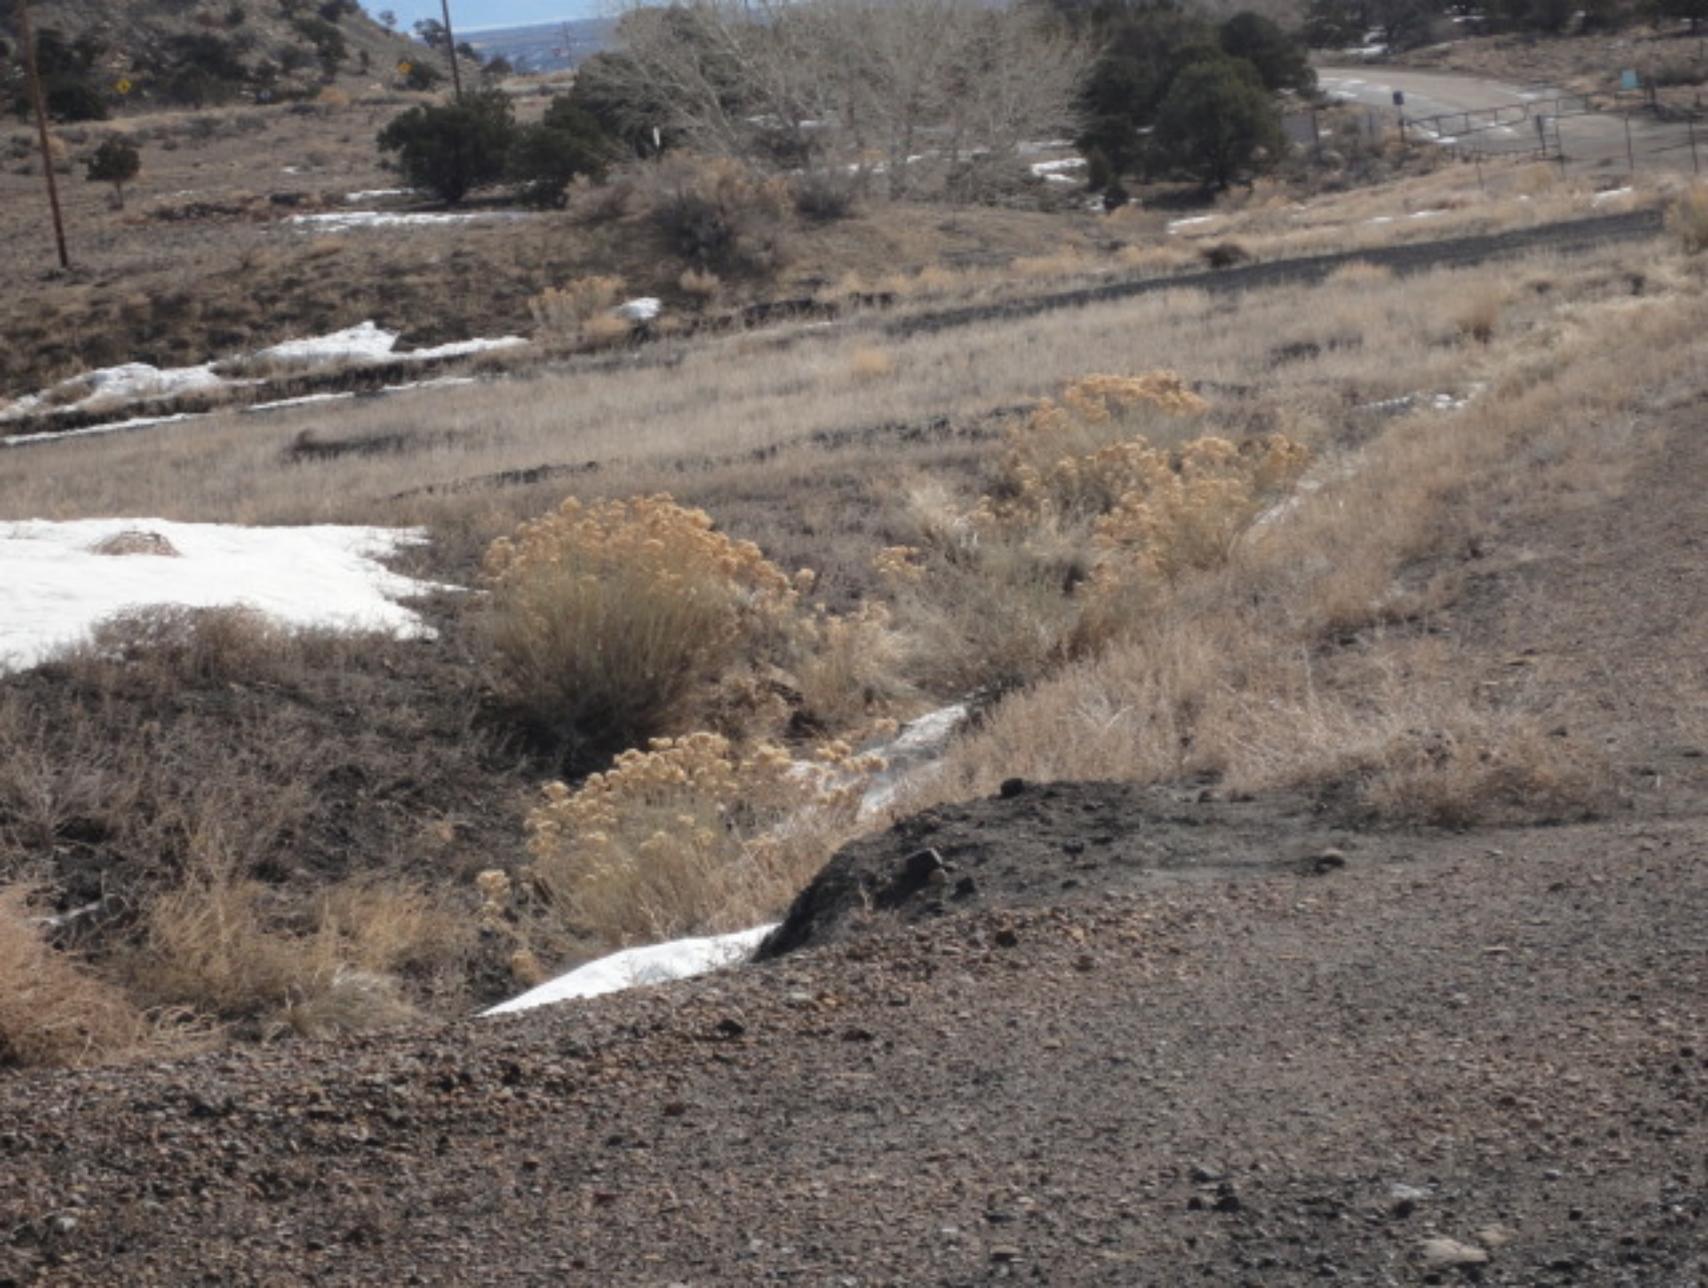
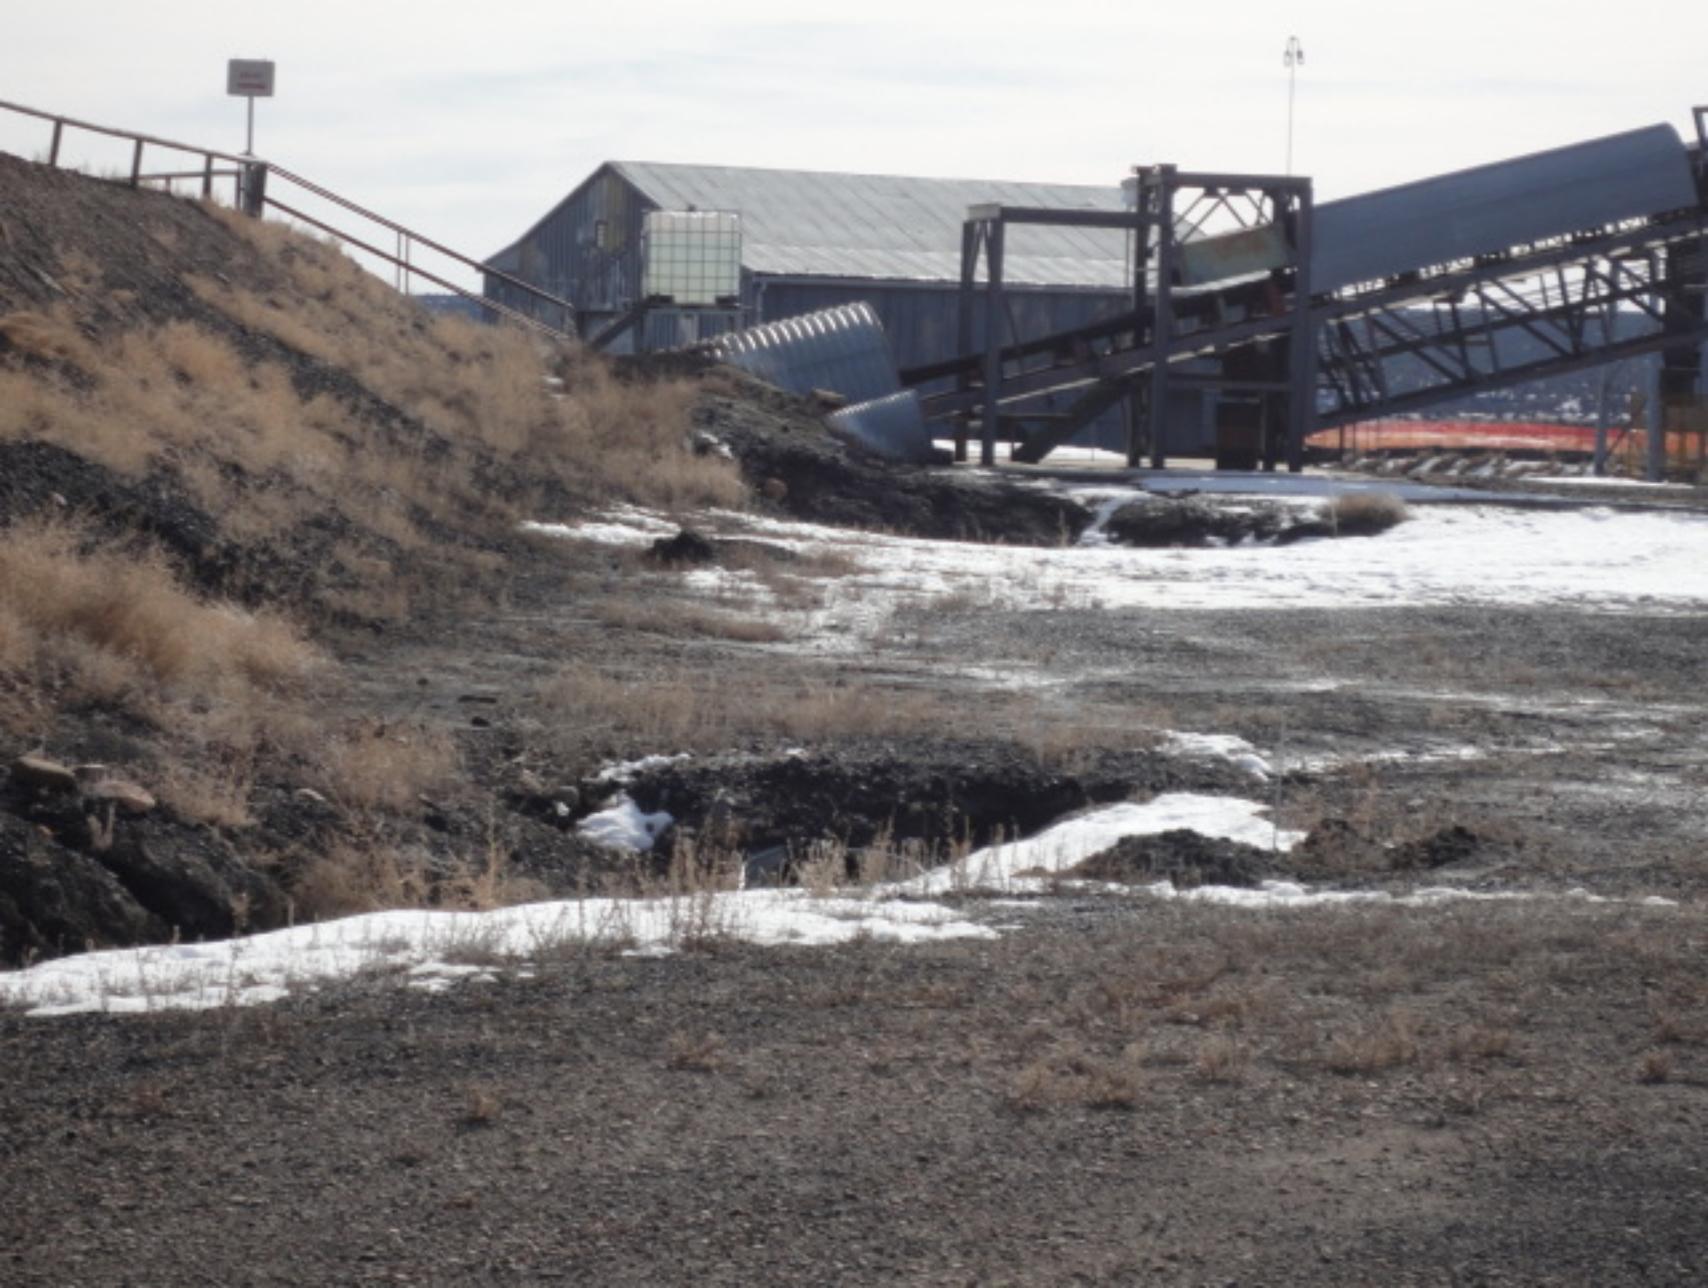
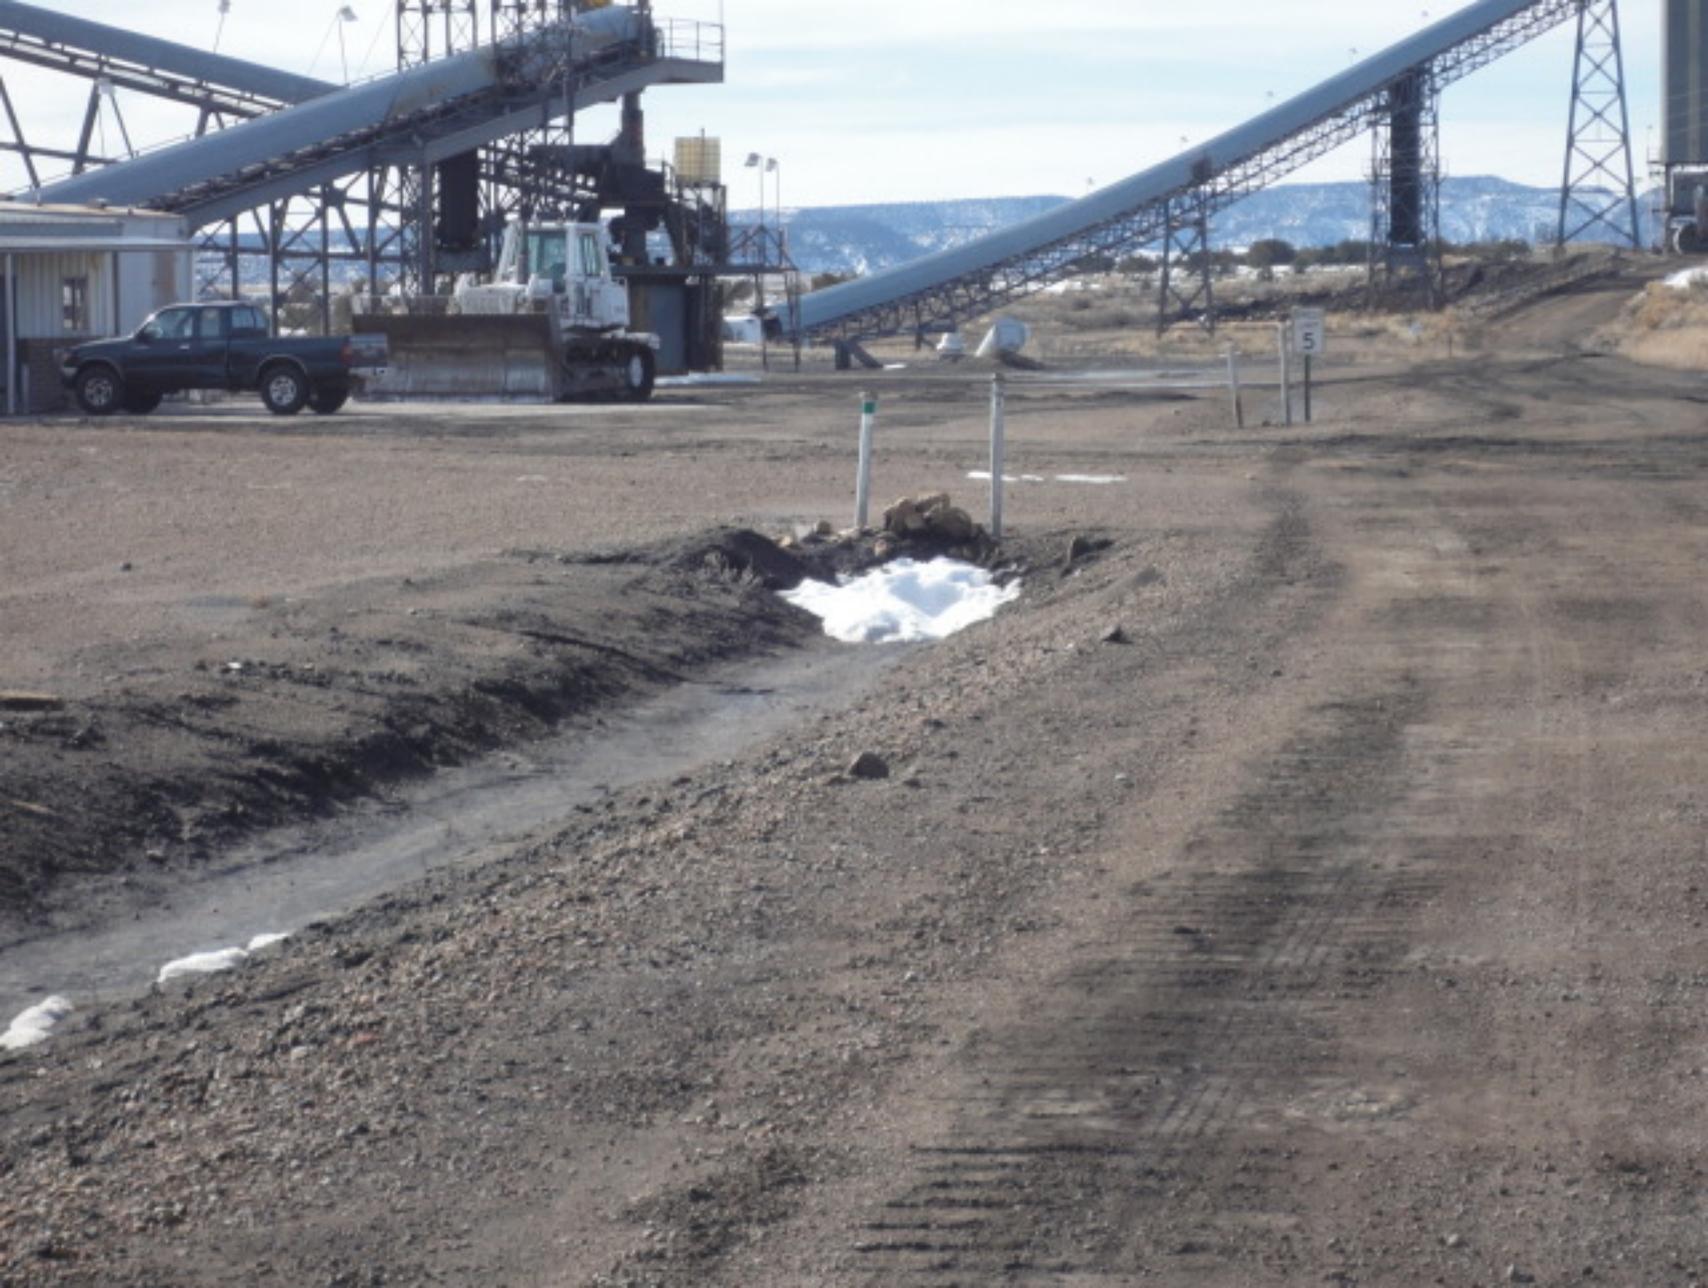
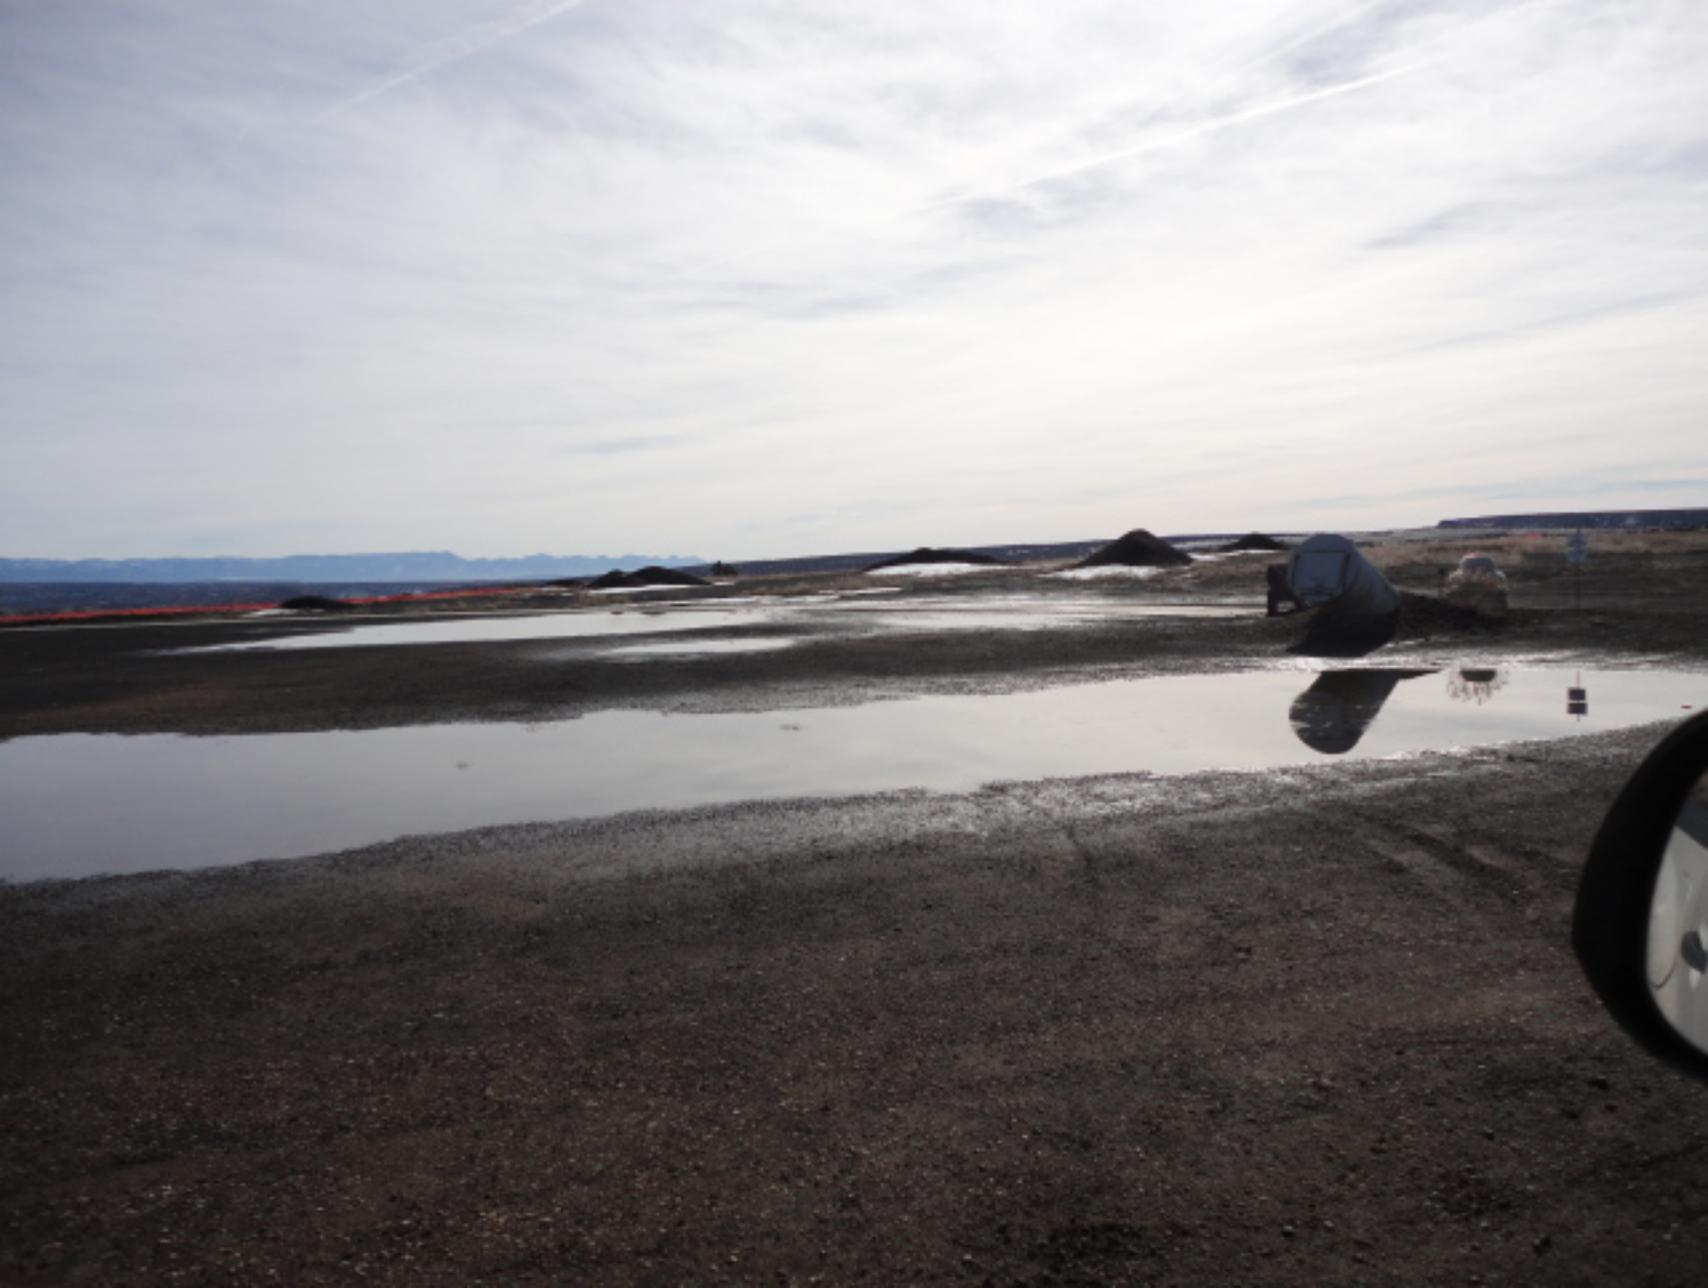
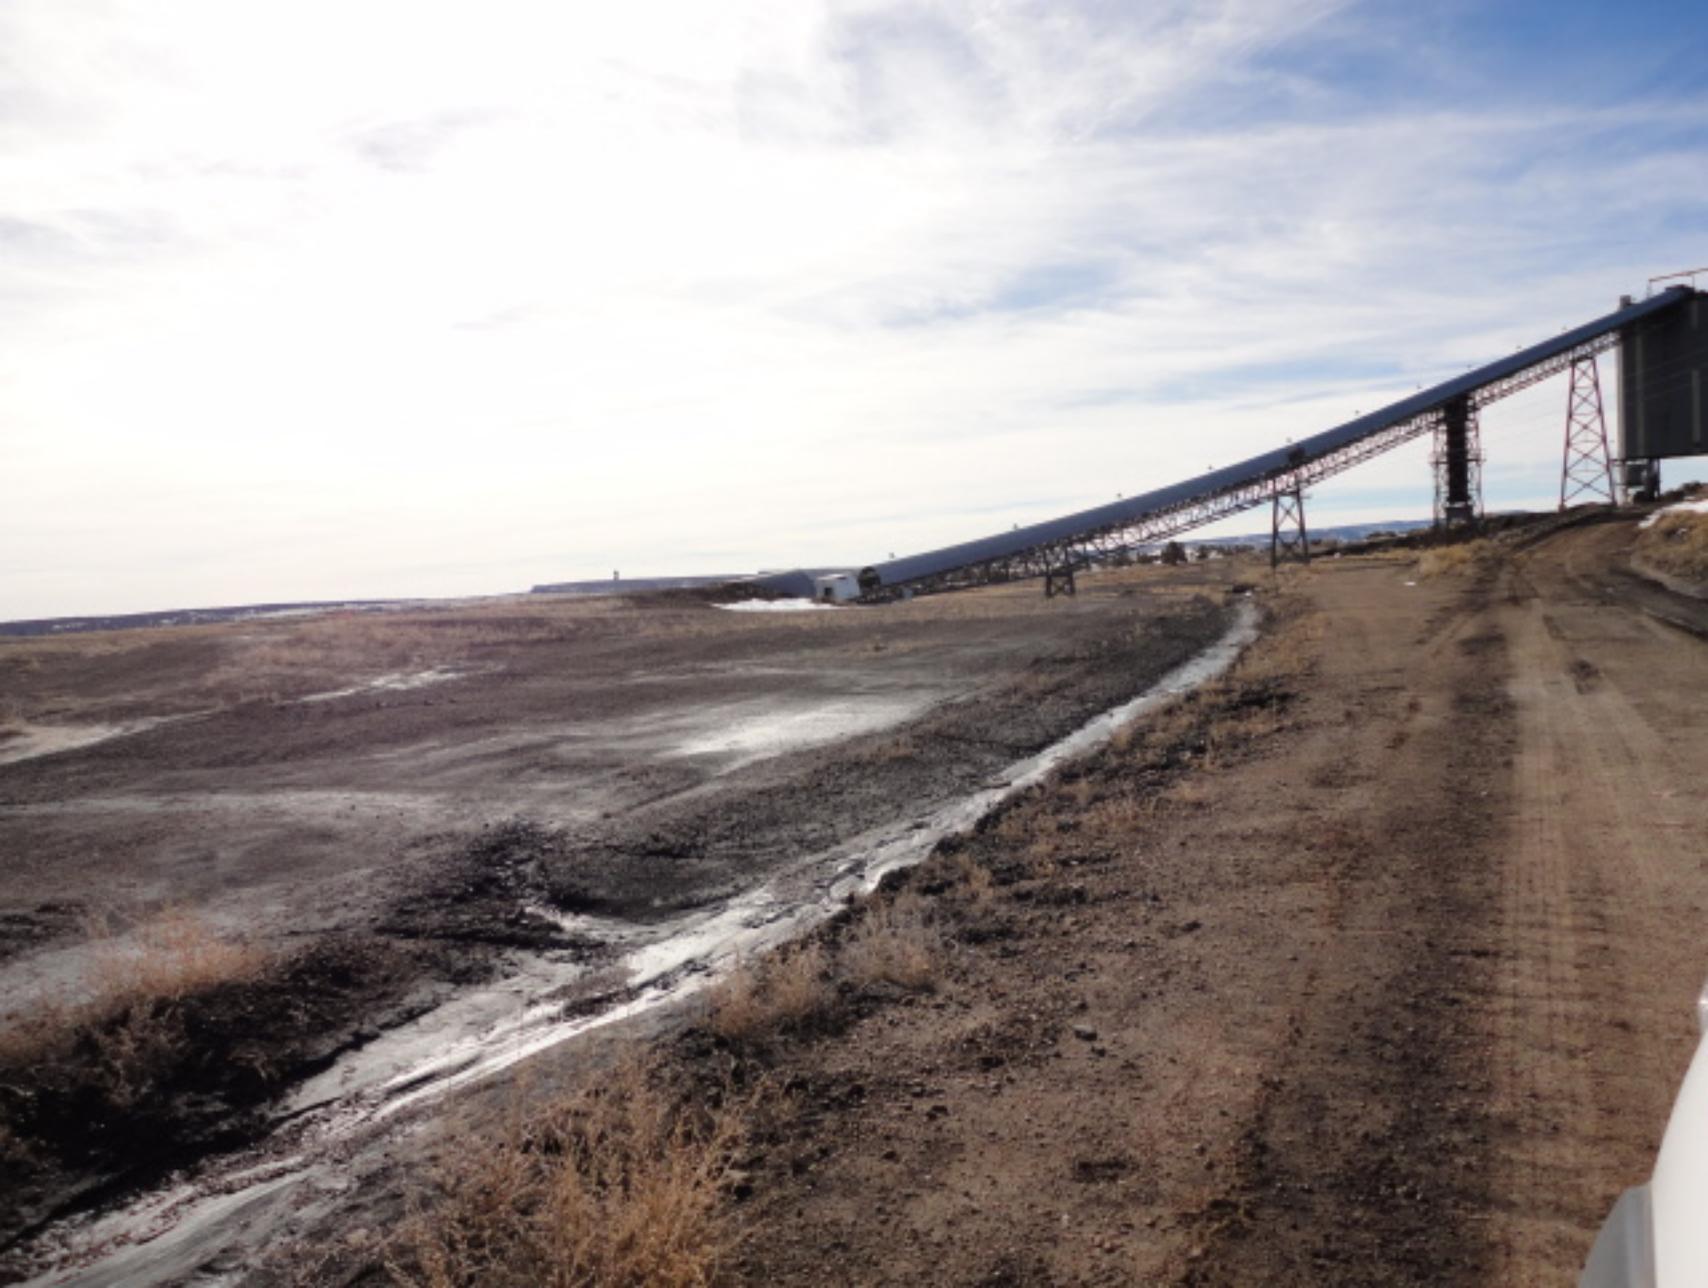
The permittee conducted a fourth quarter sediment pond inspection on Sept. 18 and December 18, 2015. No hazardous conditions were reported. I inspected the sediment ponds and they appear to be stable with no hazardous conditions. The sediment ponds contain little to no water. See Pictures

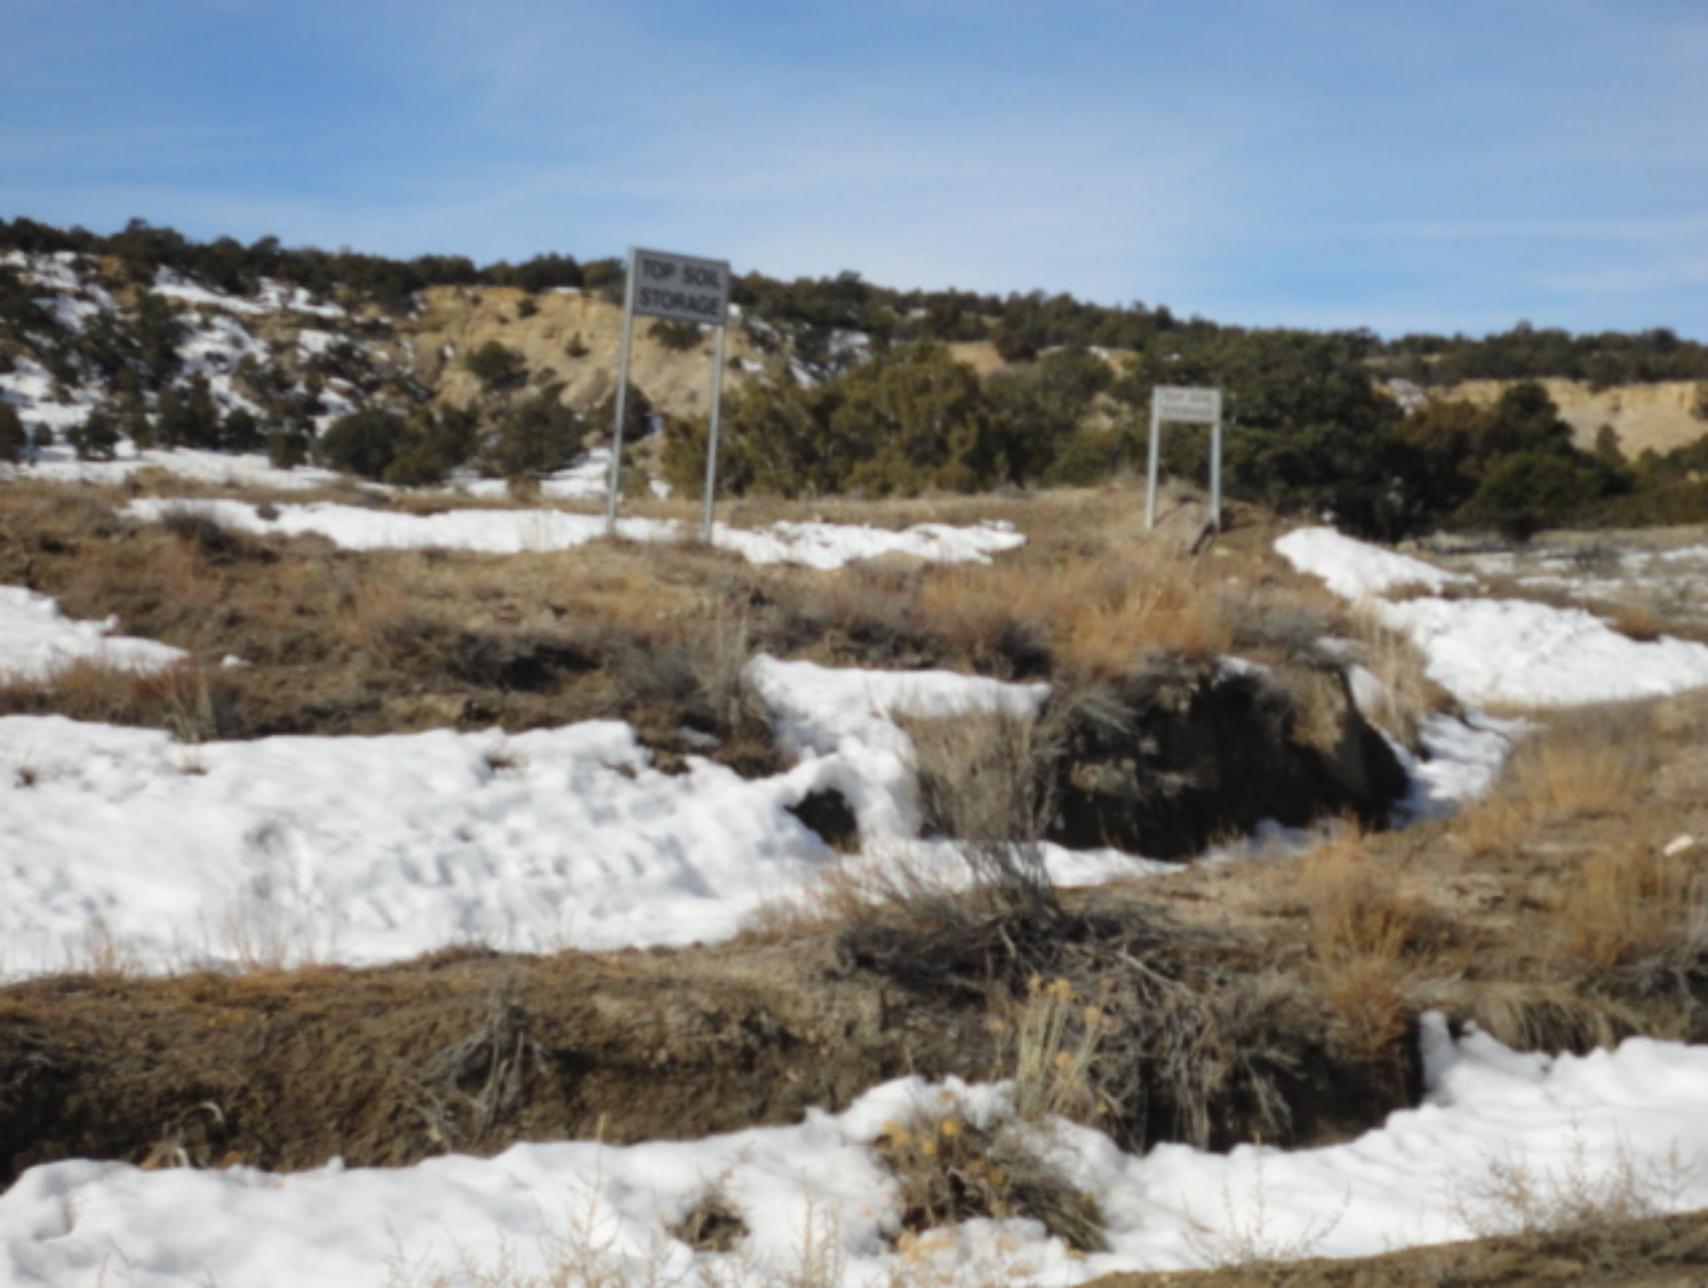
TOP SOIL  
STORAGE

I inspected the topsoil piles which were stable with no signs of wind or water erosion. The topsoil piles are is protected by berms.

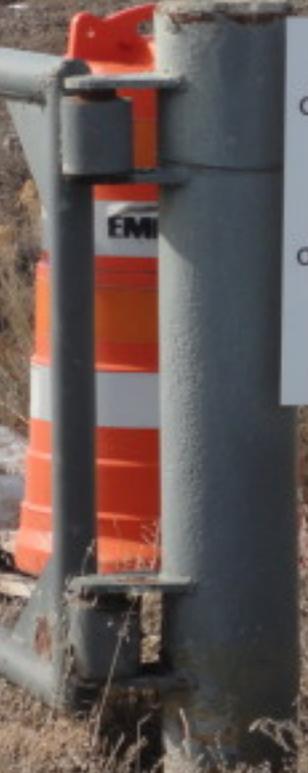
**WILDCAT LOAD OUT**

OWNER: INTERMOUNTAIN POWER AGENCY  
P.O. BOX 51111 - ROOM 1263  
LOS ANGELES, CALIFORNIA 90051  
PHONE: 213-367-0289  
UDOGM PERMIT NO. C/007/033

OPERATOR:  
WILD WEST EQUIPMENT & HAULING, LLC  
P.O. BOX 1  
PRICE, UTAH 84501  
PHONE: 435-472-3988  
MSHA ID NO. 42-01864
