# Inspection Report

Permit Number:	<b>C0070033</b>
Inspection Type:	COMPLETE
Inspection Date:	Wednesday, April 20, 2016
Start Date/Time:	4/20/2016 10:00:00 AM
End Date/Time:	4/20/2016 2:00:00 PM
Last Inspection:	Thursday, March 17, 2016

Permitee: **INTERMOUNTAIN POWER AGENCY**  
 Operator: **WILD WEST EQUIPMENT & HAULING, LLC**  
 Site: **WILDCAT LOADOUT**  
 Address: **PO BOX 1, PRICE UT 84501**  
 County: **CARBON**  
 Permit Type: **PERMANENT COAL PROGRAM**  
 Permit Status: **ACTIVE**

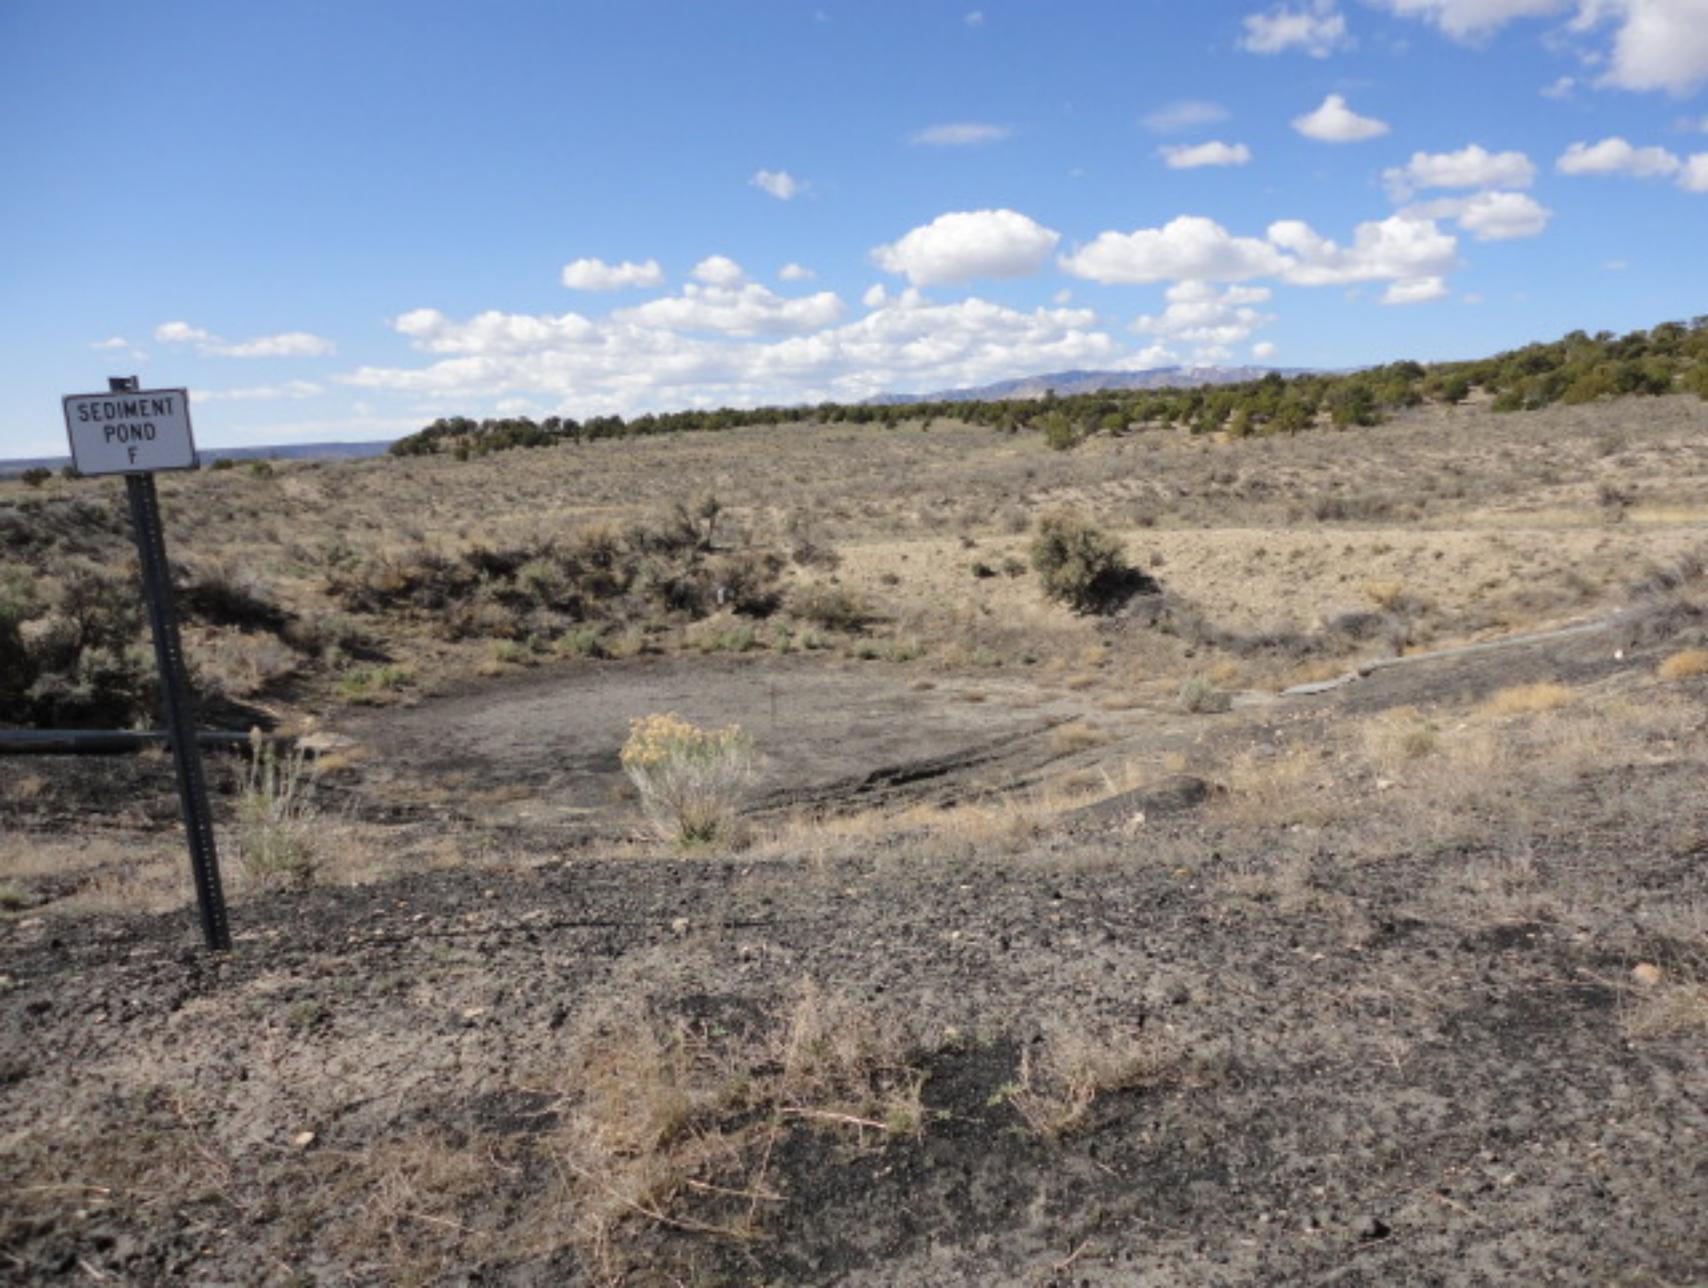
SEDIMENT  
POND  
F

The sediment ponds were dry or partially dry. No hazardous conditions were noticed during the inspection. The inlets and outlets were functioning as designed. No water was going to the sediment ponds. The diversions were dry. The sediment ponds were inspected by the permittee for the first quarter on March 8, 2016. No hazardous conditions were reported.

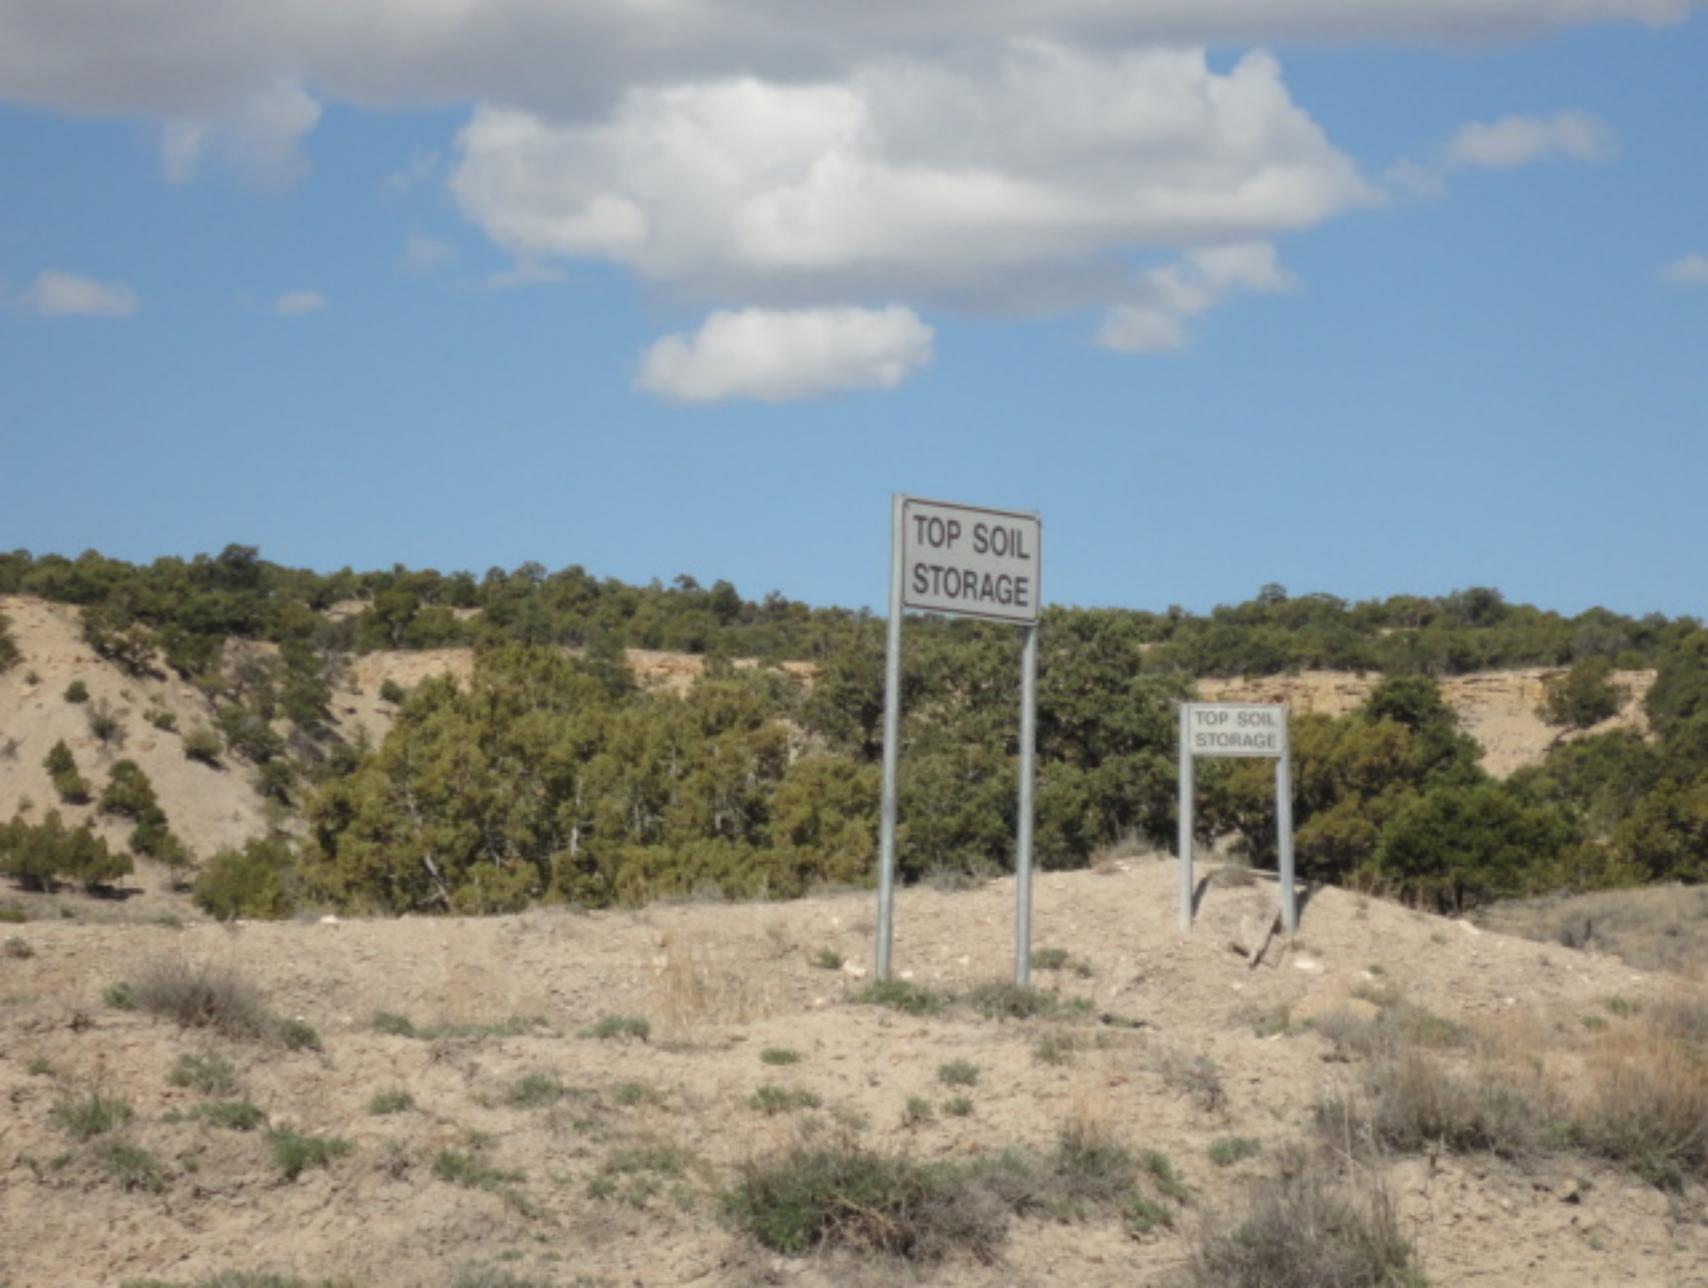
TOP SOIL  
STORAGE

The topsoil pile was inspected with no signs of wind or water erosion. See picture
