Inspection Report

Permit Number:	C0070033
Inspection Type:	COMPLETE
Inspection Date:	Tuesday, June 27, 2017
Start Date/Time:	6/27/2017 10:00:00 AM
End Date/Time:	6/27/2017 2:00:00 PM
Last Inspection:	Wednesday, May 17, 2017

Permitee: **INTERMOUNTAIN POWER AGENCY**
 Operator: **WILD WEST EQUIPMENT & HAULING, LLC**
 Site: **WILDCAT LOADOUT**
 Address: **PO BOX 1, PRICE UT 84501**
 County: **CARBON**
 Permit Type: **PERMANENT COAL PROGRAM**
 Permit Status: **INACTIVE**

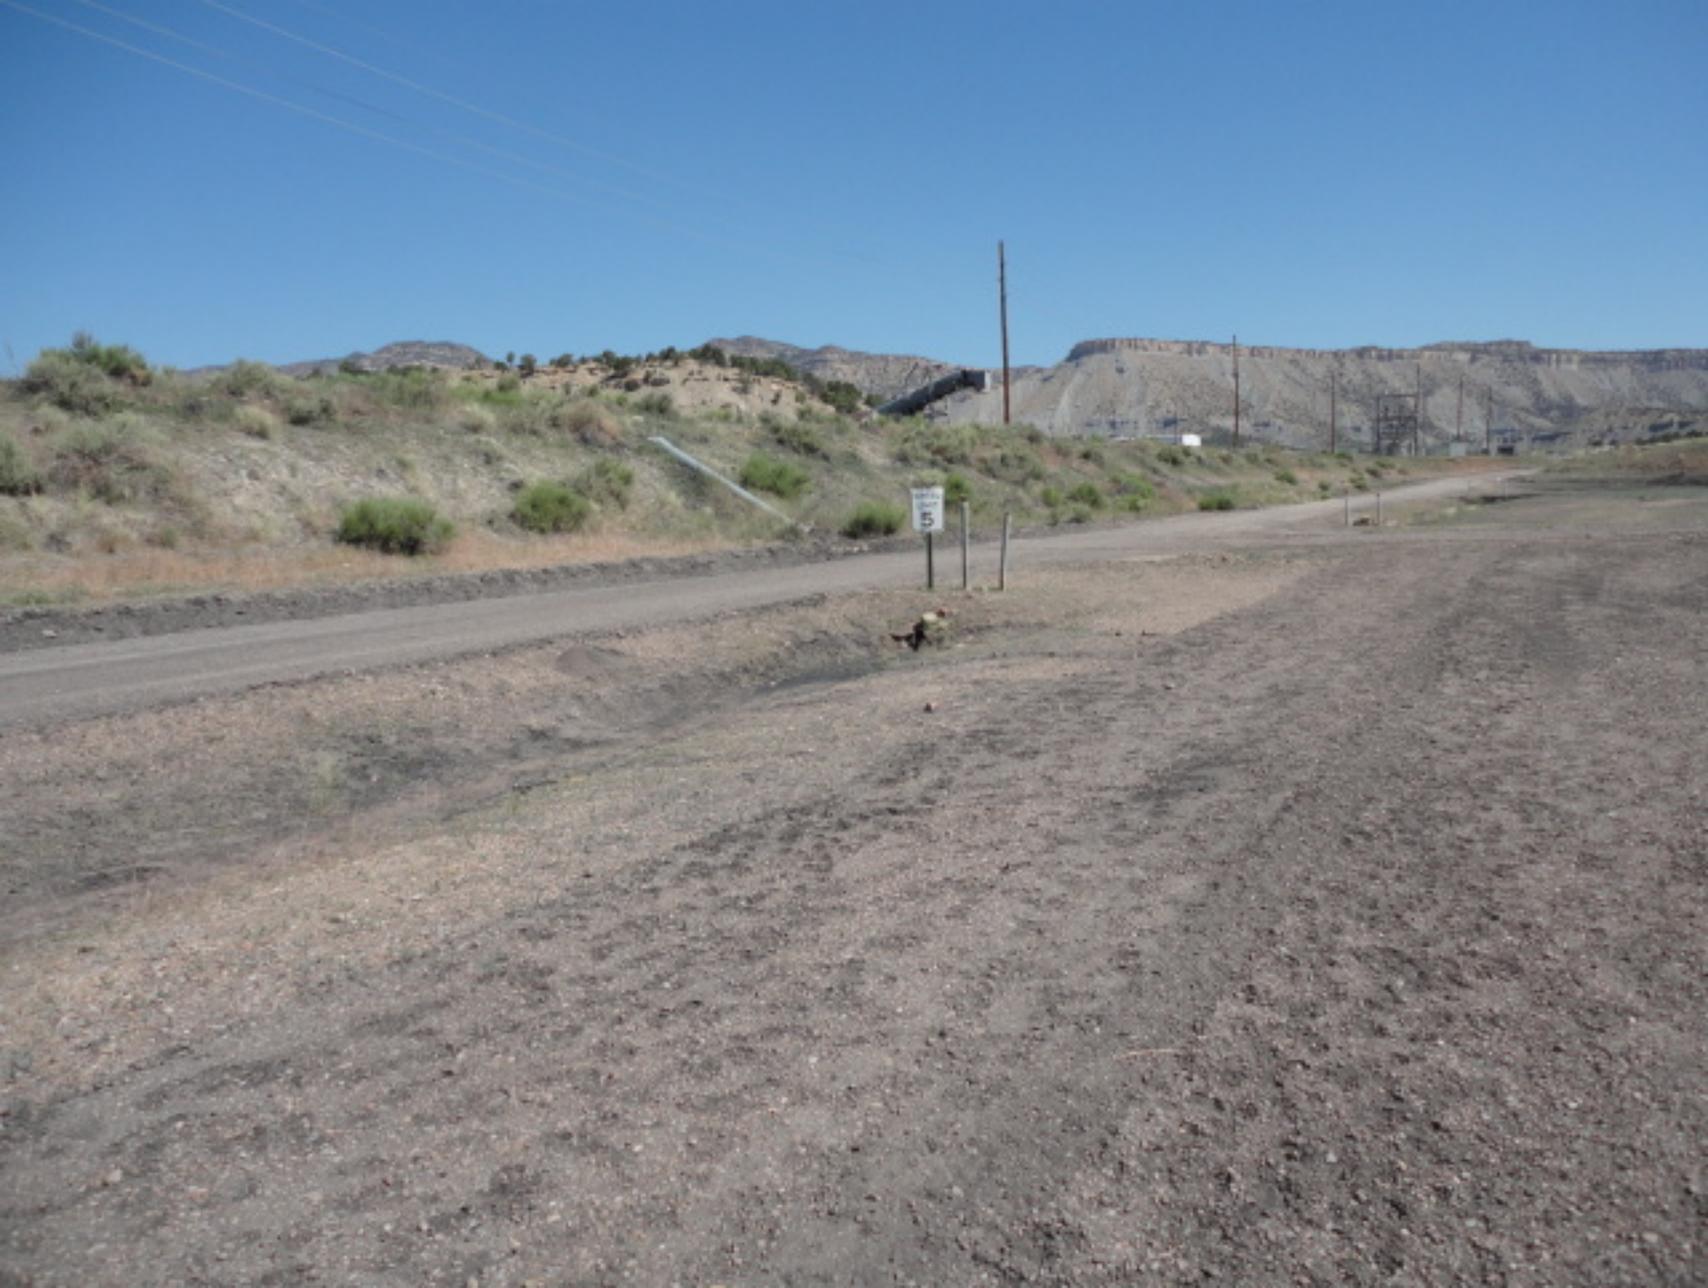
The identification sign was inspected and it meets the requirements of the R645 Coal Rules. See Photo

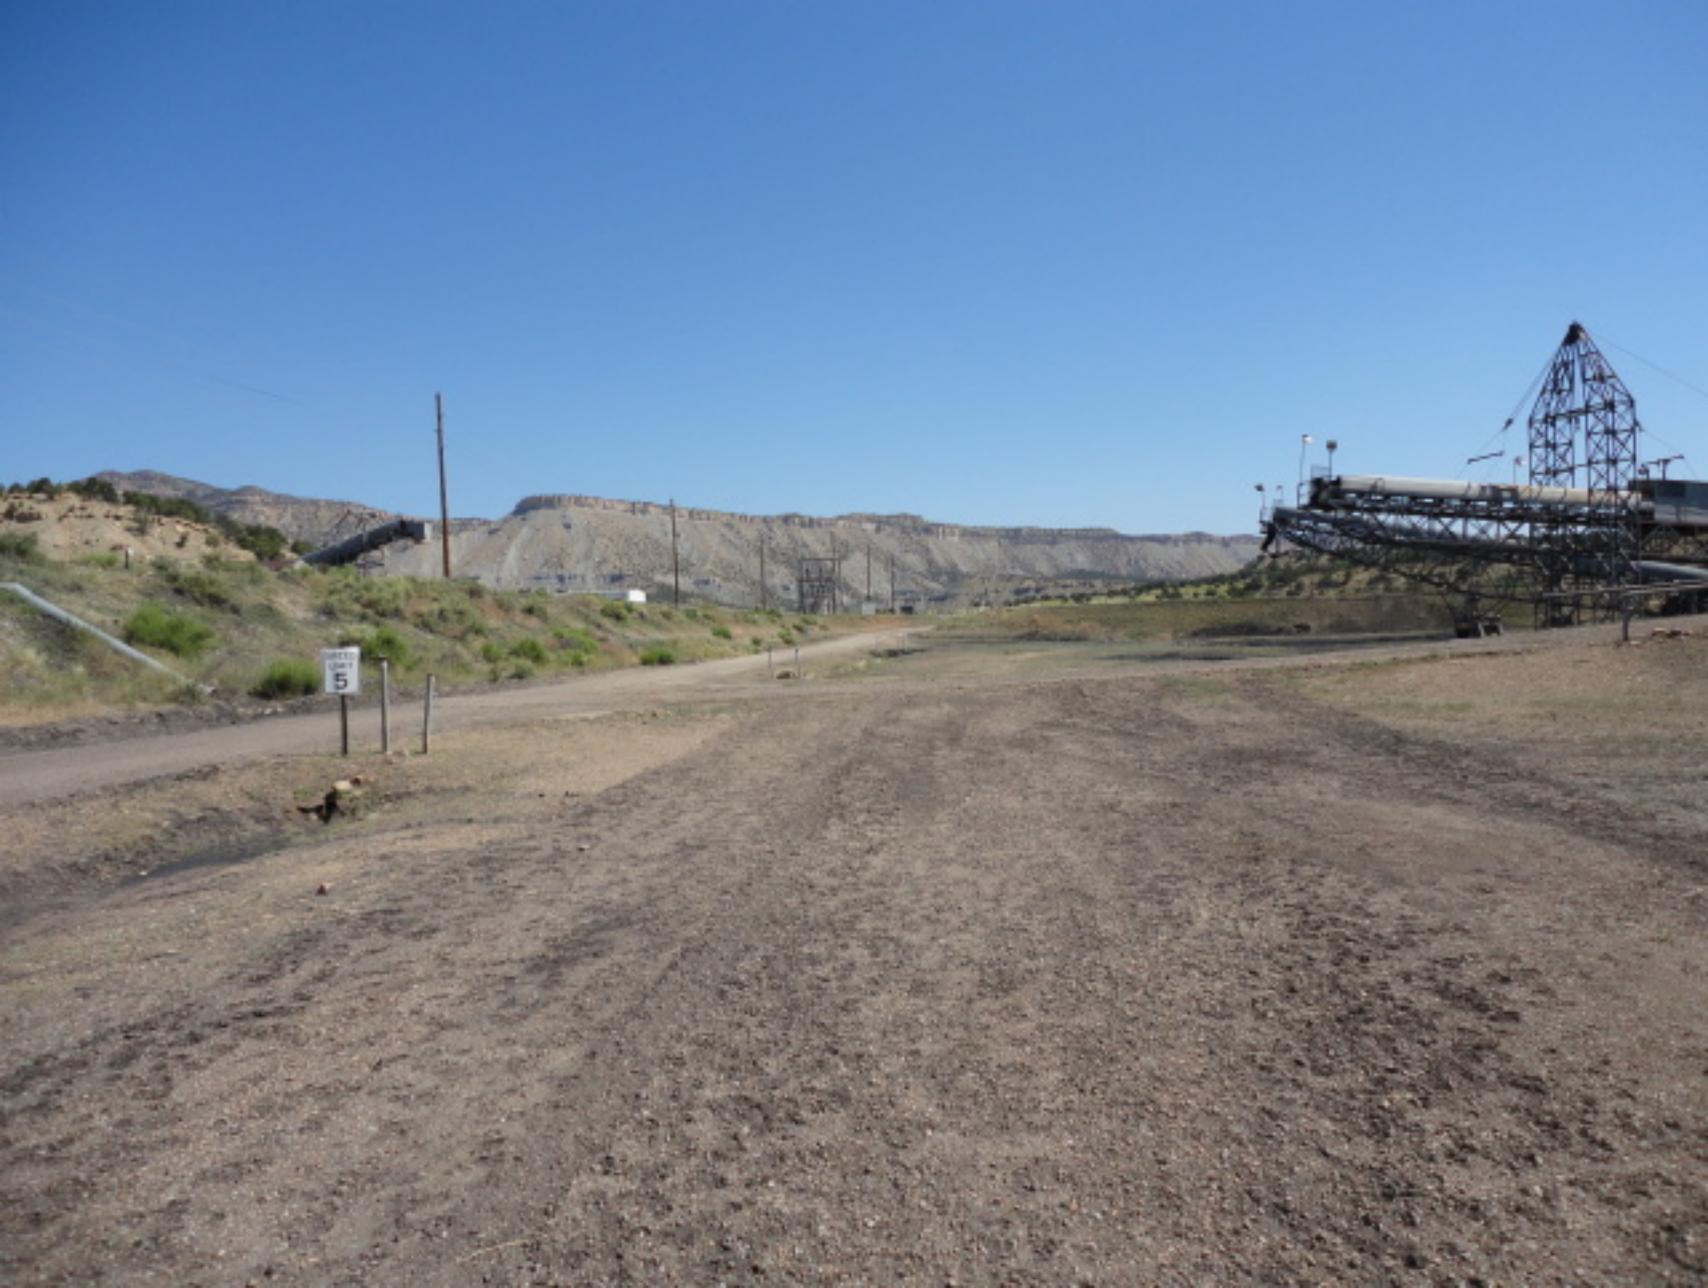
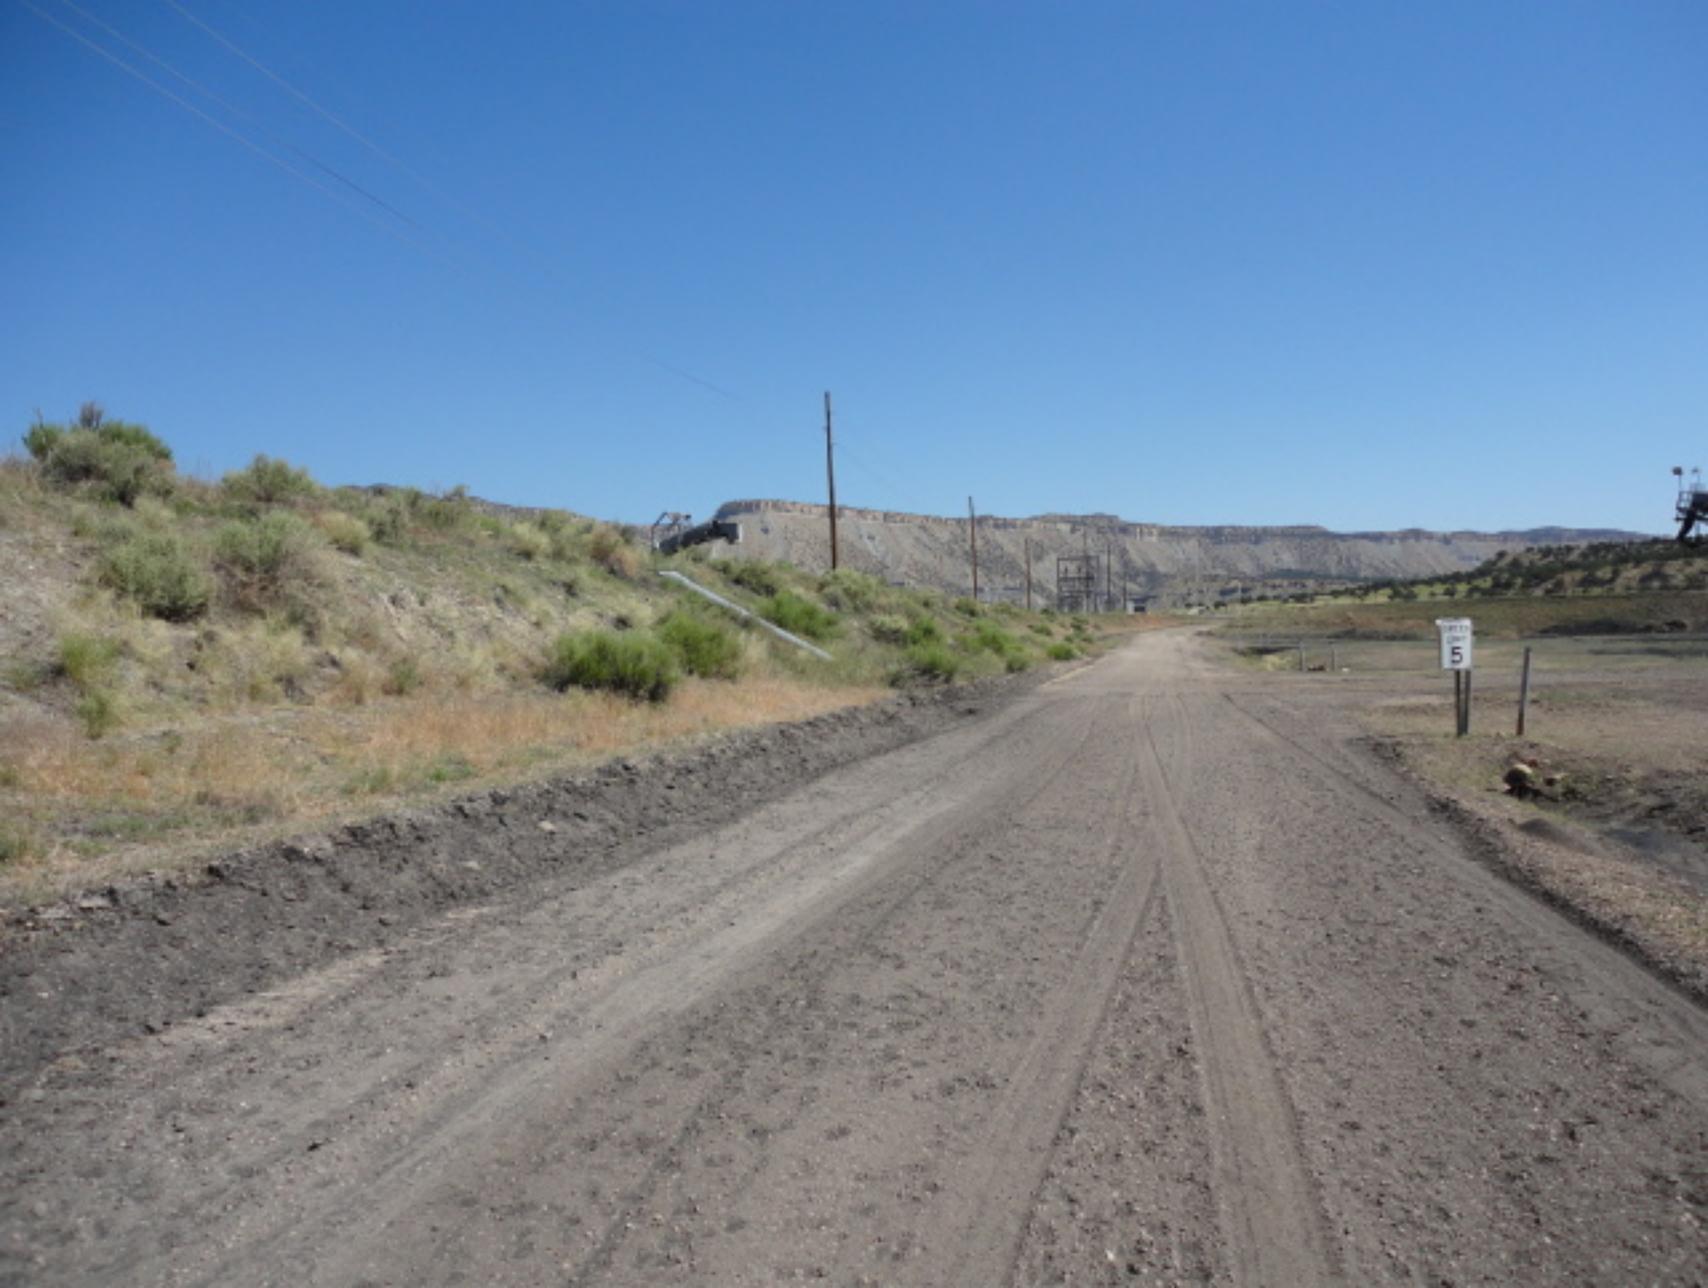
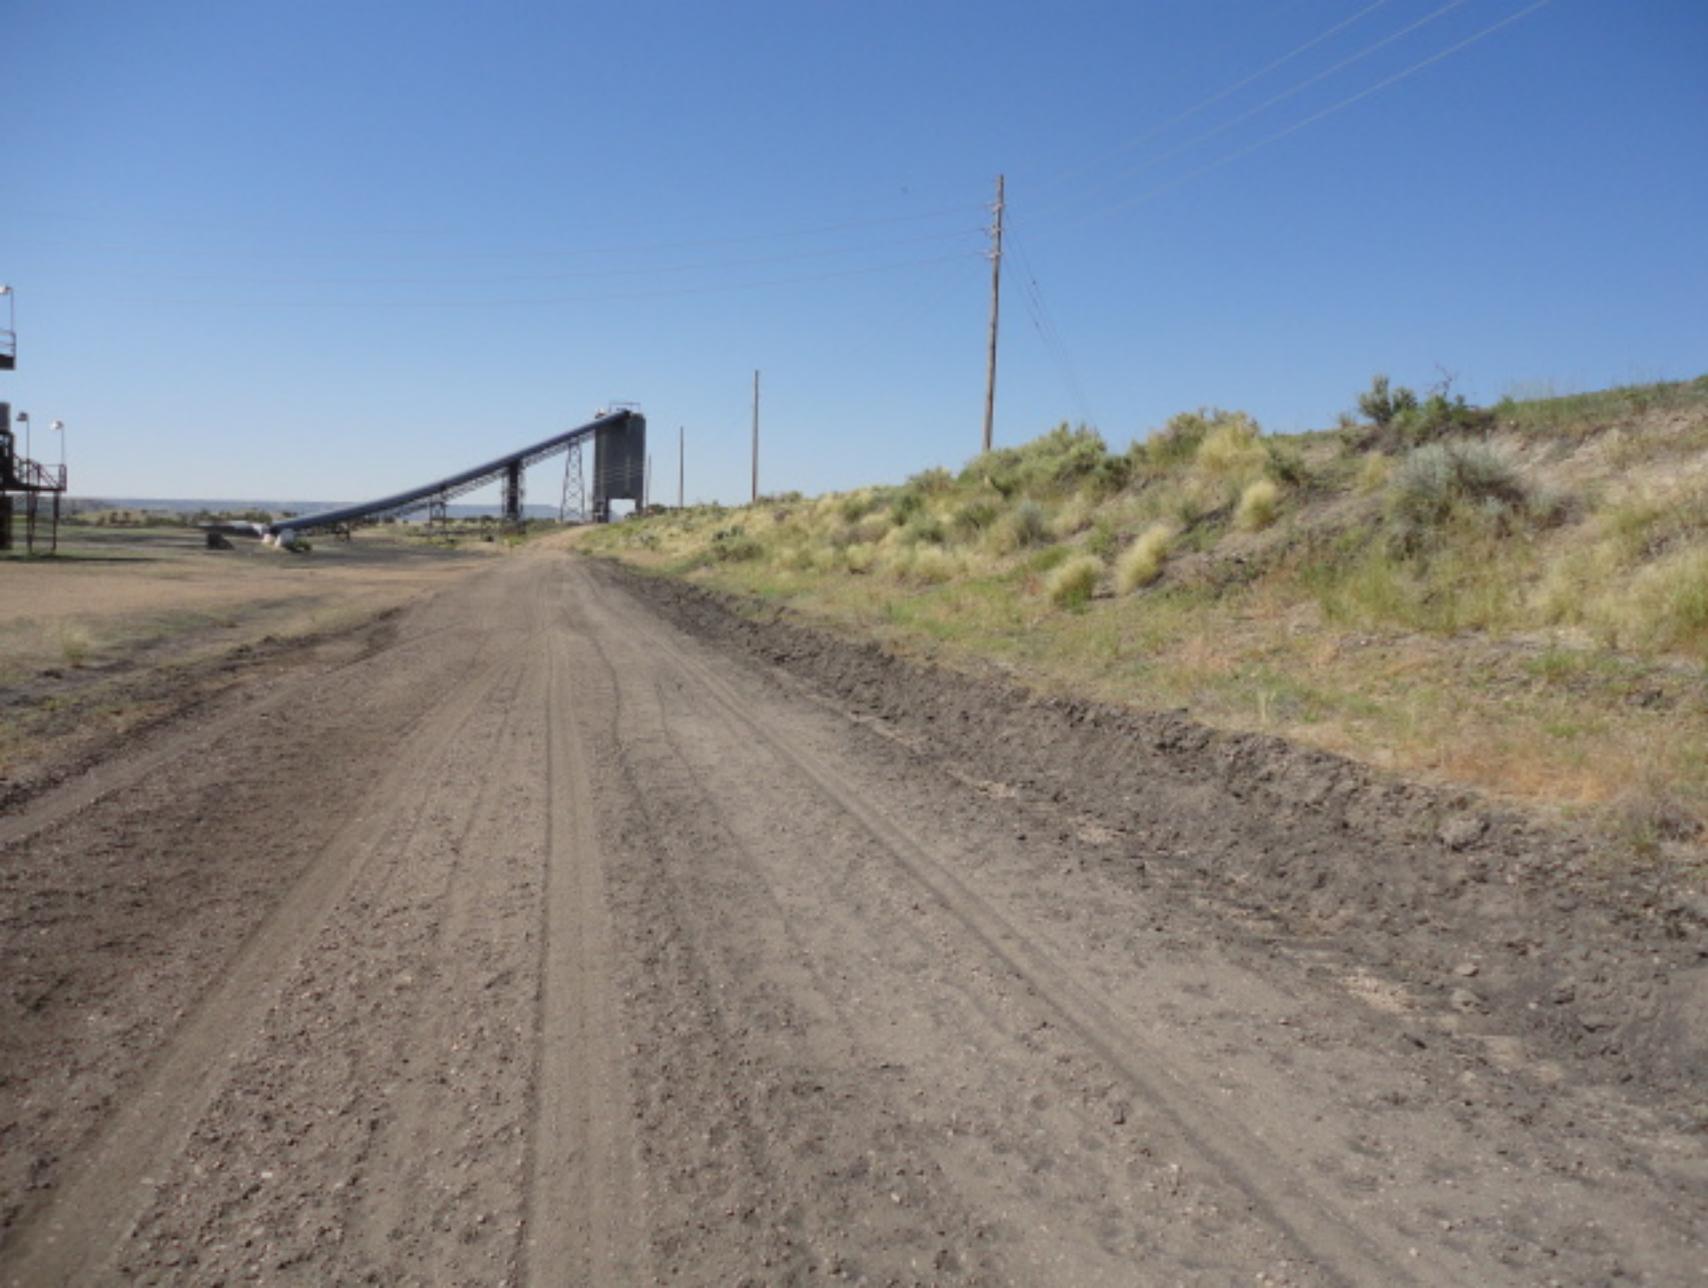
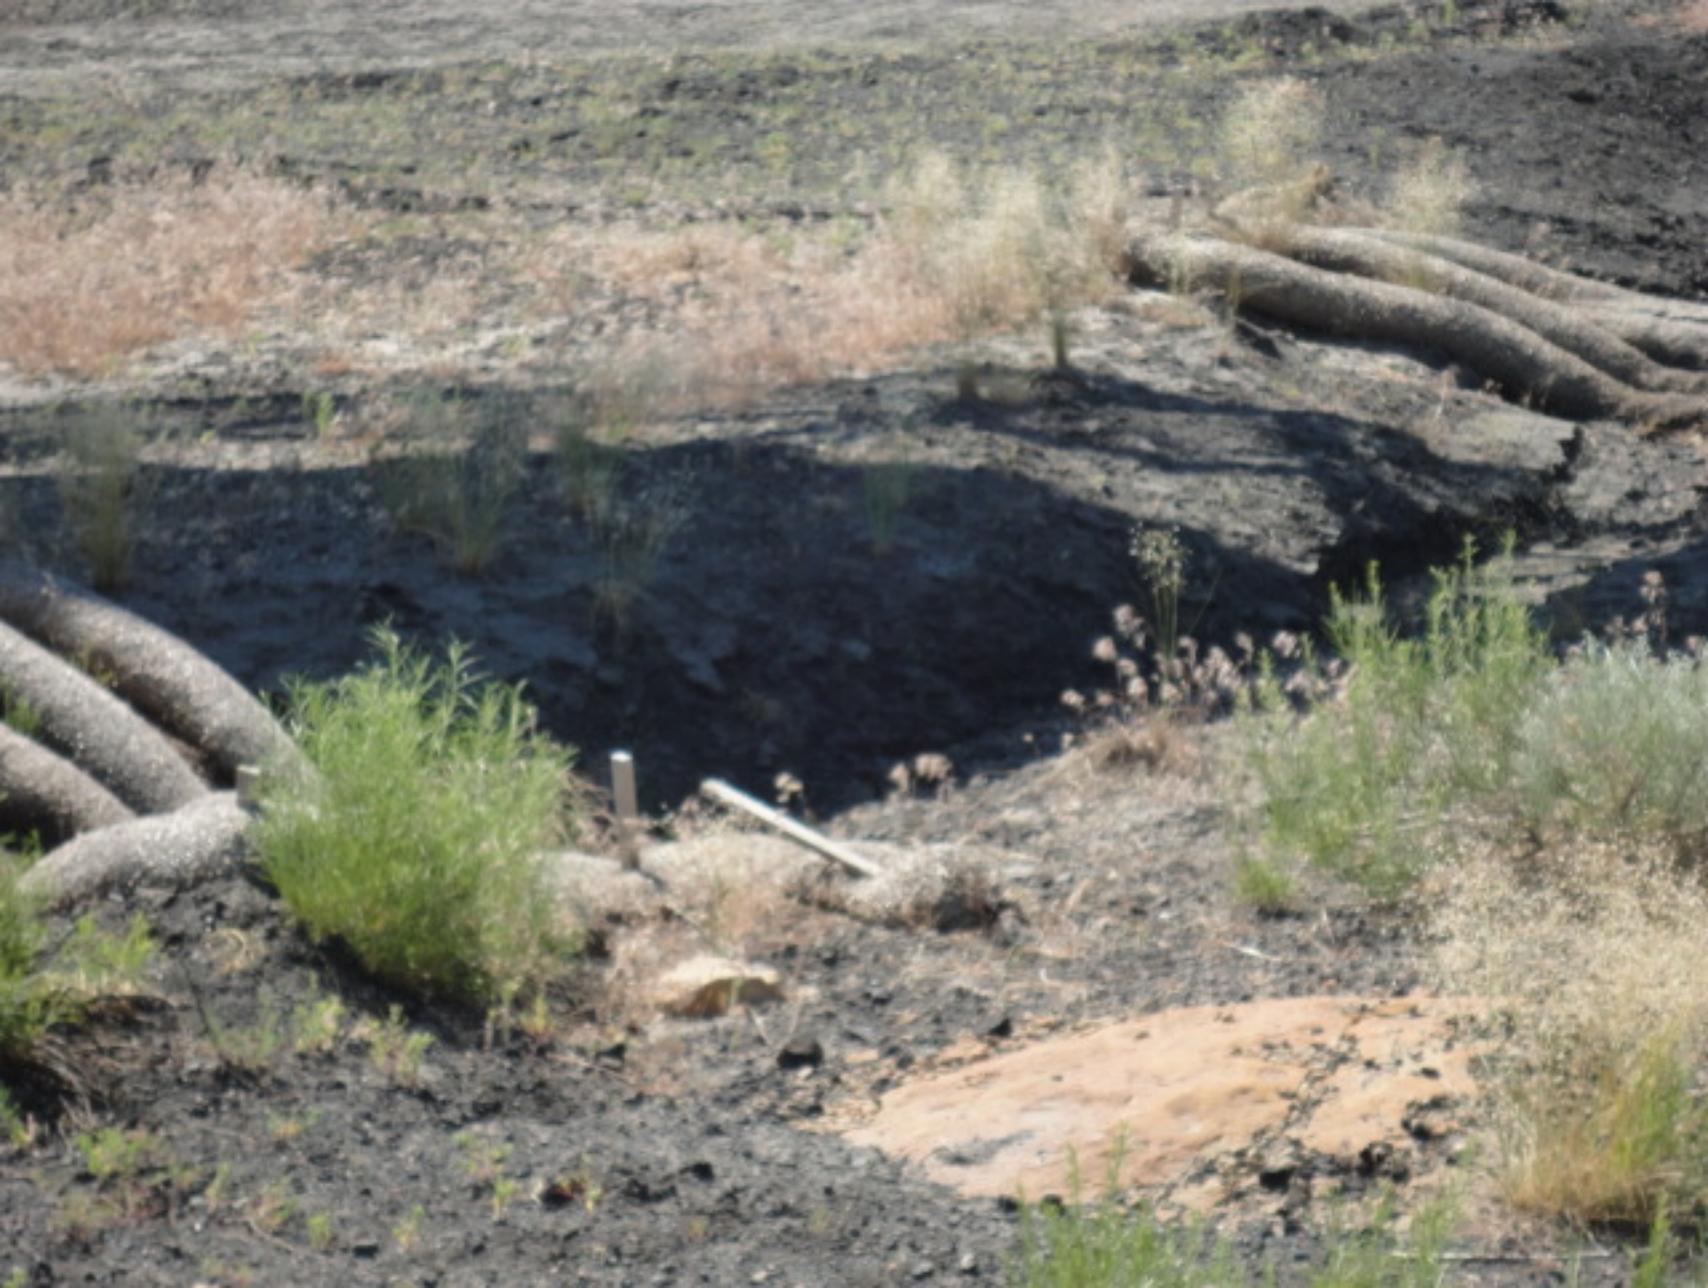
I inspected the refuse pile and it appears to be stable. I did not notice any hazardous conditions to the embankments. The refuse pile is active. The permittee conducted a third quarter refuse pile inspection on March 8,, 2016. This document is P.E. certified. No hazardous conditions were reported. See Photos

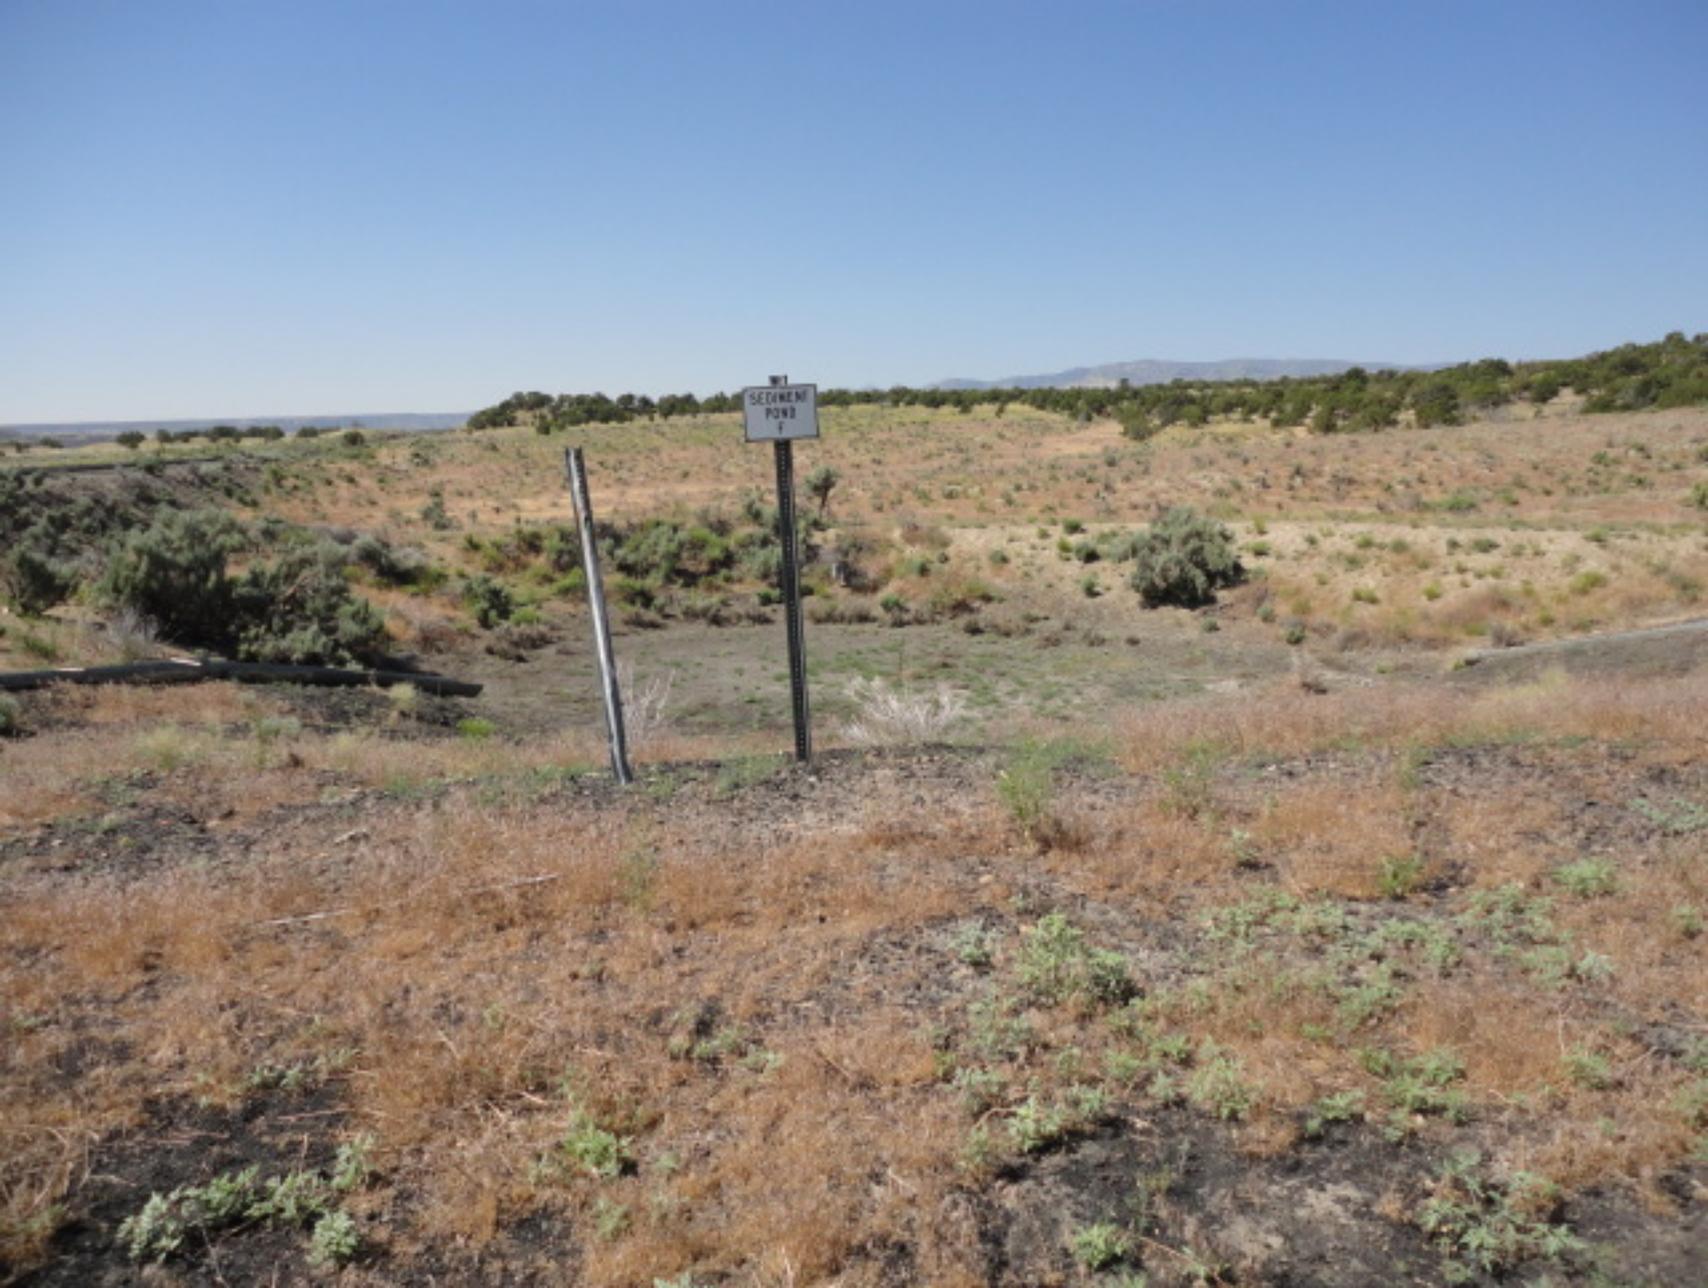
W1
SEDIMENT
POND
F

I inspected the sediment ponds throughout the property. They did not contain water. It is unlikely these structures will discharge in the near future. The embankments appear to be stable. Inlets and outlets would function as designed. I did not see any hazardous conditions to these structures. The permittee conducted a first quarter inspection of these ponds on March 8, 2017. No hazardous conditions were reported.

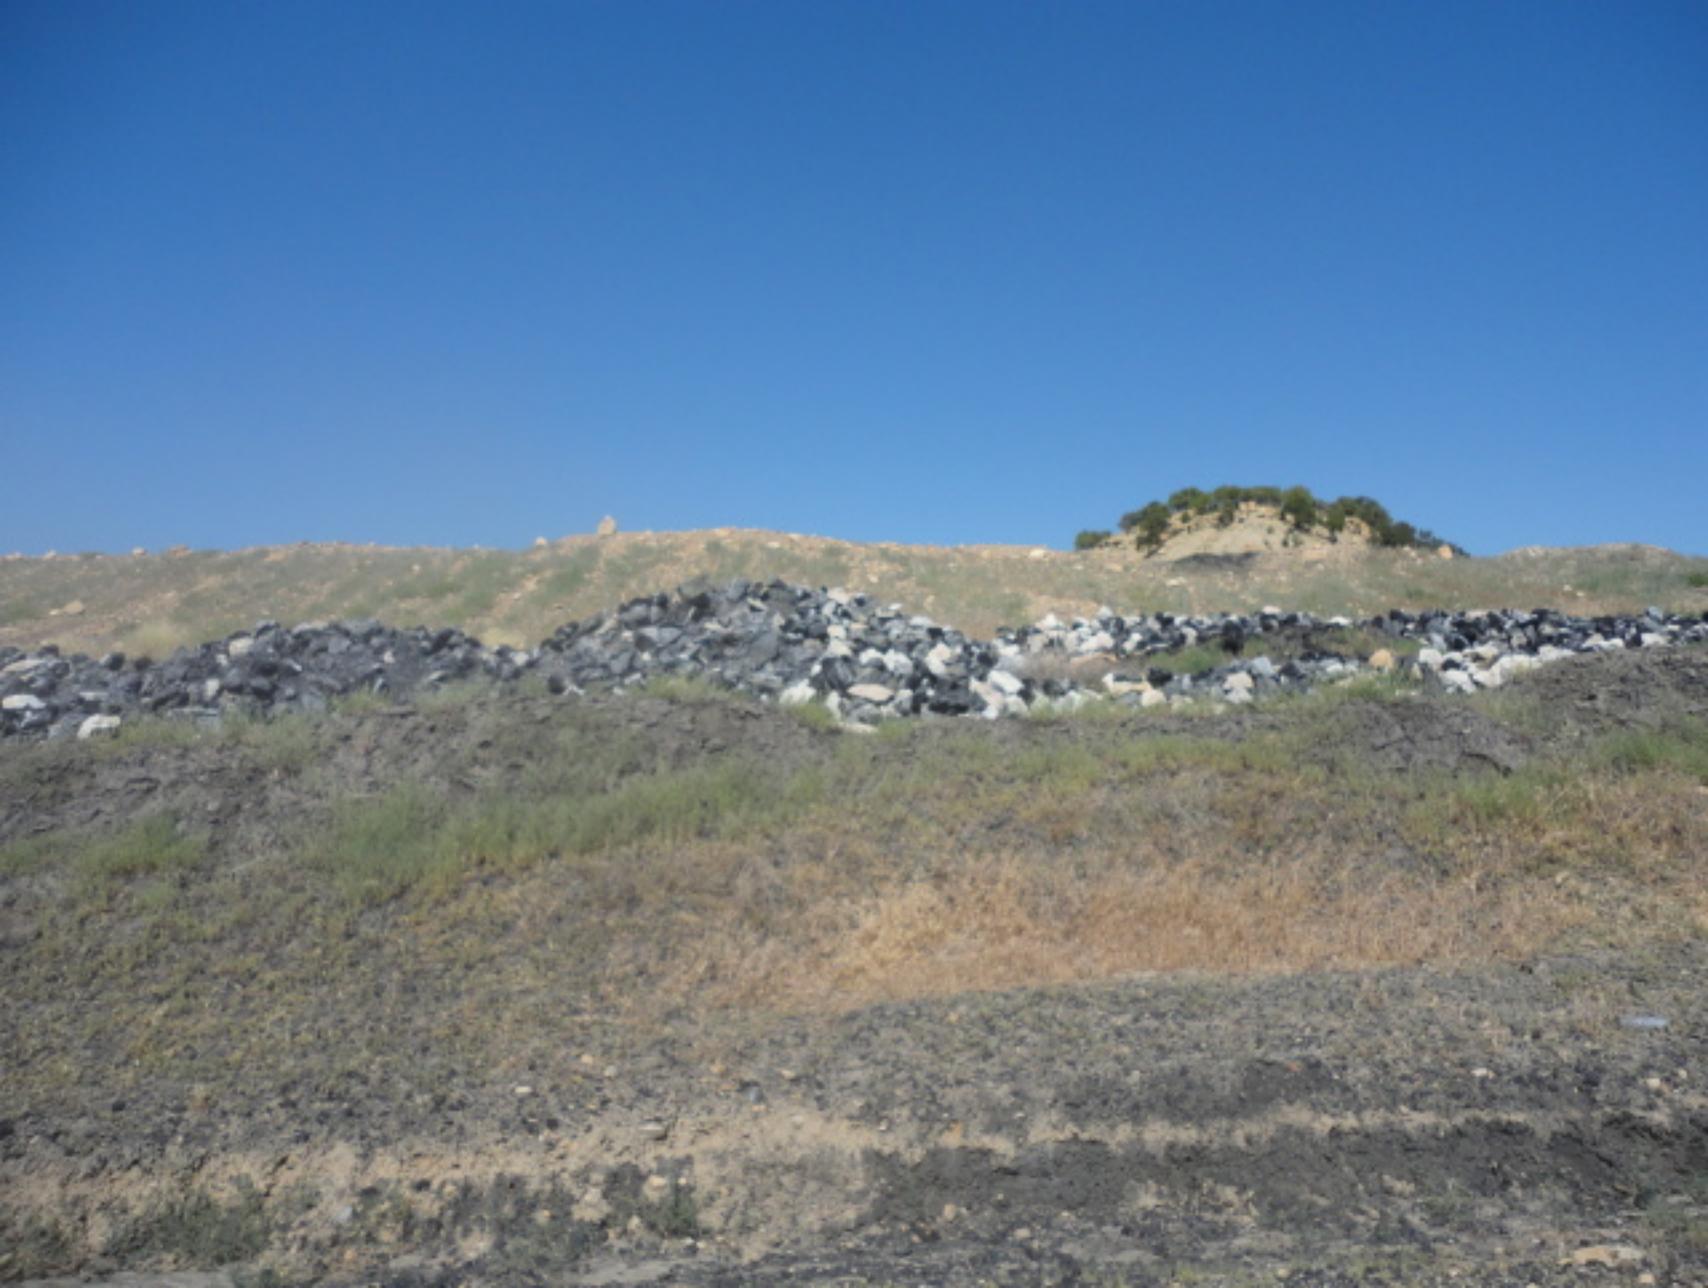
TOP SOIL
STORAGE

I inspected the topsoil piles and I did not see any signs of wind or water erosion. The topsoil piles appear to be stable and protected by a berm. See Photo

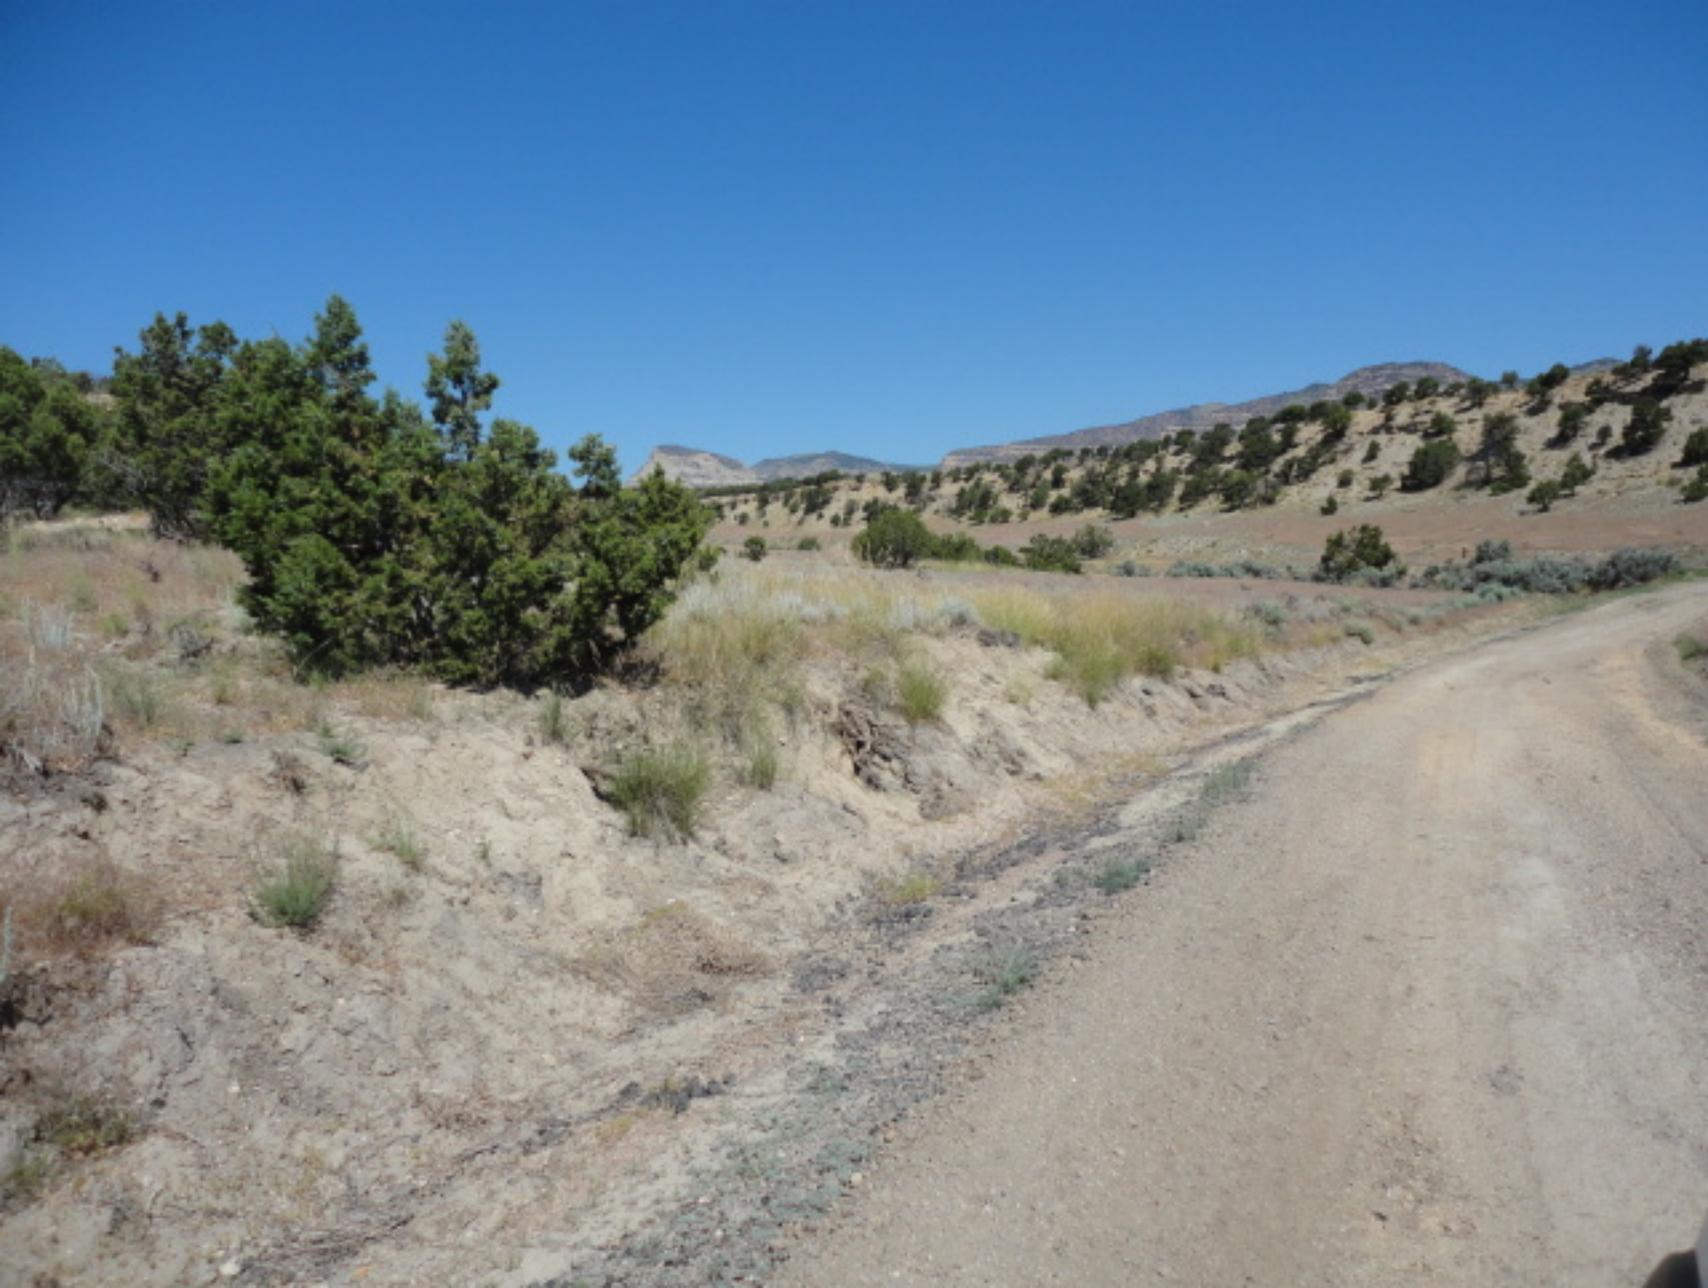
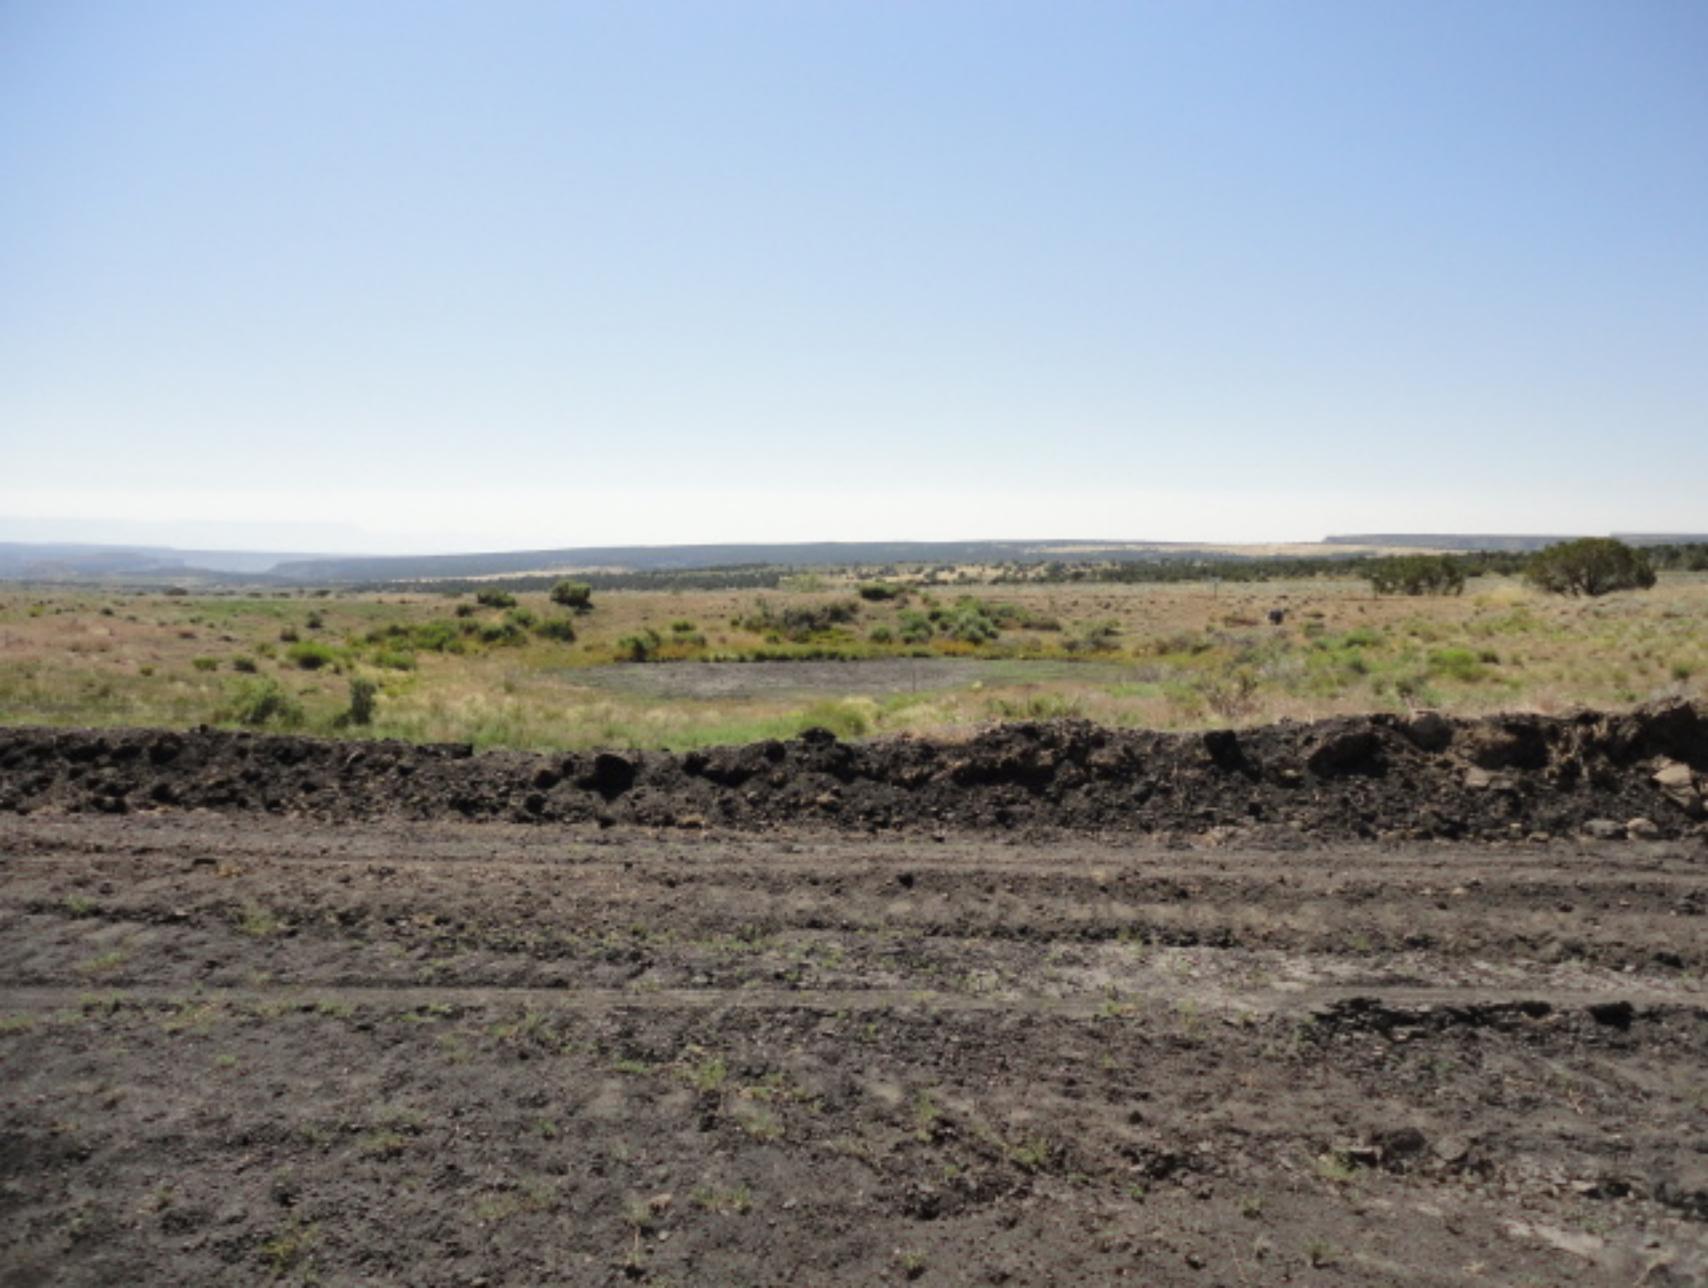
I inspected diversions and culverts throughout the property. They were open and would function as designed during a storm event. The structures were recently re-graded and clean out of sediment. See photos
