Inspection Report

Permit Number:	C0070033
Inspection Type:	COMPLETE
Inspection Date:	Tuesday, June 27, 2017
Start Date/Time:	6/27/2017 10:00:00 AM
End Date/Time:	6/27/2017 2:00:00 PM
Last Inspection:	Wednesday, May 17, 2017

Permitee: **INTERMOUNTAIN POWER AGENCY**
 Operator: **WILD WEST EQUIPMENT & HAULING, LLC**
 Site: **WILDCAT LOADOUT**
 Address: **PO BOX 1, PRICE UT 84501**
 County: **CARBON**
 Permit Type: **PERMANENT COAL PROGRAM**
 Permit Status: **INACTIVE**

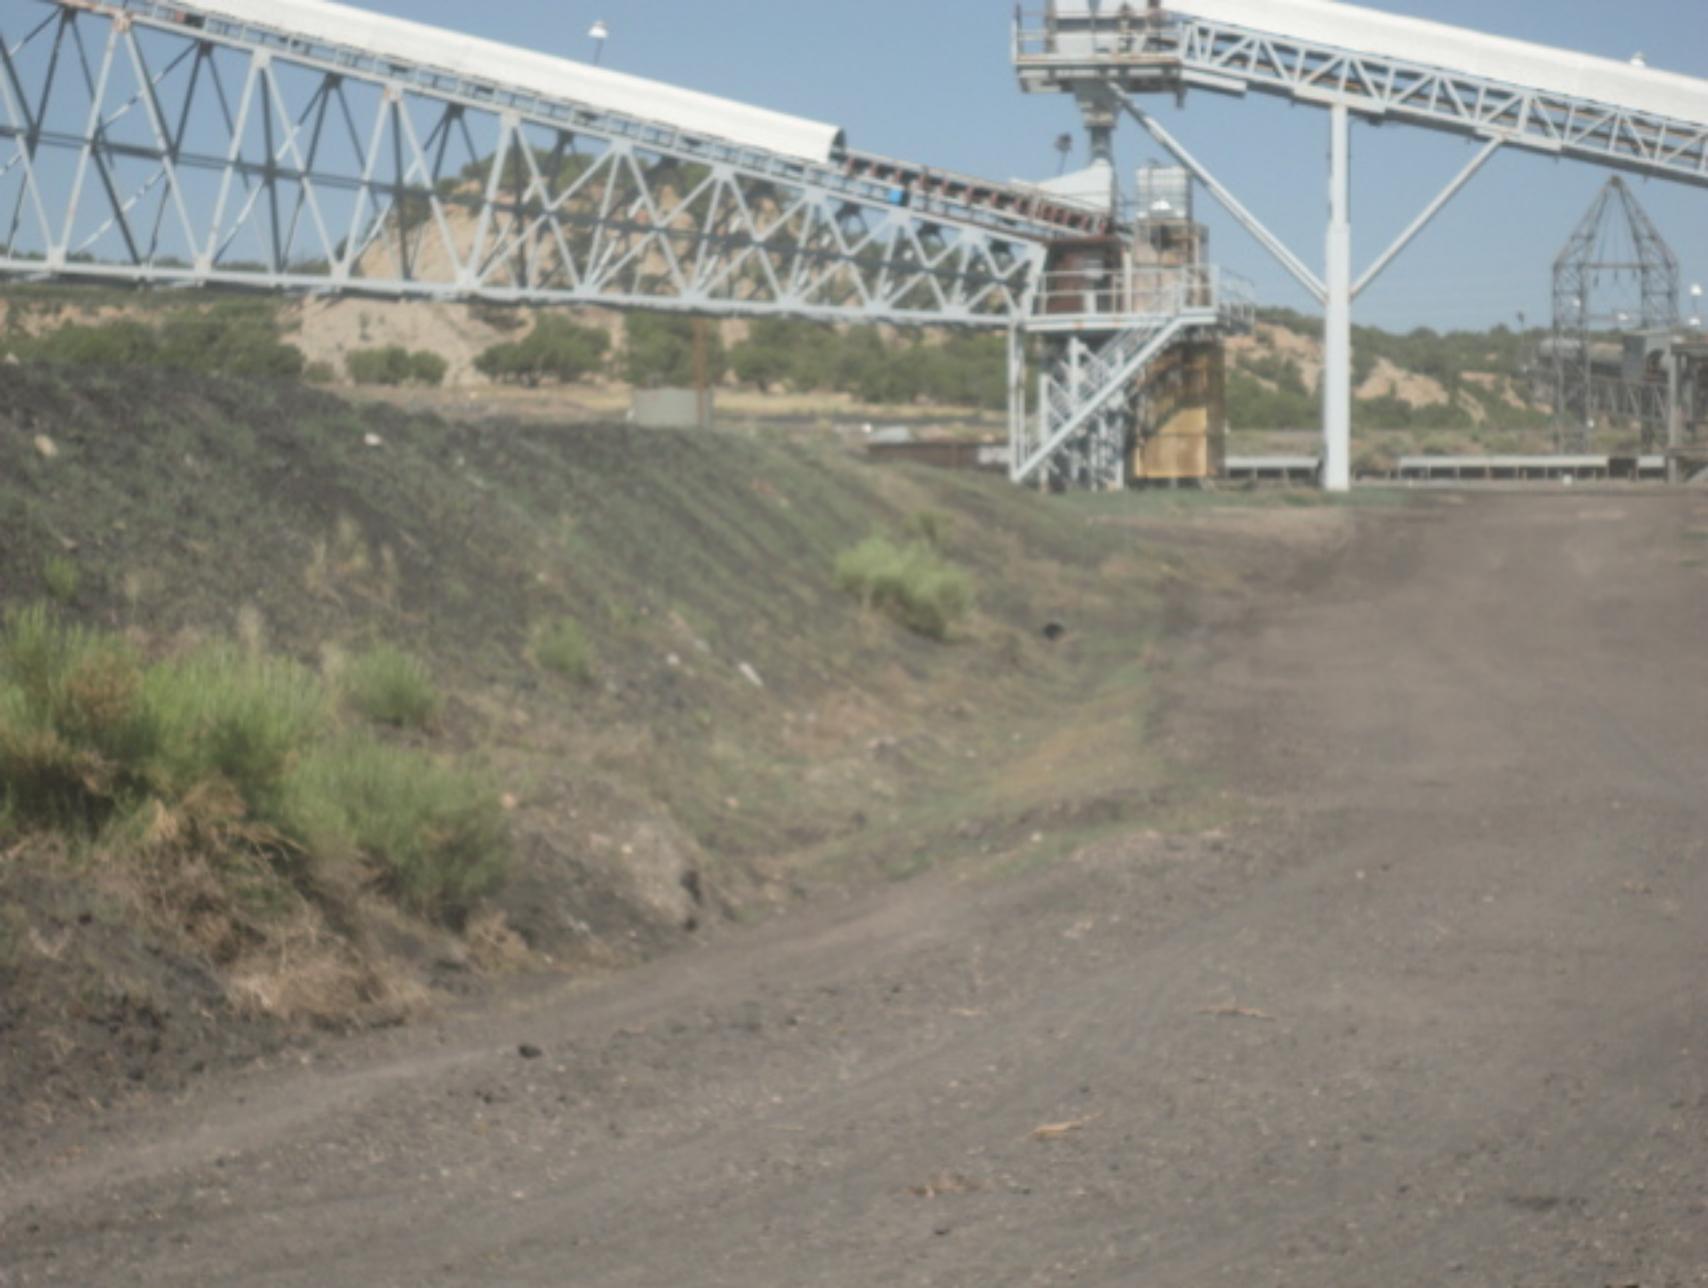
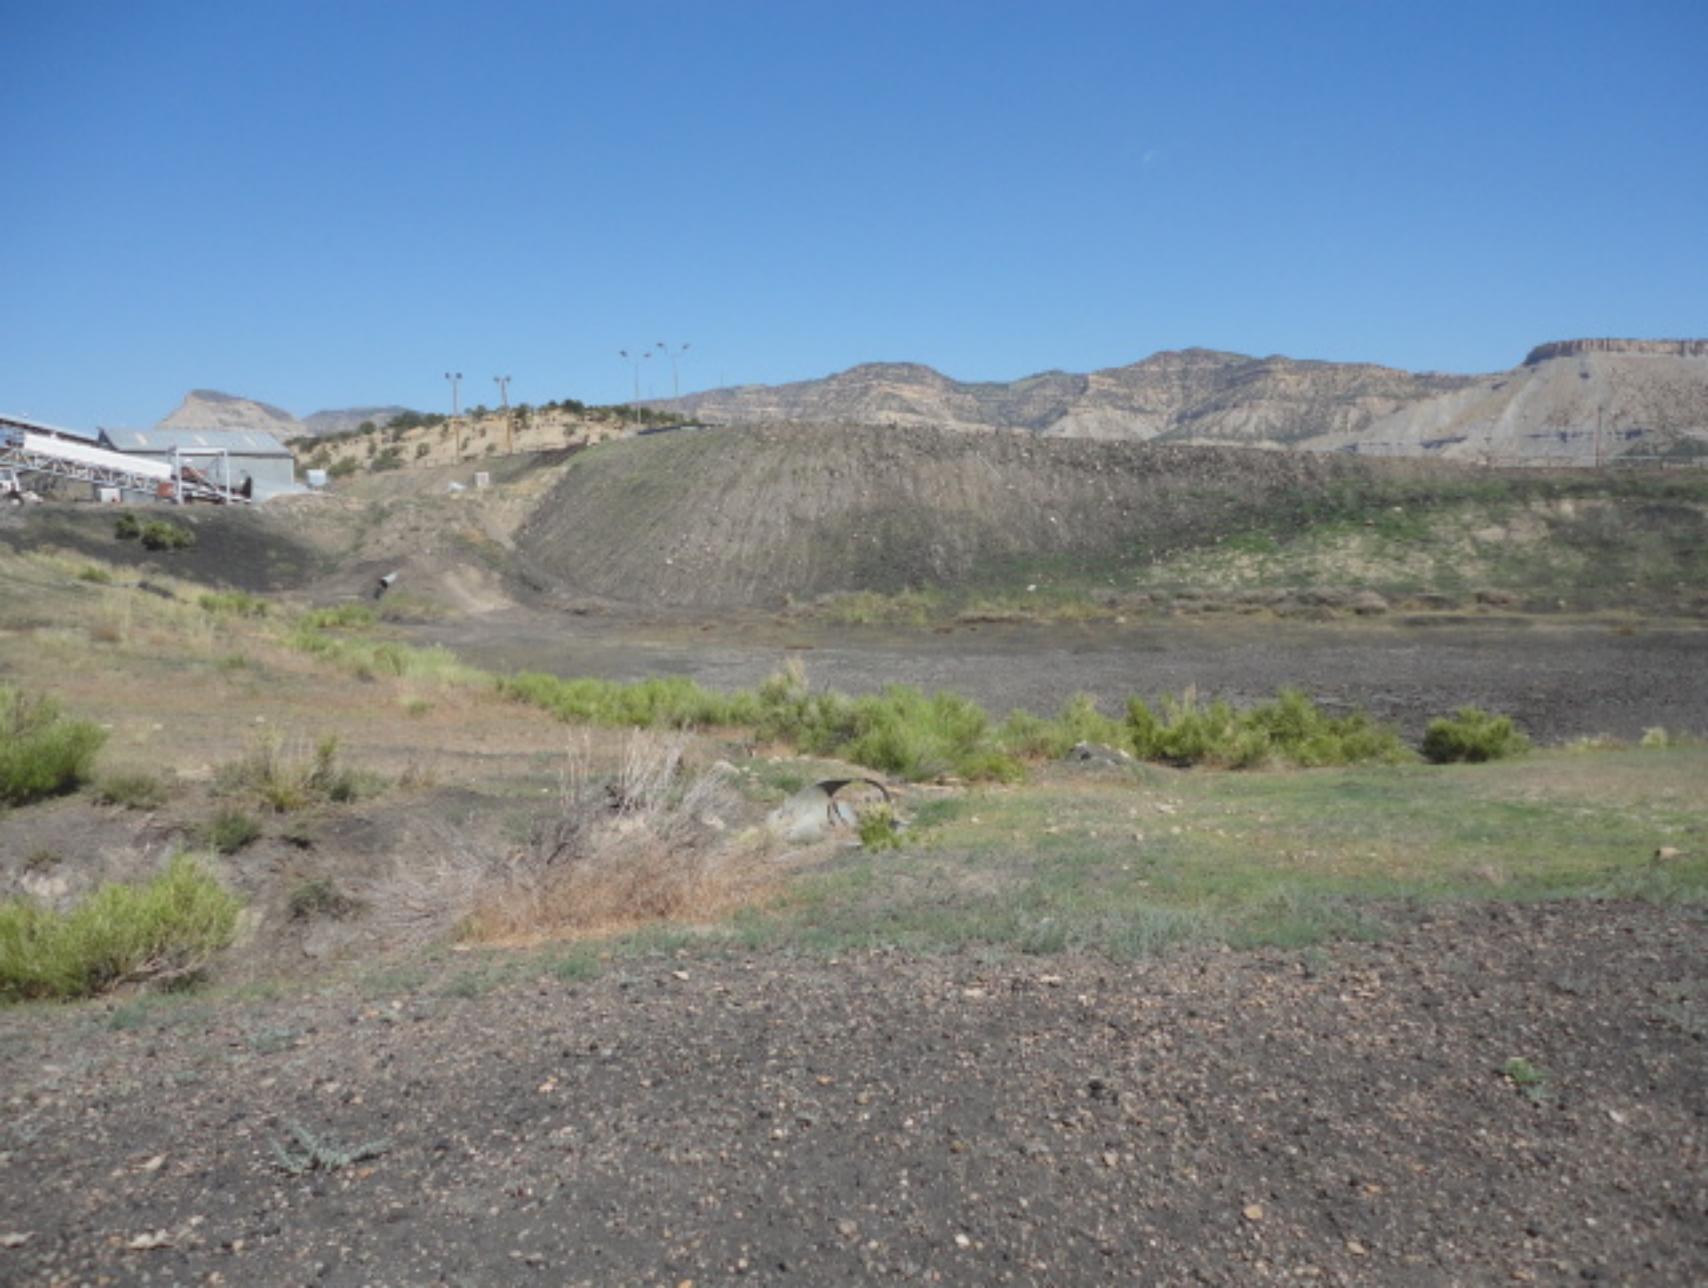
I inspected the refuse pile and it appears to be stable. I did not notice any hazardous conditions to the embankments. The refuse pile is active. The permittee conducted a third quarter refuse pile inspection on March 8,, 2016. This document is P.E. certified. No hazardous conditions were reported. See Photos

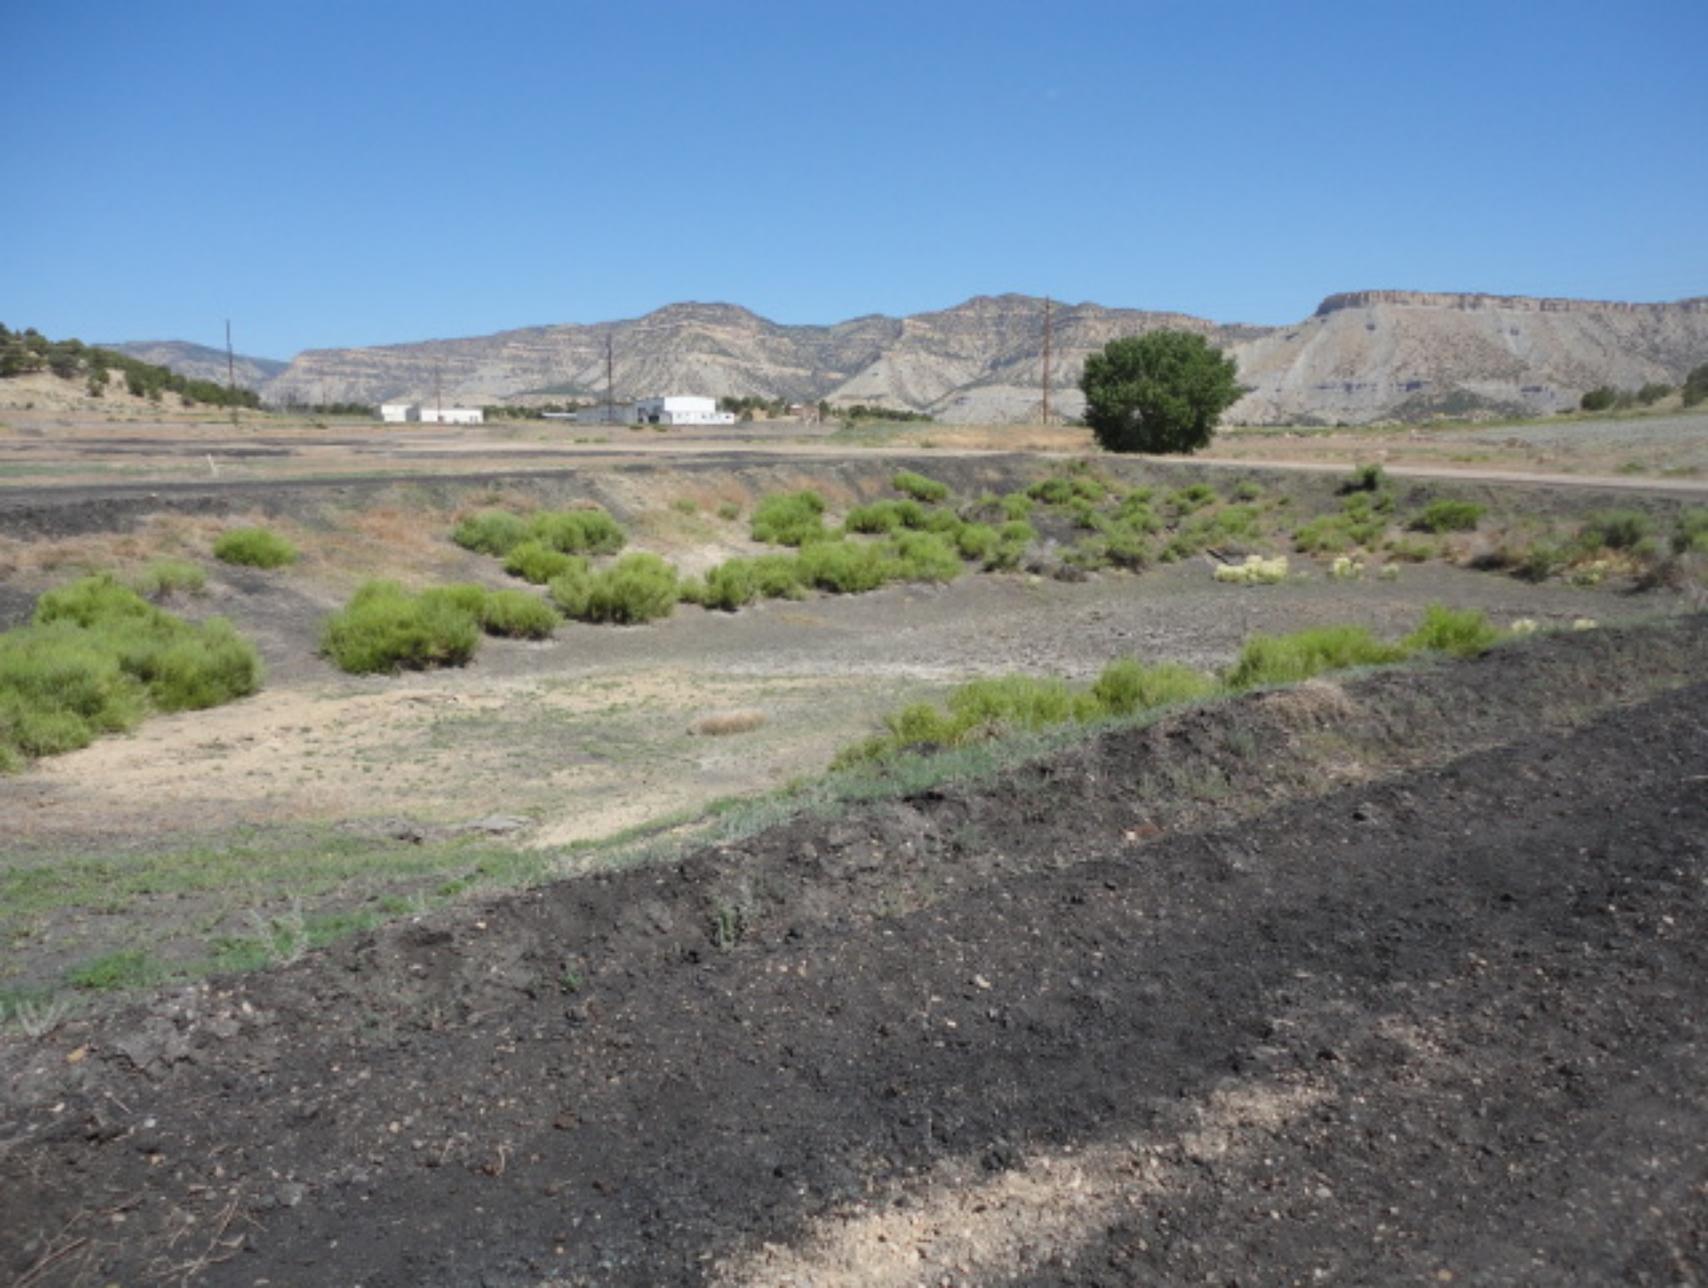
I inspected the road diversions and culverts throughout the property. They were functioning as designed. See Photos
