## Inspection Report

Permit Number:	C0070033
Inspection Type:	COMPLETE
Inspection Date:	Thursday, August 17, 2017
Start Date/Time:	8/17/2017 10:00:00 AM
End Date/Time:	8/17/2017 2:00:00 PM
Last Inspection:	Thursday, July 27, 2017

Permitee: **INTERMOUNTAIN POWER AGENCY**

Site: **WILDCAT LOADOUT**

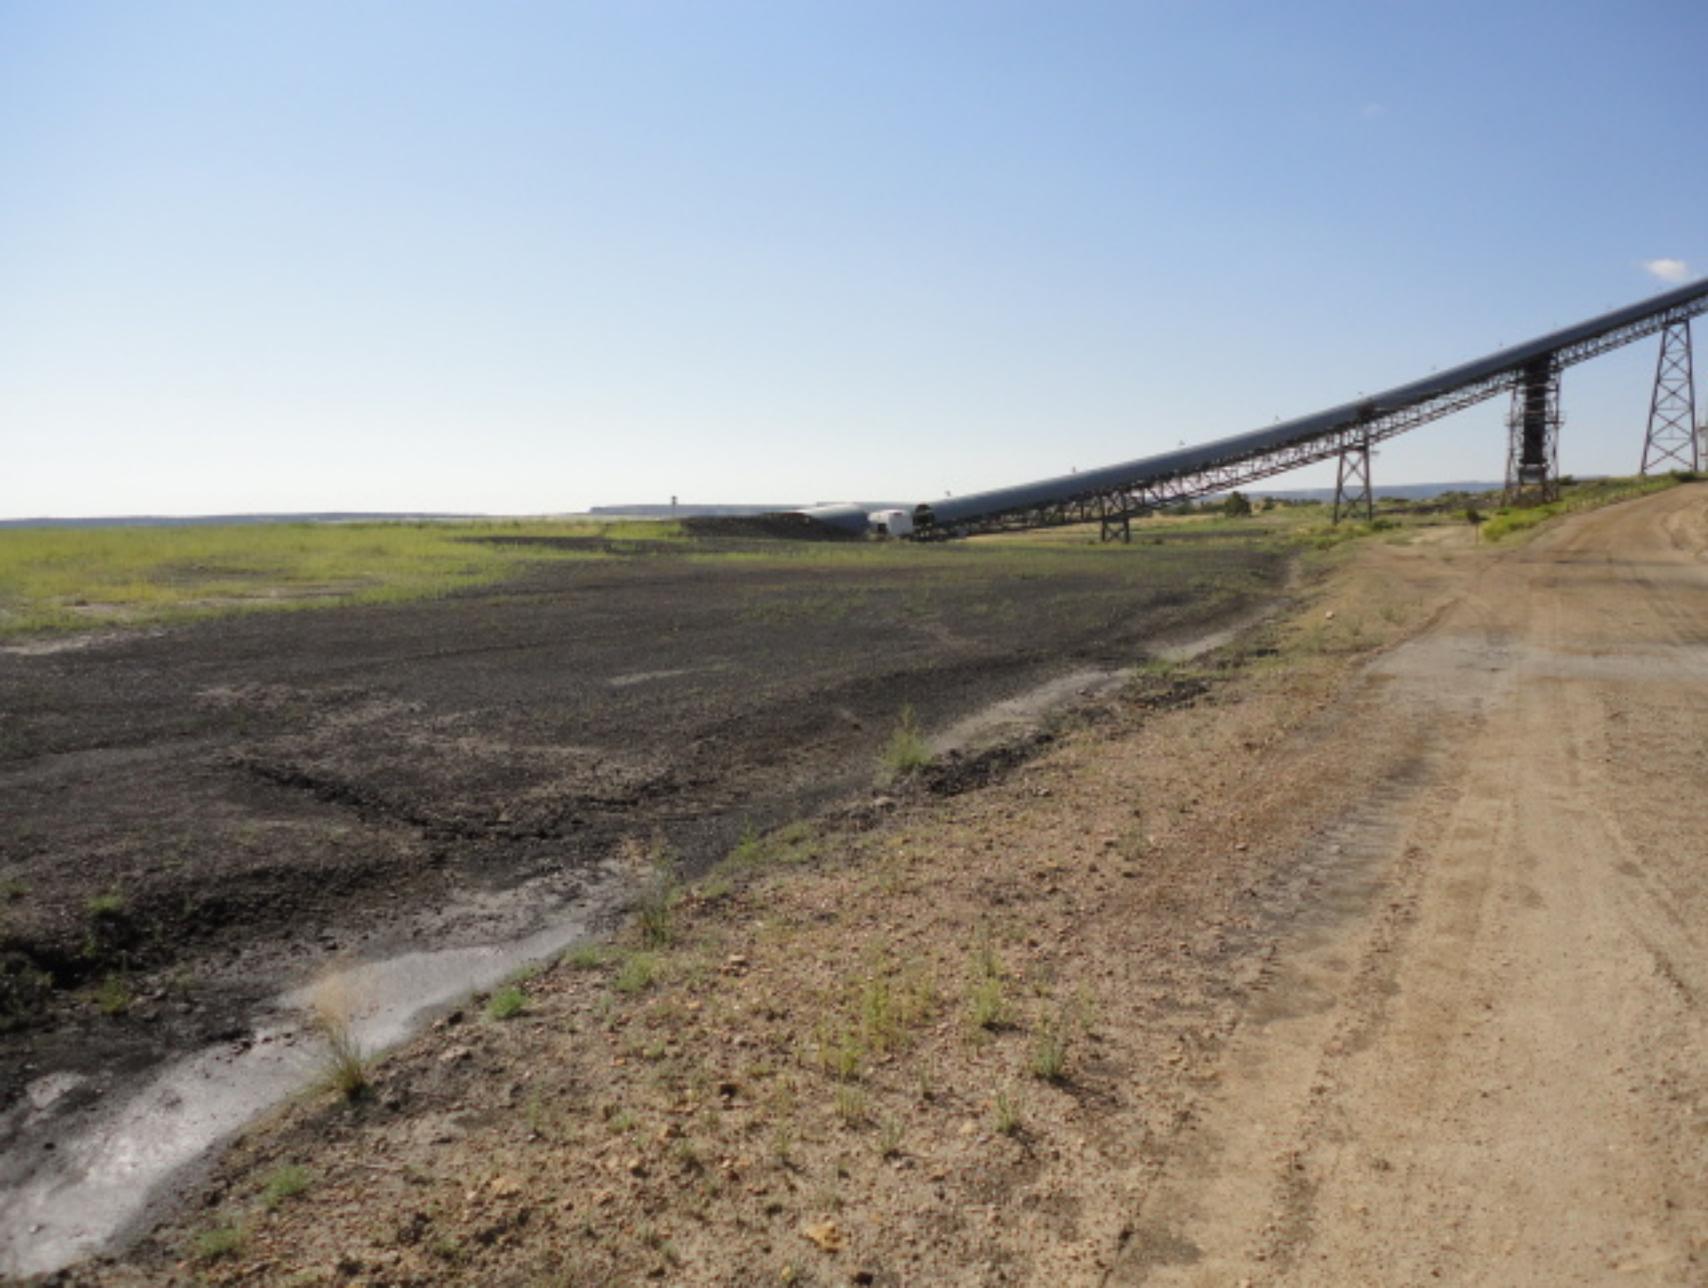
I inspected the topsoil piles and I did not see any signs of wind or water erosion. The topsoil piles appear to be stable and protected by a berm. Weeds are growing mostly on the pile. See Photo

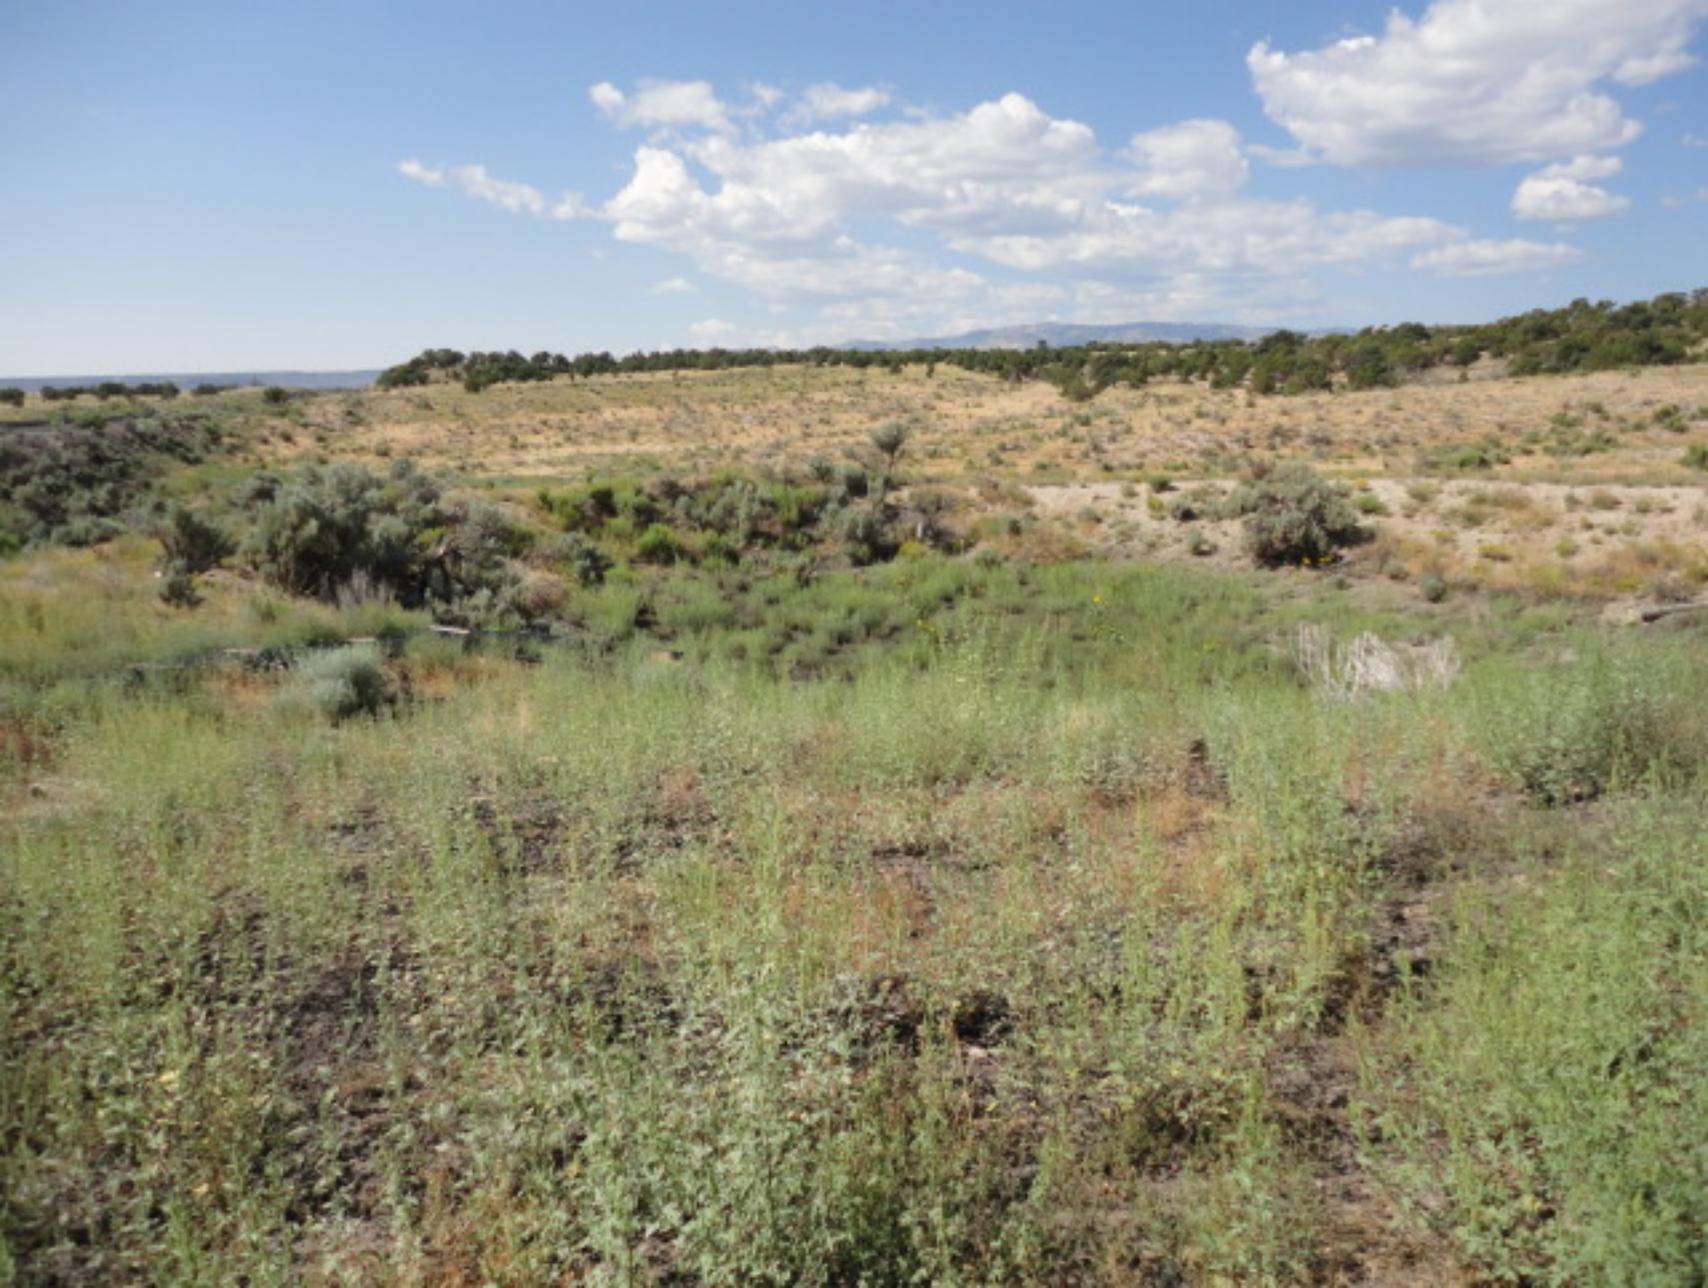
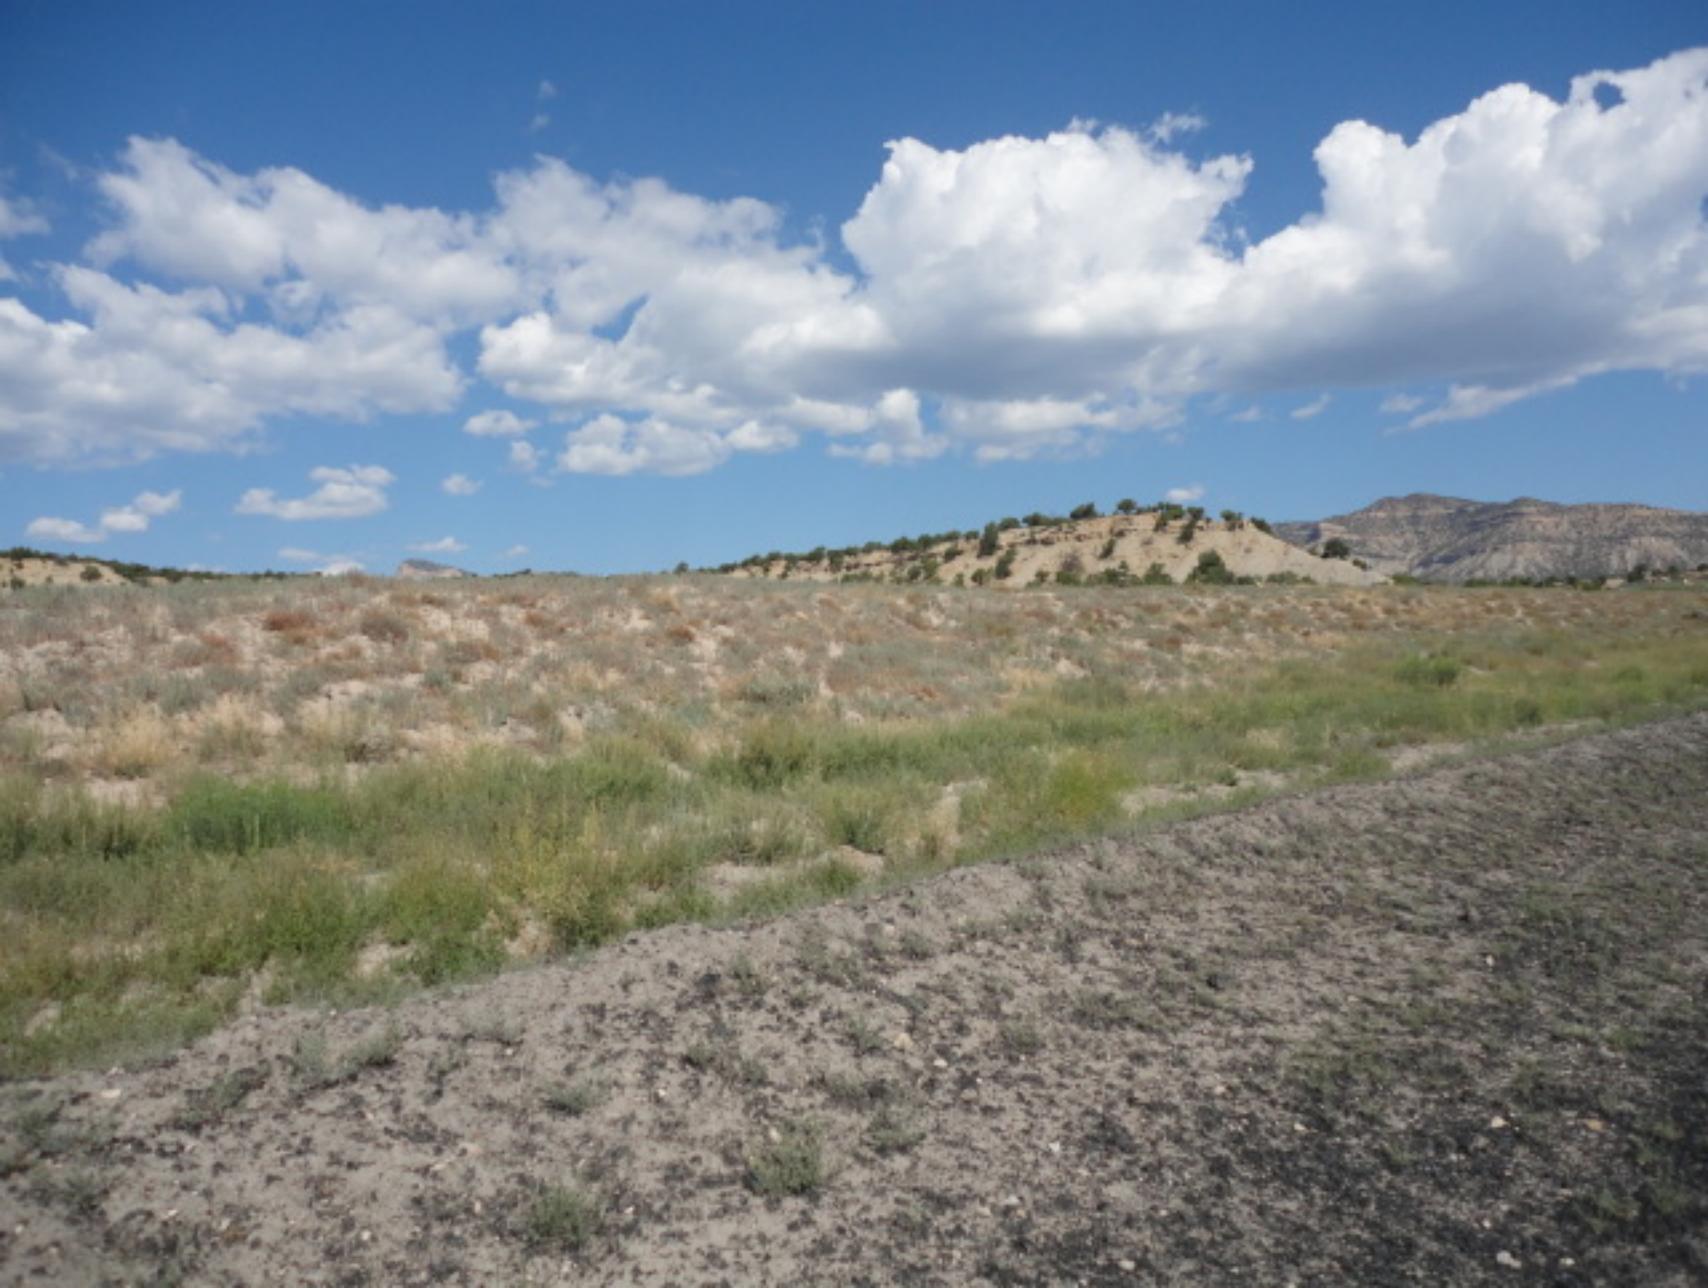
I inspected the refuse pile and it appears to be stable. I did not notice any hazardous conditions to the embankments. The refuse pile is inactive. The permittee conducted a second quarter refuse pile inspection on May 18, 2017. This document is P.E. certified. No hazardous conditions were reported. See Photos
