Inspection Report

Permit Number:	C0070033
Inspection Type:	COMPLETE
Inspection Date:	Thursday, July 19, 2018
Start Date/Time:	7/19/2018 11:00:00 AM
End Date/Time:	7/19/2018 2:00:00 PM
Last Inspection:	Thursday, June 28, 2018

Permitee: **INTERMOUNTAIN POWER AGENCY**
 Operator: **WILD WEST EQUIPMENT & HAULING, LLC**
 Site: **WILDCAT LOADOUT**
 Address: **PO BOX 1, PRICE UT 84501**
 County: **CARBON**
 Permit Type: **PERMANENT COAL PROGRAM**
 Permit Status: **INACTIVE**

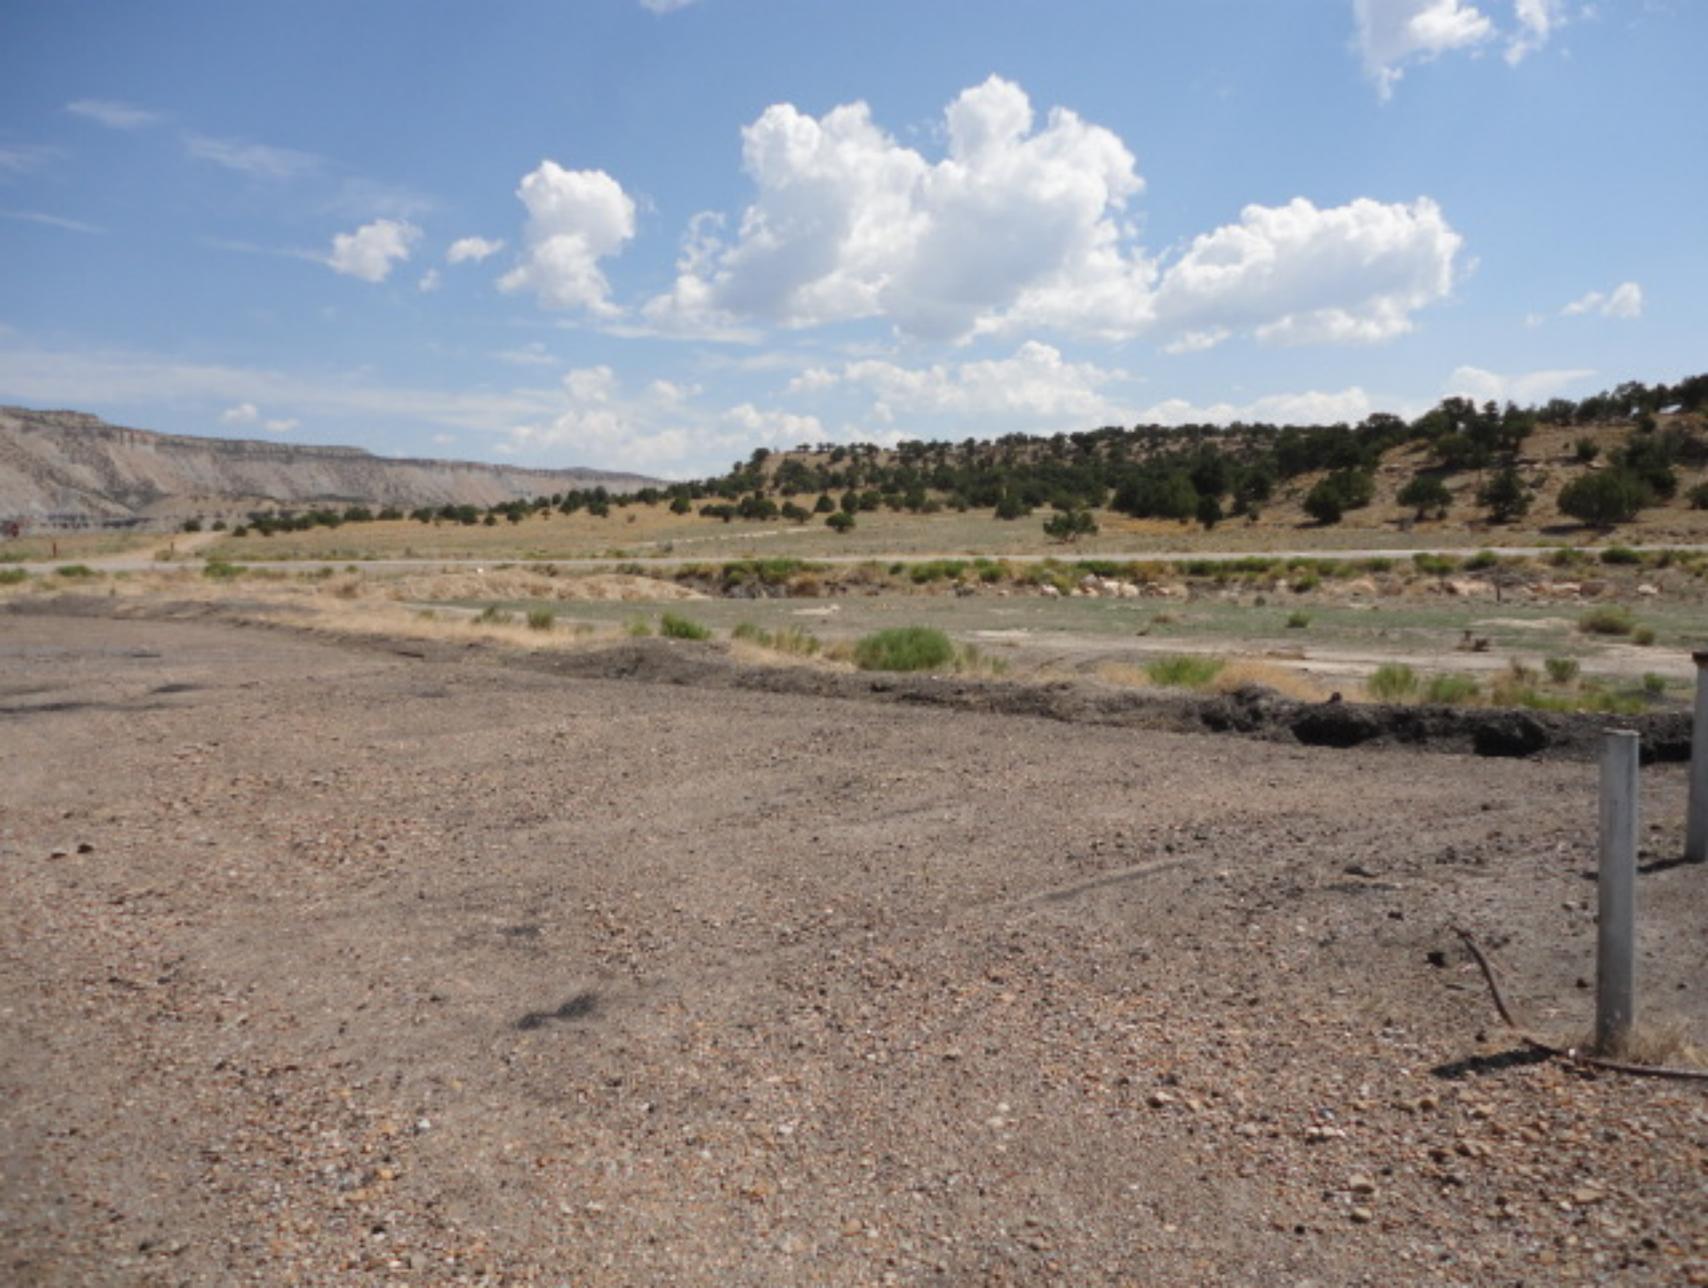
The identification sign was inspected and it meets the requirements of the R645 Coal Rules. See Photo

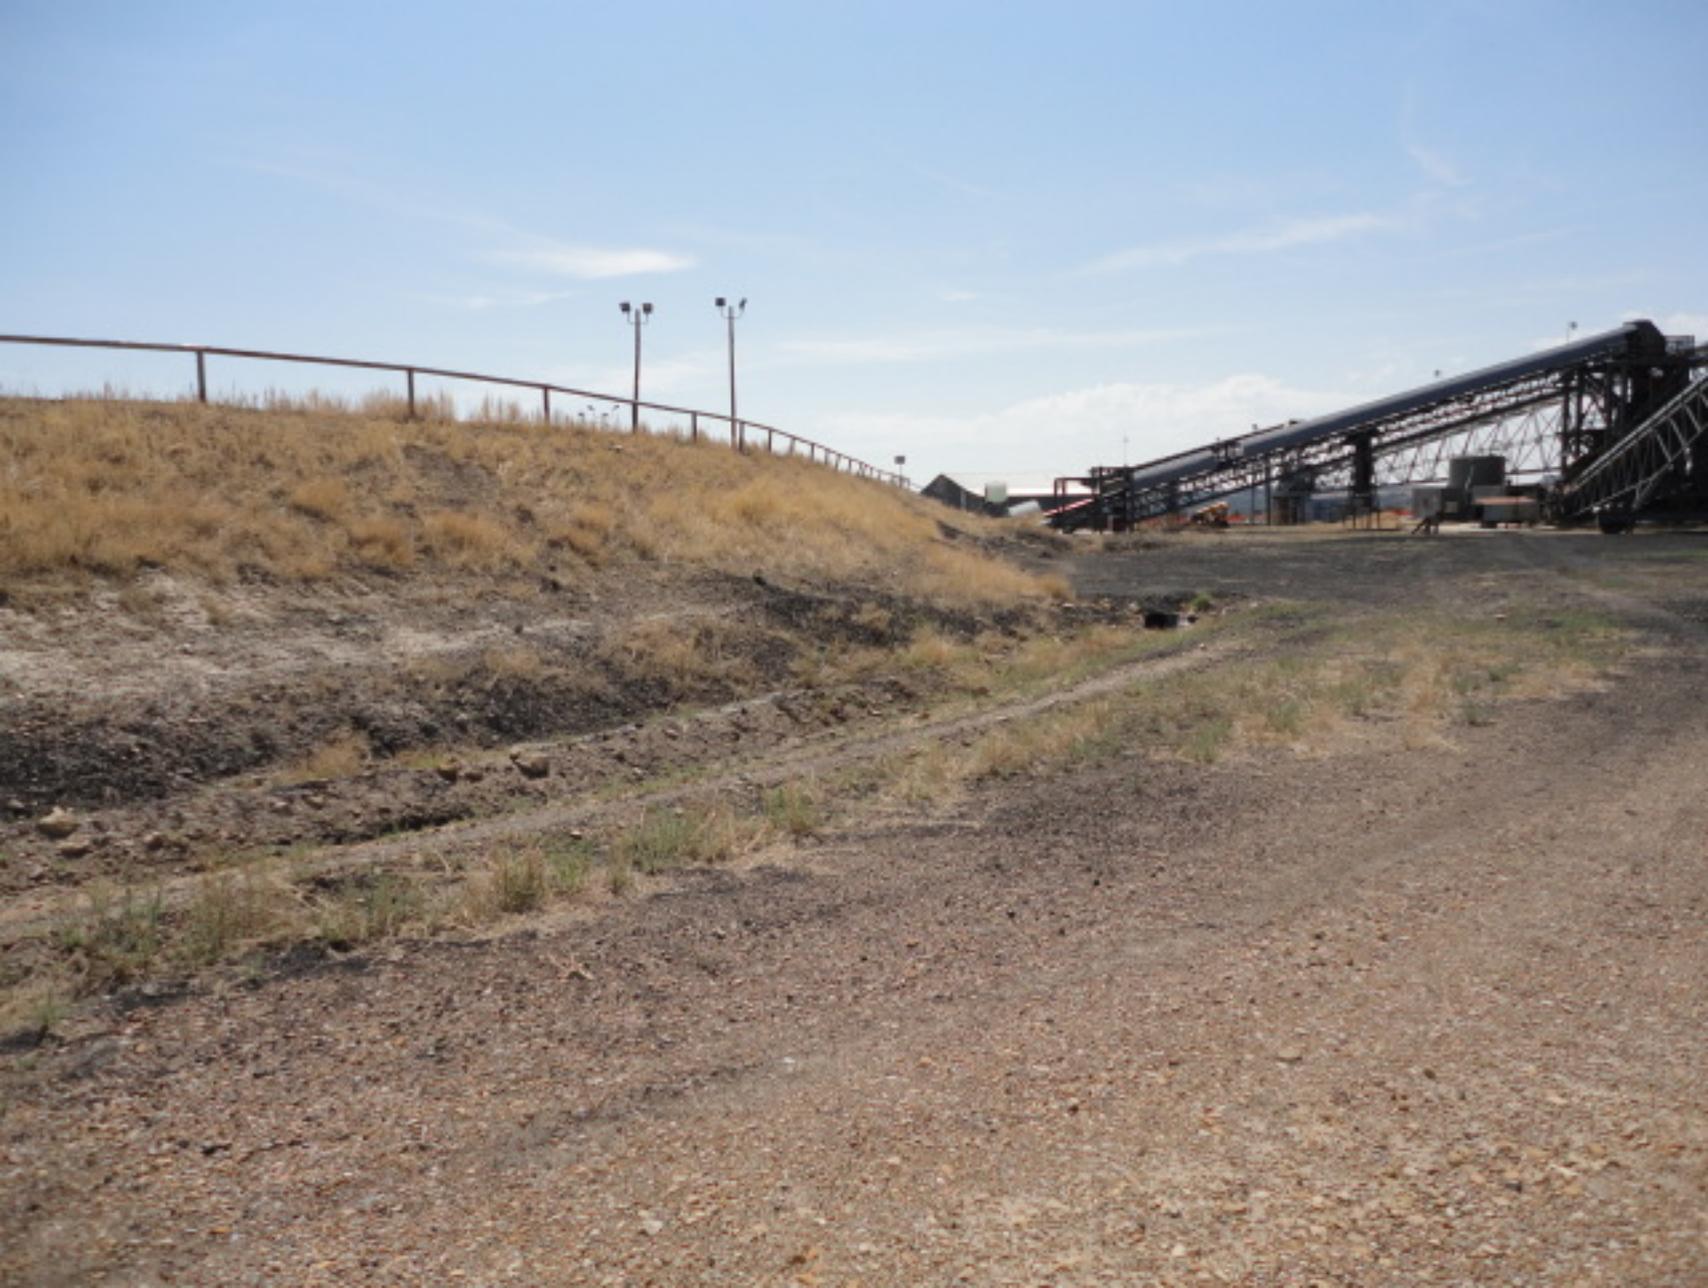
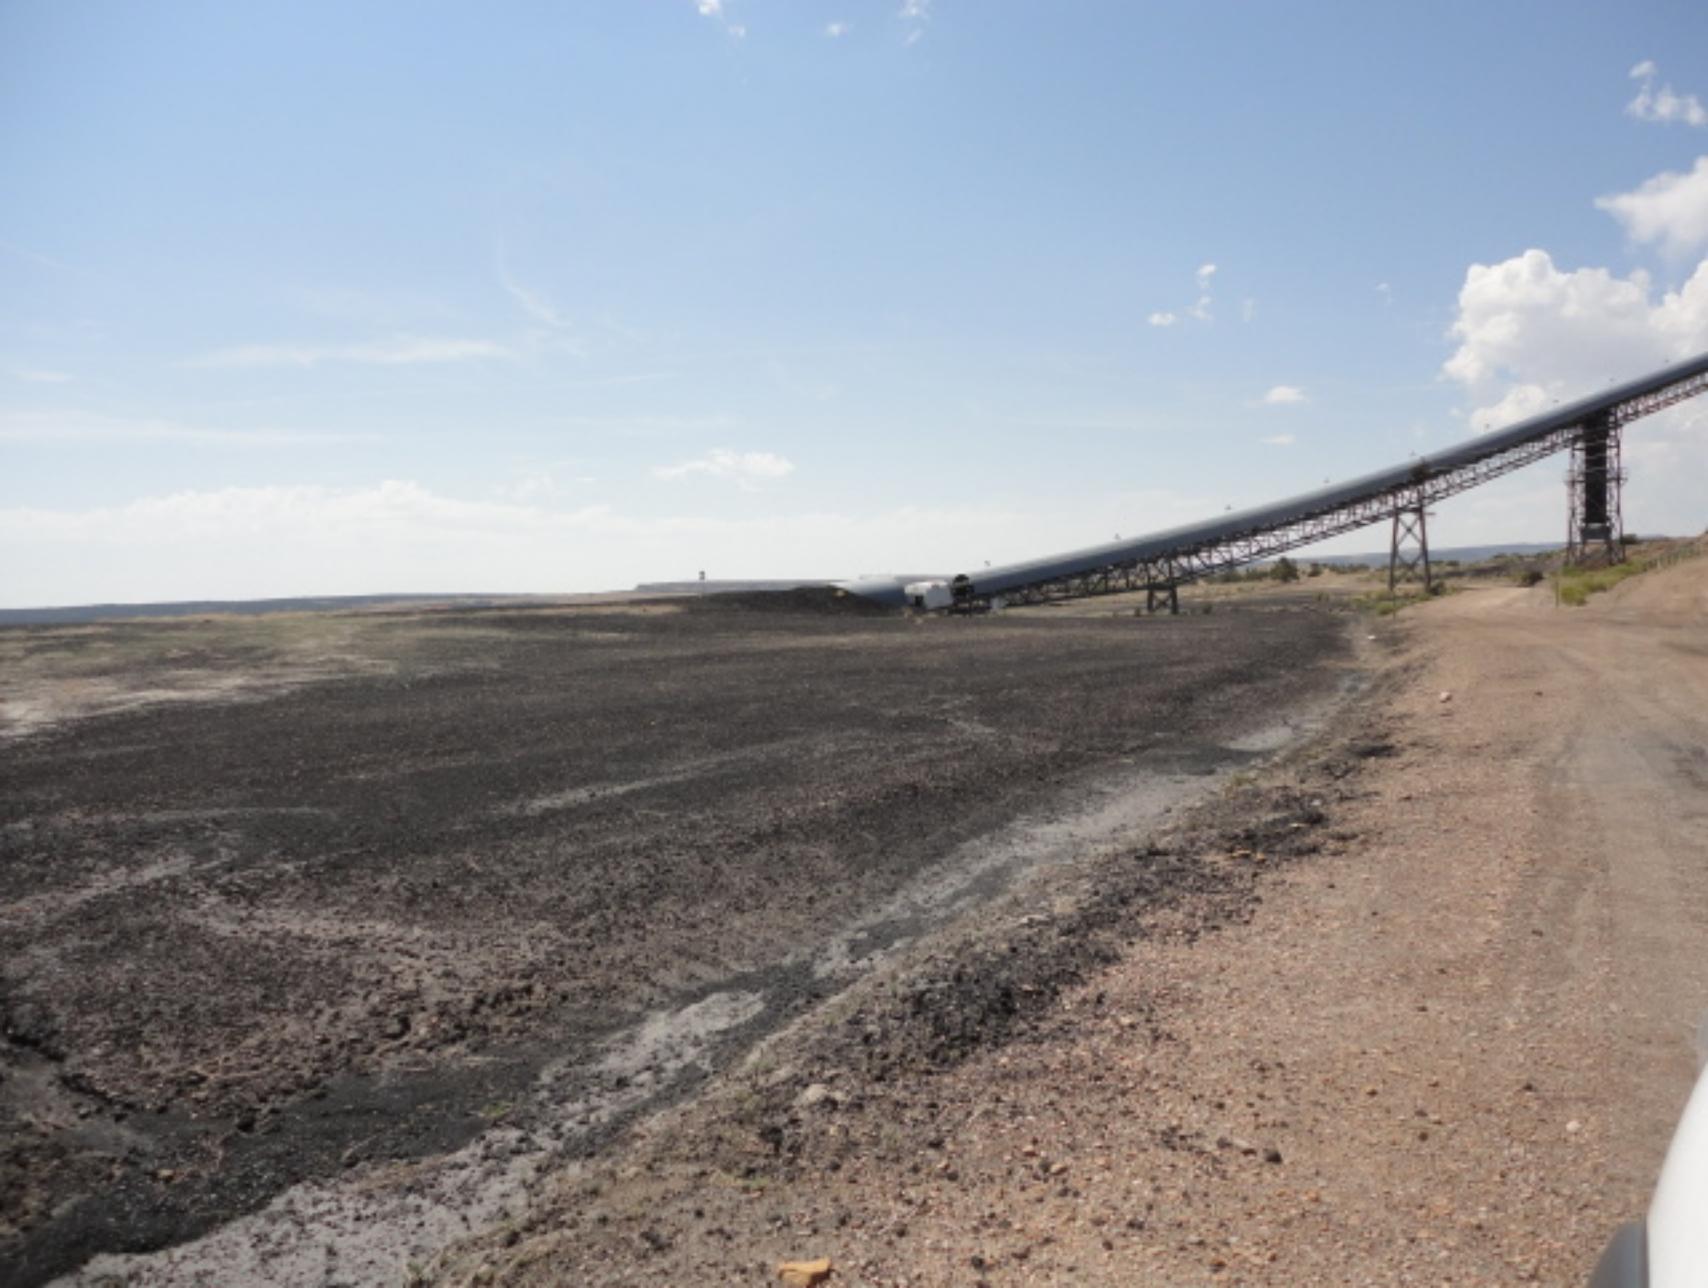
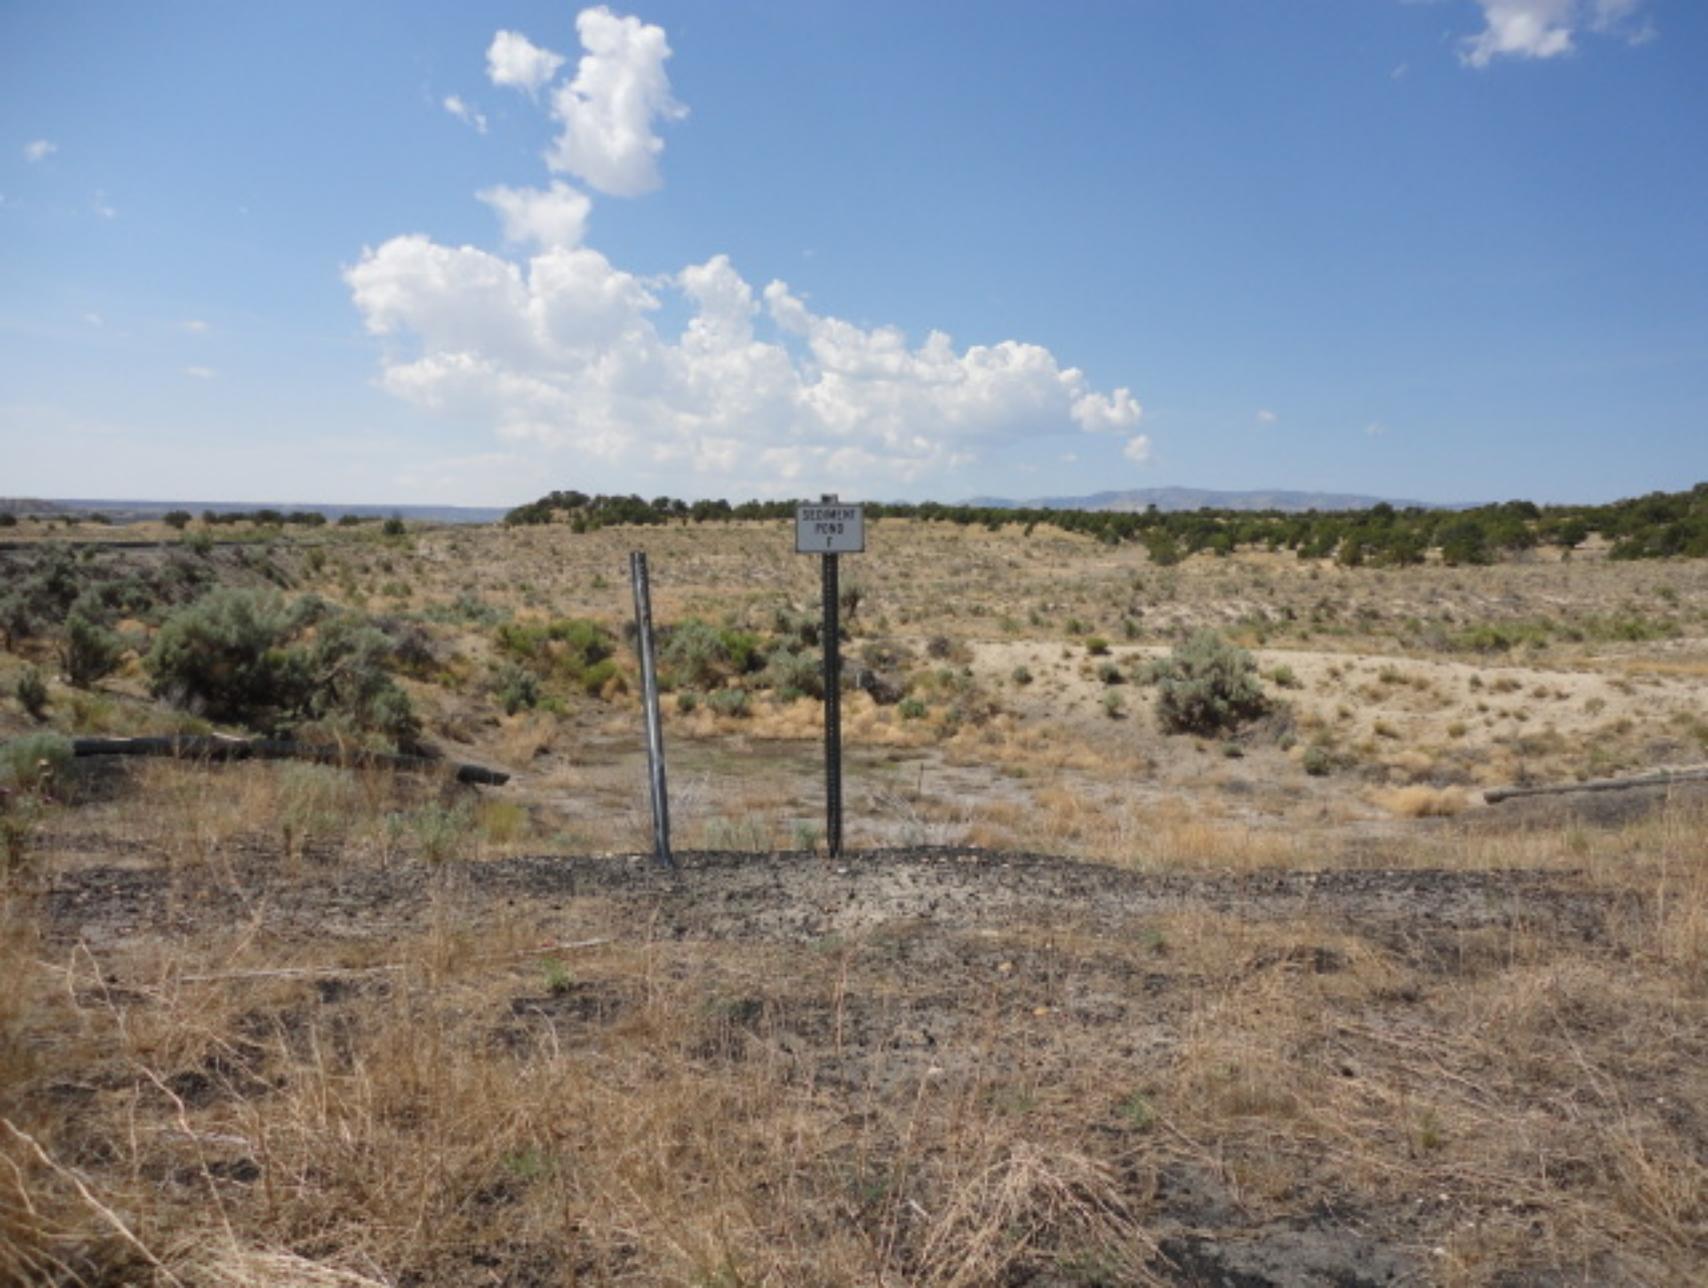
I inspected diversions and culverts throughout the property. They were open and would function as designed in a storm event. See Photos.

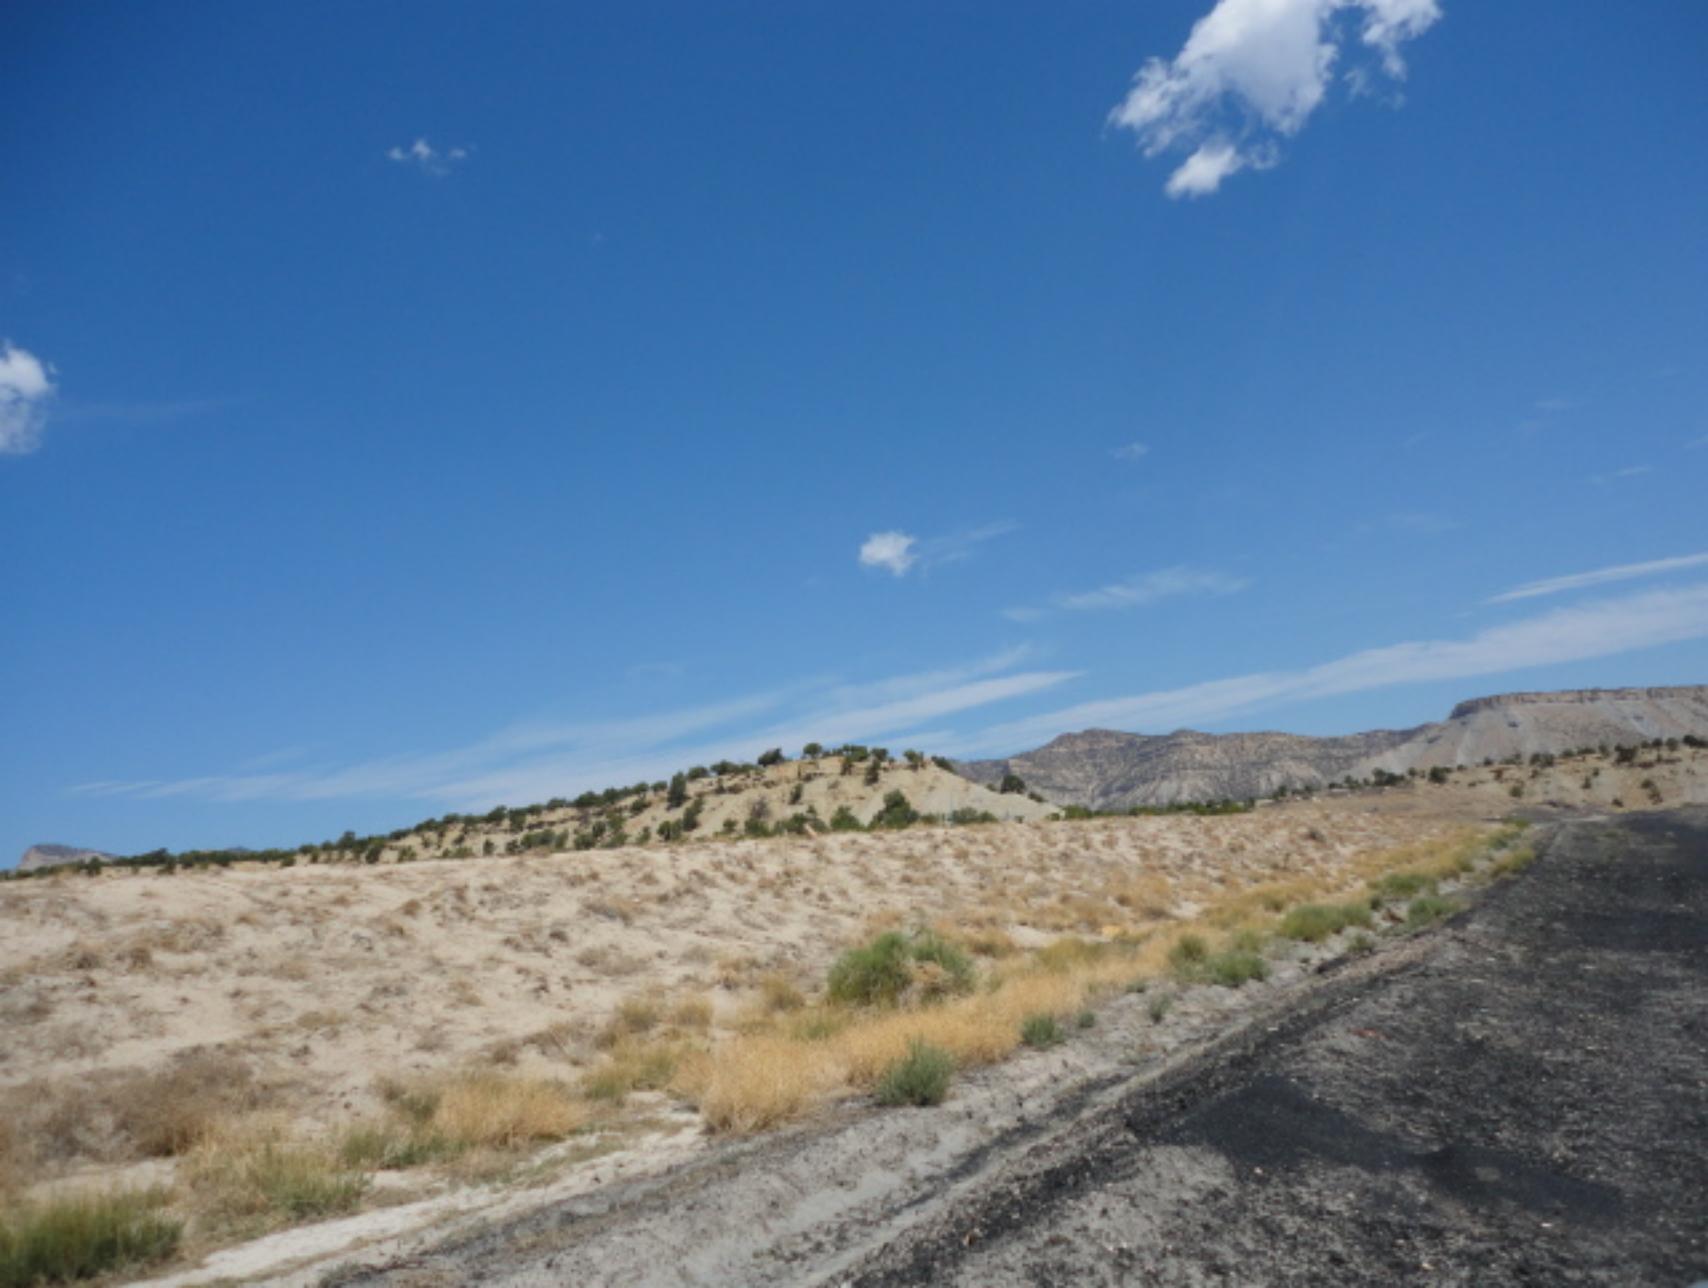
SEDIMENT
POND
F

I inspected the sediment ponds throughout the property. They contained some water but were not discharging. It is unlikely these structures will discharge in the near future. The embankments appear to be stable. Inlets and outlets would function as designed. I did not see any hazardous conditions to these structures. However, some erosion has taken place to the inlet of sediment pond near topsoil pile. This was due to the recent rainstorm. Maintenance most likely will be needed when another rainstorm hits the property. The soil is sandy and it is very easy for erosion to occur. A second quarter sediment pond inspection was conducted on April 20, 2018.
