Inspection Report

Permit Number:	C0070033
Inspection Type:	COMPLETE
Inspection Date:	Thursday, October 25, 2018
Start Date/Time:	10/25/2018 11:00:00 AM
End Date/Time:	10/25/2018 2:30:00 PM
Last Inspection:	Thursday, September 20, 2018

Permittee: **INTERMOUNTAIN POWER AGENCY**
 Operator: **WILD WEST EQUIPMENT & HAULING, LLC**
 Site: **WILDCAT LOADOUT**
 Address: **PO BOX 1, PRICE UT 84501**
 County: **CARBON**
 Permit Type: **PERMANENT COAL PROGRAM**
 Permit Status: **INACTIVE**

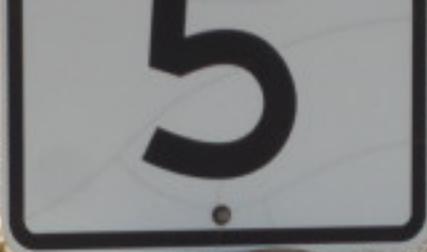
The identification sign was inspected and it meets the requirements of the R645 Coal Rules. See Photo New identification signs will be needed once the permit transfer is approved.

WILDCAT LOAD OUT

OWNER: INTERMOUNTAIN POWER AGENCY
P.O. BOX 51111 - ROOM 1263
LOS ANGELES, CALIFORNIA 90051
PHONE: 213-367-0289
UDOGM PERMIT NO. C/007/033

OPERATOR:
WILD WEST EQUIPMENT & HAULING, LLC
P.O. BOX 1
PRICE, UTAH 84501
PHONE: 435-472-3988
MSHA ID NO. 42-01864
