**U.S. DEPT. OF THE INTERIOR  
OFFICE OF SURFACE MINING  
Mine Site Evaluation  
State Program**

**Denver Field Branch  
Mine Site Evaluation Narrative**

Permittee: Coal Energy Group 2, LLC  
Operator: Coal Energy Group 2, LLC  
Site: Wildcat Loadout  
Permit No: C/007/0033  
Date of Inspection: October 30, 2019  
Inspection Type: Oversight comprehensive  
Weather: Cold and sunny with dry ground conditions  
Operator Representative(s): Larry Johnson and Lee Tweddell  
State Official(s): Steve Demczak, Division of Oil, Gas and Mining  
OSMRE Official(s): Tom Medlin #562

This was an oversight comprehensive inspection at the Wildcat Loadout in Carbon County, Utah. The permit area is 111.62 acres. The Wildcat Loadout is currently in Temporary Cessation status. The operator representative indicated plans are in place to resuscitate the loadout and begin coal handling in the near future.

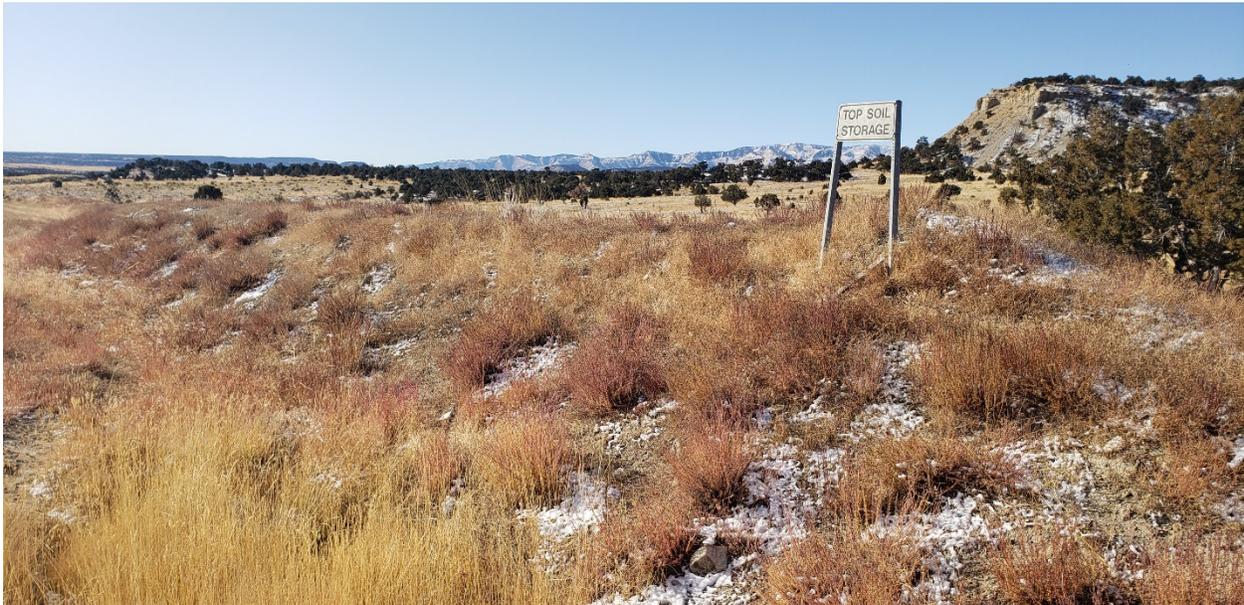
Topsoil stockpiles E, B, and F were inspected for protection against resource loss. The stockpiles were stable, well-vegetated, and bermed. No issues were noted. See Figure 1.

All topsoil stockpiles were marked as required. See Figure 1.

Figure 1. Topsoil stockpile E.

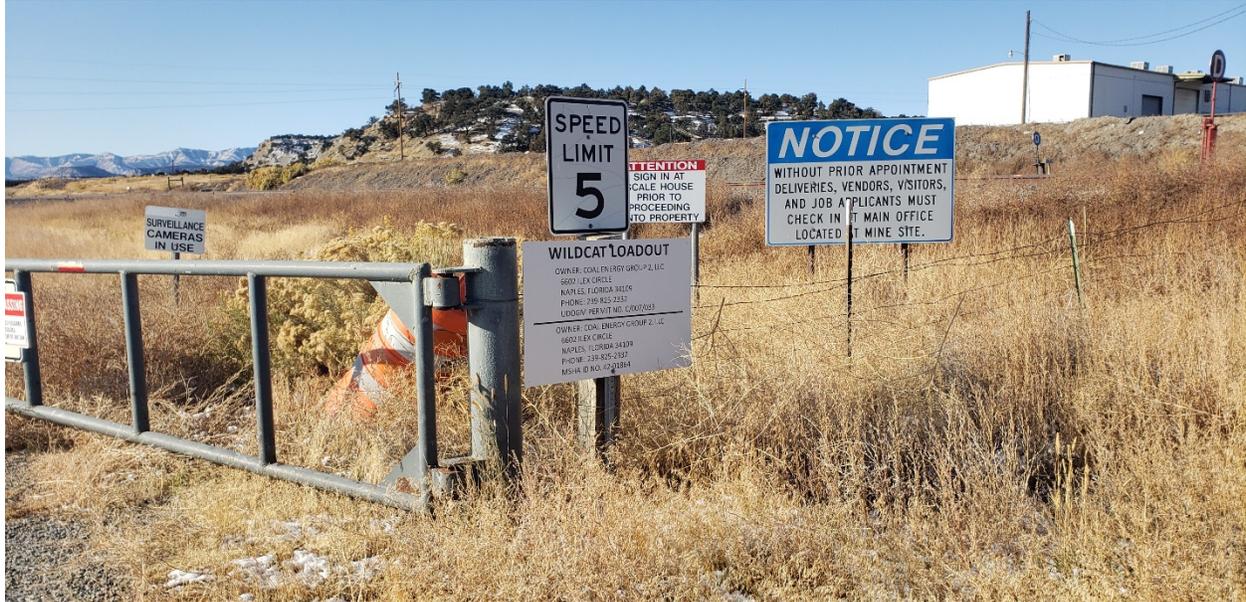
A mine and permit identification sign containing the required information was stationed at the loadout entrance on Trestle Road. No issues were noted. See Figure 2.

Figure 2. Mine and permit identification sign.

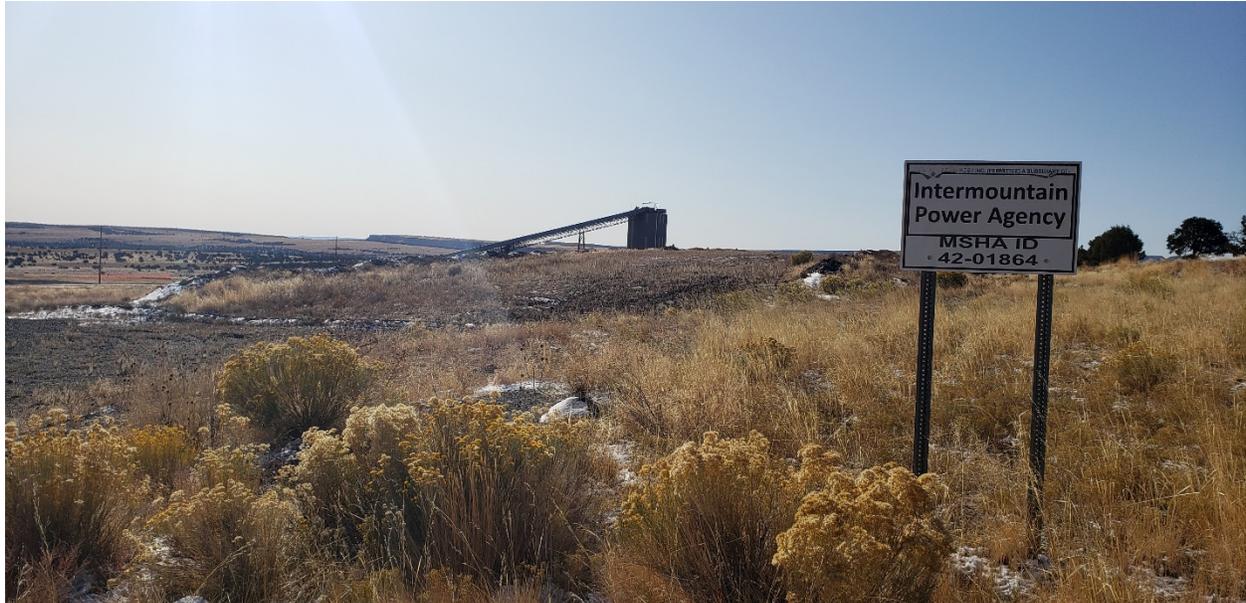
The Refuse Disposal Area was inspected for signs of instability; none were observed. The pile was well vegetated as it had not received any new material in some time. The operator representative indicated the outdated MSHA identification sign will be replaced. See Figure 3.

Figure 3. Refuse Disposal Area.

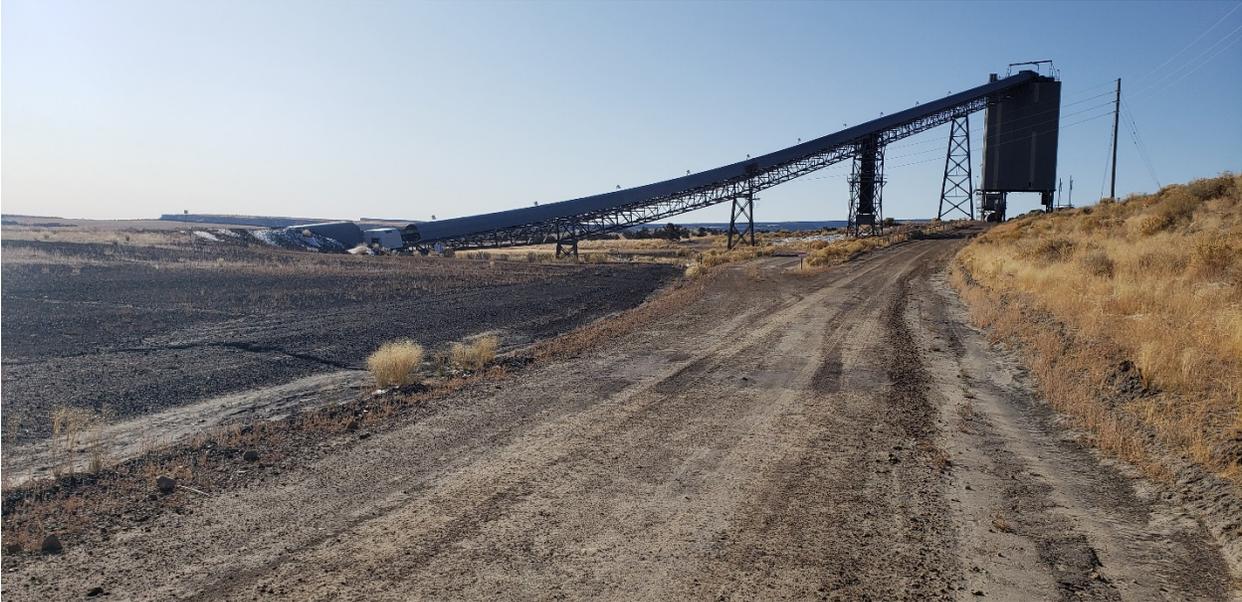
The mine site was tidy and free of uncontrolled noncoal mine waste. This site is prone to windblown tumbleweeds. Mr. Tweddell clears accumulated tumbleweeds regularly to maintain site accessibility and the functionality of surface hydrologic controls. See Figure 4.

The haul road and access roads throughout the site were compacted, stable, and graded. No

issues were noted. See Figure 4.

Figure 4. Site overview and access road.

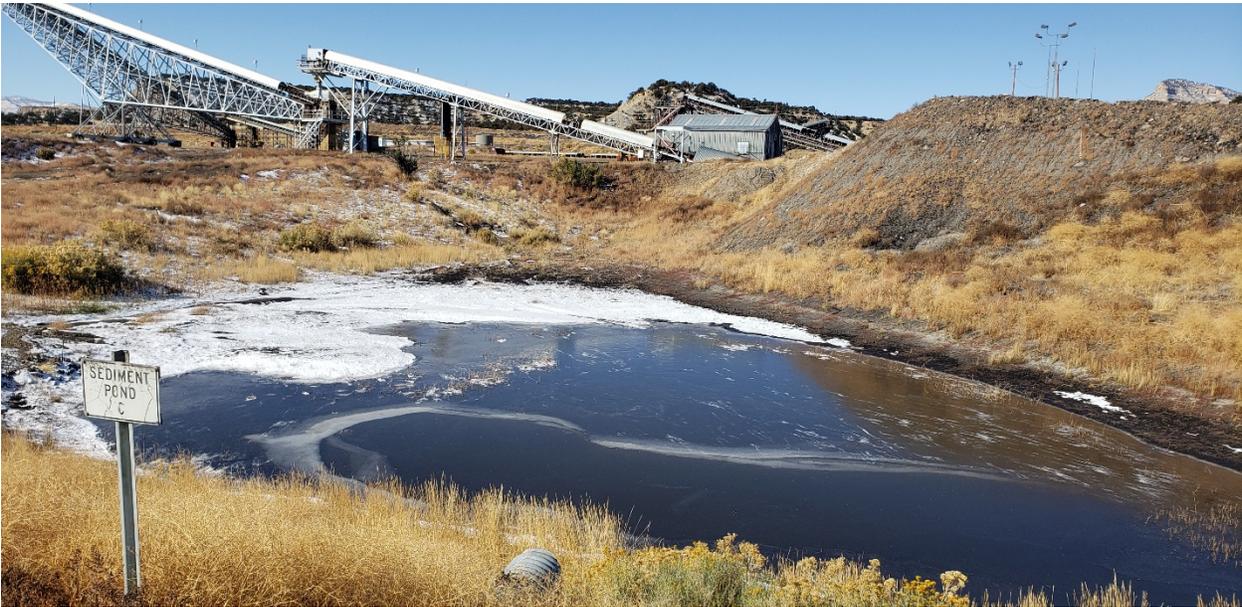
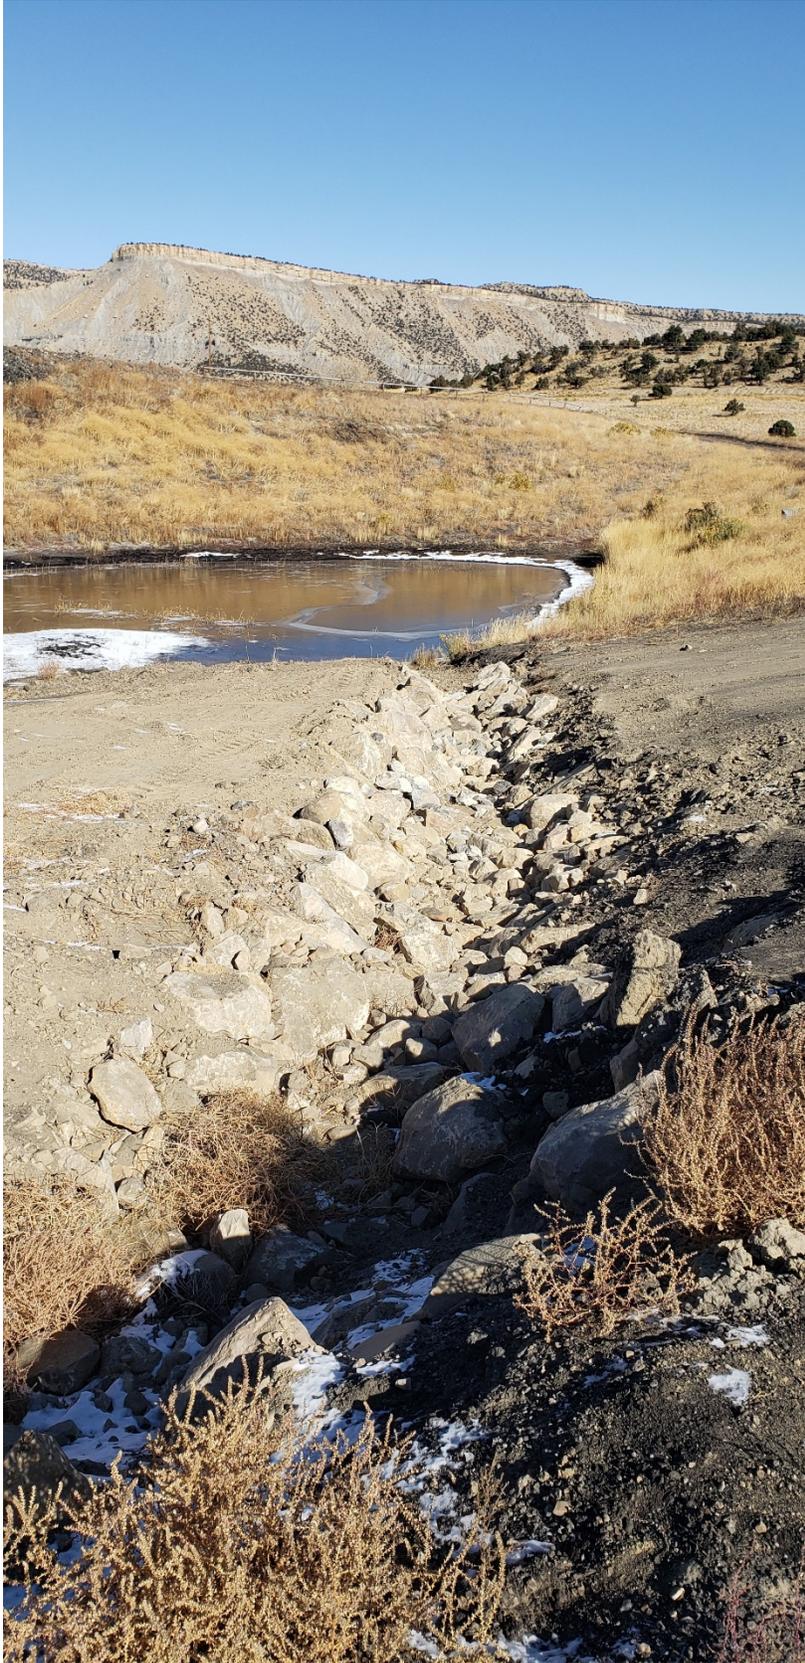
Pond C: retaining a moderate amount of water. The inlet was recently modified from a half-culvert to rip-rap channel design to reduce undercutting. A permit revision incorporating this change has been filed with the Division. The operator representative agreed to seed the small area surrounding the inlet which was disturbed by heavy equipment during rip-rapping. See Figures 5 and 6.

Figure 5. Pond C.

Figure 6. Recently reconstructed inlet at Pond C.

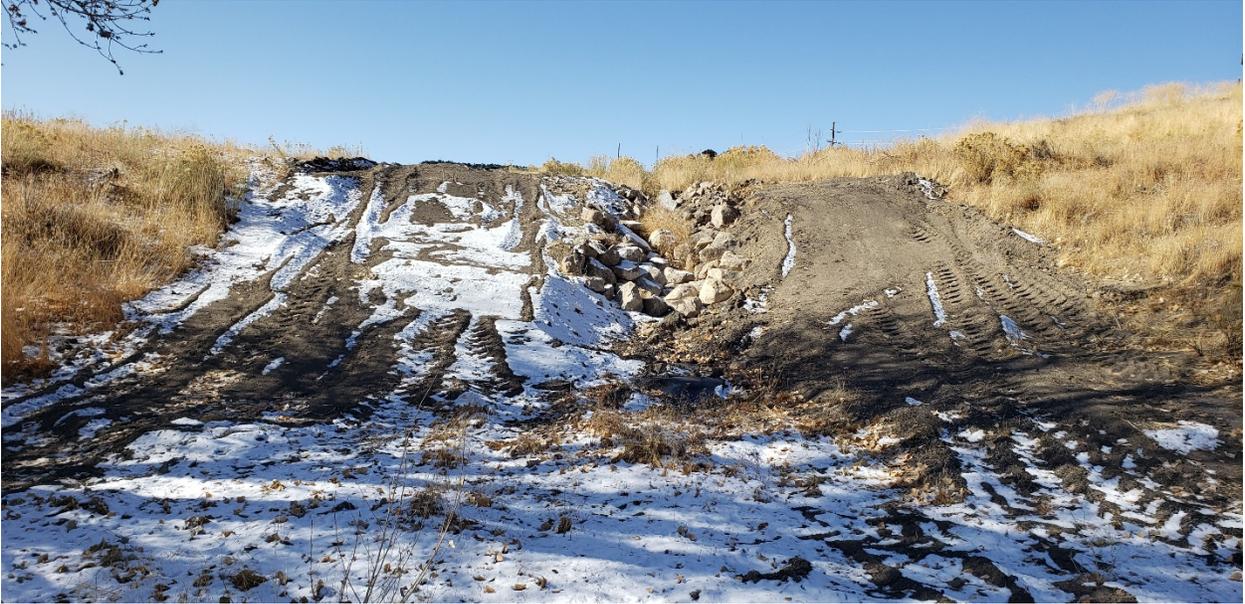
Pond E: dry. Inlet was recently modified from a half-culvert to rip-rap channel design. The operator will submit a permit revision to reflect on-the-ground conditions and seed the inlet area, as with Pond C. See Figure 7.

Figure 7. Recently reconstructed inlet at Pond E. Operator will seed this disturbed area, as well as at Pond C.

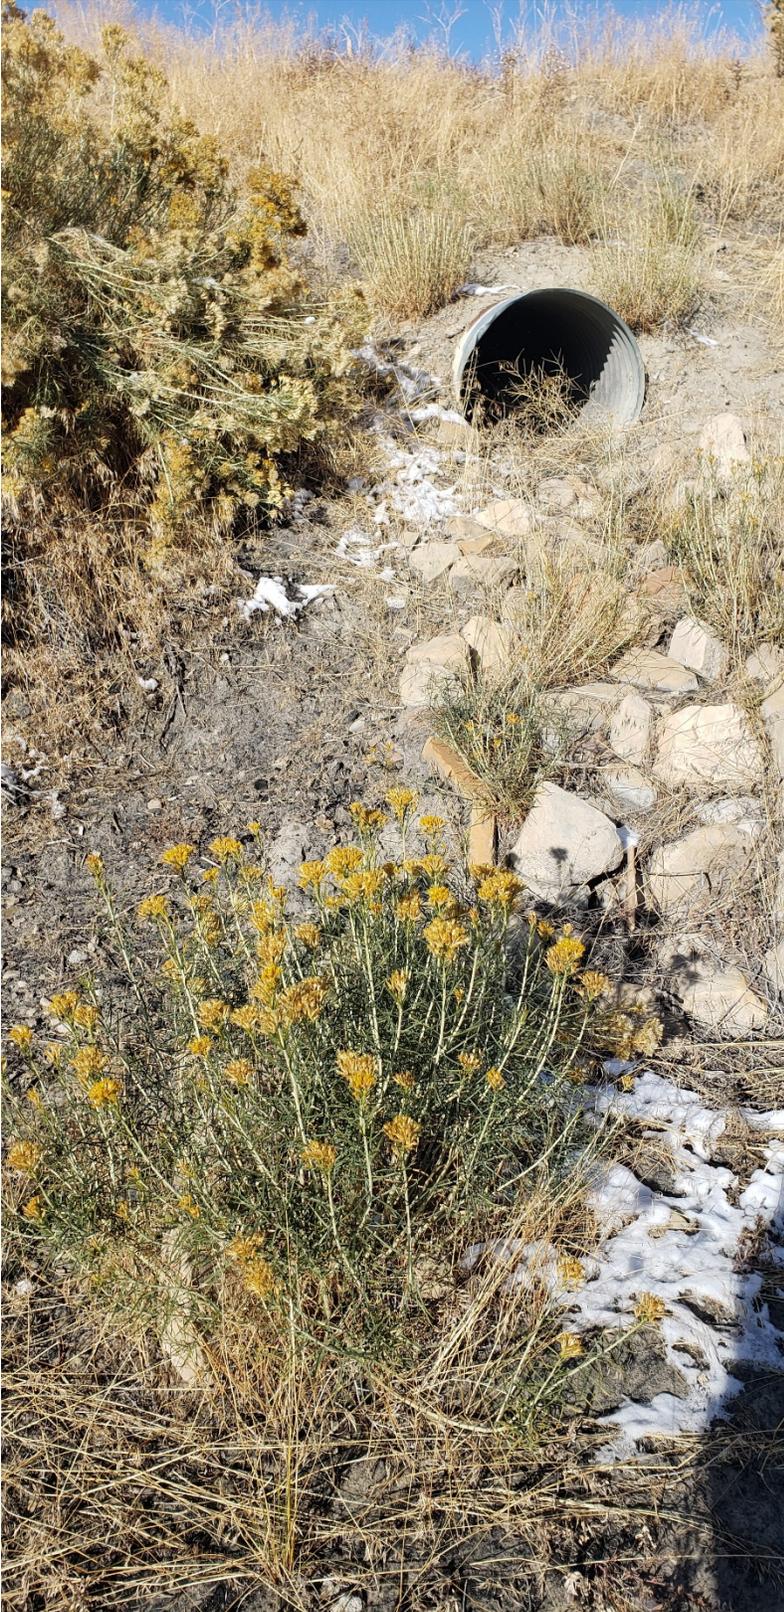
Disturbed area drainage ditches and culverts throughout the property were inspected for any maintenance or design issues which would impact their functionality during precipitation events. No issues were noted. See Figure 8.

Figure 8. Typical unobstructed drainage culvert along western access road.
