Inspection Report

Permit Number:	C0070033
Inspection Type:	COMPLETE OVERSITE
Inspection Date:	Wednesday, October 30, 2019
Start Date/Time:	10/30/2019 9:00:00 AM
End Date/Time:	10/30/2019 4:00:00 PM
Last Inspection:	Thursday, October 3, 2019

Permittee: **COAL ENERGY GROUP 2, LLC**
 Operator: **COAL ENERGY GROUP 2, LLC**
 Site: **WILDCAT LOADOUT**
 Address: **6602 ILEX CIRCLE, NAPLES FL 34109**
 County: **CARBON**
 Permit Type: **PERMANENT COAL PROGRAM**
 Permit Status: **INACTIVE**

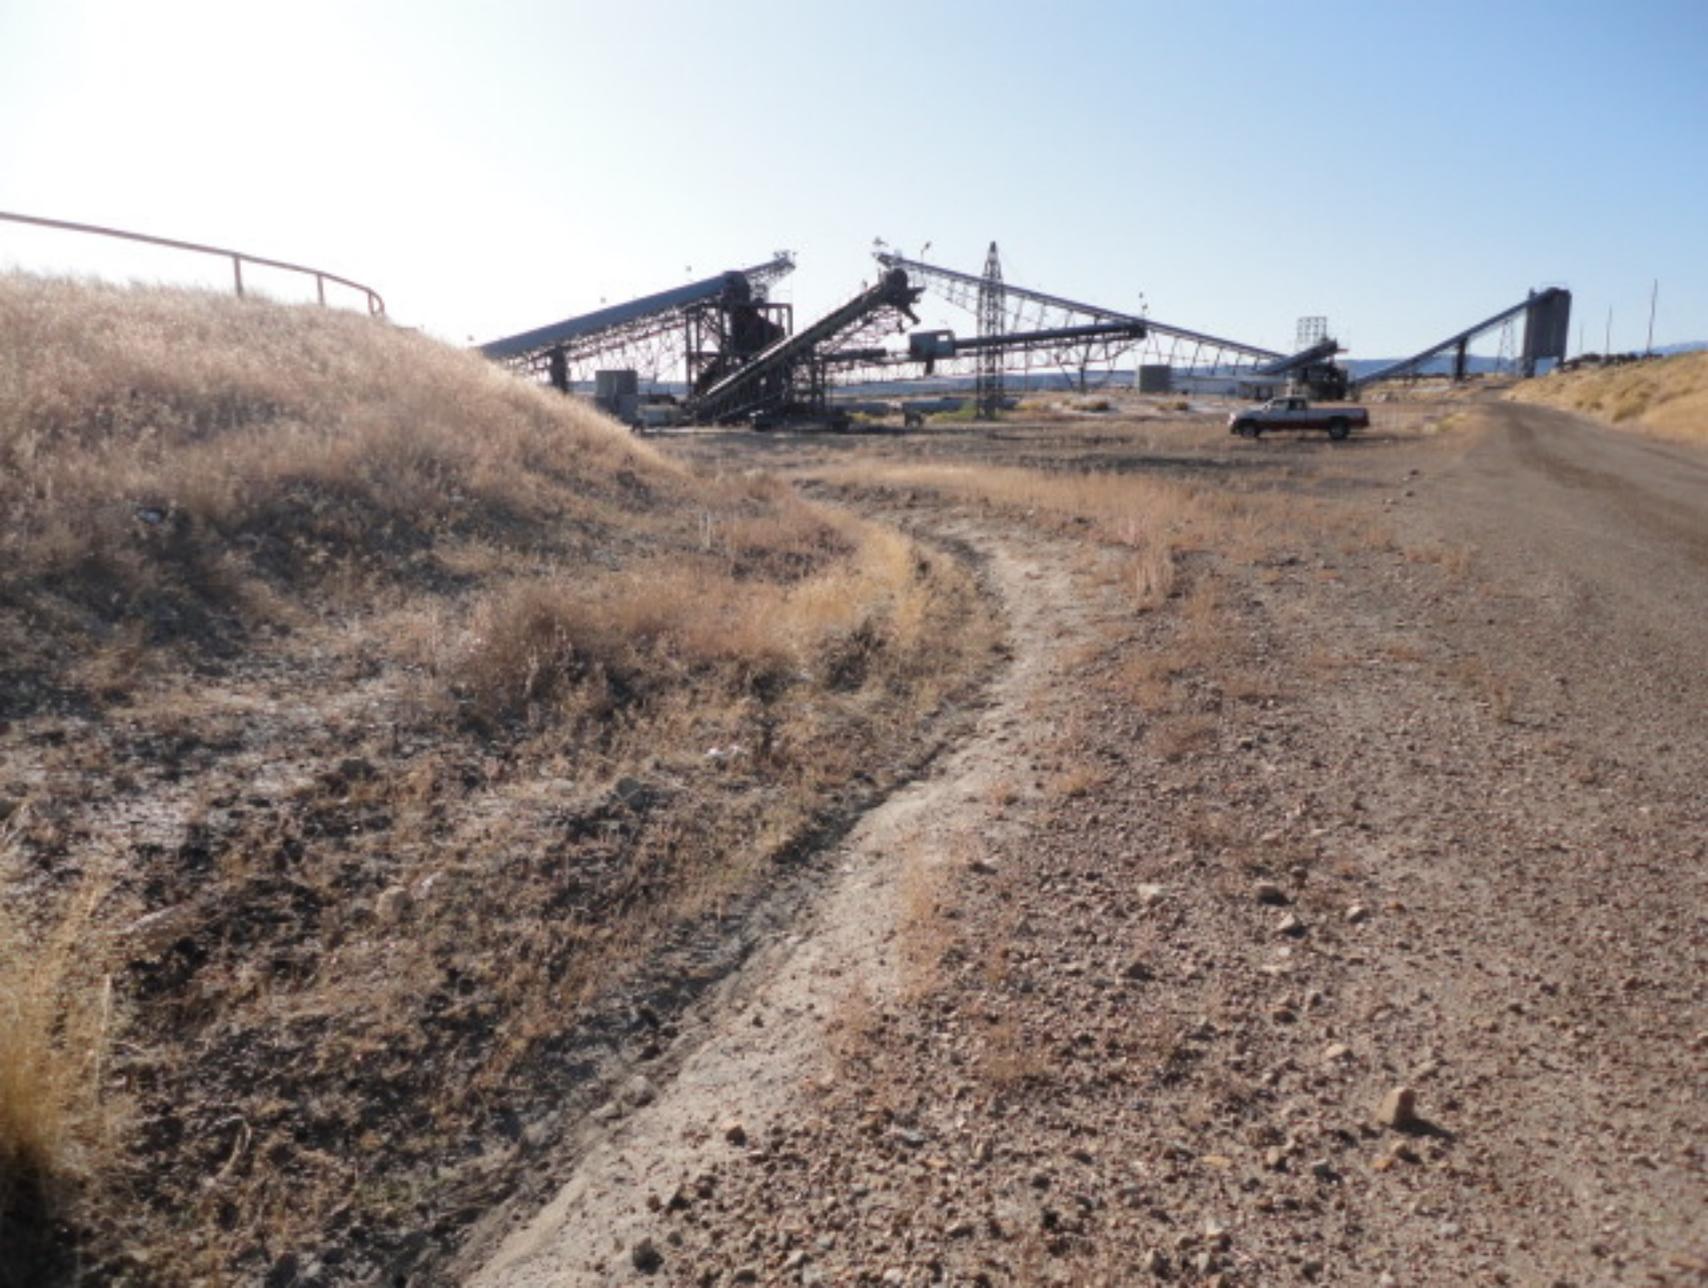
WILDCAT LOADOUT
OWNER: COAL ENERGY GROUP S.L.C.
800 S EX 0900
TAPPAH, KANECA, AZ85
PHONE: 208-625-2302
REGISTRATION NO: C207033
OWNER: COAL ENERGY GROUP S.L.C.
800 S EX 0900
TAPPAH, KANECA, AZ85
PHONE: 208-625-2302
REGISTRATION NO: C207033

NOTICE
WITHOUT PRIOR APPOINTMENT
DELIVERIES, VENDORS, VISITORS,
AND JOB APPLICANTS MUST
CHECK IN AT MAIN OFFICE
LOCATED AT MINE SITE.

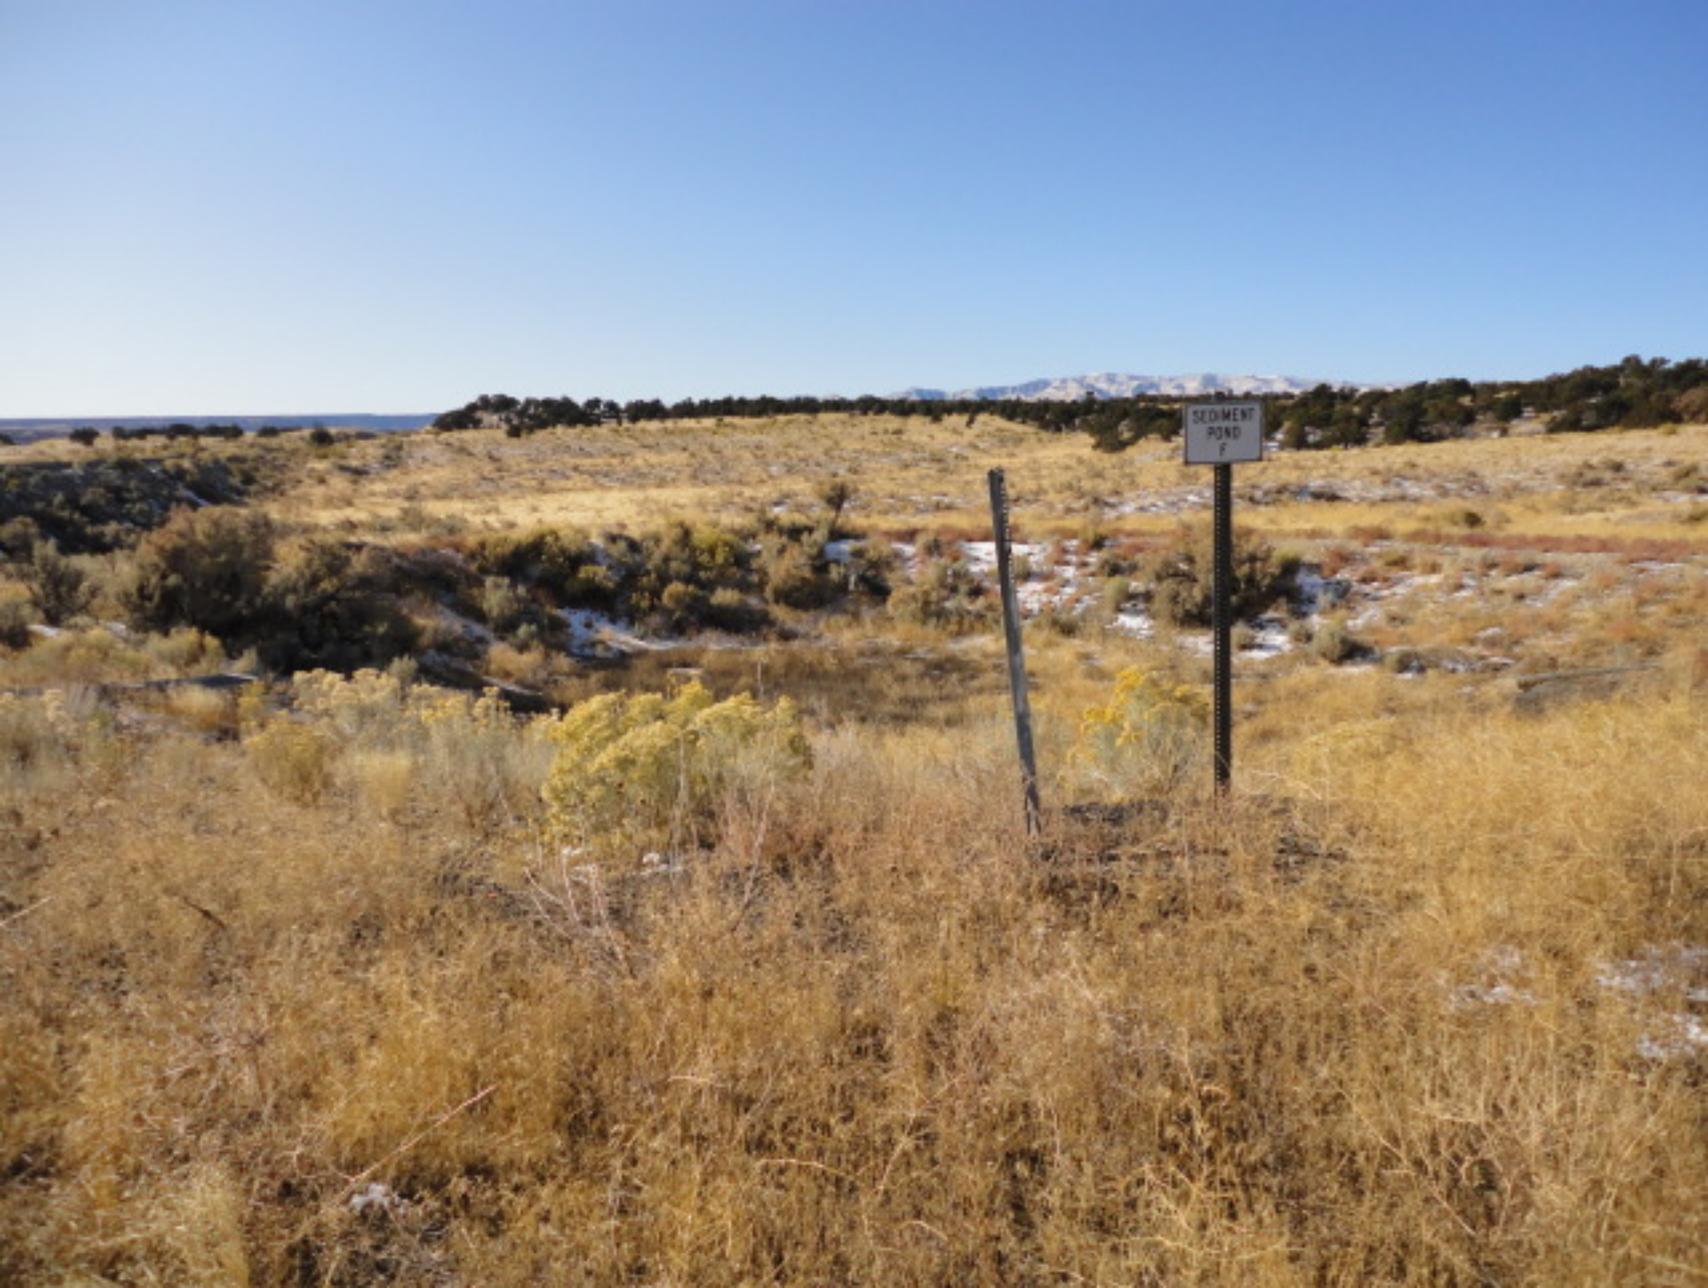
SEDIMENT
POND
F

I inspected the sediment ponds throughout the property. They contained some water but were not discharging. It is unlikely these structures will discharge in the near future. The embankments appear to be stable. Inlets and outlets would function as design. I did not see any hazardous conditions to these structures. The permittee conducted a third quarter sediment pond inspections on September 23, 2019. No hazardous conditions were reported.

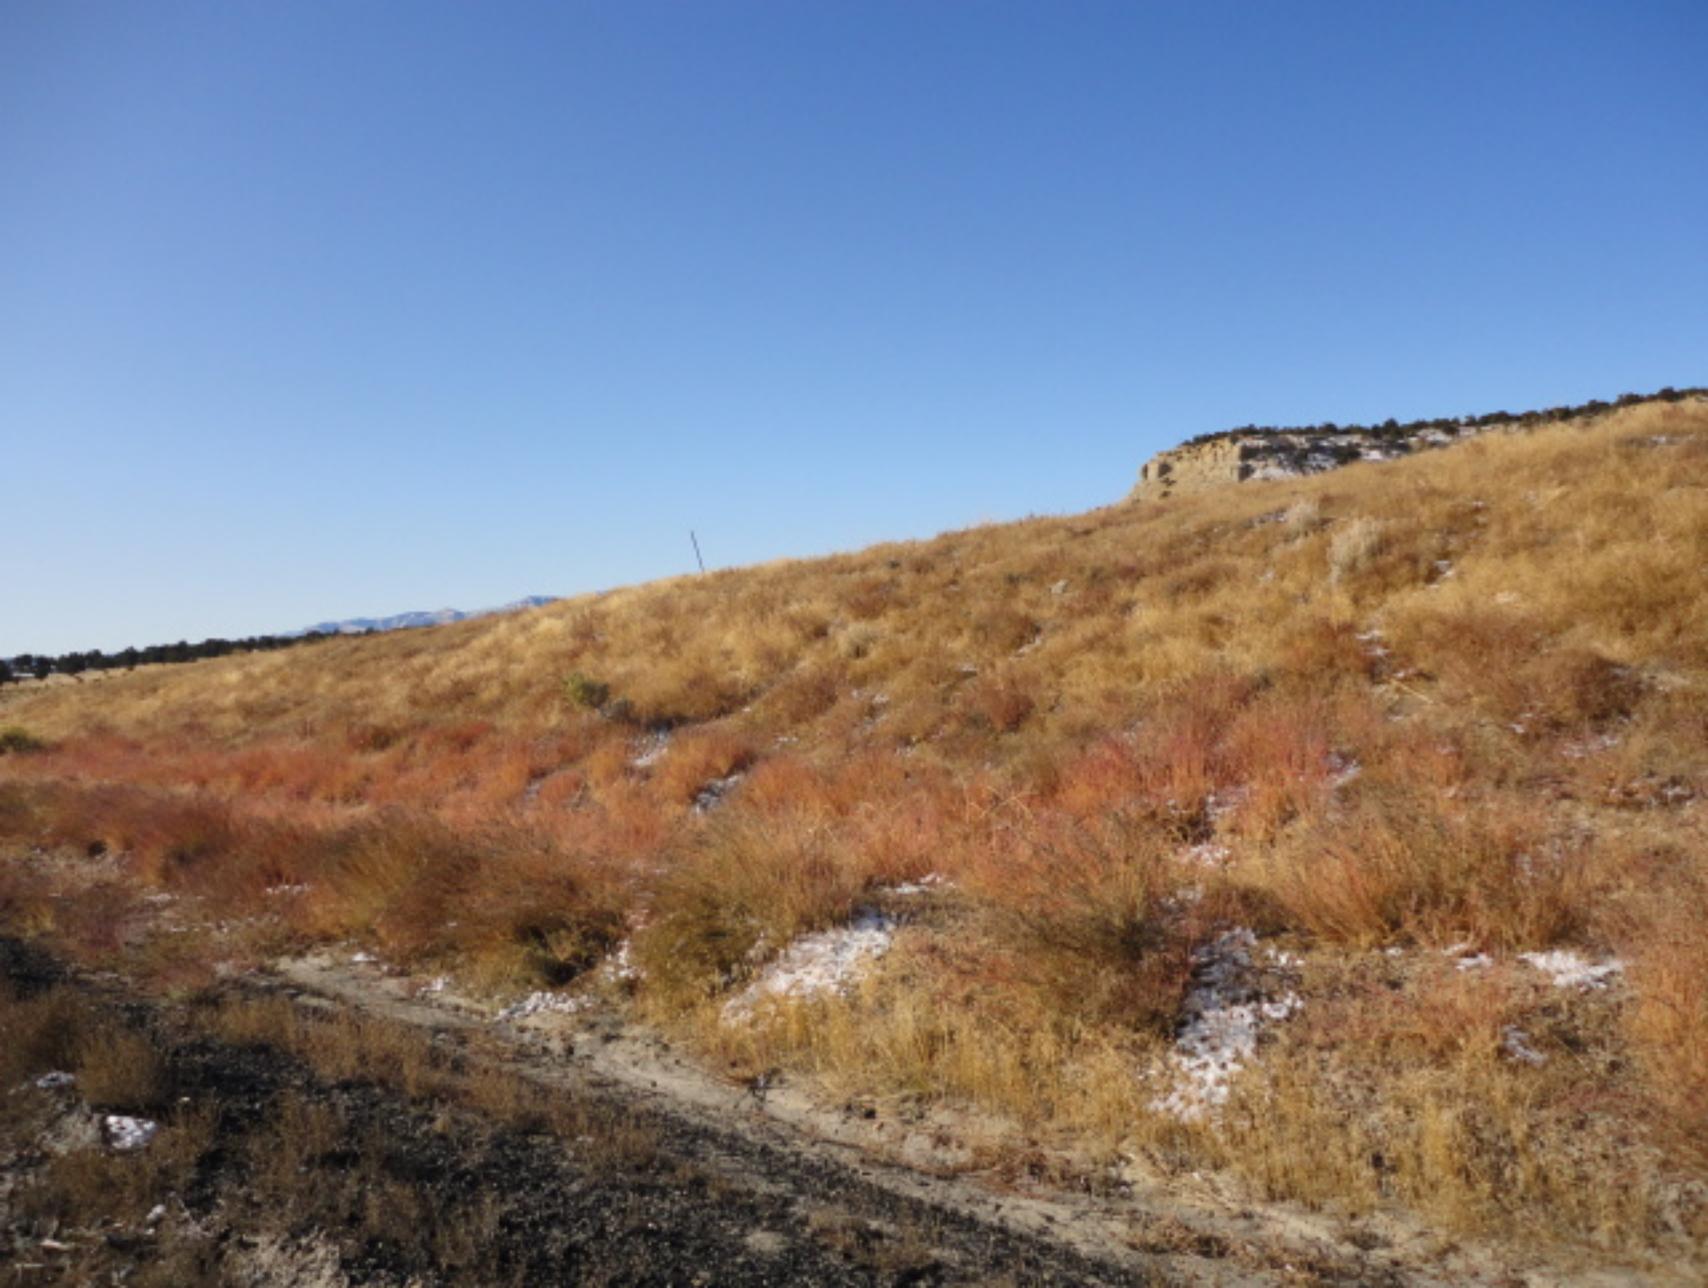
TOP SOIL
STORAGE

I inspected the topsoil piles and I did not see any signs of wind or water erosion. The topsoil piles appear to be stable and protected by a berm. See Photo
