RE: Partial Phase II, and III Bond Release, Sunnyside Refuse and Slurry Site, Permit No. UT-007-035, DOGM Proposed Decision and Findings of Compliance, May 18, 2011

Mine Site Evaluation

Sunnyside Refuse and Slurry, Sunnyside Cogeneration Associates (SCA)
Utah Division of Oil, Gas, and Mining (DOGGM) Permit No. UT-007-035
Phase II and III Bond Release Inspection

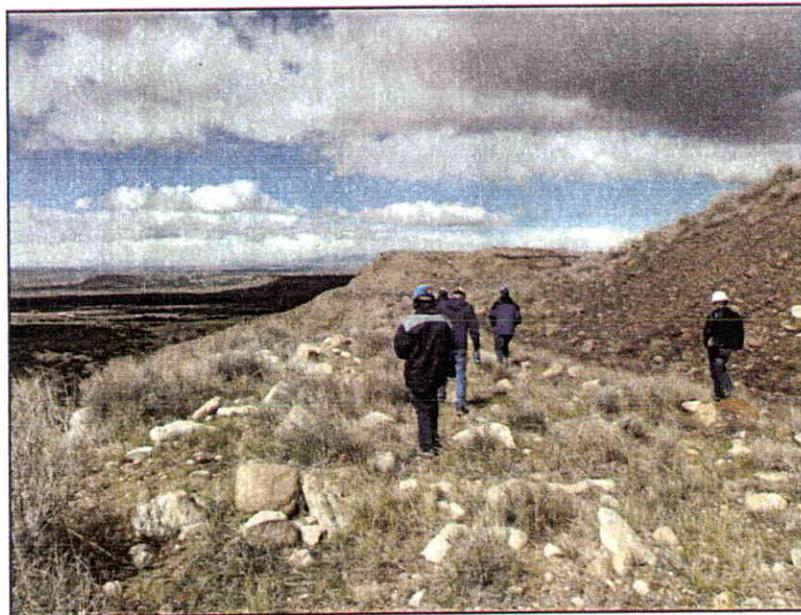
Photo 1 – portion of reclaimed road

The group began the inspection at the mine office. Mr. Carlson briefed us on the reclamation efforts regarding this 5.35-acre area and answered questions. We then drove to the OCR and began walking the length of the reclaimed road. All bridges and culverts were removed from the road. The slopes were regraded to blend with the natural drainage pattern of the surrounding area (see Photos 1 and 2). The road was backfilled using material that had previously been

pushed over the edge of the road. It was placed on the inside cut of the road in one-foot lifts. This material was shown to be acid-forming and the mining company was therefore required to cover this material with four feet of non-hazardous borrow material. Later, another foot of soil was placed on the out slopes of the road for additional cover. The road slope appeared stable.

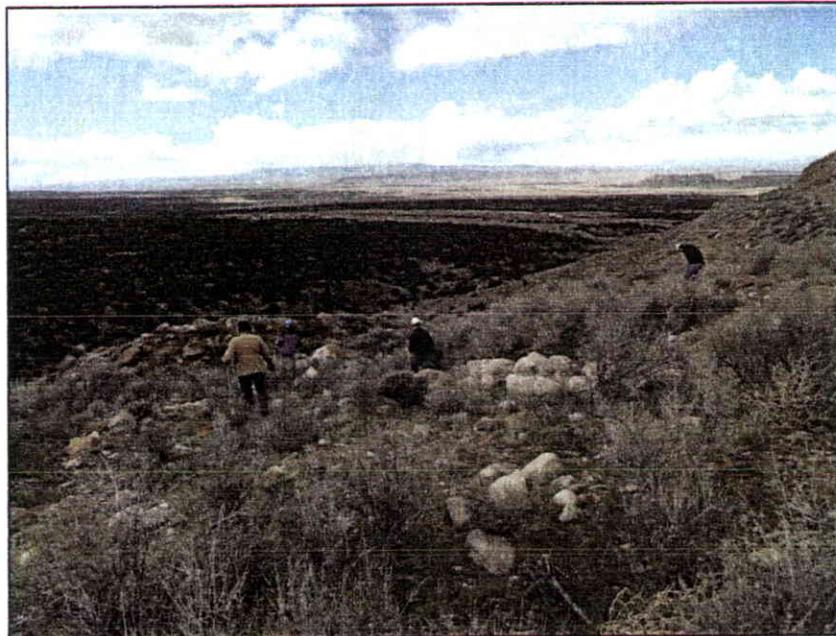
Photo 3 – well established vegetation

The vegetation along the reclaimed road was well established (see Photo 3). The land surface was roughened, thus providing sediment control and a good environment for successful vegetative growth. There is no indication of erosion in this area. The bond release area has a variety of shrubs with fewer grasses (due to the timing of the inspection). There is a high occurrence of four-wing salt brush. The cheat grass in this area helps with erosion control on the steep slopes. Vegetation sampling occurred in the early seasons of 2006 and 2007. The group observed the vegetation reference area, which consisted of more grasses than shrubs (see Photo 4). Vegetation of the reclaimed road was proven to be higher in woody plant density and total percent cover than the reference area.

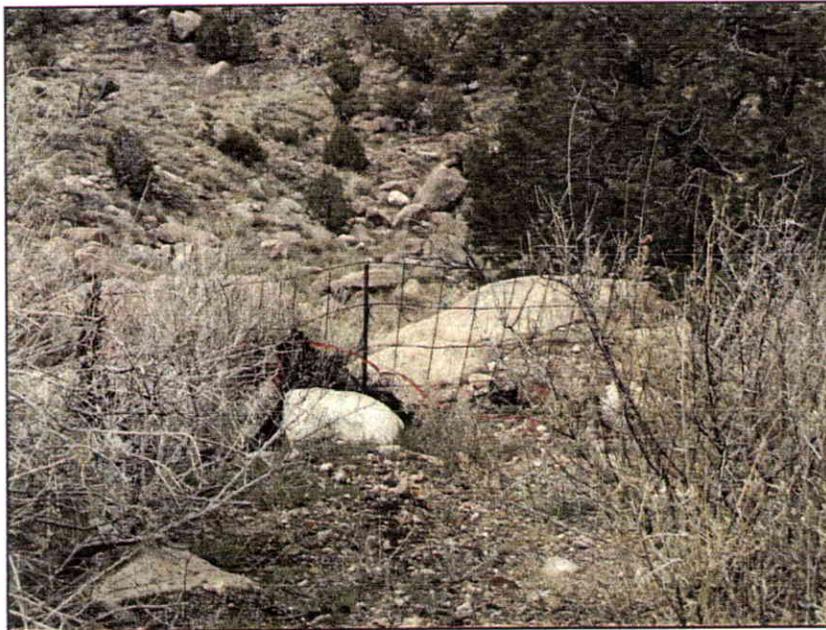
Photo 5 – Silt Fence remnants that must be removed

There were still remnants of silt fences on the down-slope portion of the OCRR (see Photo 5). This fence was previously used to control drainage and catch sediment. The group agreed that SCA must remove all remnants of the silt fence and rebar before bond release can be granted. An inspector from DOGM will verify that this occurs before DOGM proposes their decision regarding this bond release request.
