# Inspection Report

Permit Number:	<b>C0070035</b>
Inspection Type:	COMPLETE
Inspection Date:	Monday, November 27, 2017
Start Date/Time:	11/27/2017 12:00:00 PM
End Date/Time:	11/27/2017 4:00:00 PM
Last Inspection:	Monday, October 30, 2017

Permitee: **SUNNYSIDE COGENERATION ASSOCIATES**  
 Operator: **SUNNYSIDE COGENERATION ASSOCIATES**  
 Site: **SUNNYSIDE REFUSE & SLURRY**  
 Address: **PO BOX 159, SUNNYSIDE UT 84539**  
 County: **CARBON**  
 Permit Type: **PERMANENT COAL PROGRAM**  
 Permit Status: **ACTIVE**

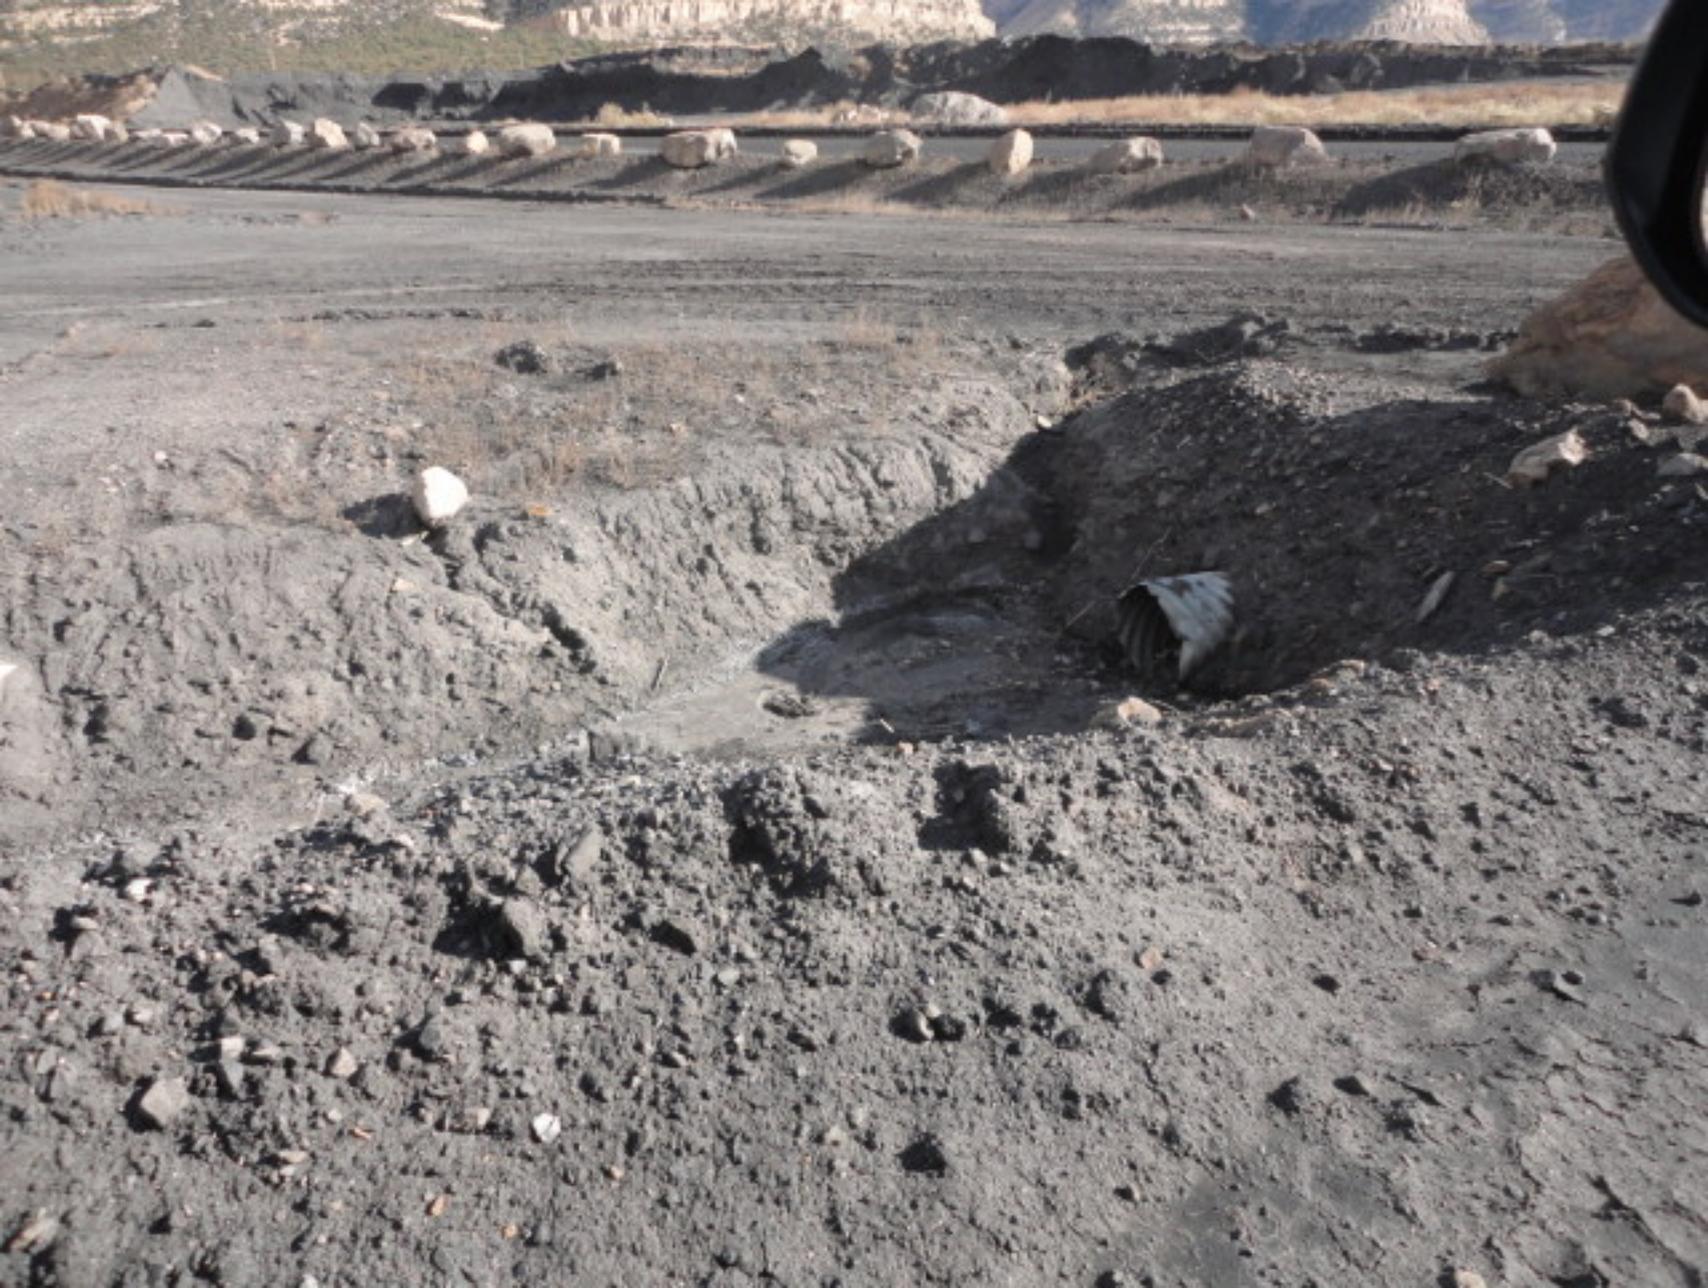
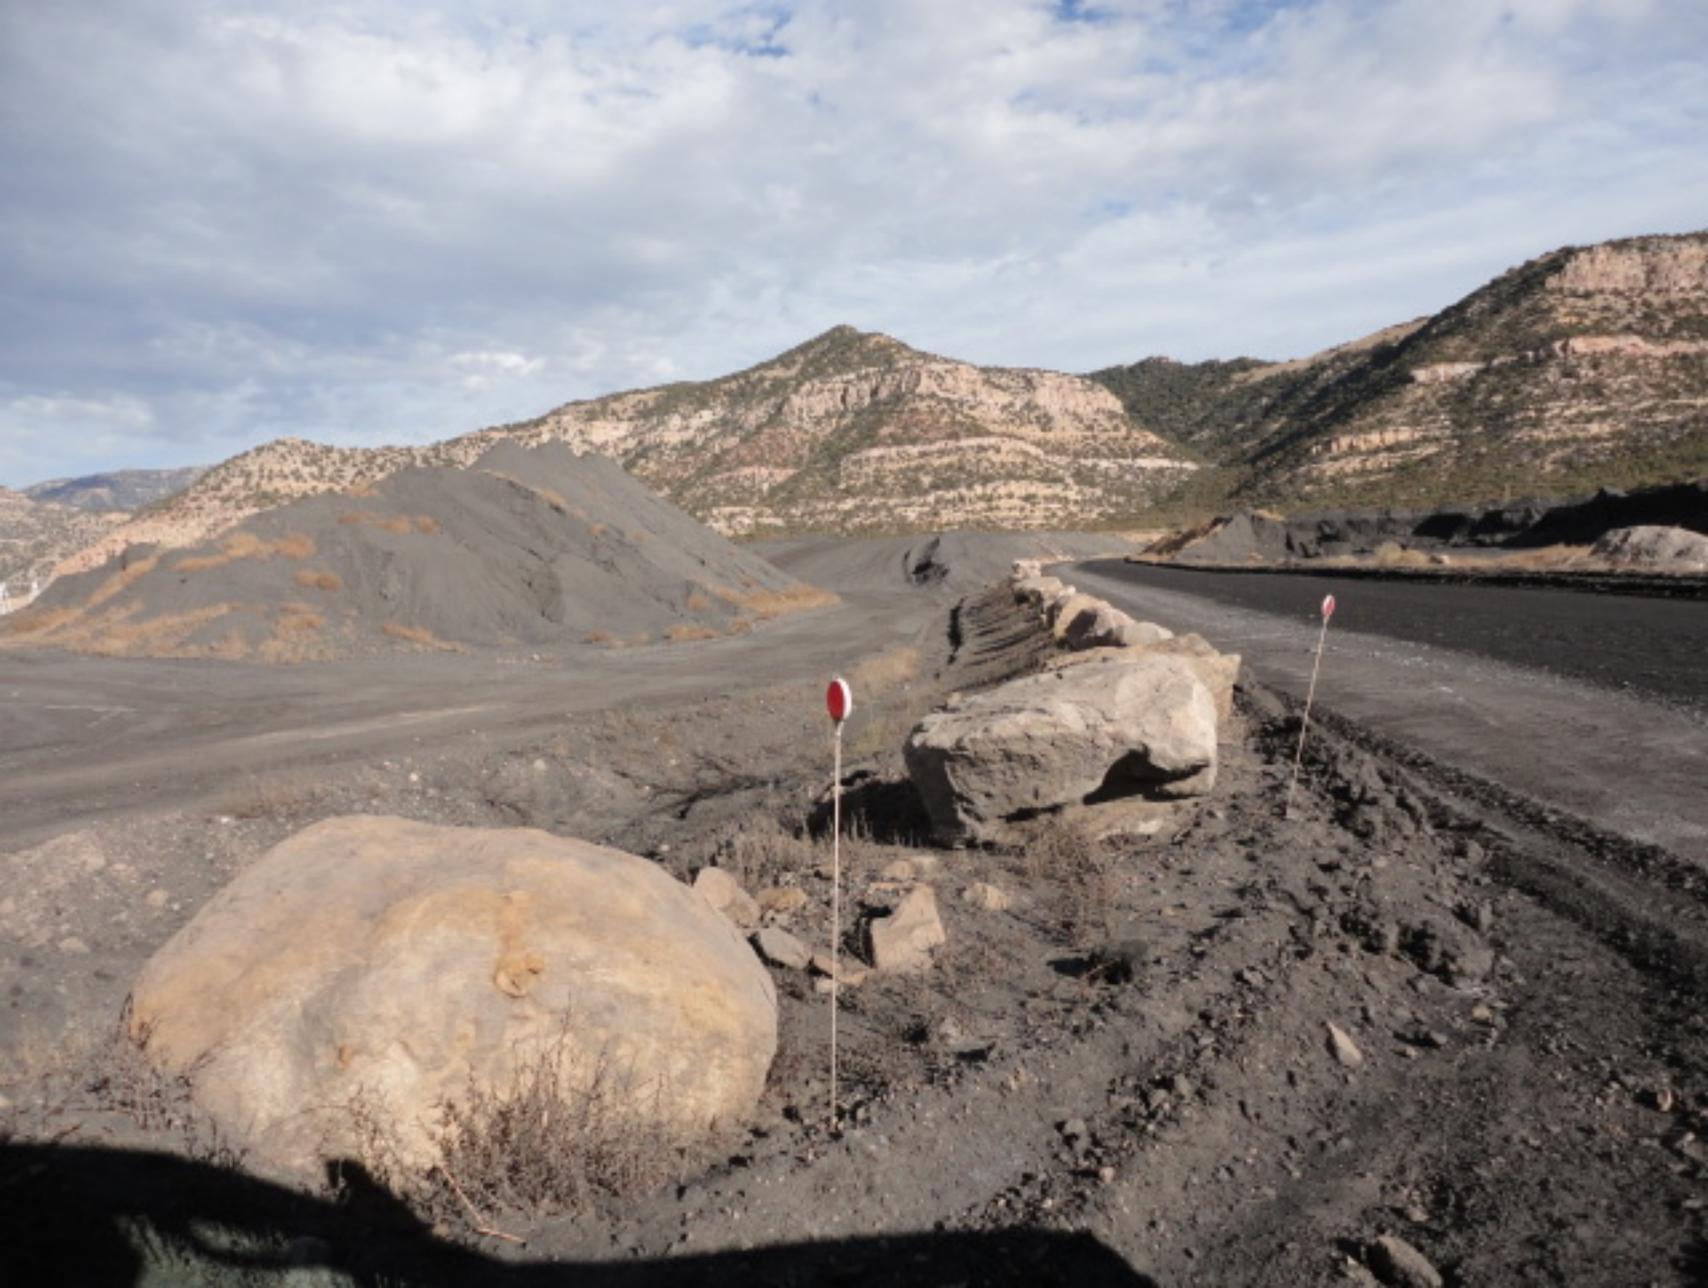
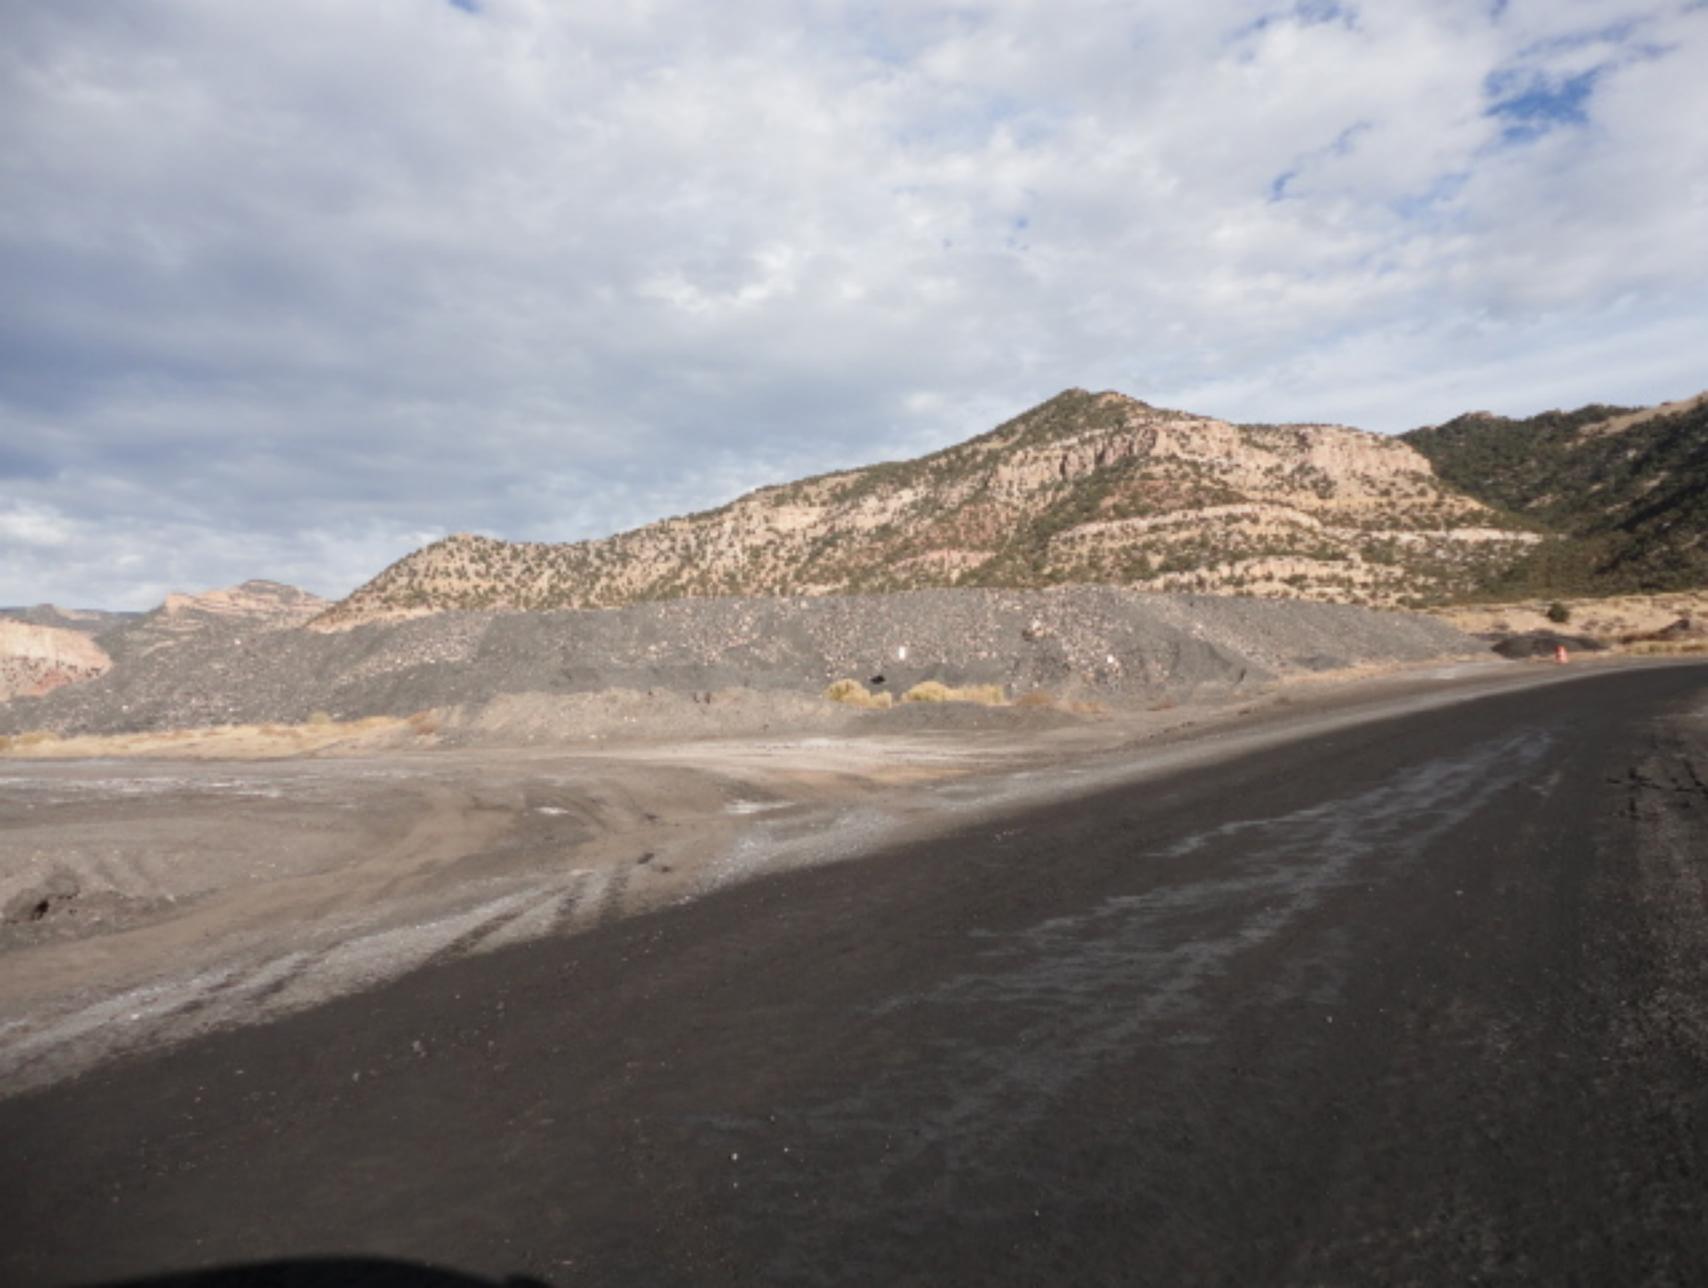
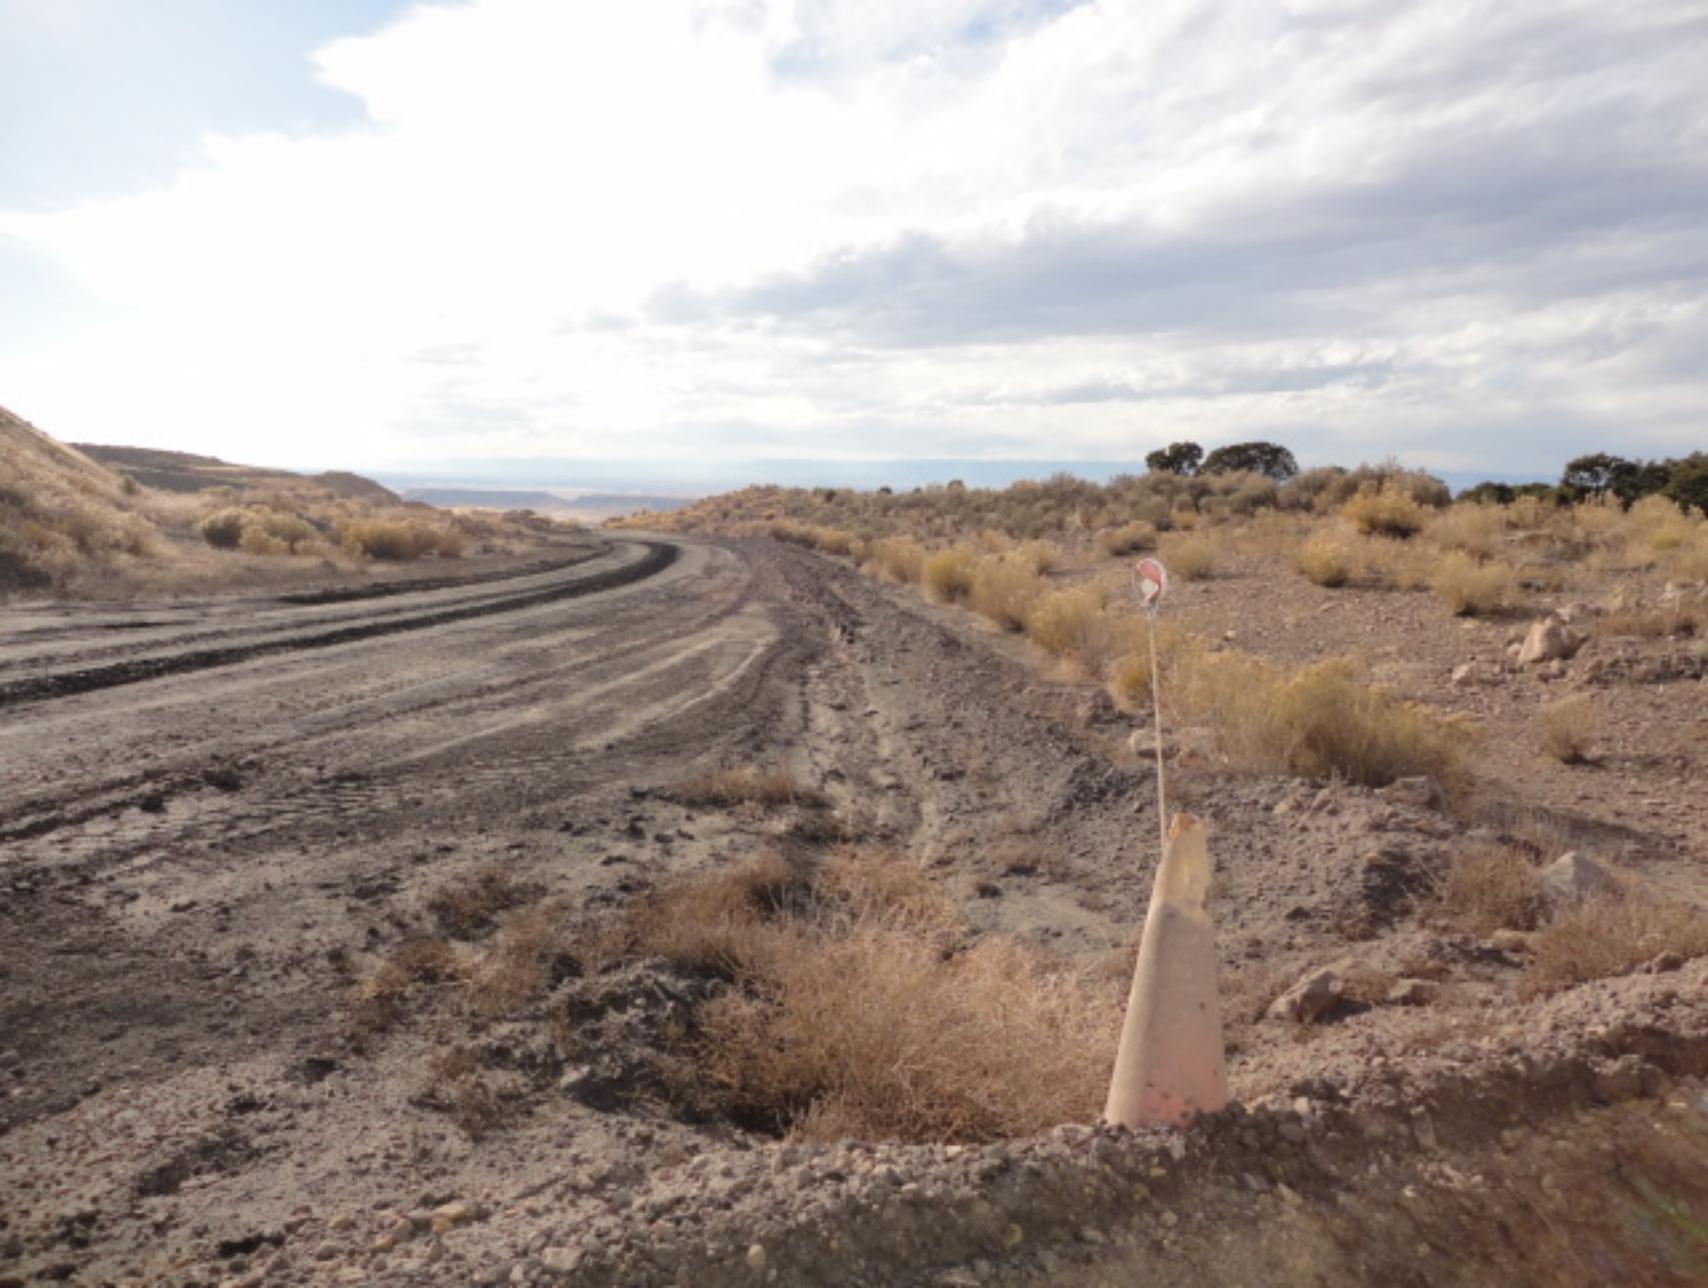
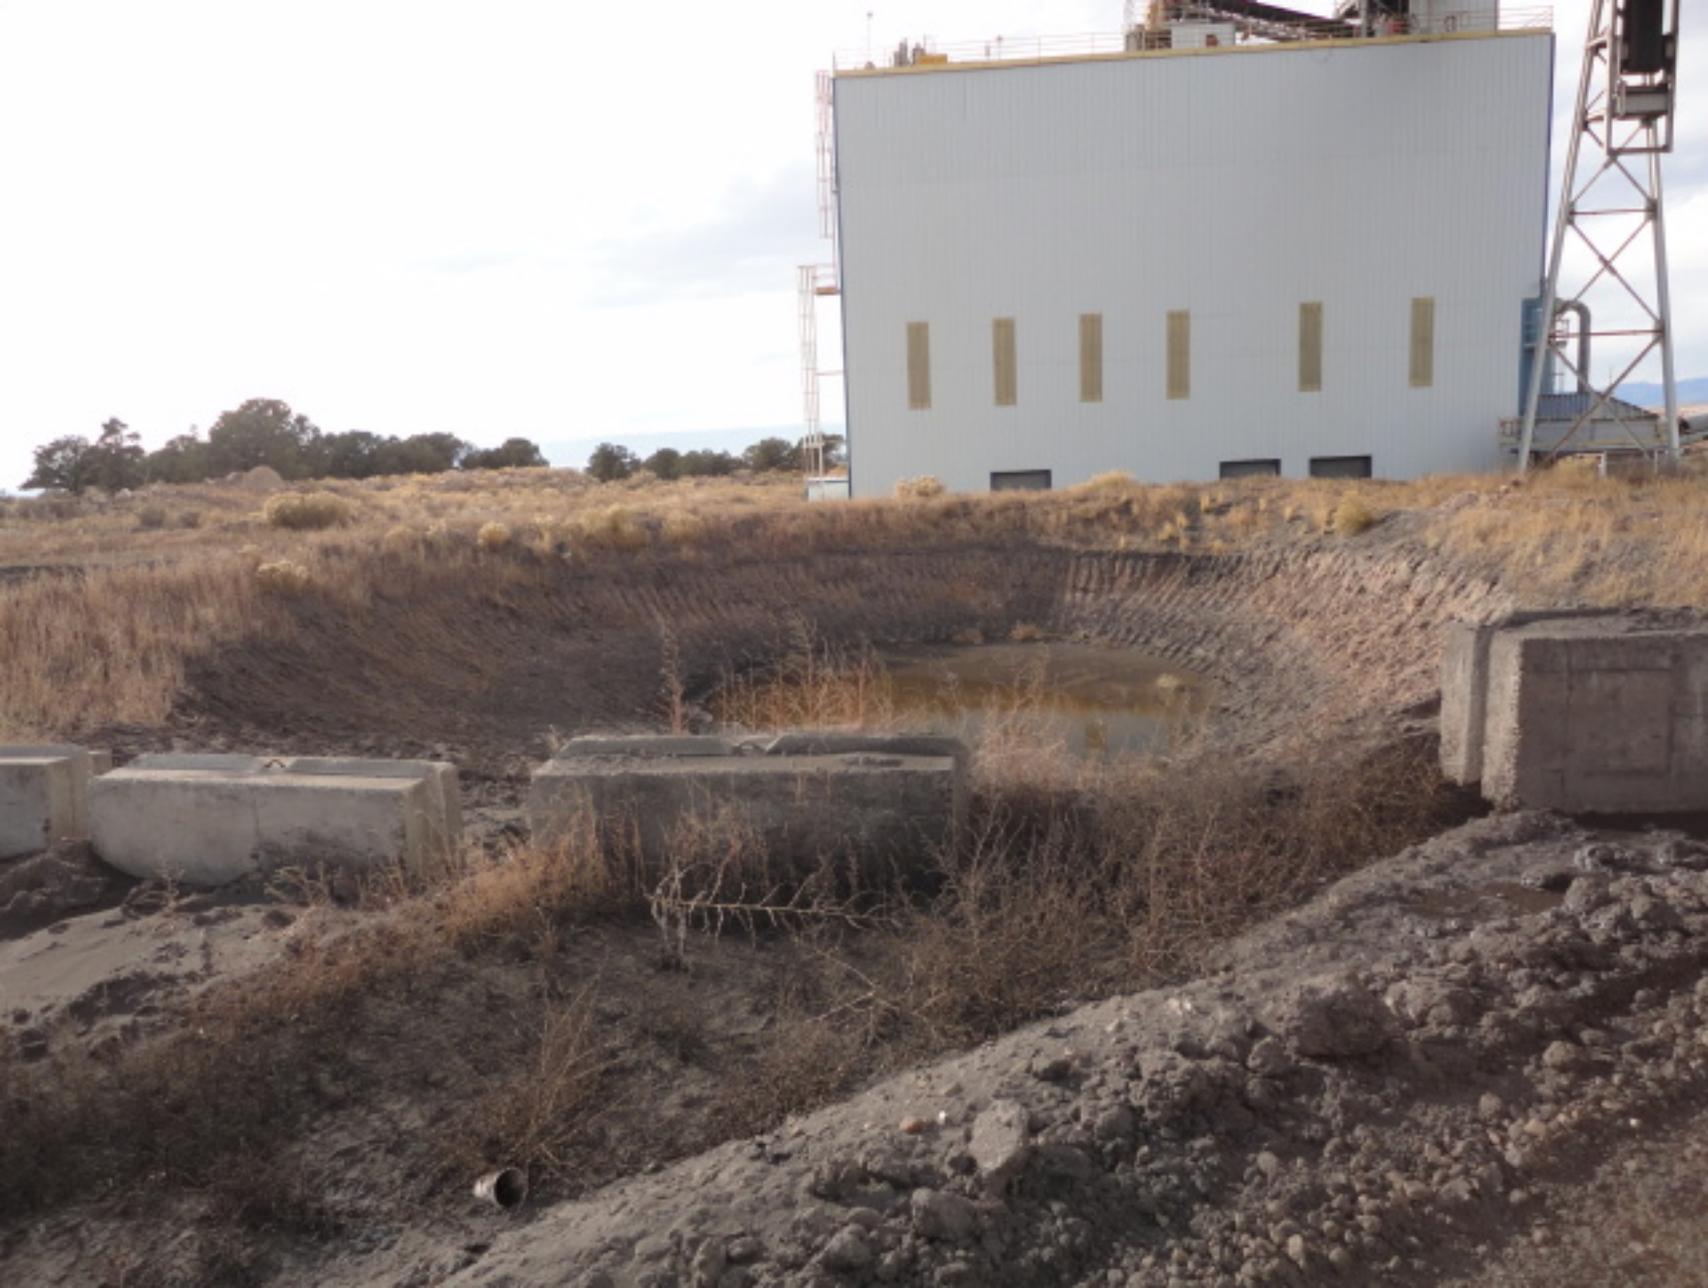
I inspected diversions and culverts throughout the property. They were open and would function as designed in a storm event. See Photos.
