# Inspection Report

Permit Number:	C0070035
Inspection Type:	PARTIAL
Inspection Date:	Wednesday, January 24, 2018
Start Date/Time:	1/24/2018
End Date/Time:	1/24/2018 4:00:00 PM
Last Inspection:	Monday, December 11, 2017

Permitee: **SUNNYSIDE COGENERATION ASSOCIATES**

Site: **SUNNYSIDE REFUSE & SLURRY**

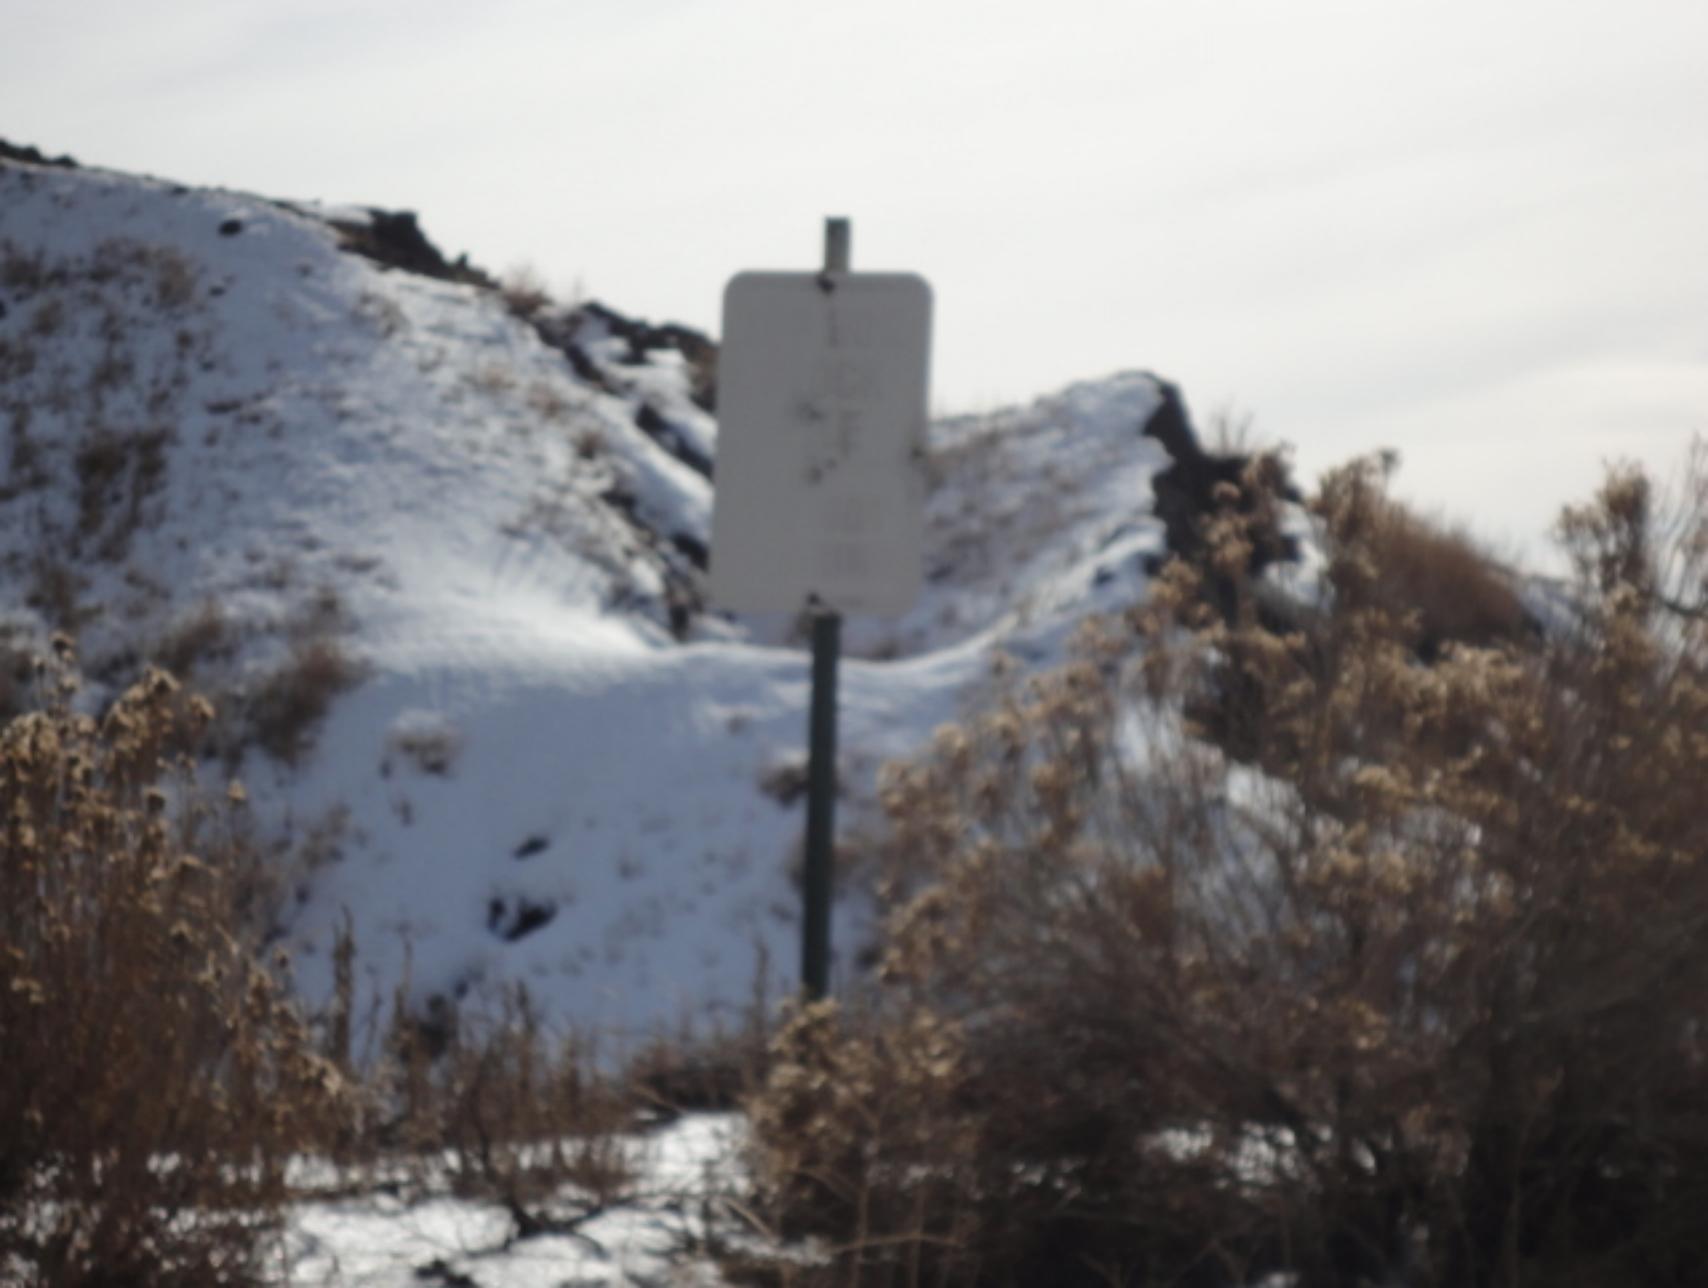
I inspected the topsoil piles and I did not see any signs of wind or water erosion. The topsoil piles appear to be stable and protected by a berm. The topsoil sign was faded out. The permittee has replaced the sign prior to this report and notified the inspector. See Photo
