# Inspection Report

Permit Number:	C0070035
Inspection Type:	PARTIAL
Inspection Date:	Thursday, June 21, 2018
Start Date/Time:	6/21/2018 12:00:00 PM
End Date/Time:	6/21/2018 3:30:00 PM
Last Inspection:	Monday, May 14, 2018

Permitee: **SUNNYSIDE COGENERATION ASSOCIATES**  
 Operator: **SUNNYSIDE COGENERATION ASSOCIATES**  
 Site: **SUNNYSIDE REFUSE & SLURRY**  
 Address: **PO BOX 159, SUNNYSIDE UT 84539**  
 County: **CARBON**  
 Permit Type: **PERMANENT COAL PROGRAM**  
 Permit Status: **ACTIVE**

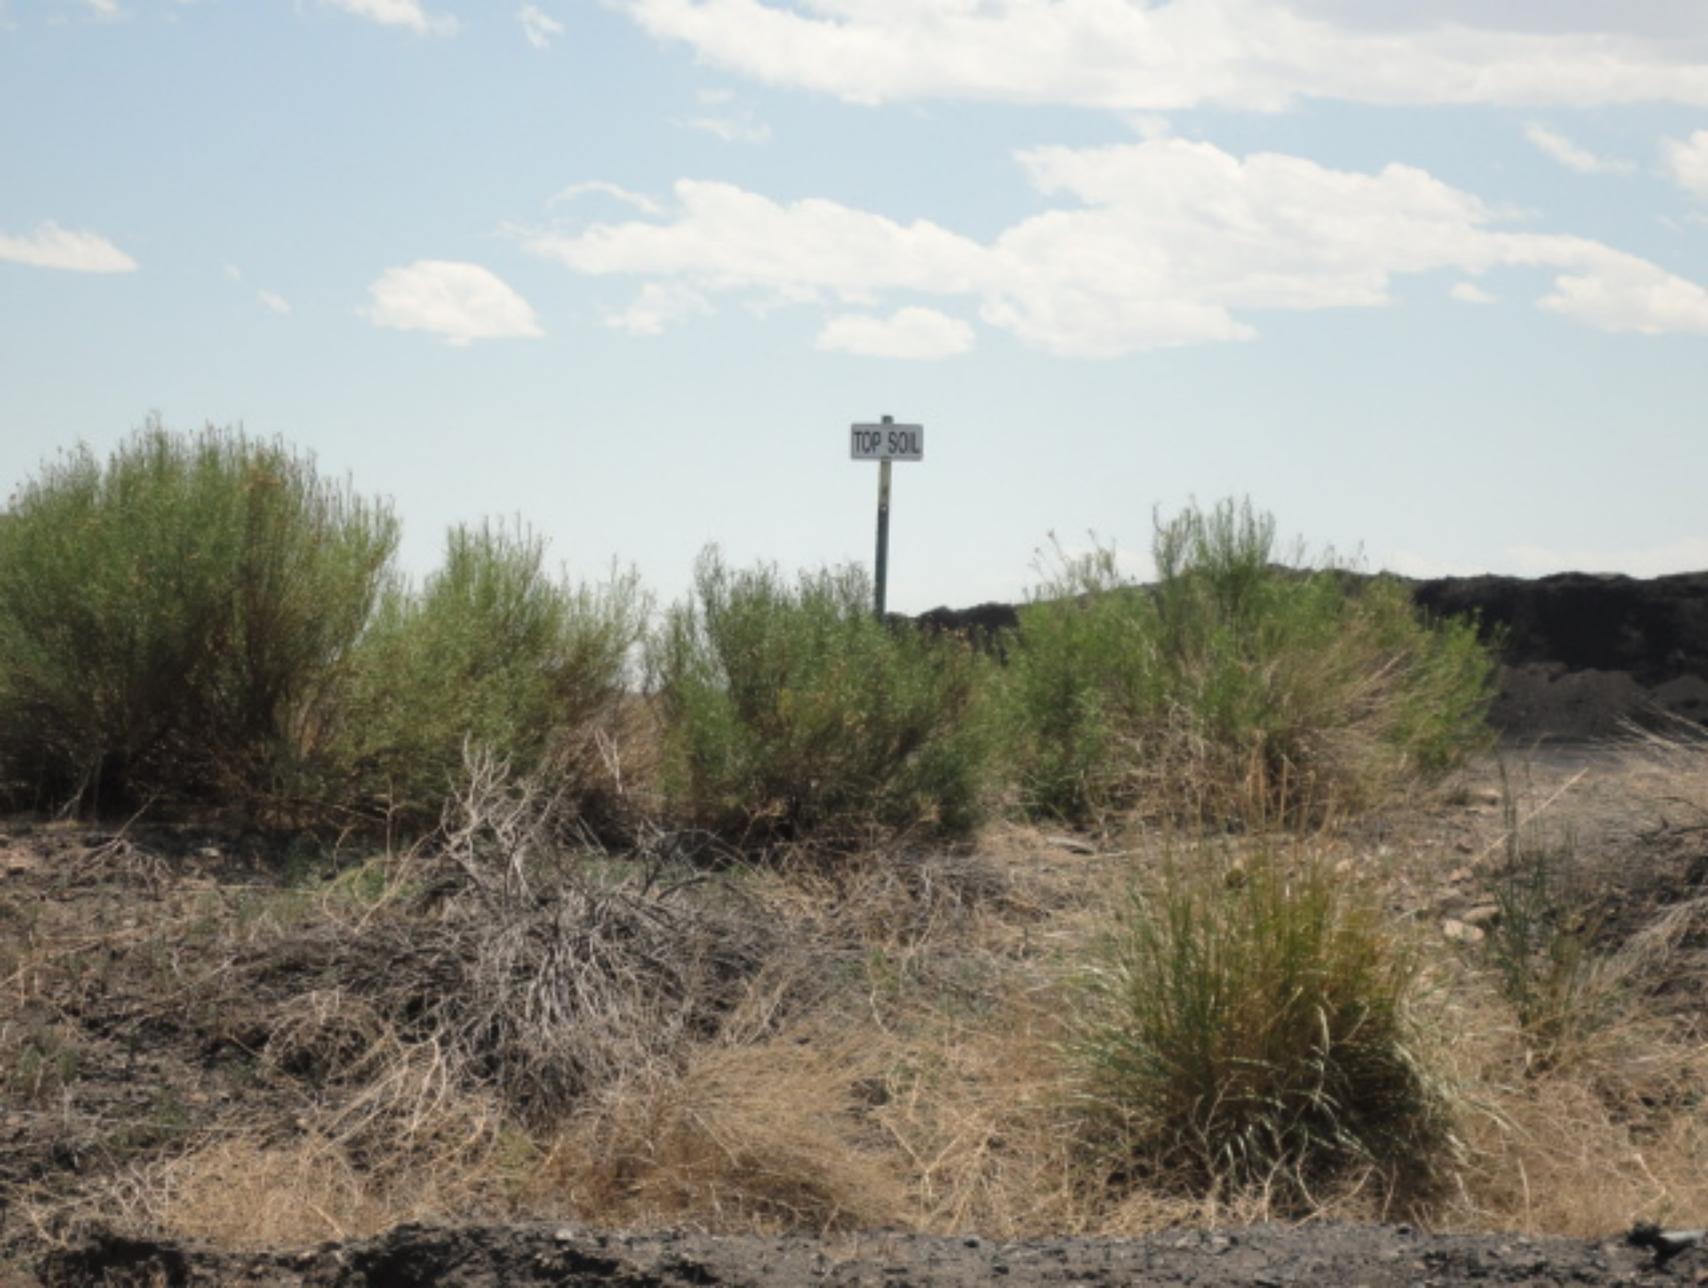
TOP SOIL

I inspected the topsoil piles and I did not see any signs of wind or water erosion. The topsoil piles appear to be stable and protected by a berm.

A photograph of a field with various green and brown shrubs. In the center background, a wooden sign on a post reads "TOP SOIL". The sky is blue with scattered white clouds. The ground in the foreground is dark and appears to be volcanic ash or soil.

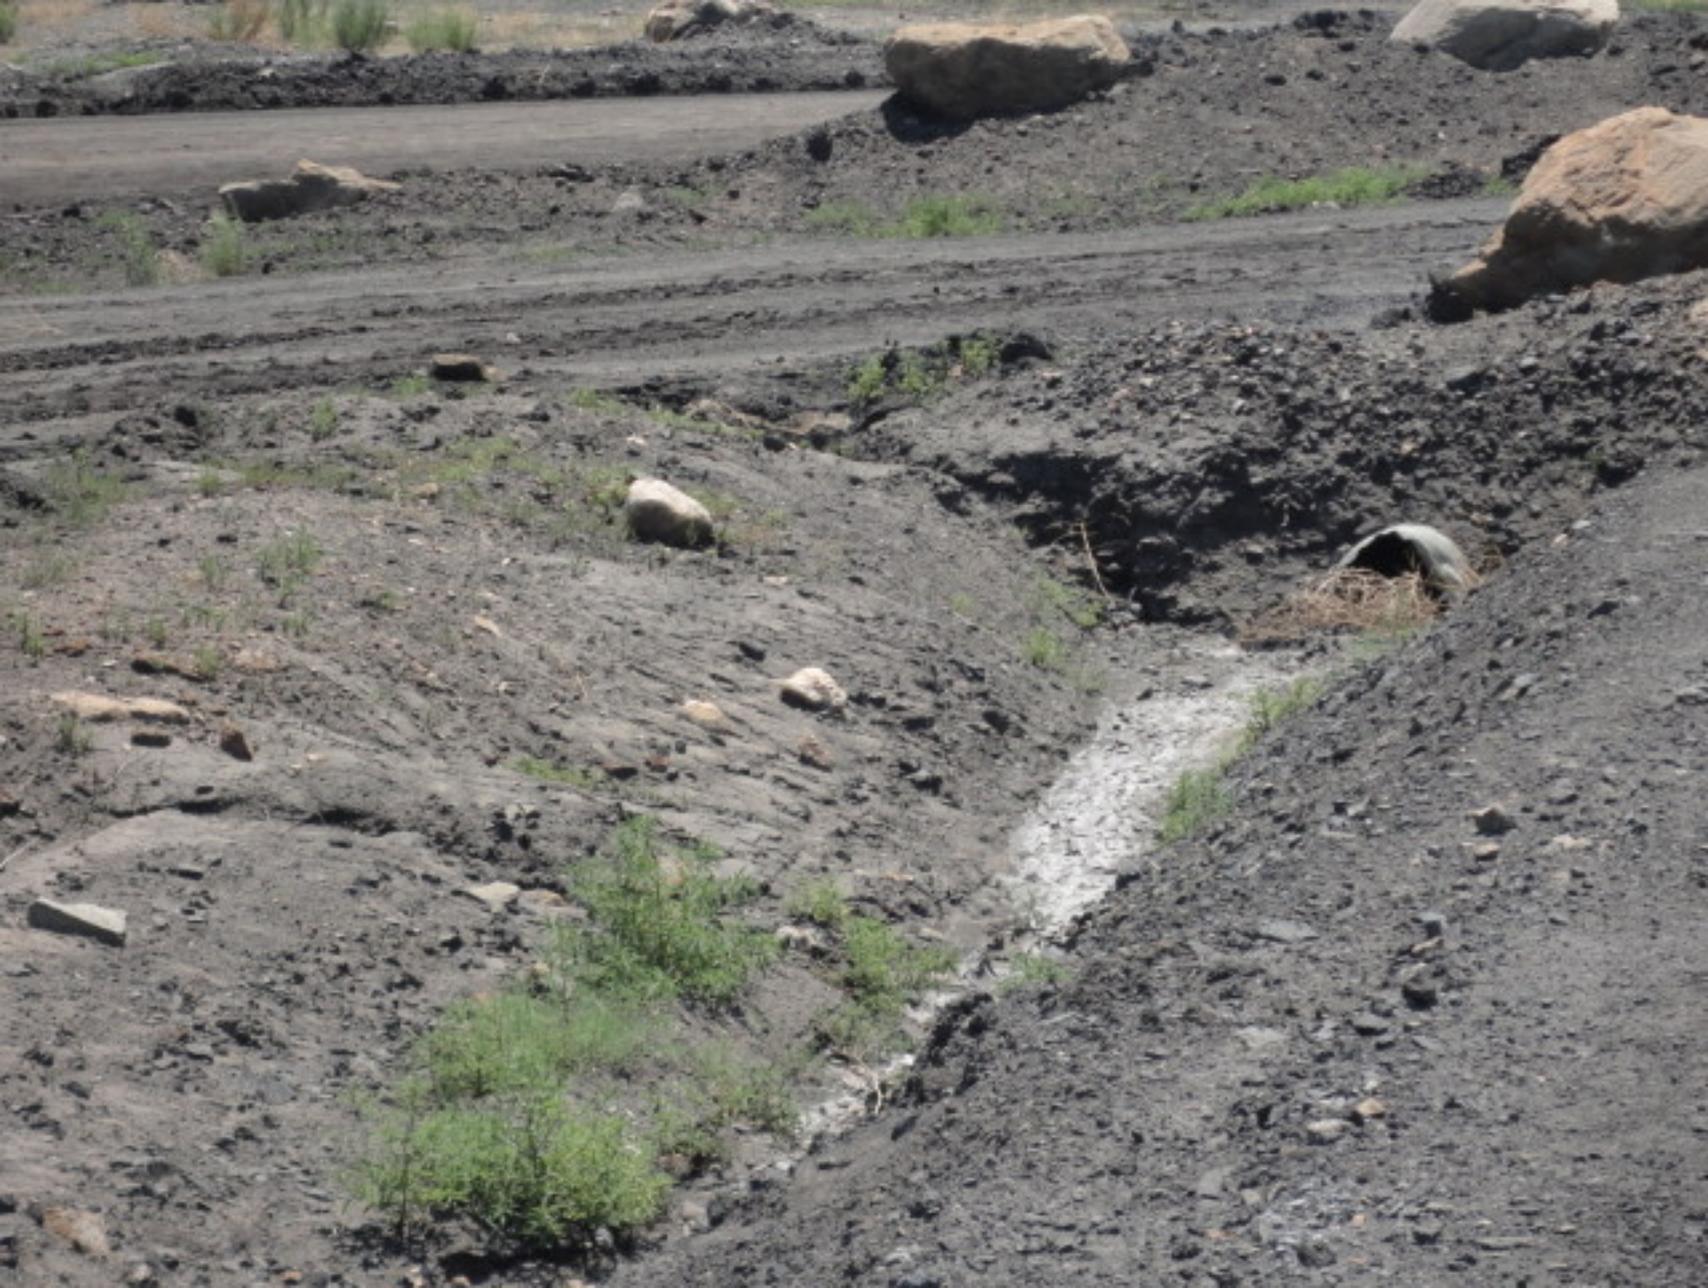
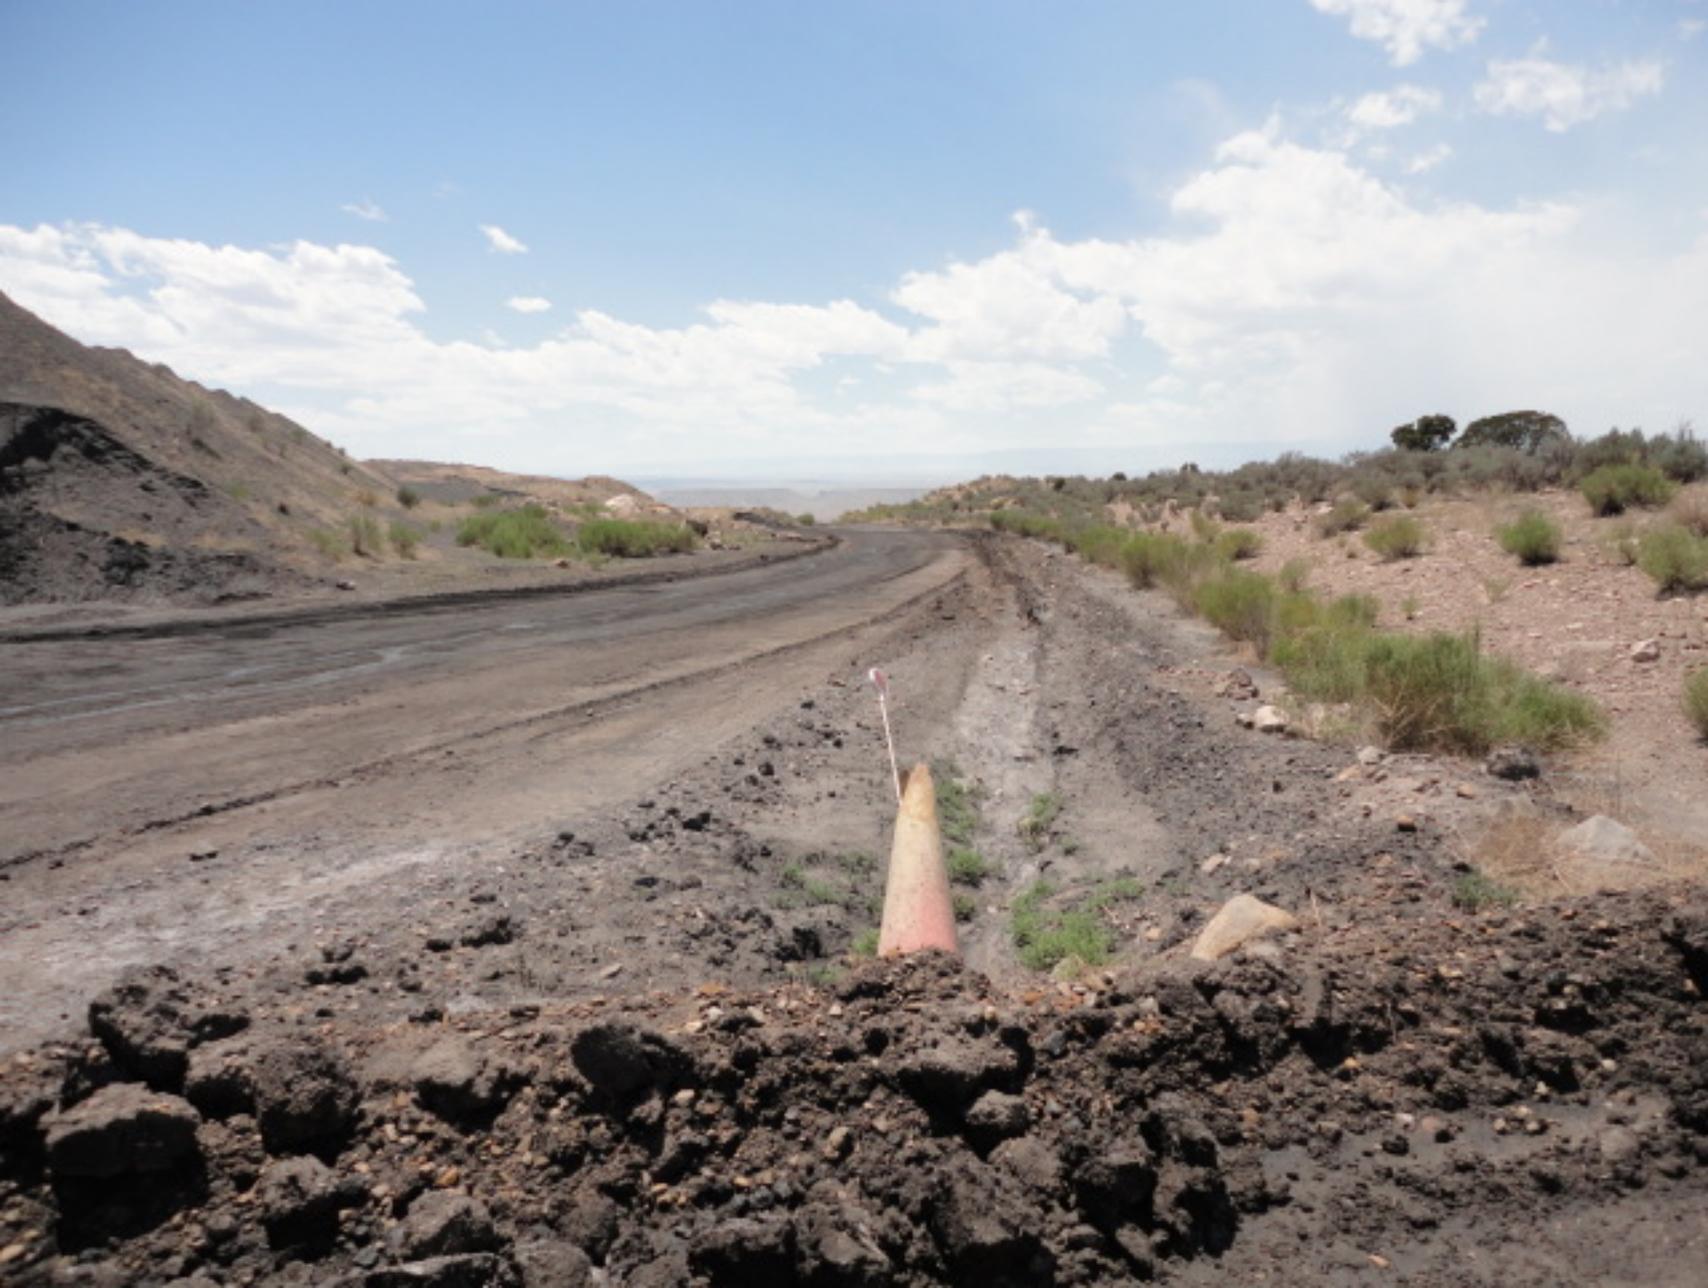
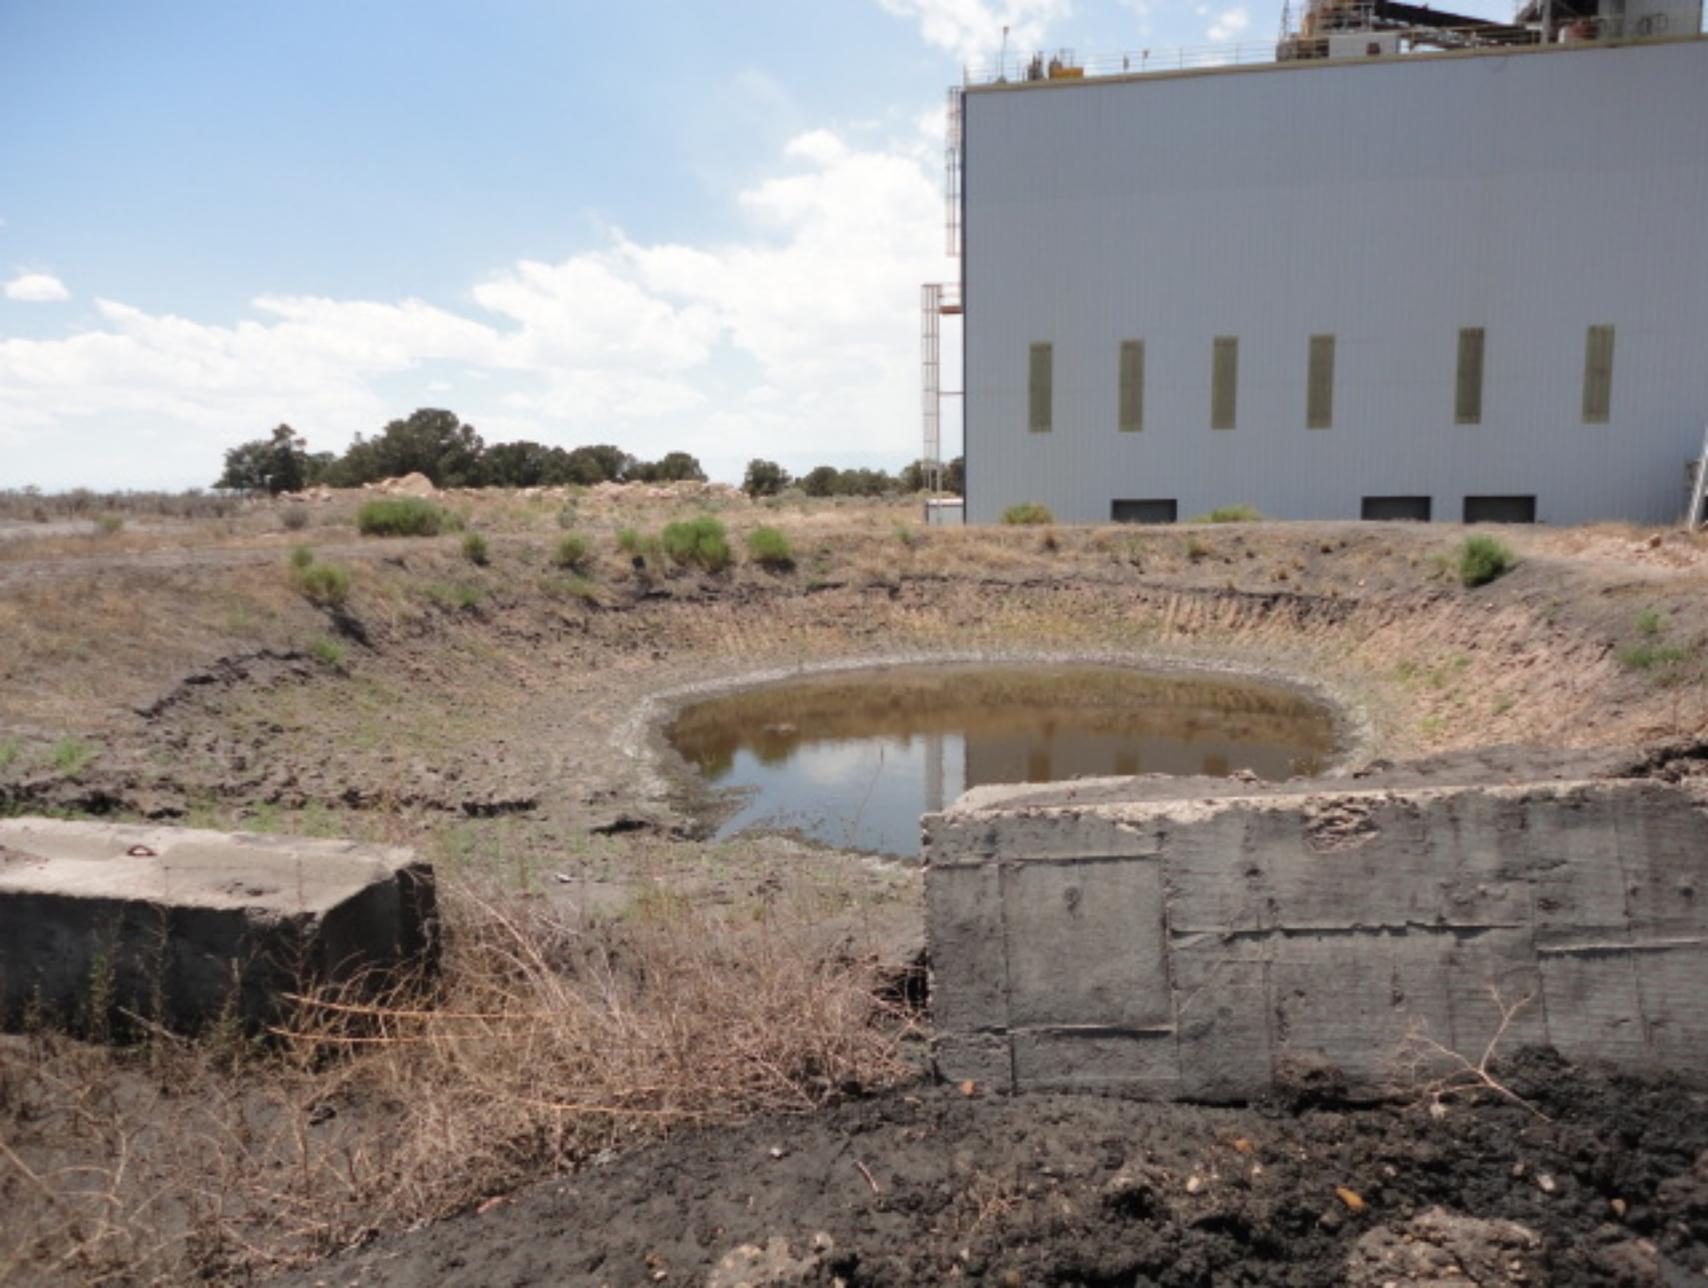
I inspected diversions and culverts throughout the property. They were open and would function as designed during a storm event. The structures were recently re-graded and cleaned out of sediment. See photos

I inspected the road diversions and culverts throughout the property. They were functioning as designed. See Photos
