Inspection Report

Permit Number:	C0070035
Inspection Type:	PARTIAL
Inspection Date:	Wednesday, September 16, 2020
Start Date/Time:	9/16/2020 2:00:00 PM
End Date/Time:	9/16/2020 4:00:00 PM
Last Inspection:	Monday, August 17, 2020

Permittee: **SUNNYSIDE COGENERATION ASSOCIATES**
 Operator: **SUNNYSIDE COGENERATION ASSOCIATES**
 Site: **SUNNYSIDE REFUSE & SLURRY**
 Address: **PO BOX 159, SUNNYSIDE UT 84539**
 County: **CARBON**
 Permit Type: **PERMANENT COAL PROGRAM**
 Permit Status: **ACTIVE**

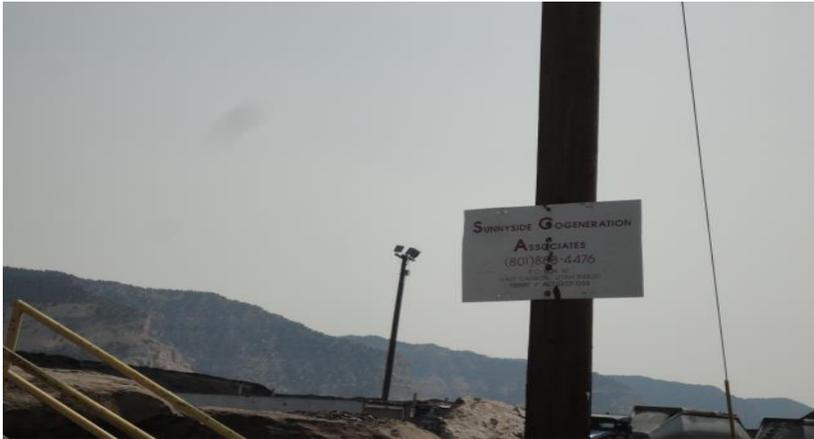
PHOTO 1
Identification Sign

The identification sign was inspected and it meets the requirements of the R645 Coal Rules. See Photo

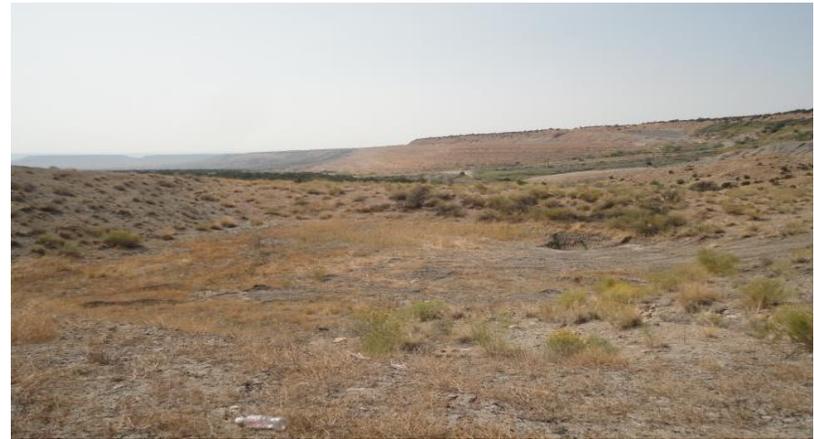
PHOTO 2
Sediment Pond

4b I inspected the sediment pond. It contained some water but was not discharging. It is unlikely this structure will discharge in the near future. The embankments appear to be stable. Inlets and outlets would function as design. I did not see any hazardous conditions to this structure.

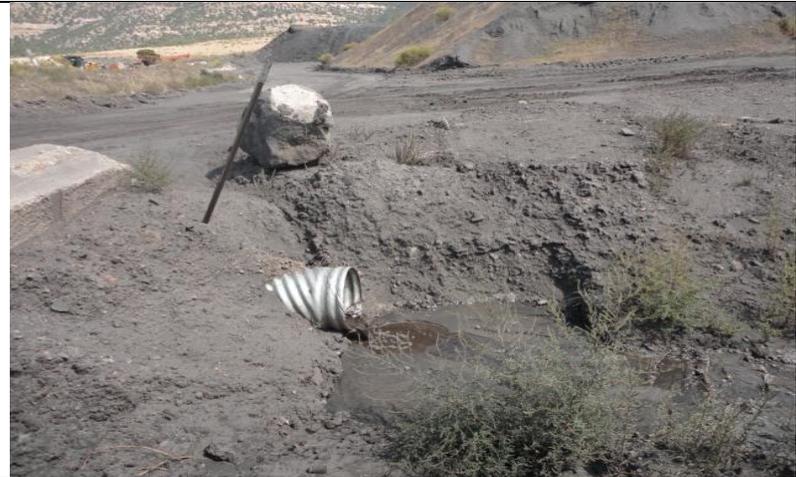
PHOTO 4
Diversion DD3

I inspected diversions and culverts throughout the property. They were open and would function during a storm event. The several structures were recently re-graded and clean out of sediment. See photos
