Portals sealed at Willow Creek

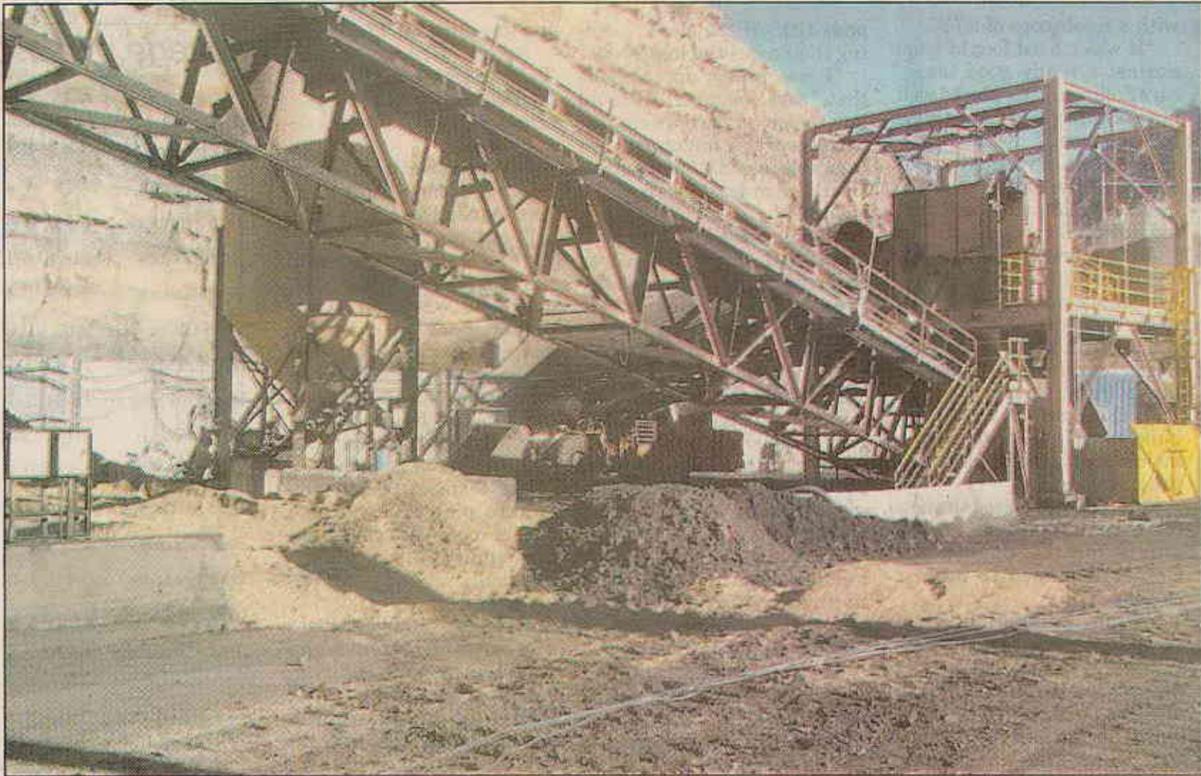
Above: Piles of dirt are still present in front of the portals that were closed last Thanksgiving day. The dirt was placed inside the portal entryways and then pushed up against the openings to make the seal. This was accomplished in dense smoke with the help of mine rescue teams directing the equipment.

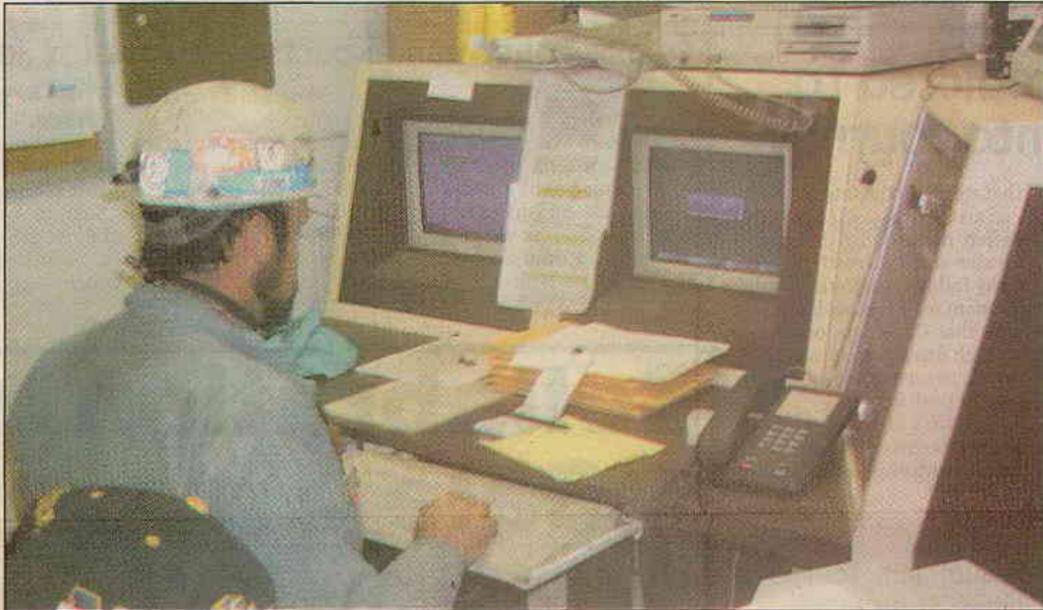
Below: Plastic tubes run the perimeter of the portals and fan entry back to the command centers that are set up to monitor the atmosphere inside the mine.

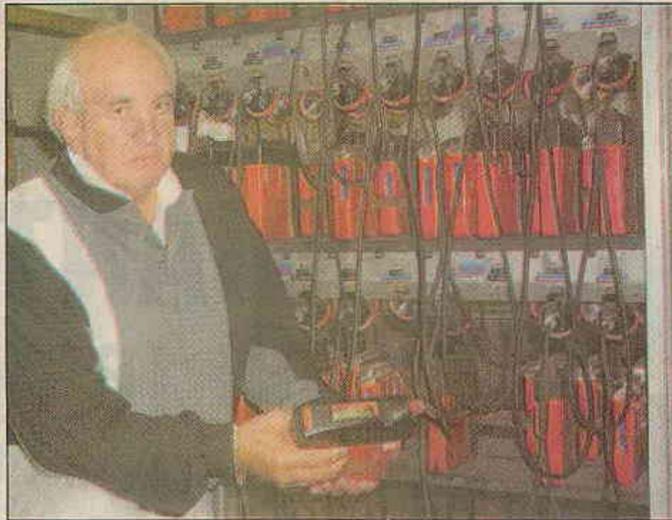
Right: Mine representative Mike Dmitrich shows the readout on the battery pack equipped with the Personal Emergency Device system. This device was used to contact the miners with a message to evacuate the mine.

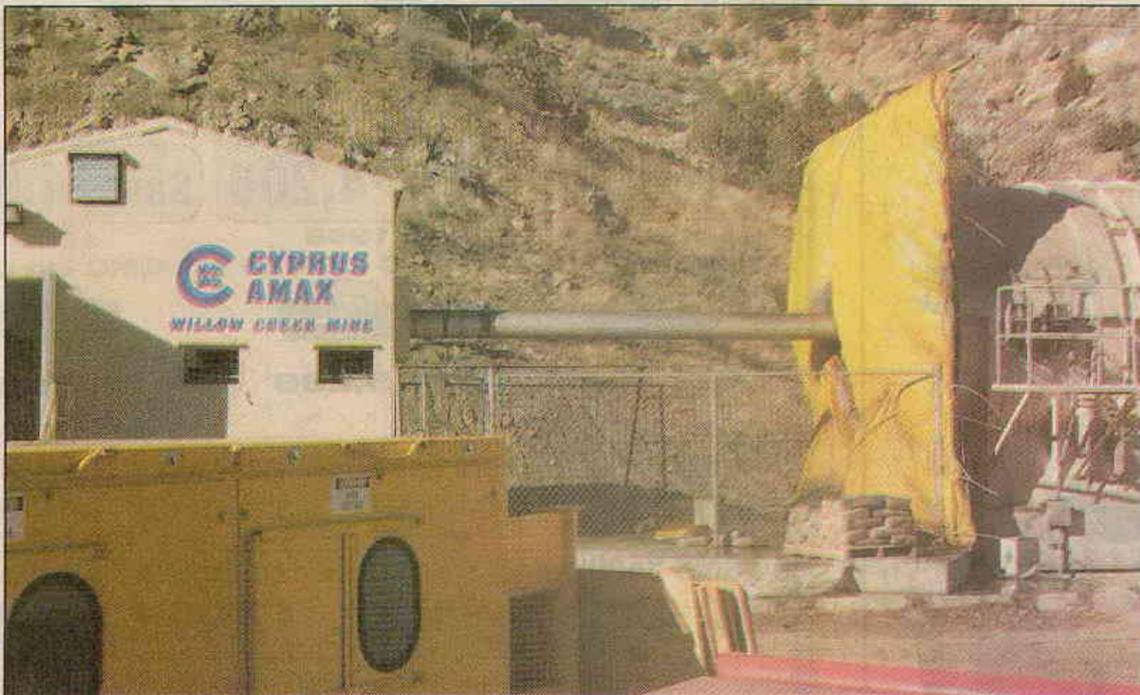
This is the brattice covering over the fan intake. It is bulged outward as the air inside of the mine escapes. Crews inspect the escaping air continually. The air is comprised of

less and less smoke as well as oxygen and greater amounts of carbon dioxide and methane. This is a good sign as crews prepare to enter back into the mine hopefully within two weeks.

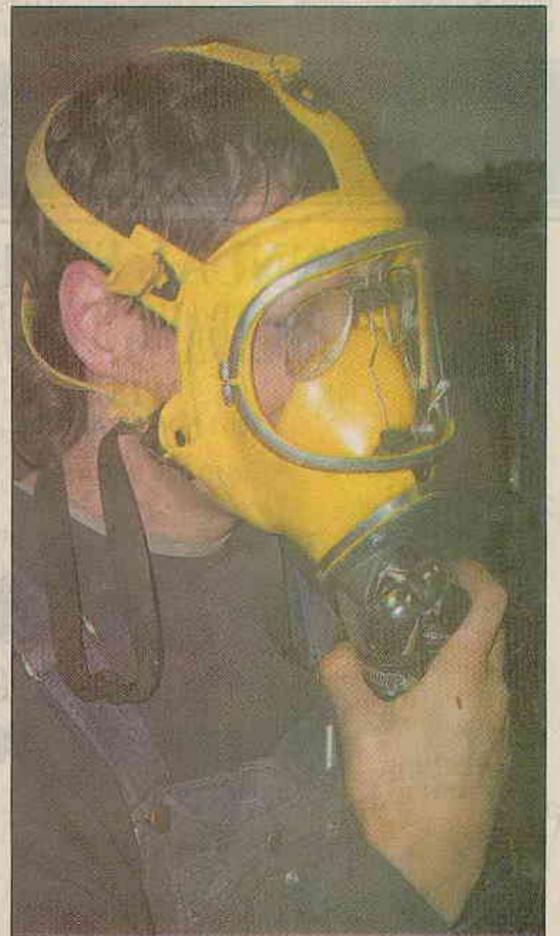
Tad Fausett reviews his rescue device. The 38 pound pack has enough oxygen for four hours of use. Mine rescue teams used these packs to help direct heavy equipment when the portals were being sealed.
