Inspection Report

Permit Number:	C0070039
Inspection Type:	PARTIAL
Inspection Date:	Thursday, December 16, 2010
Start Date/Time:	12/16/2010 9:30:00 AM
End Date/Time:	12/16/2010 11:30:00 AM
Last Inspection:	Tuesday, December 14, 2010

Permittee: **CANYON FUEL COMPANY**
 Operator: **CANYON FUEL COMPANY**
 Site: **DUGOUT CANYON MINE**
 Address: **PO BOX 1029, WELLINGTON UT 84542**
 County: **CARBON**
 Permit Type: **PERMANENT COAL PROGRAM**
 Permit Status: **ACTIVE**

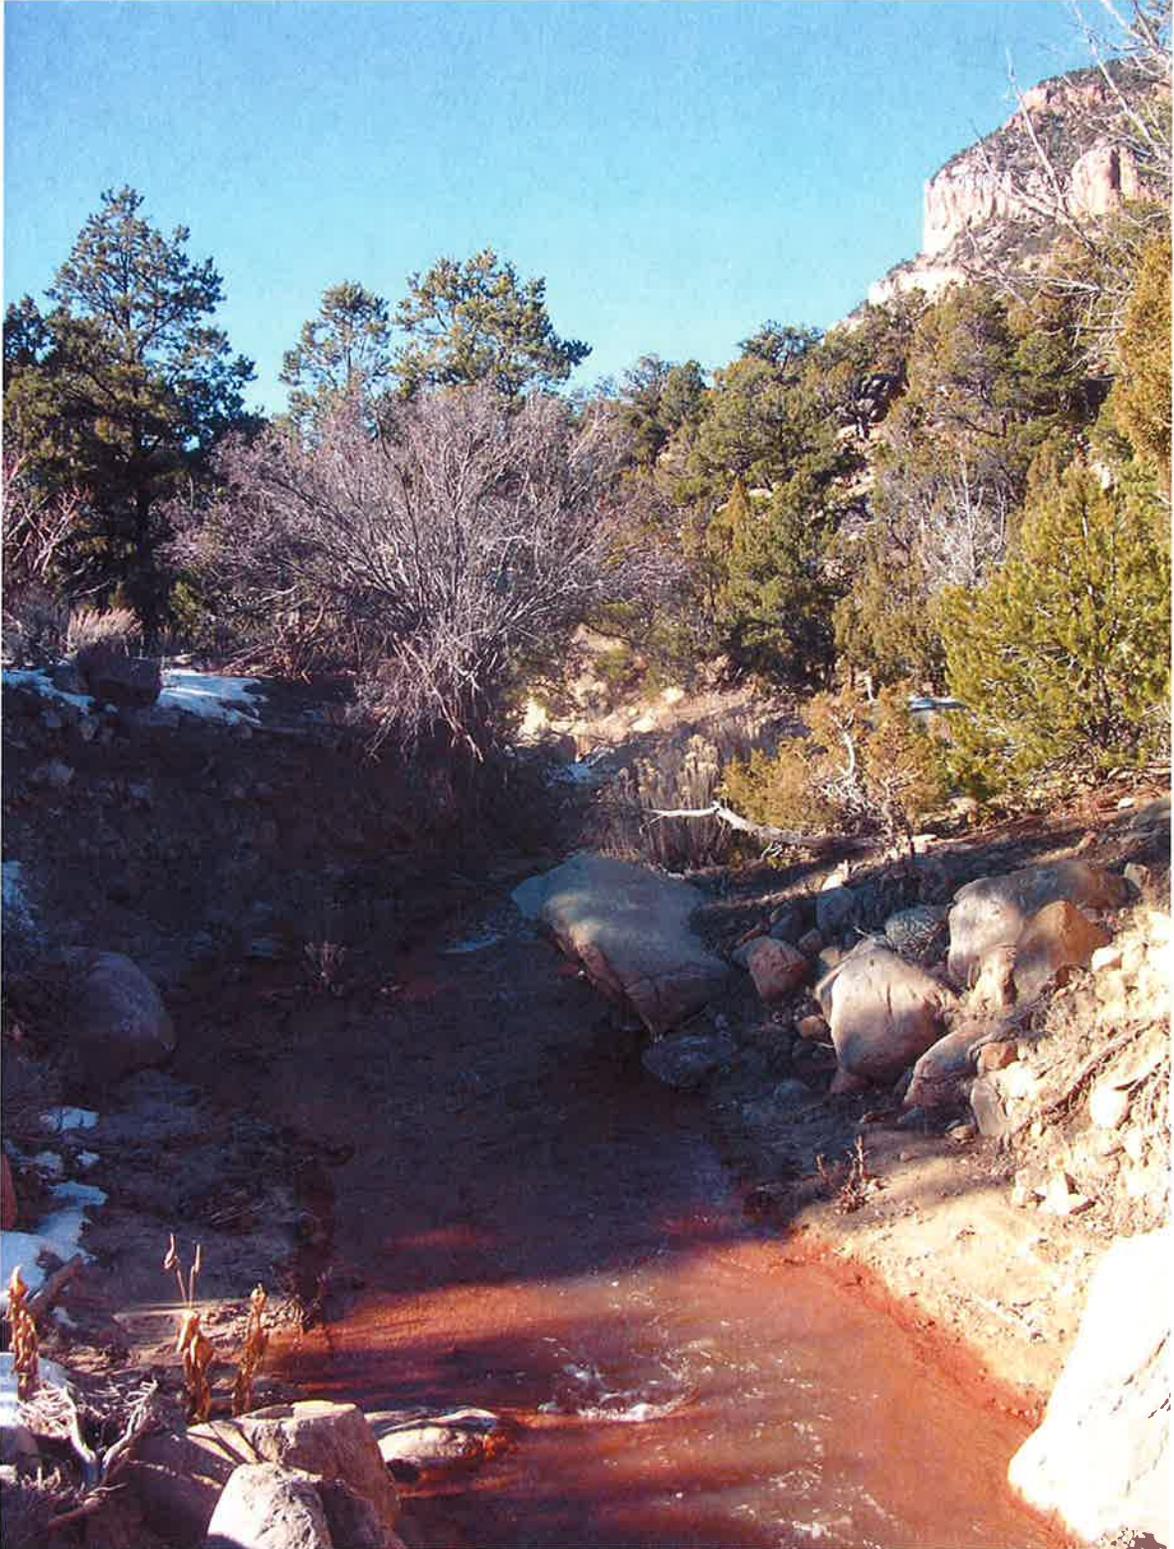
The orange staining within the Pace Creek drainage was observed outside of the permit area. The mine-water discharge is currently being routed into a pre-existing diversion that reports to Clarks Valley Reservoir. According to Dugout representative Vicky Miller, the staining extends from the outlet of UPDES Outfall 005 to the diversion that routes the mine-water to the reservoir.

Pace Canyon Just Below Permit Boundary Looking Downstream

Vicky Miller indicated that the mine-water discharge at Outfall 005 was in compliance for the month of November (based on two sampling events). However, the discharge was out of compliance (per UPDES compliance levels) for TDS. Ms. Miller indicated that an additional in-mine sump/water retention area had come on-line the previous day. She further indicated that continuing work is being done underground to ensure that the mine-water discharge remains compliant. Continued monitoring will be conducted.

In the event that underground efforts are not successful in maintaining compliant mine-water discharge, Ms. Miller indicated that they will submit a mitigation plan to the Division in early January 2011. The plan will consist of installing an underground pipe-line system to route the mine-water discharge to a series of retention ponds. Two retention ponds would be built initially, with the potential for two more. The retention ponds would be constructed on SITLA land outside the opening of Pace Canyon.

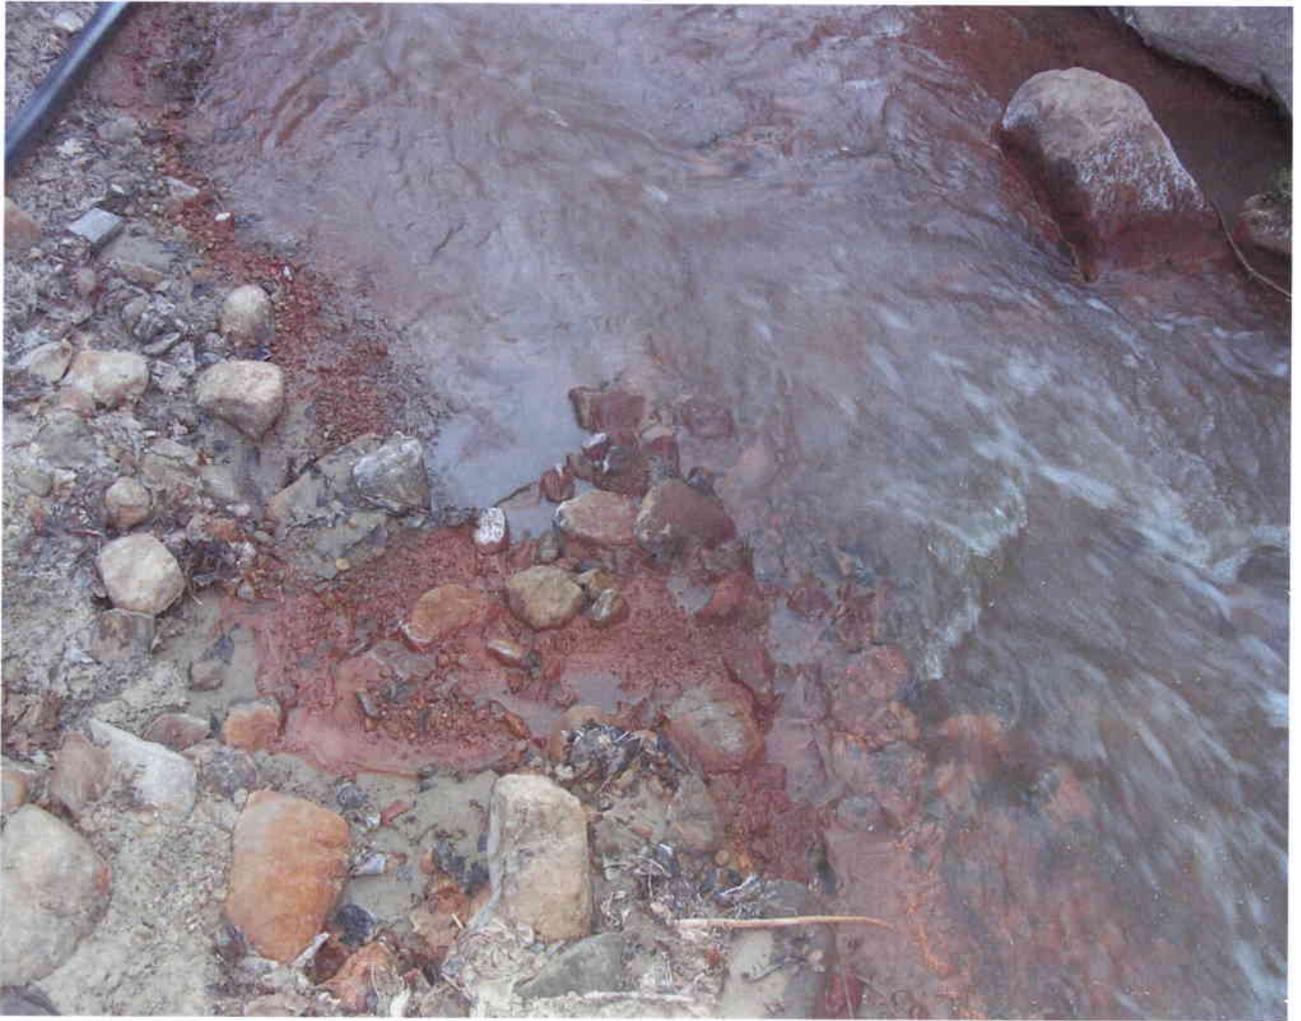
At the time of the inspection orange staining associated with the iron precipitate from the mine-water discharged within the Pace Creek drainage channel at the outlet of Outfall 005. A sample was obtained by Division personnel for laboratory analysis (Sample ID- Pace). At the time of the sampling, the discharge at Outfall 005 produced the following field readings: temperature- 20.3 degrees Celsius, ph- 7.67 and conductivity of 4,043- umhos/cm. The water was slightly turbid.

Photo Showing Iron Precipitate in Pace Creek Just Downstream from Outfall 005

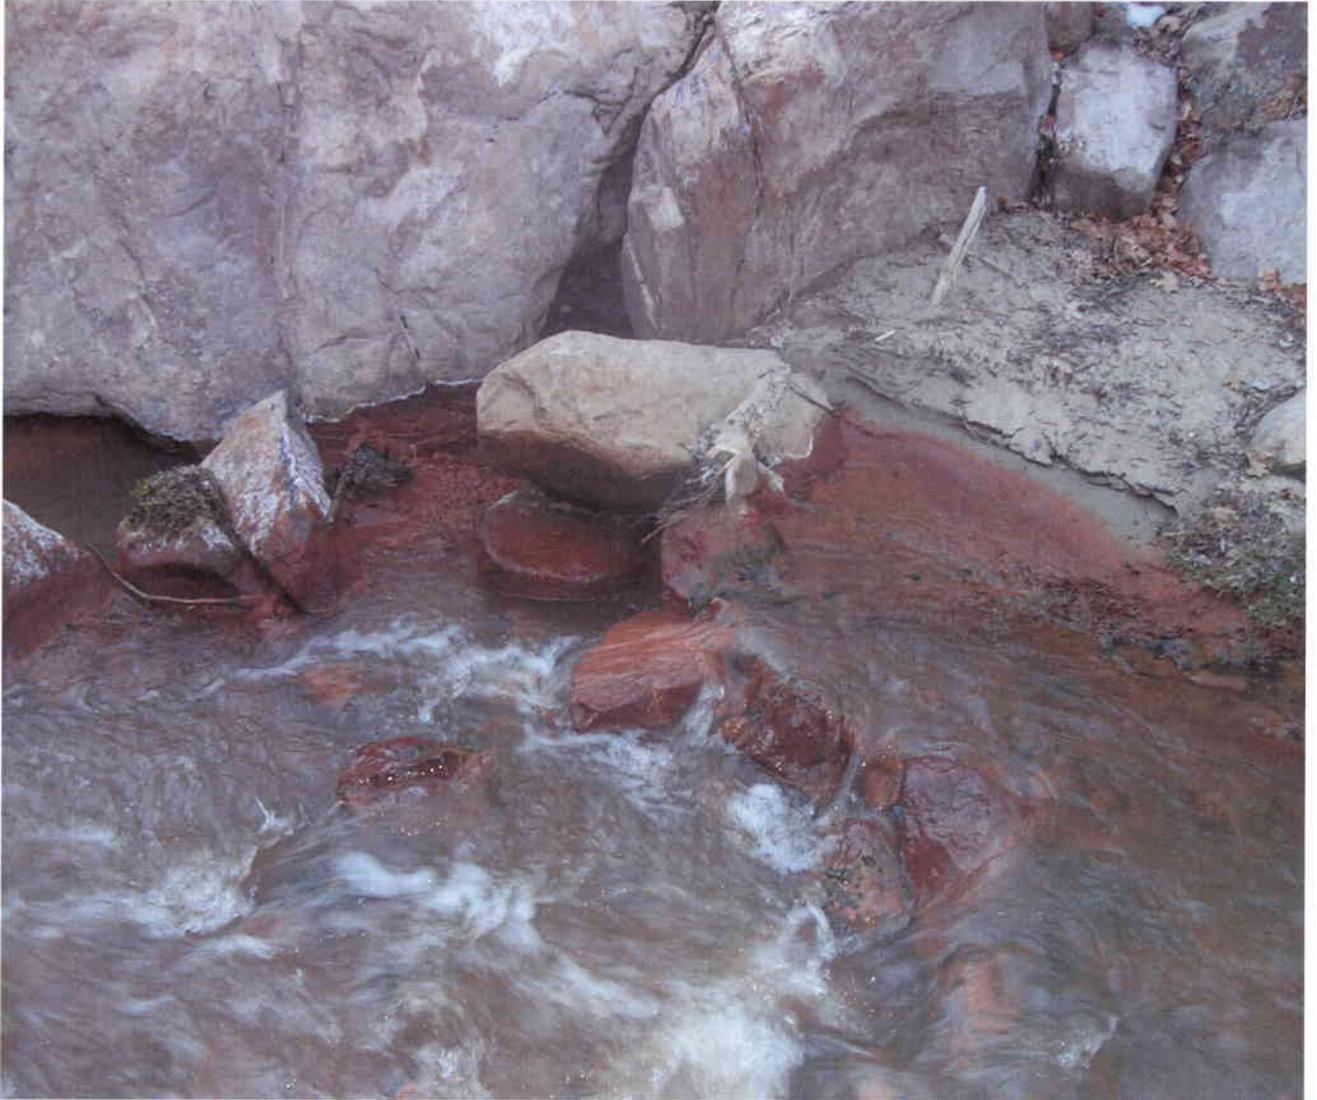
Photo Showing Iron Precipitate in Pace Creek Just Downstream from Outfall 005
