# Inspection Report

Permit Number:	<b>C0070042</b>
Inspection Type:	COMPLETE
Inspection Date:	Wednesday, November 16, 2016
Start Date/Time:	11/16/2016 9:00:00 AM
End Date/Time:	11/16/2016 12:00:00 PM
Last Inspection:	Tuesday, October 18, 2016

Permittee: **SUNNYSIDE COGENERATION ASSOCIATES**  
 Operator: **SUNNYSIDE COGENERATION ASSOCIATES**  
 Site: **STAR POINT REFUSE**  
 Address: **PO BOX 159, SUNNYSIDE UT 84539**  
 County: **CARBON**  
 Permit Type: **PERMANENT COAL PROGRAM**  
 Permit Status: **ACTIVE**

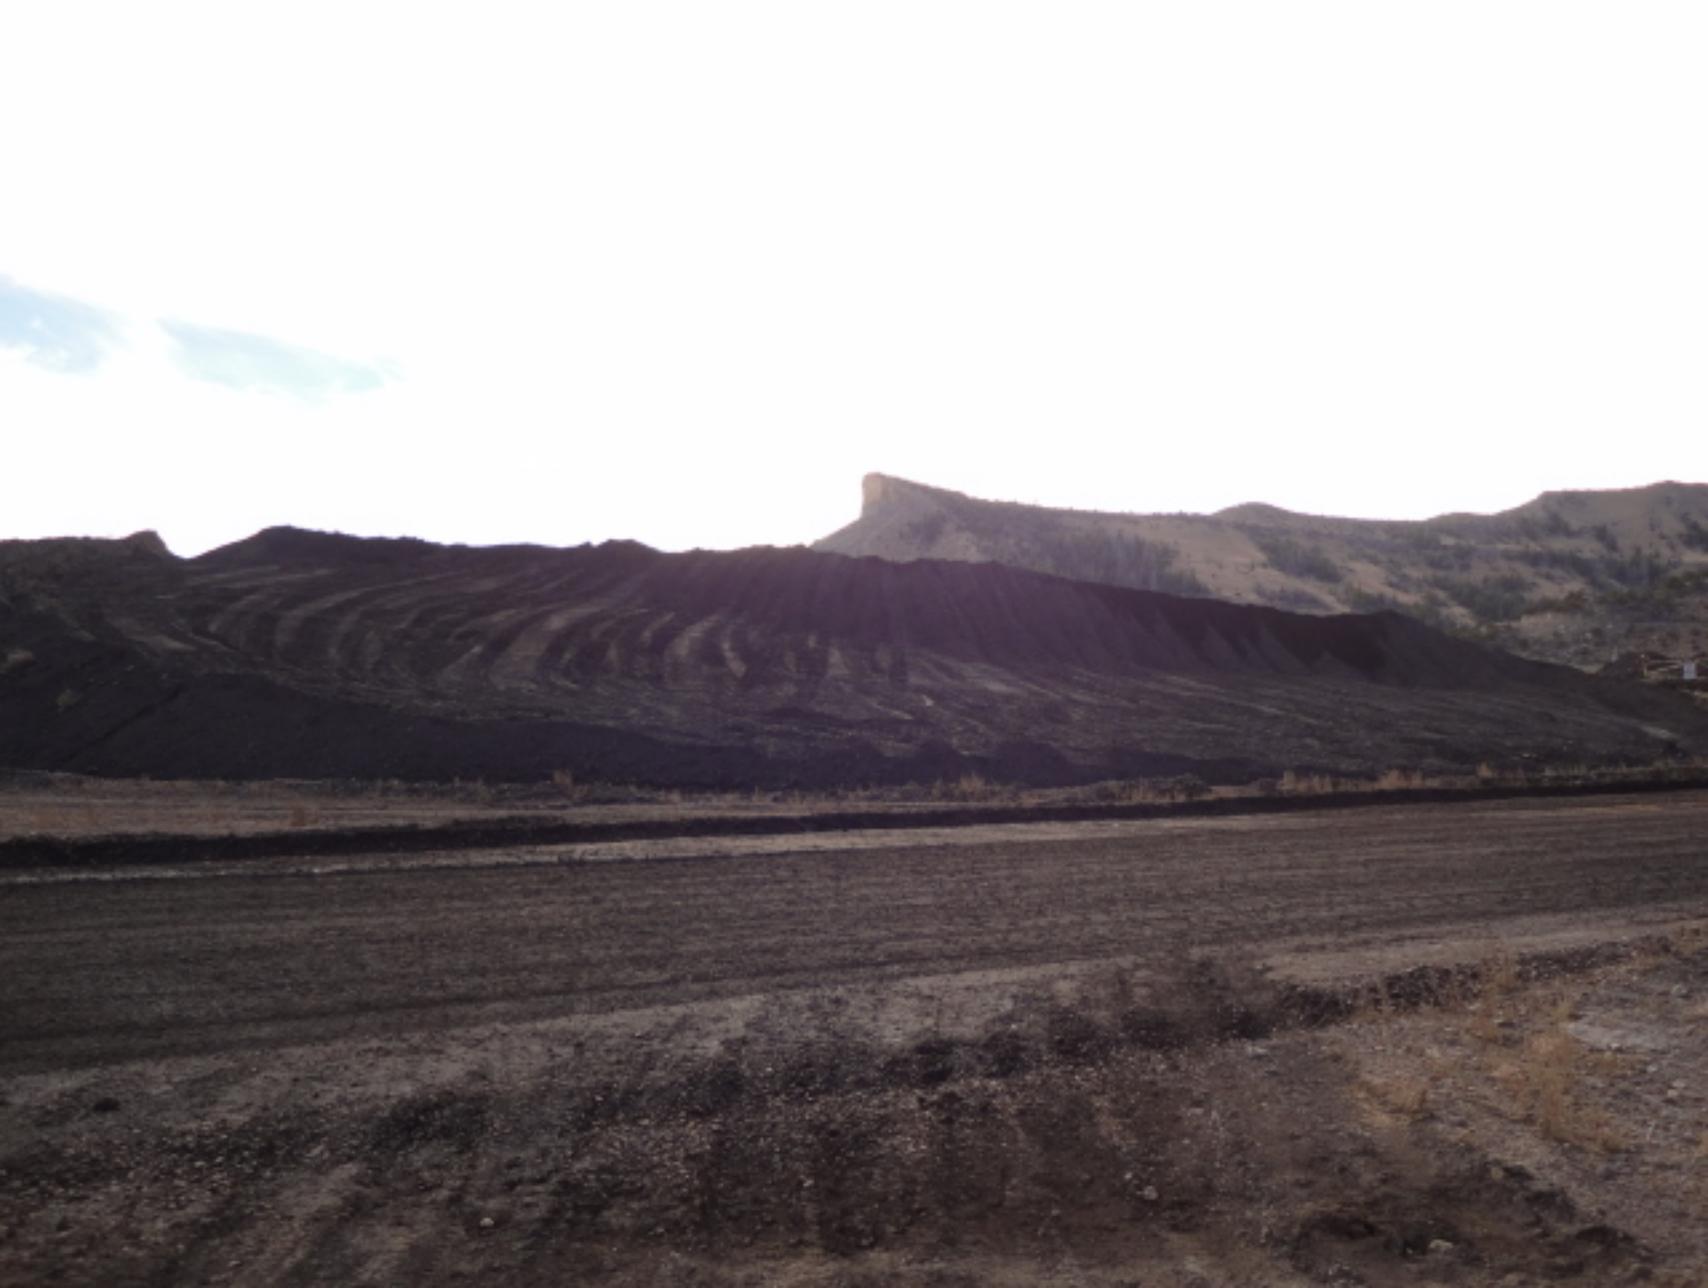
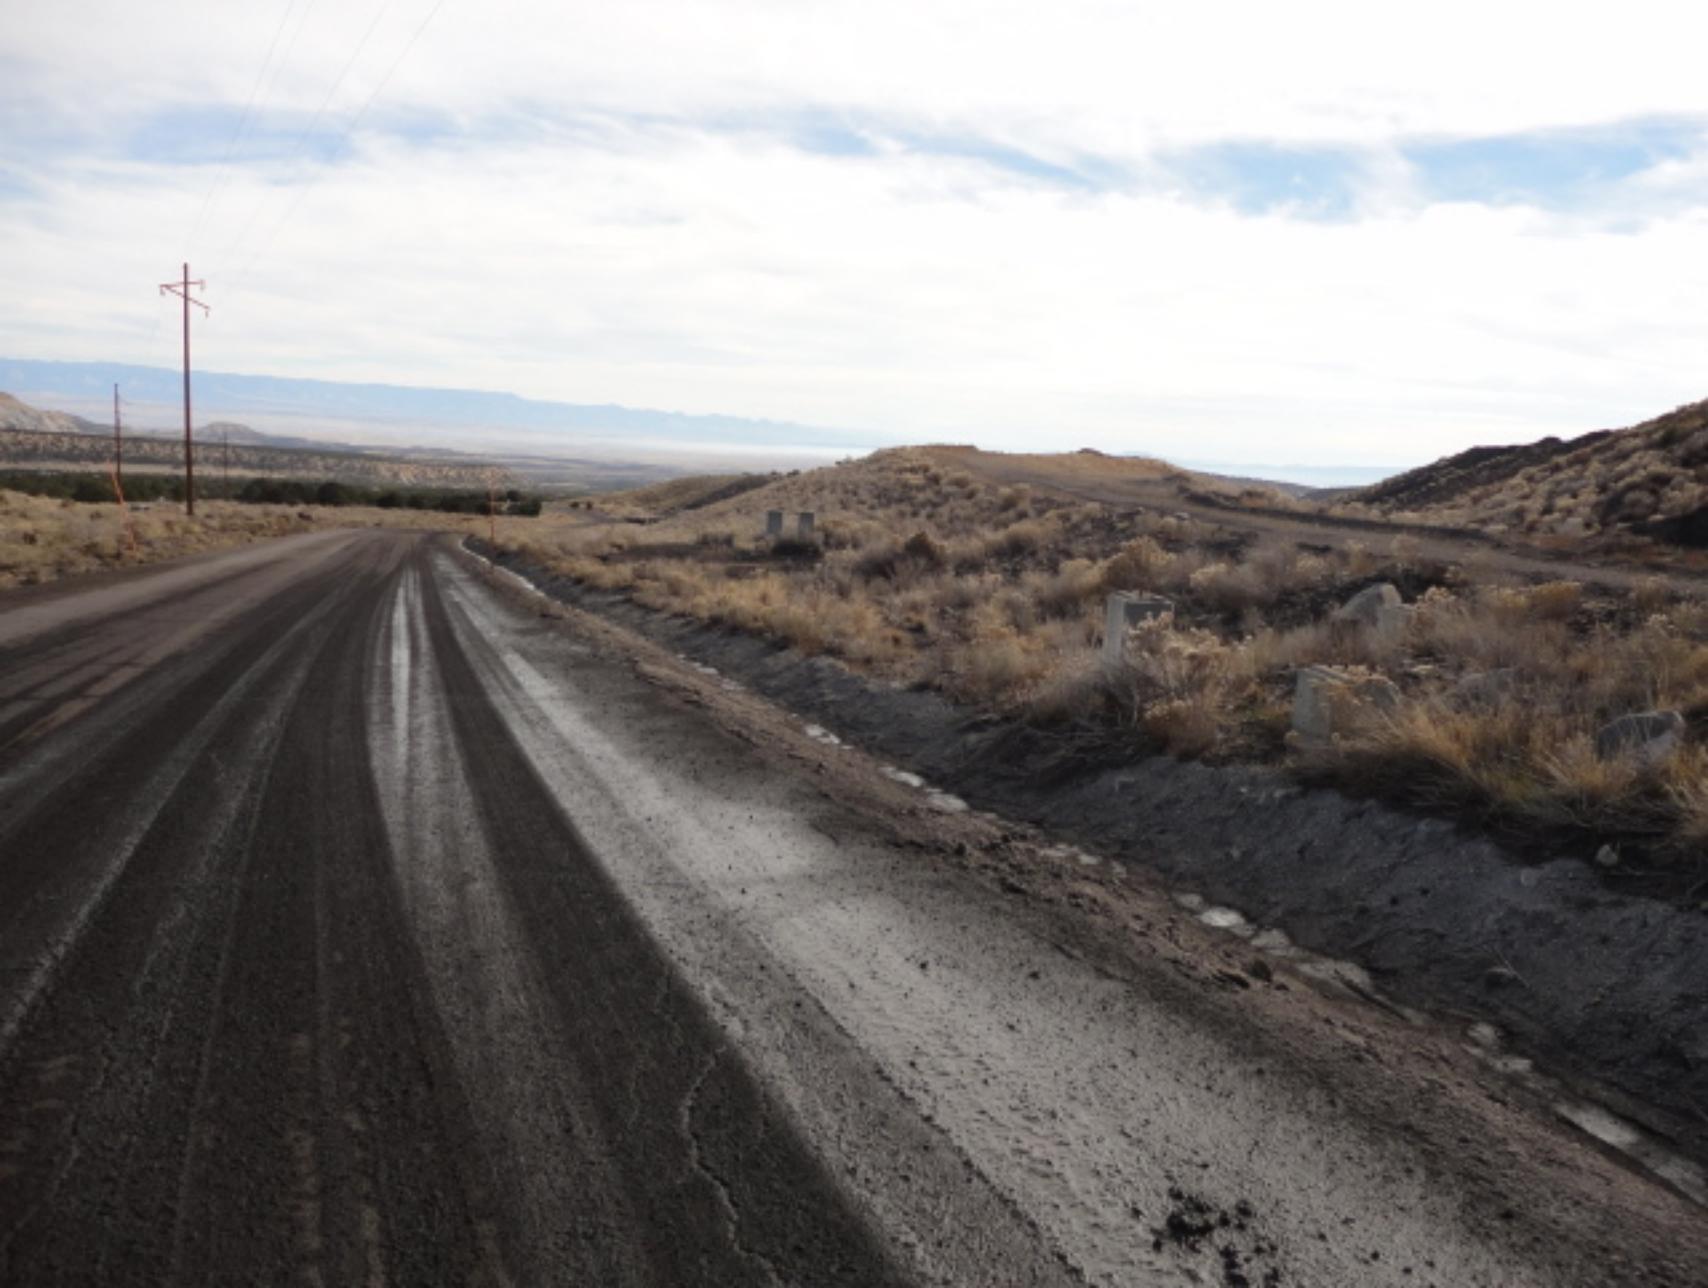
I inspected diversions and culverts throughout the property. They were open and function as designed during a storm event. See photos

I inspected diversions and culverts throughout the property. They were open and function as designed during a storm event. The structures were recently re-graded and clean out of sediment. Embankments appear to be stable. The sediment ponds contained water but was not discharging. The third quarter sediment pond inspection was taken on September 23, 2016. See photos

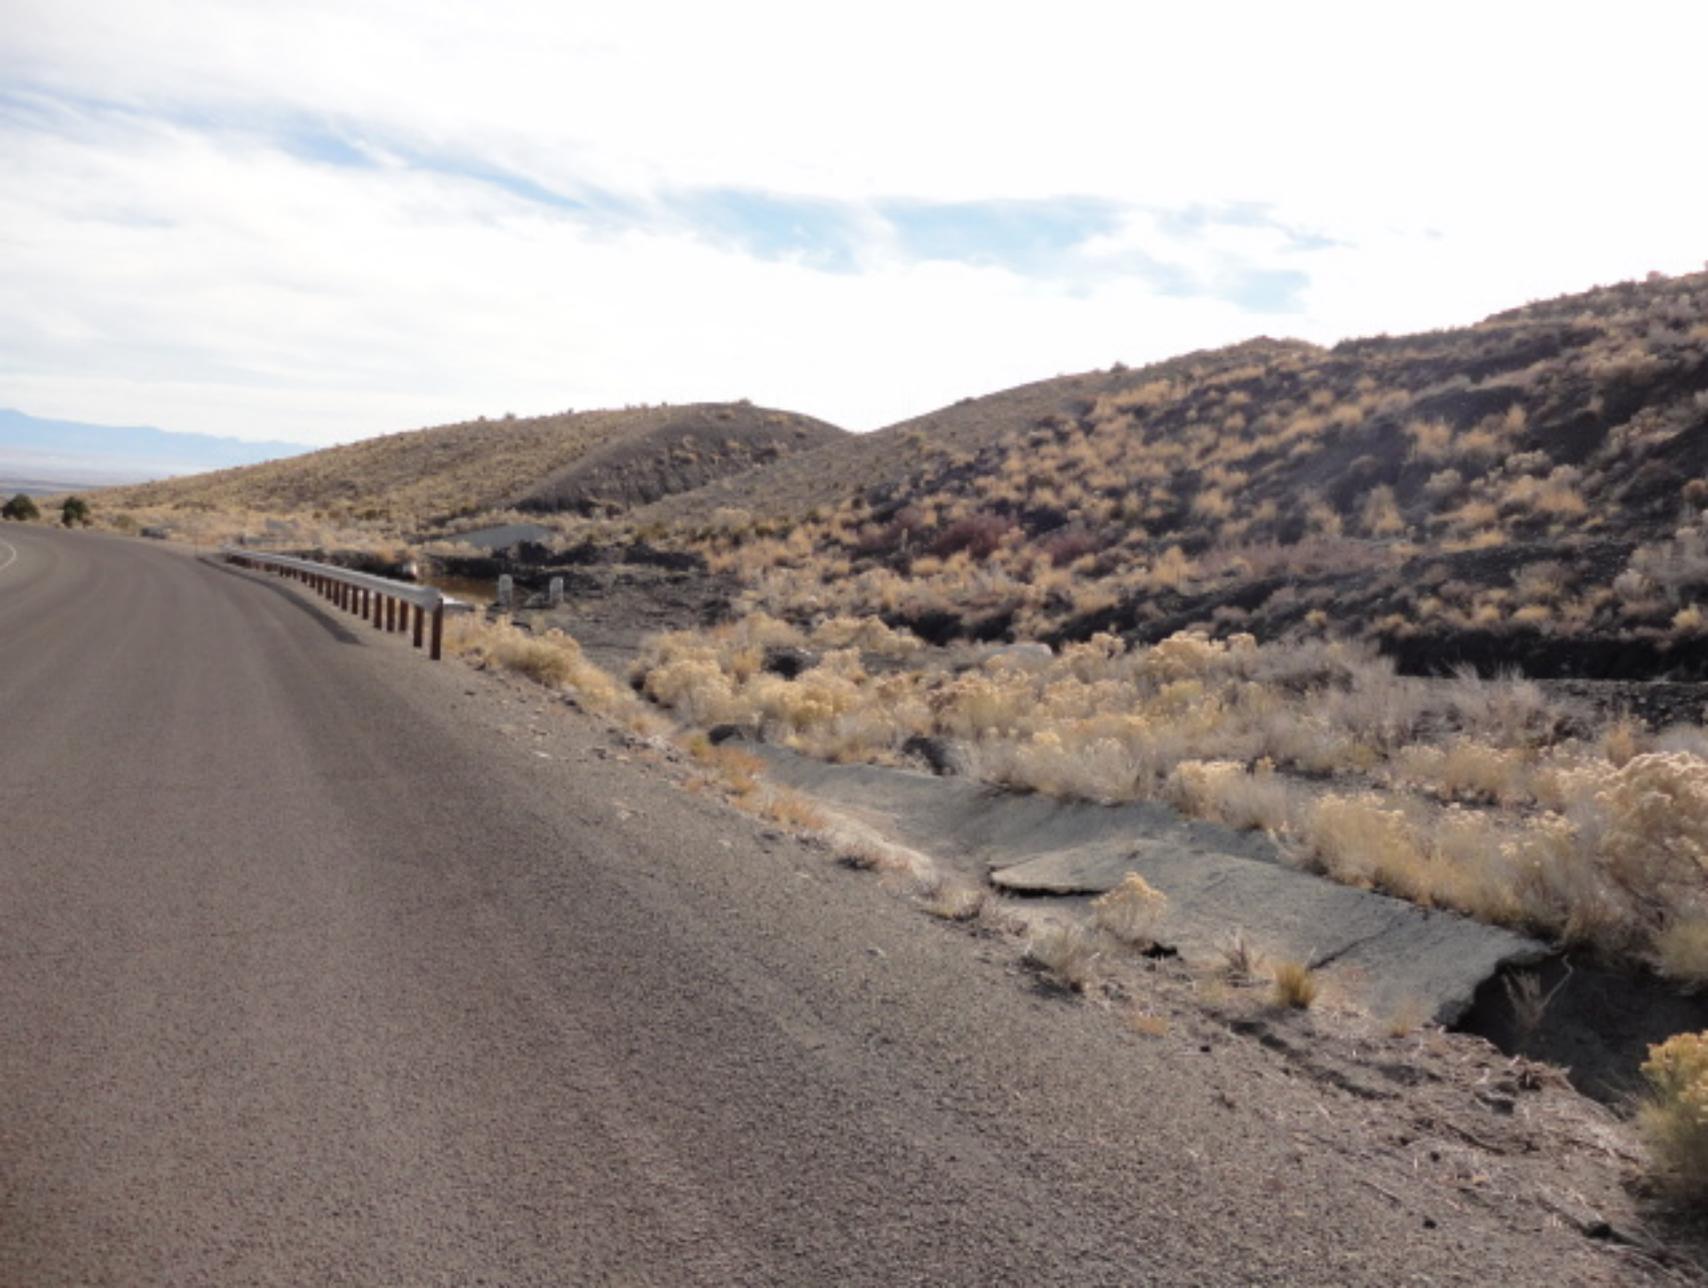
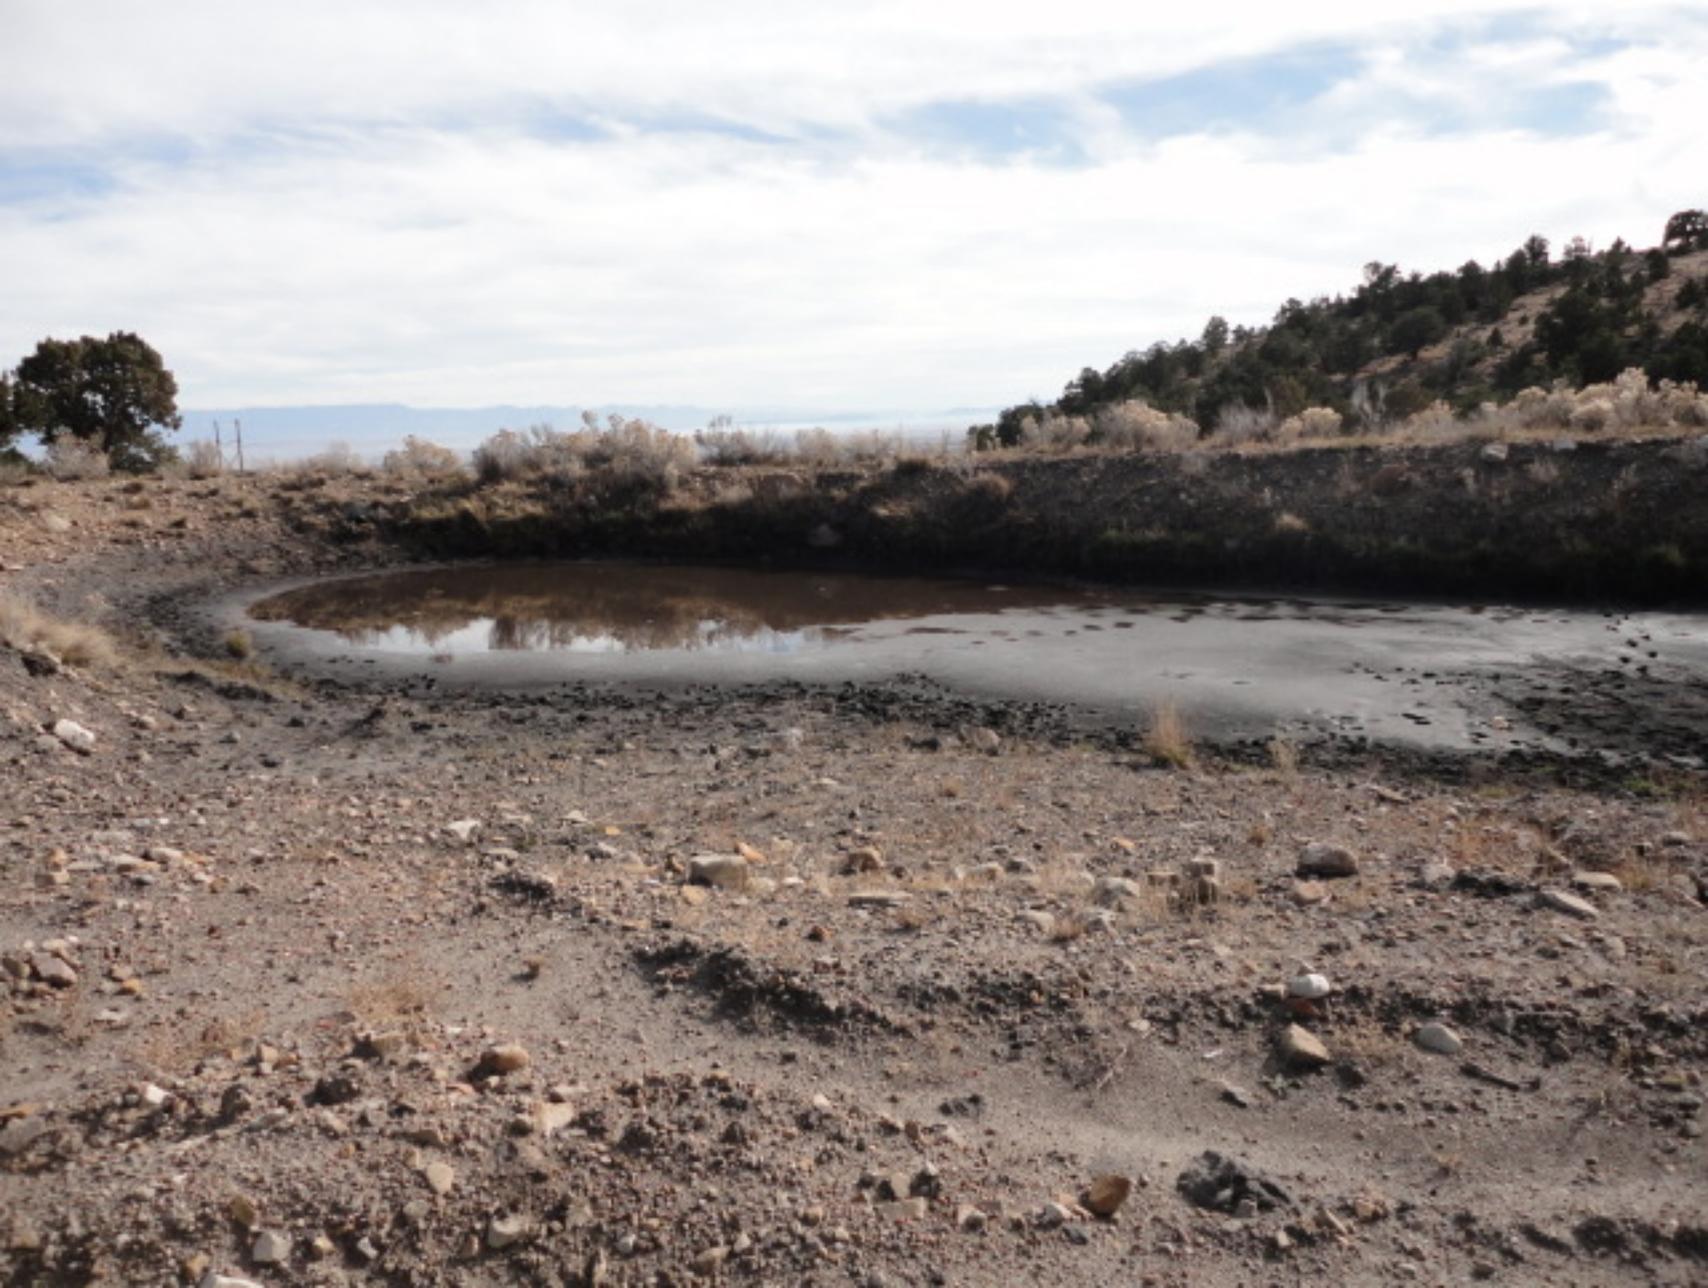
I inspected the refuse pile and it appears to be stable. I did not notice any hazardous conditions to the embankments. The refuse pile is active. The permittee conducted a third quarter refuse pile inspection on September 23, 2016. This document is P.E. certified. No hazardous conditions were reported. See Photos

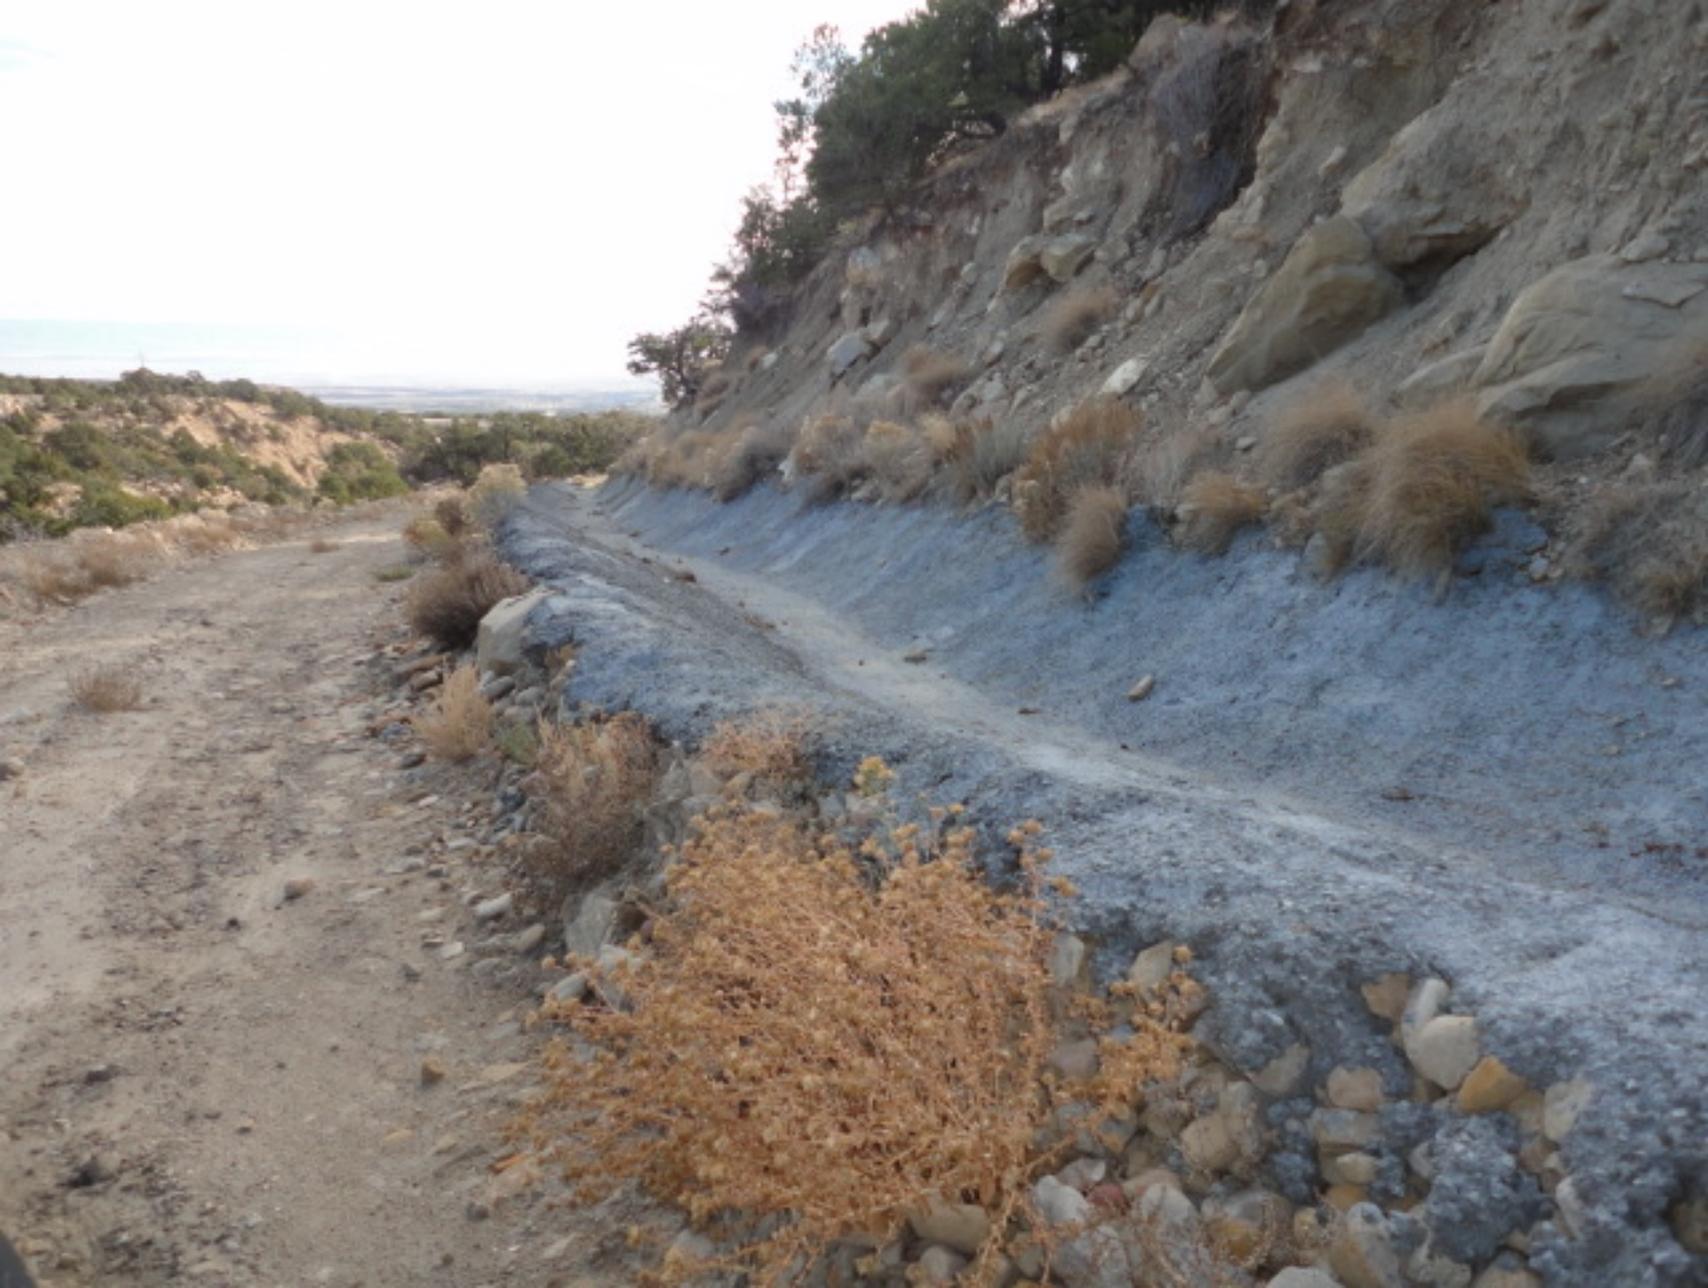
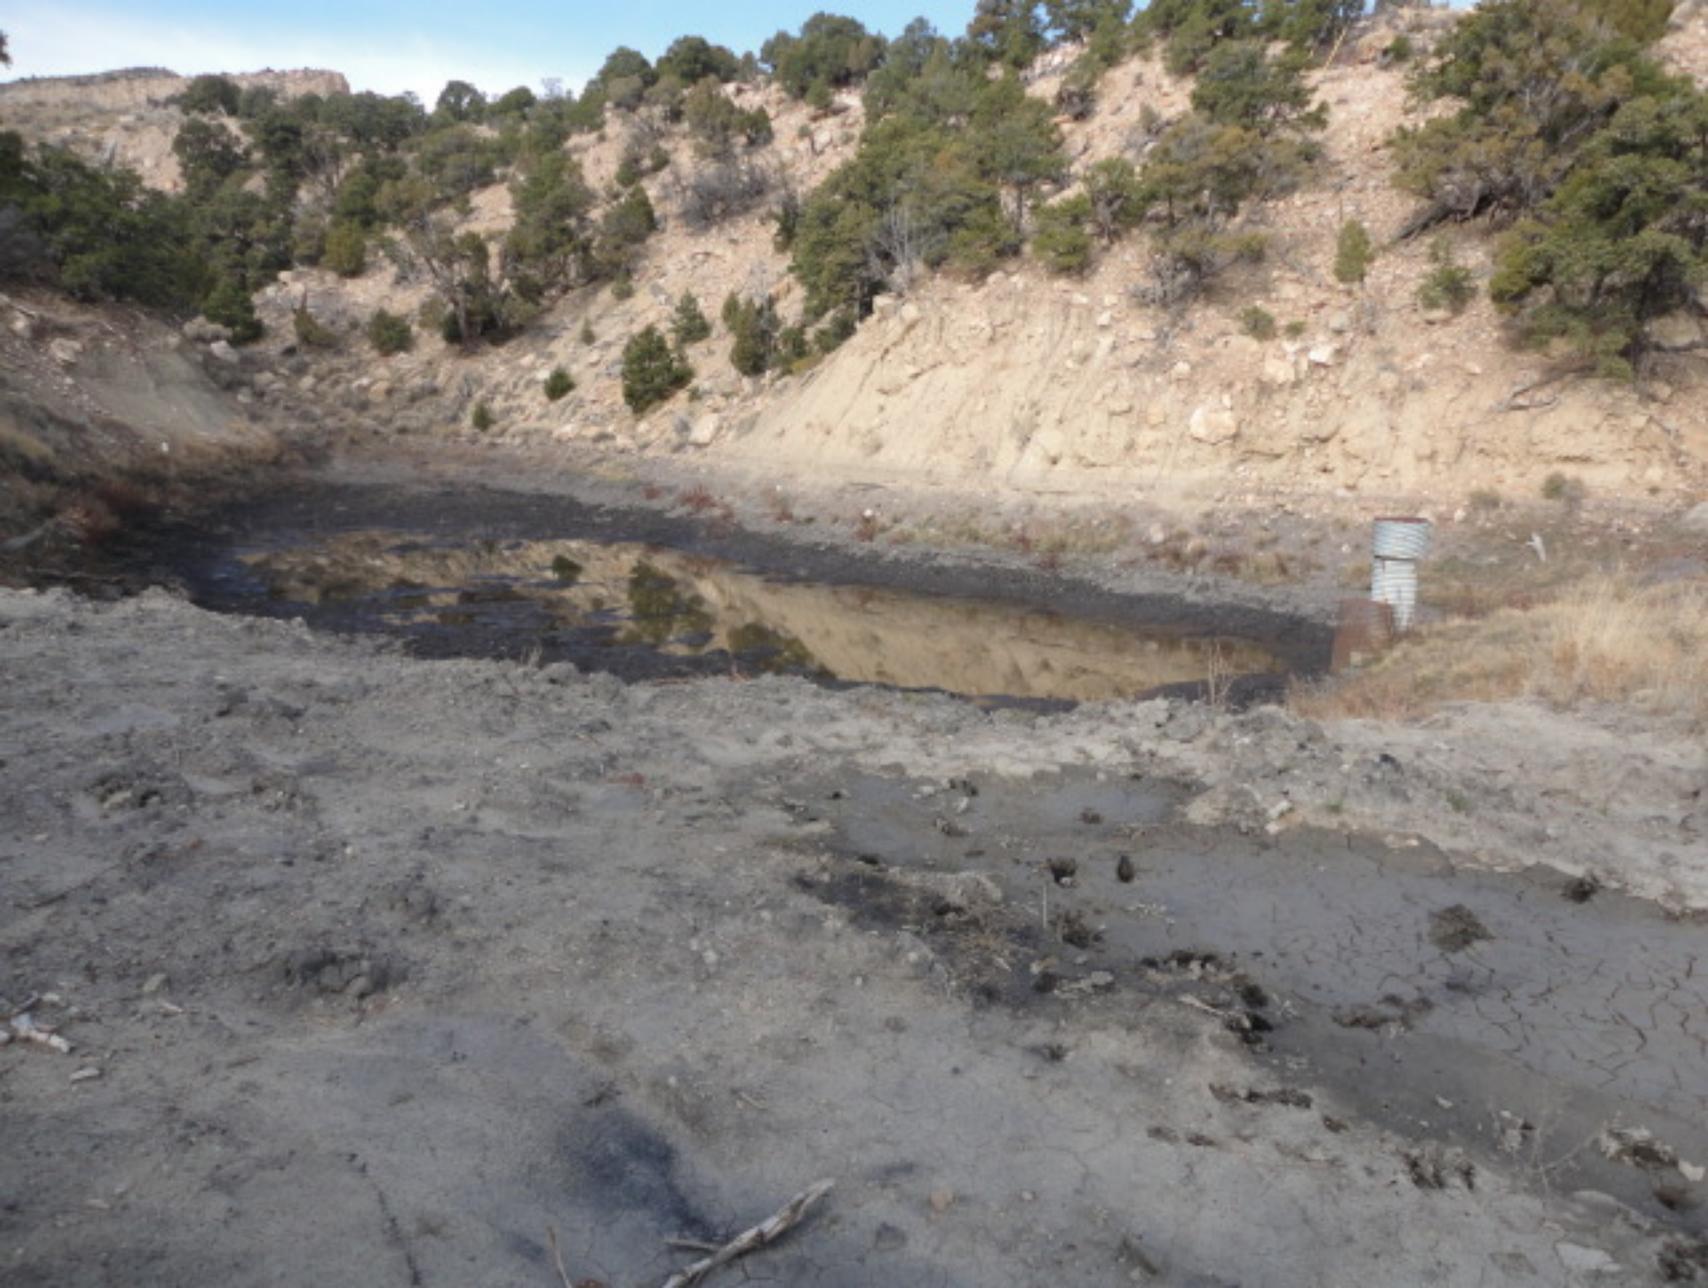
I inspected the road diversions and culverts throughout the property. They were functioning as designed. See Photos
