# Inspection Report

Permit Number:	<b>C0070042</b>
Inspection Type:	COMPLETE
Inspection Date:	Monday, February 27, 2017
Start Date/Time:	2/27/2017 9:00:00 AM
End Date/Time:	2/27/2017 12:30:00 PM
Last Inspection:	Tuesday, January 24, 2017

Permitee: **SUNNYSIDE COGENERATION ASSOCIATES**  
 Operator: **SUNNYSIDE COGENERATION ASSOCIATES**  
 Site: **STAR POINT REFUSE**  
 Address: **PO BOX 159, SUNNYSIDE UT 84539**  
 County: **CARBON**  
 Permit Type: **PERMANENT COAL PROGRAM**  
 Permit Status: **ACTIVE**

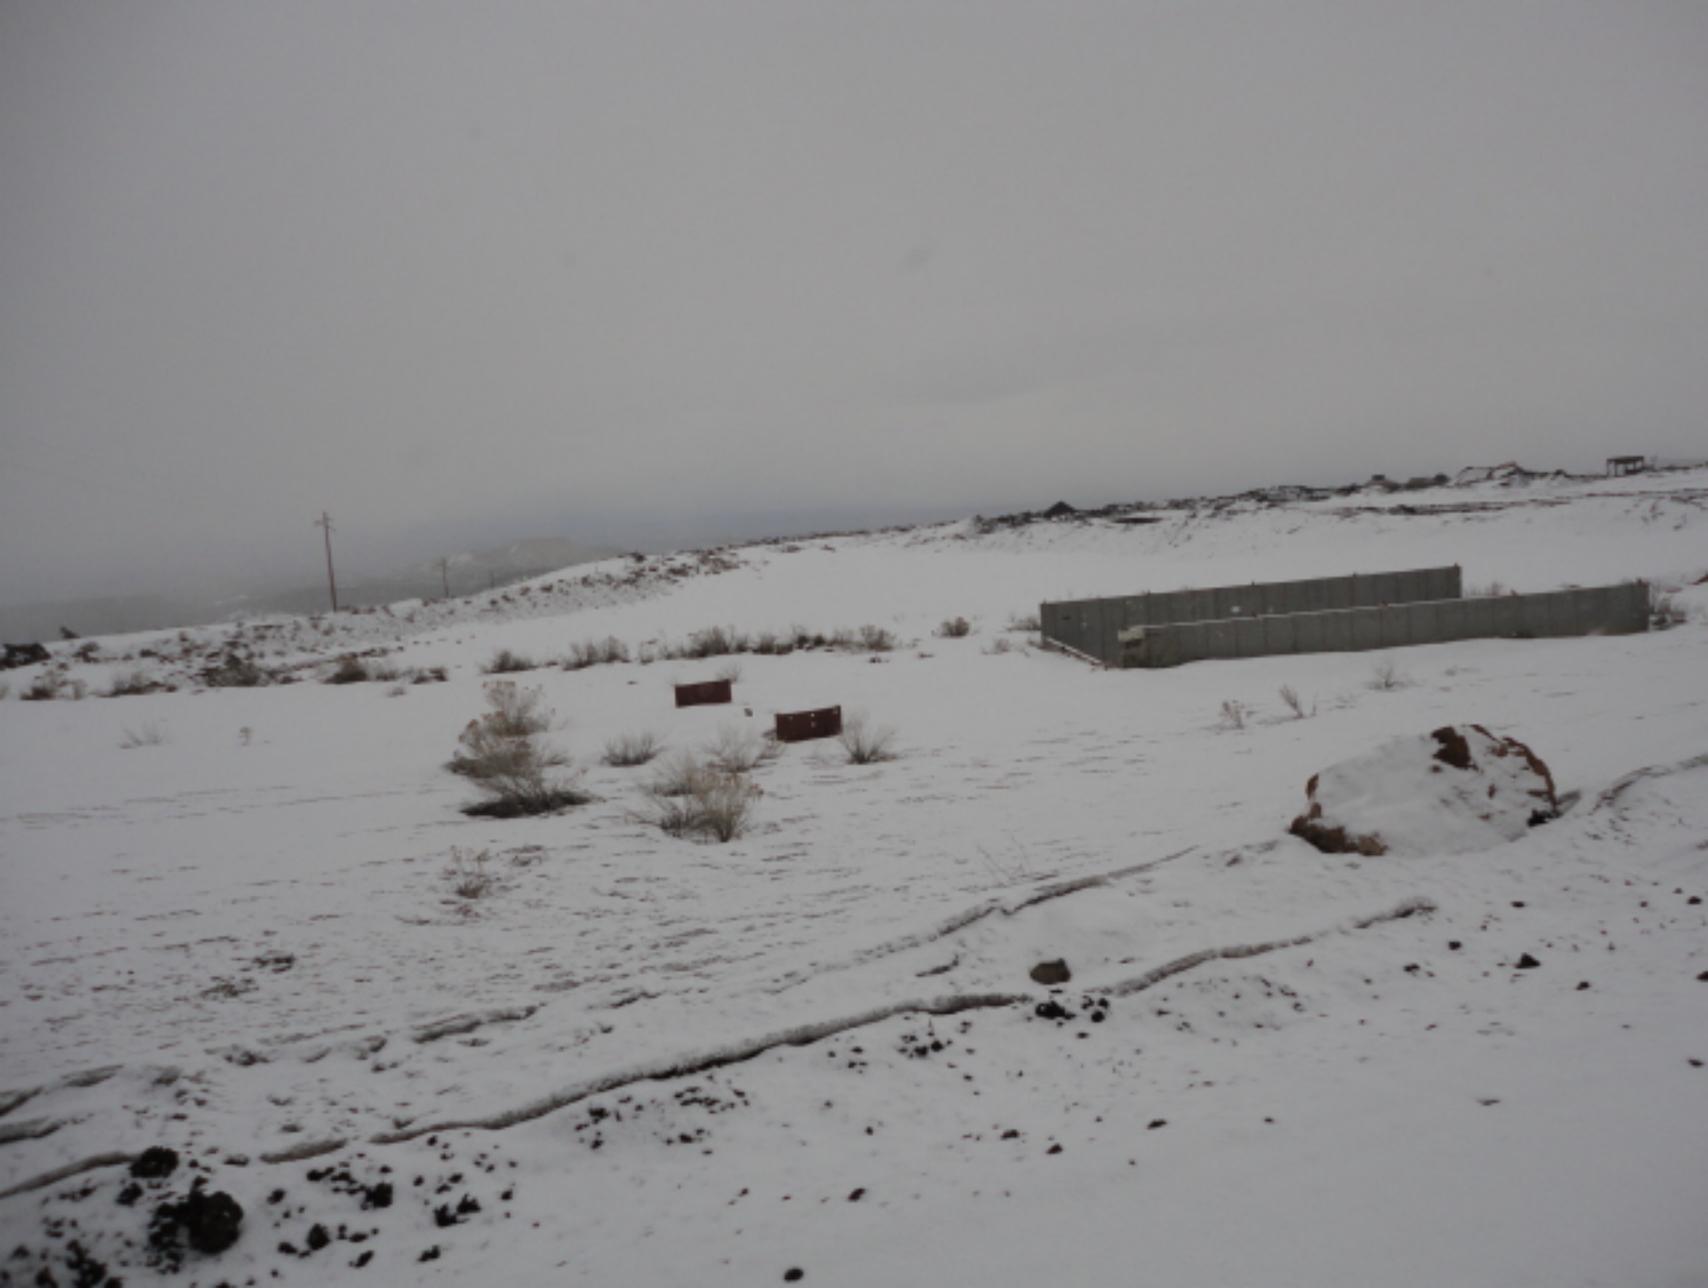
I inspected the identification sign and it meets the requirements of the R645 Coal Rules. The sign has all the required information. See Photo

**Star Point Waste Fuel**  
MSHA-ID #42-02334  
SUNNYSIDE COGEN ASS.  
C-007-042  
REFUSE PILE.  
1211-UT-09-02334-01  
1 POWER PLANT RD., SUNNYSIDE UTAH 435-888-4476

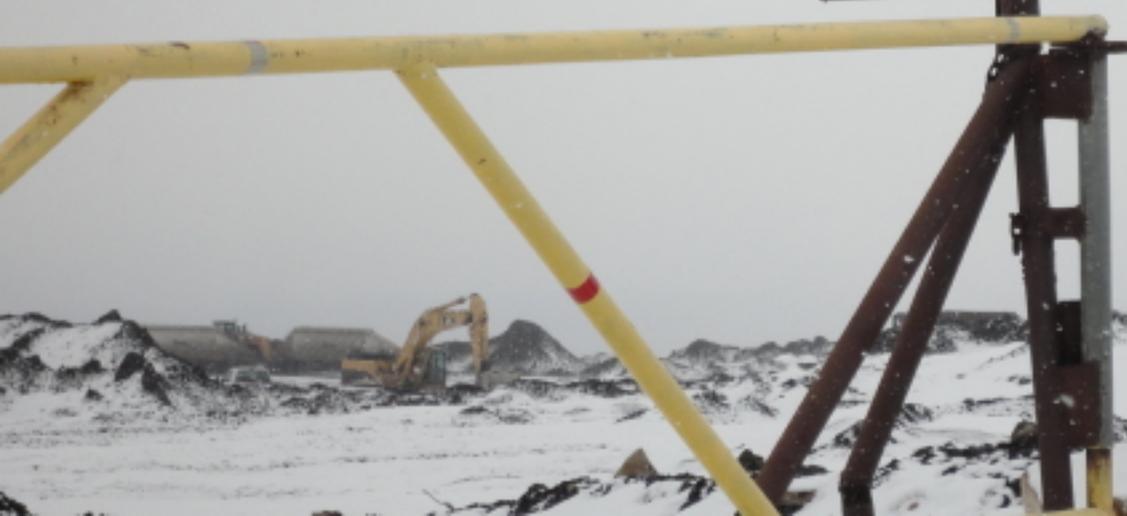
I inspected the refuse pile and it appears to be stable. I did not notice any hazardous conditions to the embankments. The refuse pile is active. The permittee conducted a fourth quarter refuse pile inspection on December 22, 2016. This document is P.E. certified. No hazardous conditions were reported. See Photos

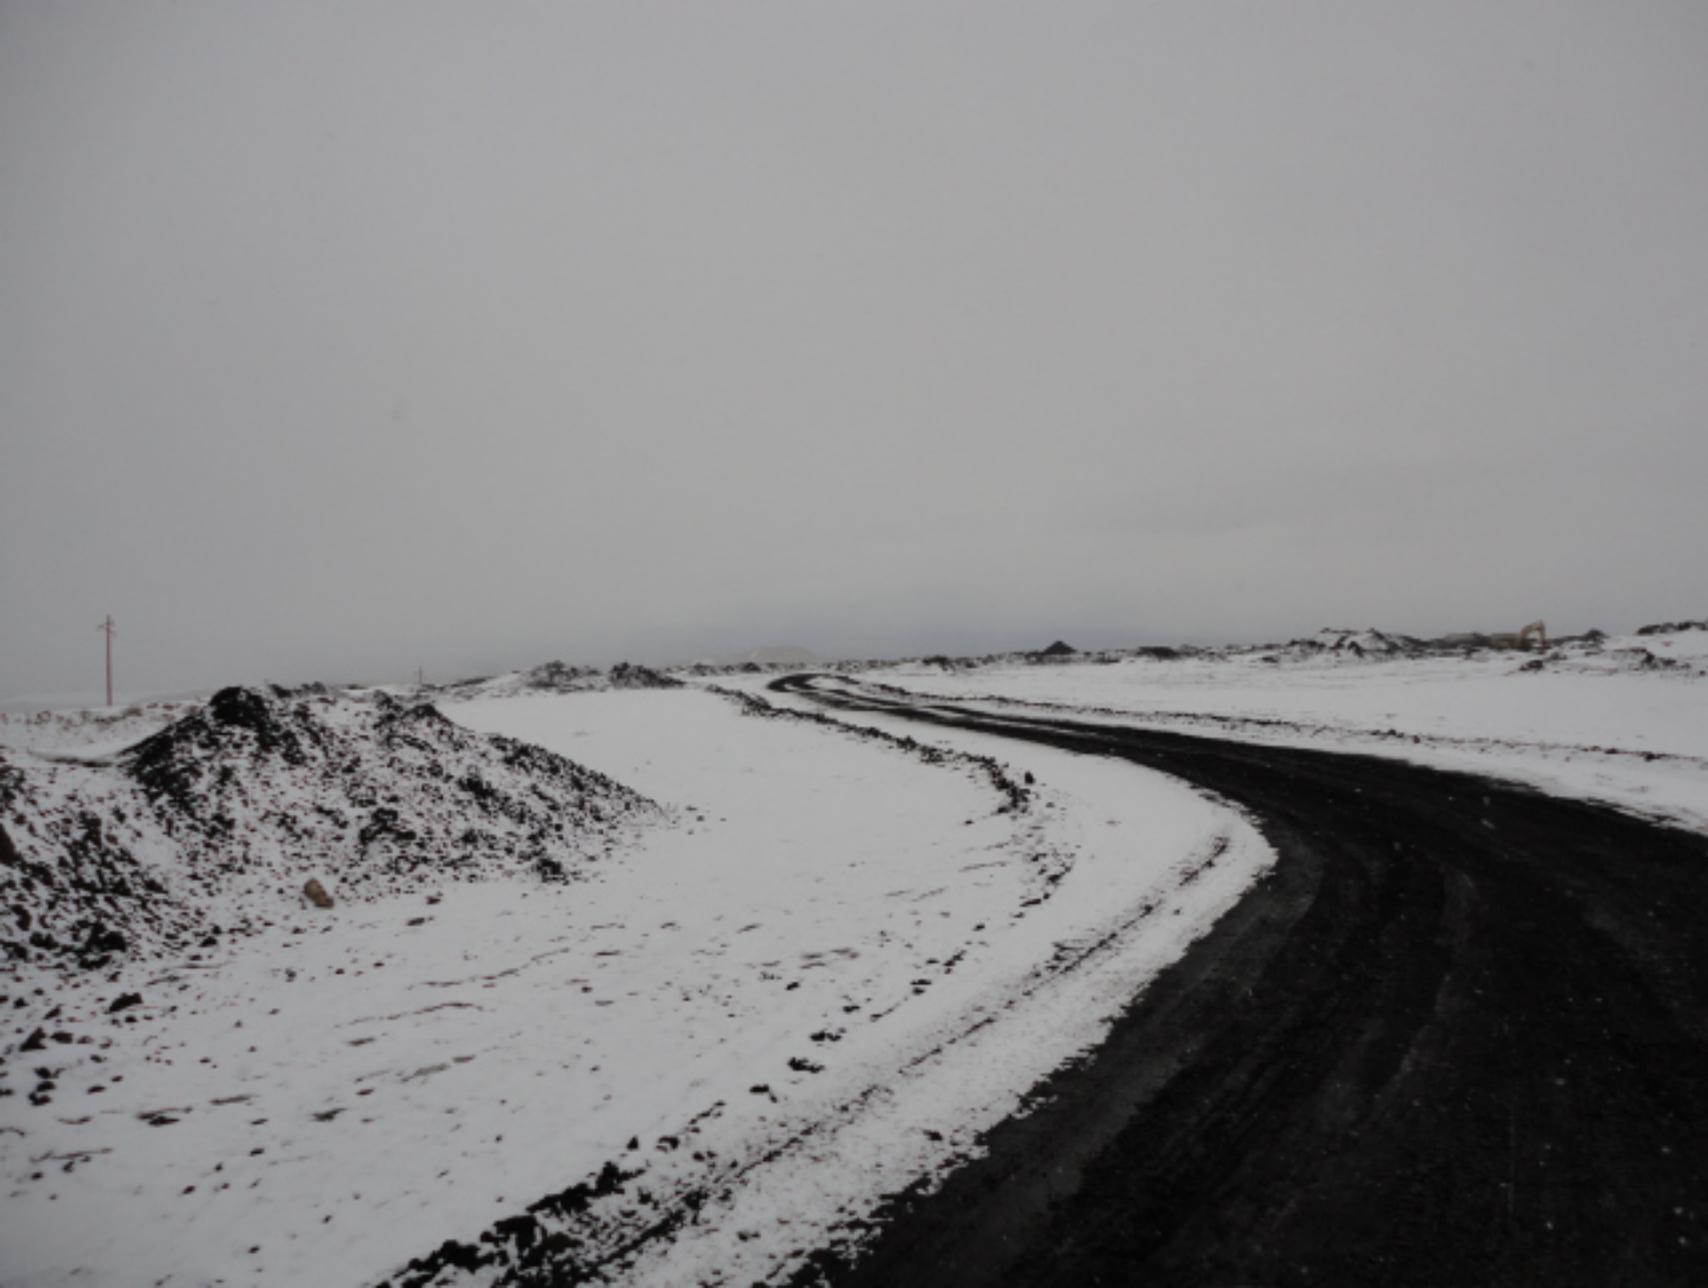
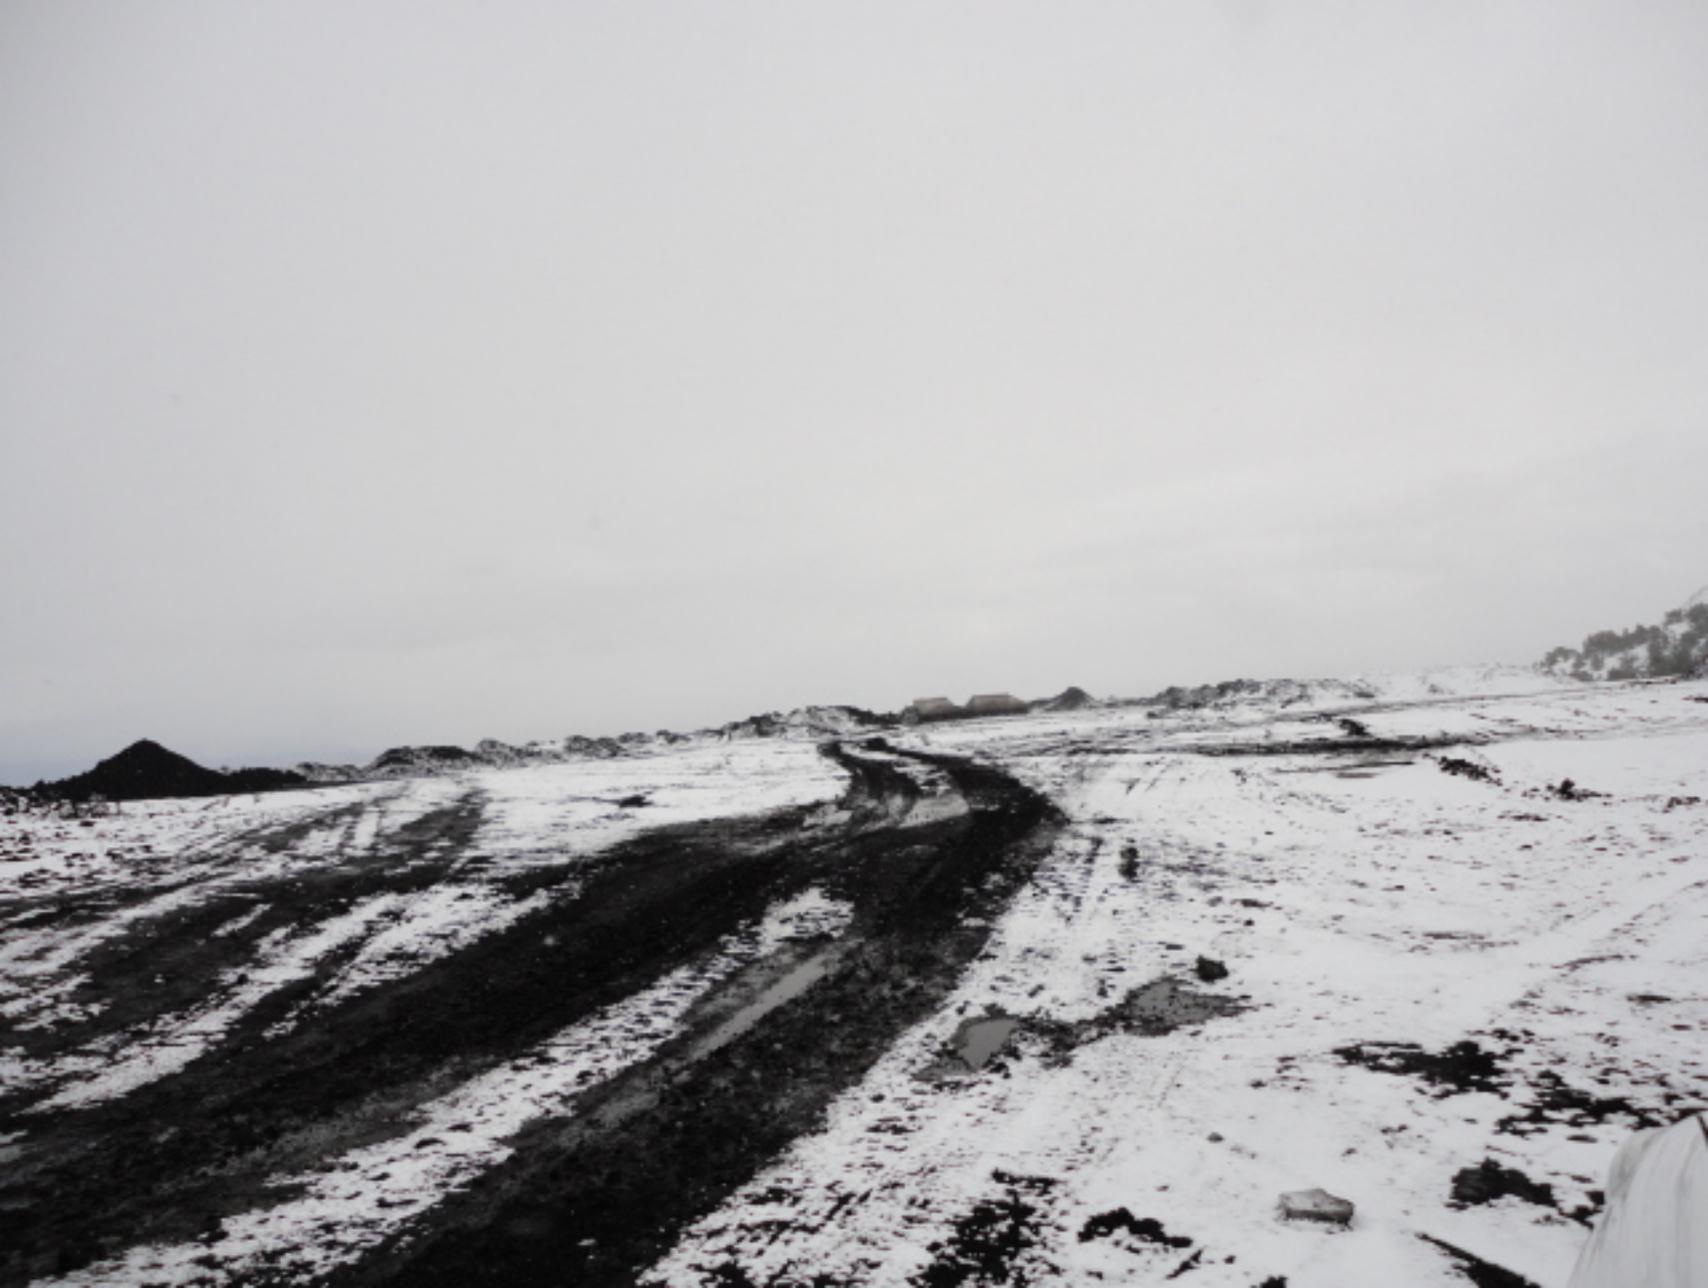
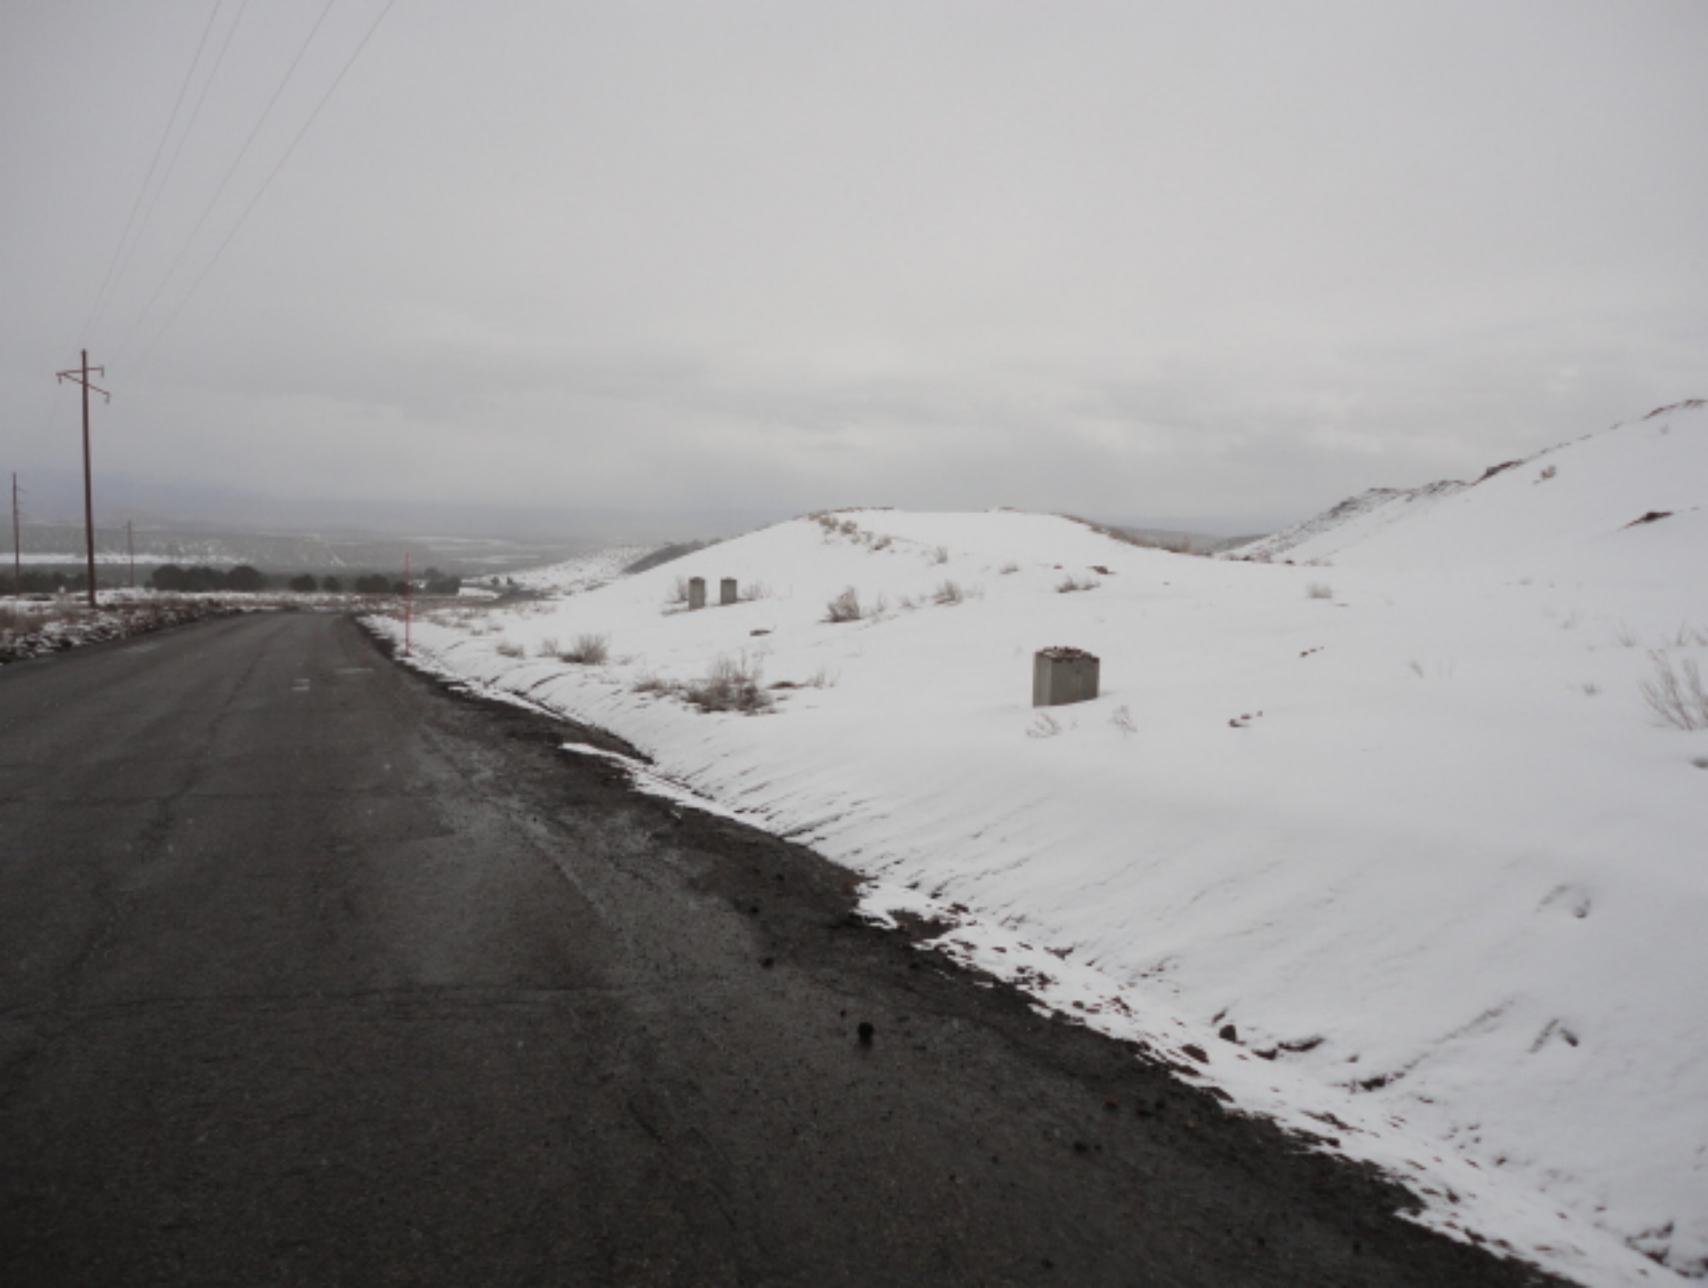
The refuse pile was active. Trucks were getting loaded to transport refuse material to the Sunnyside Co-Gen Plant. See Photos  
 The permit area was snow covered. It was impossible to go to all areas due to the snow cover.

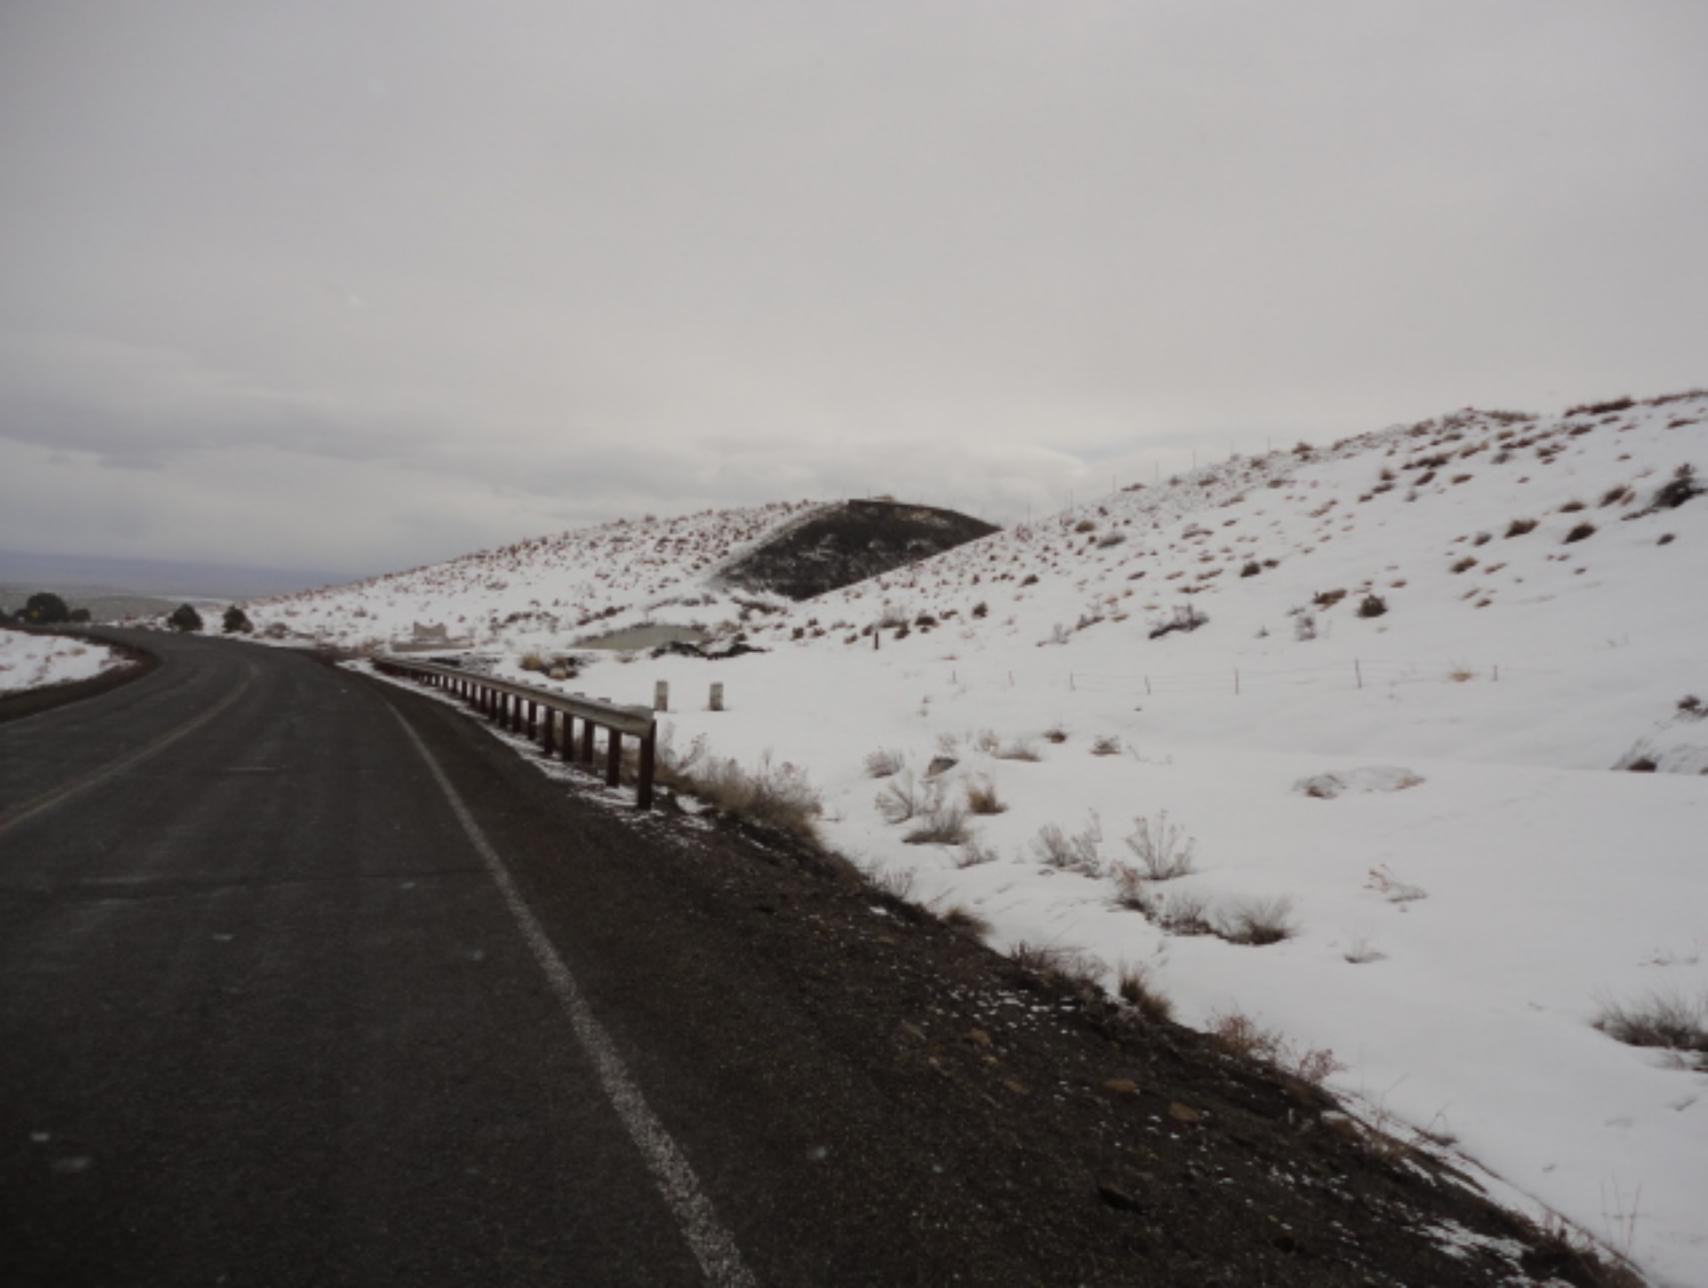
The road diversions and culverts were snow covered. See Photo
