Inspection Report

Permit Number:	C0070042
Inspection Type:	PARTIAL
Inspection Date:	Thursday, April 06, 2017
Start Date/Time:	4/6/2017 9:00:00 AM
End Date/Time:	4/6/2017 12:00:00 PM
Last Inspection:	Monday, March 20, 2017

Permitee: **SUNNYSIDE COGENERATION ASSOCIATES**
 Operator: **SUNNYSIDE COGENERATION ASSOCIATES**
 Site: **STAR POINT REFUSE**
 Address: **PO BOX 159, SUNNYSIDE UT 84539**
 County: **CARBON**
 Permit Type: **PERMANENT COAL PROGRAM**
 Permit Status: **ACTIVE**

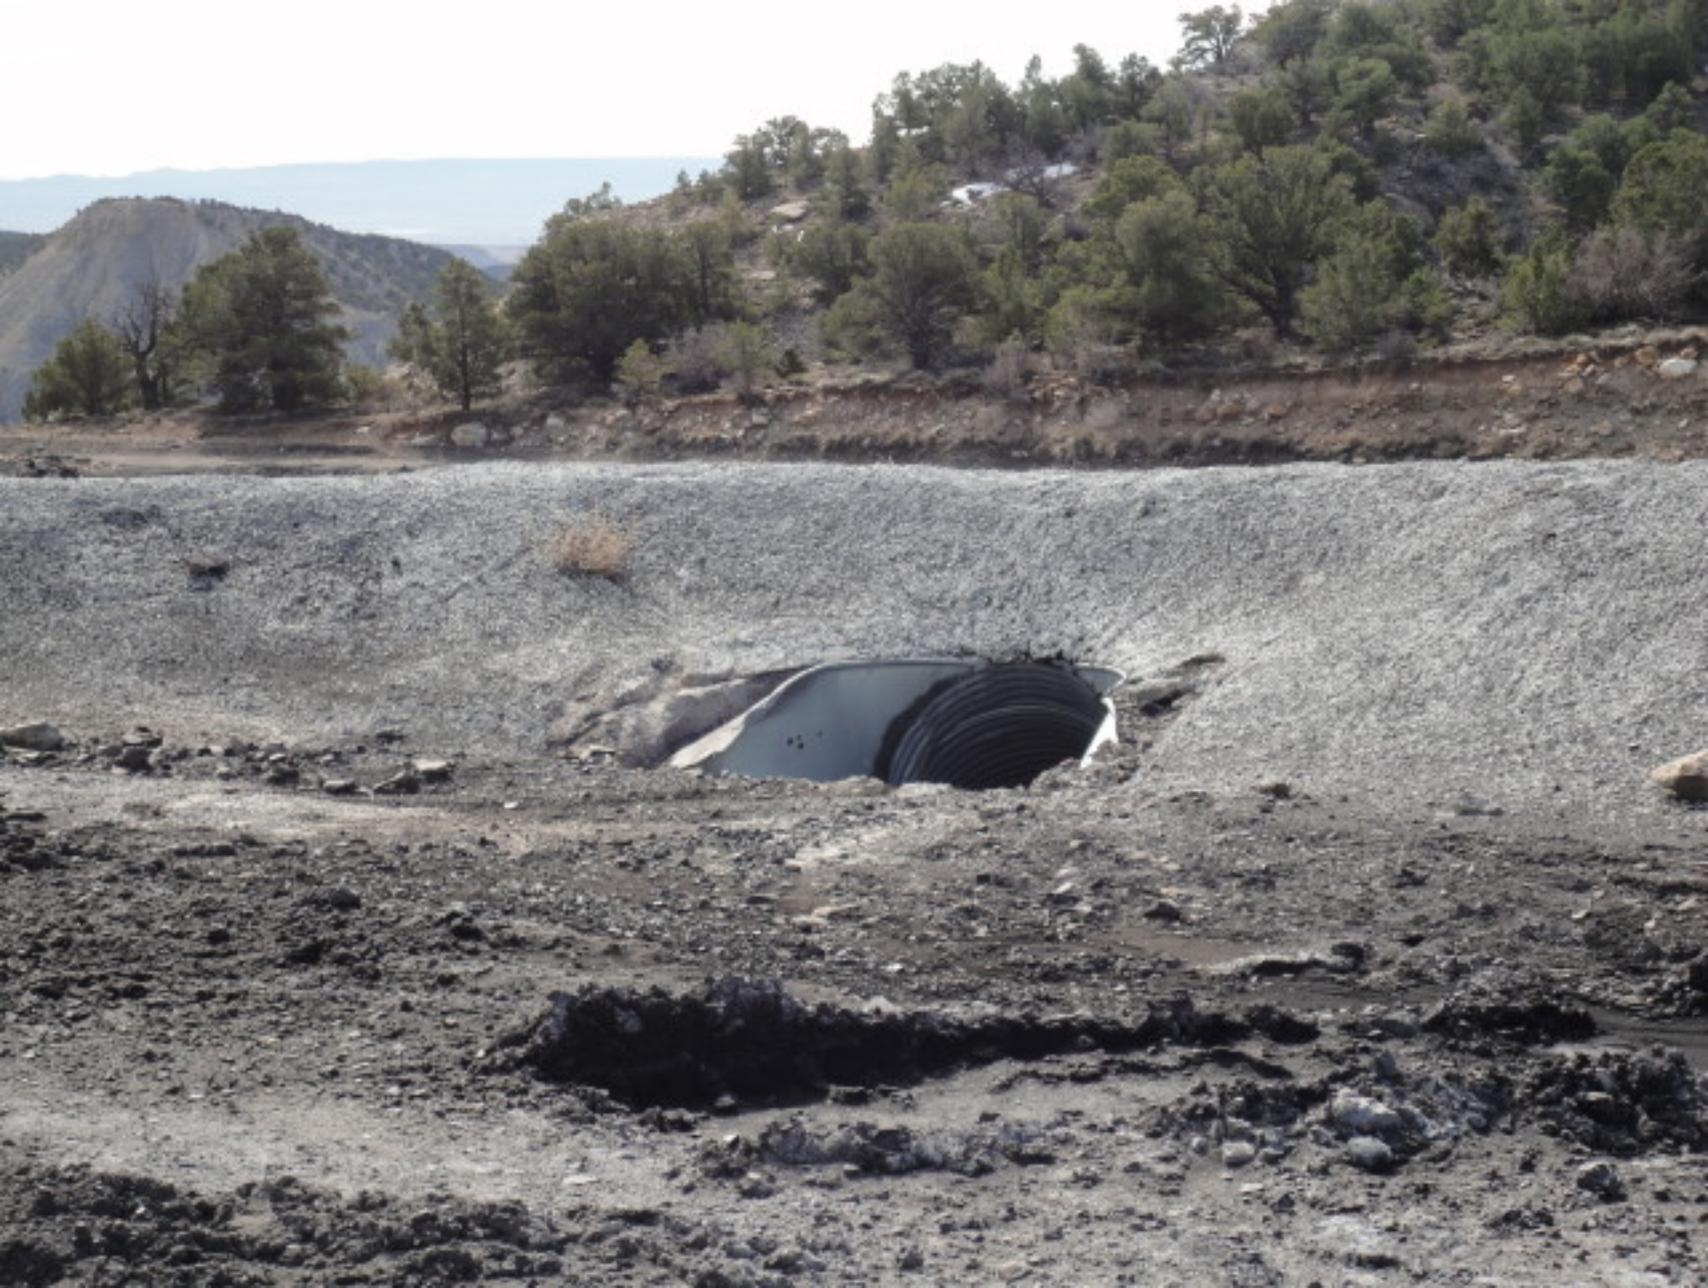
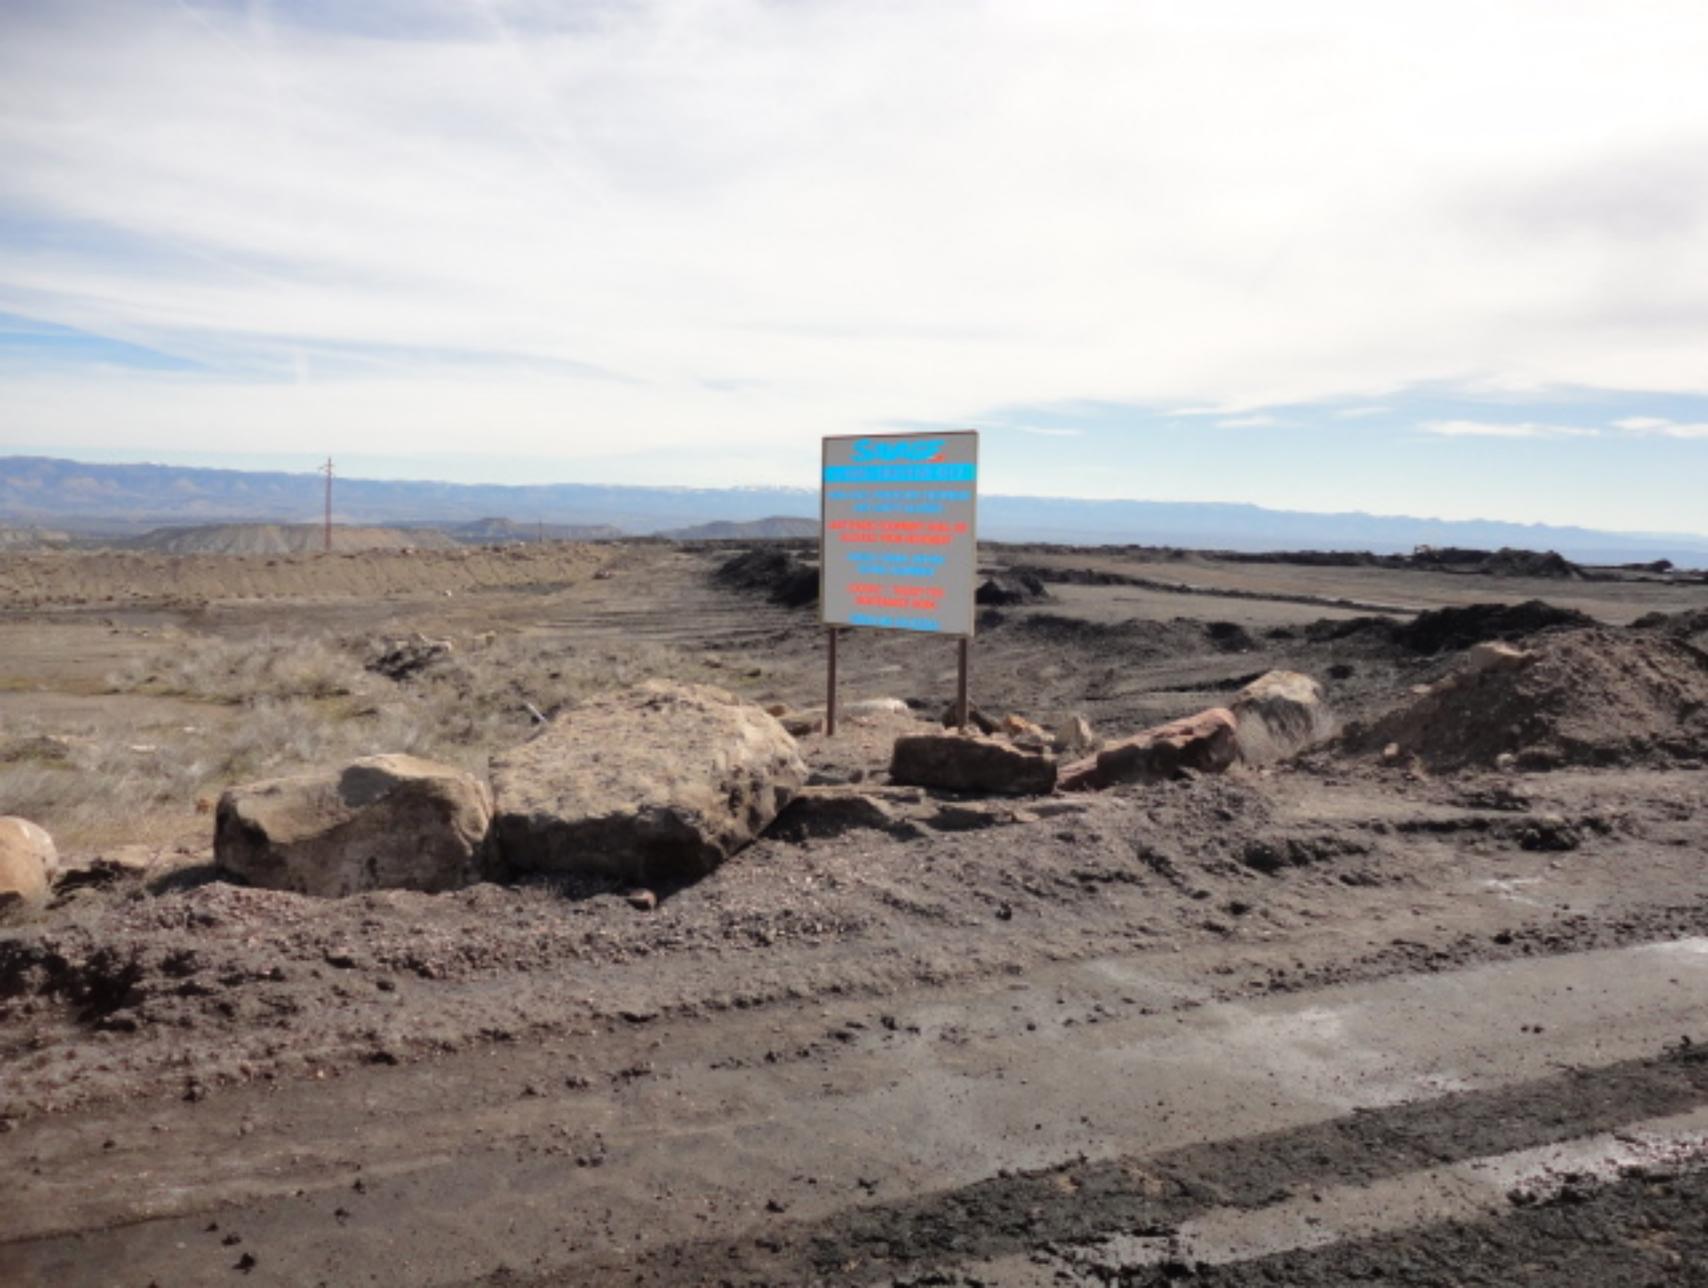
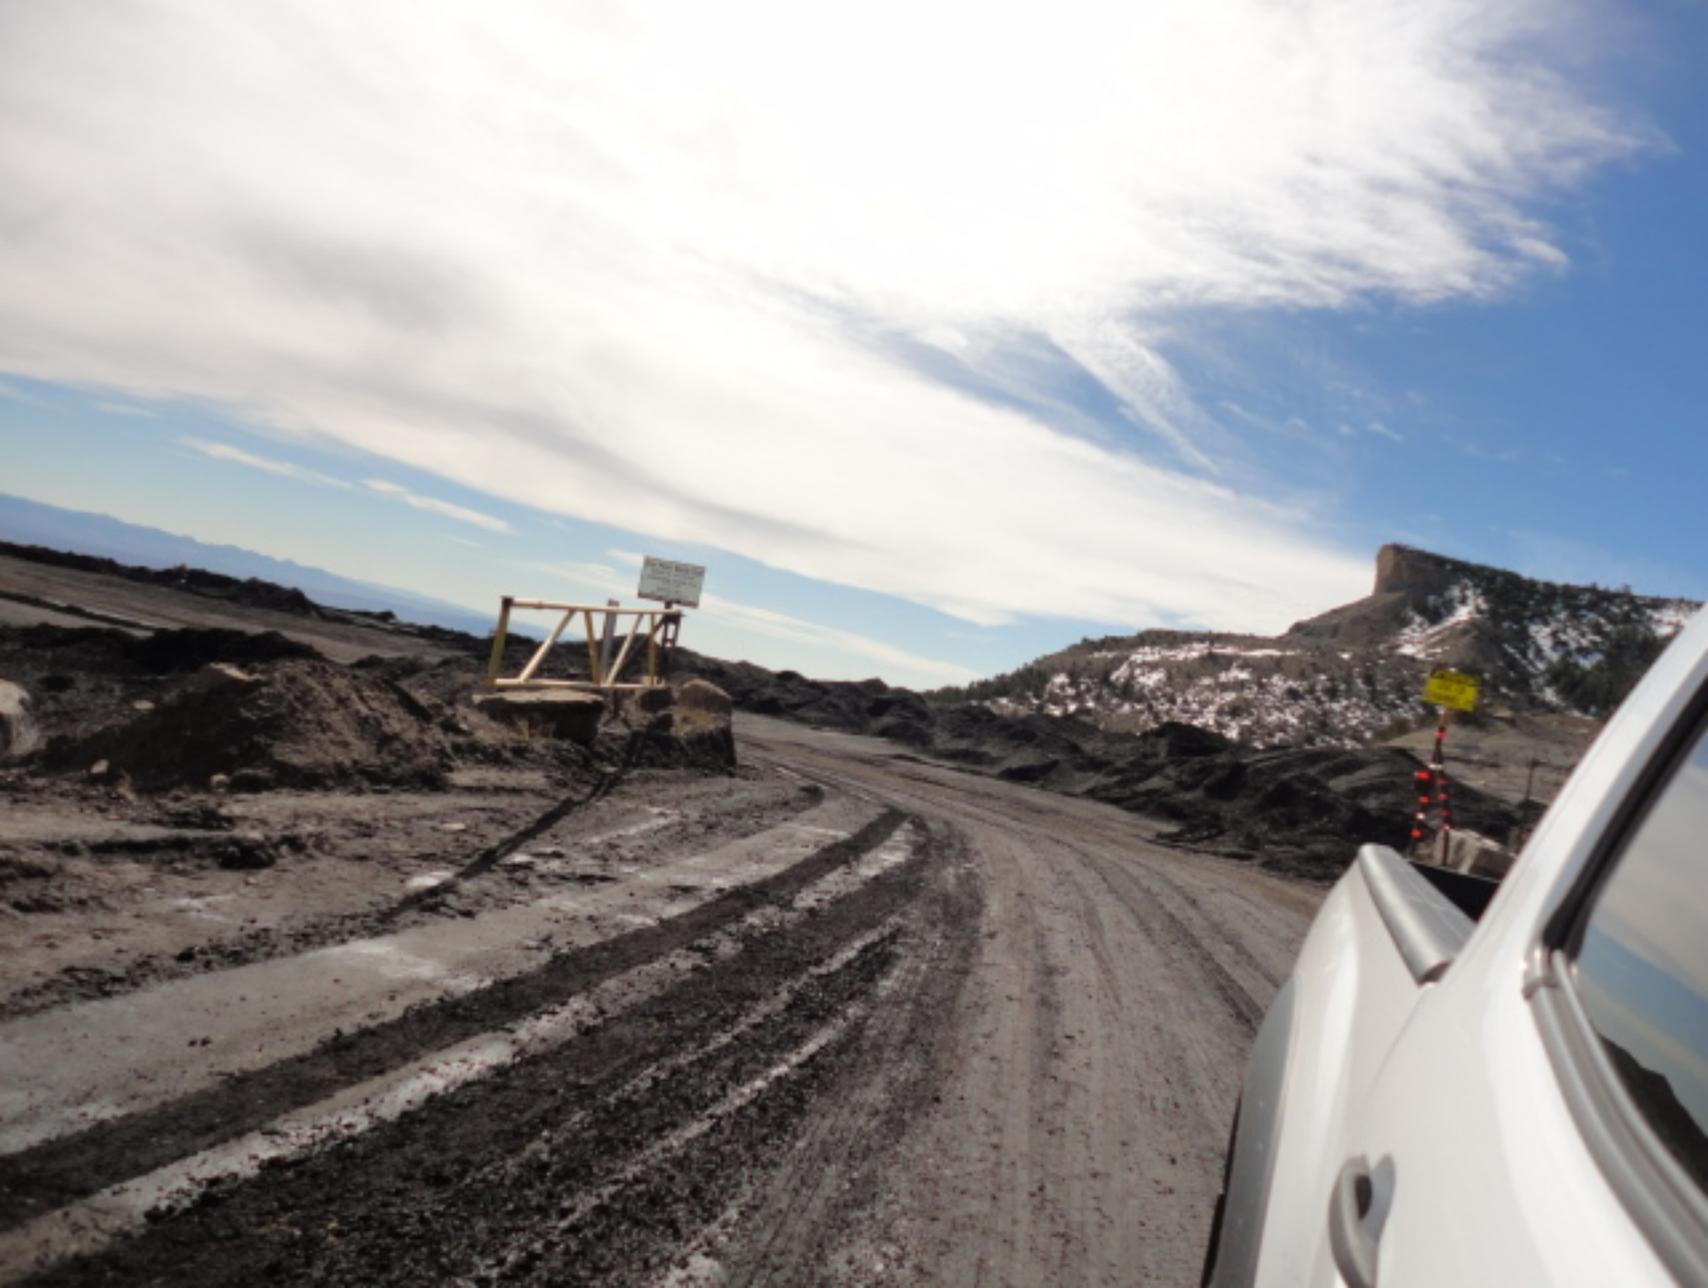
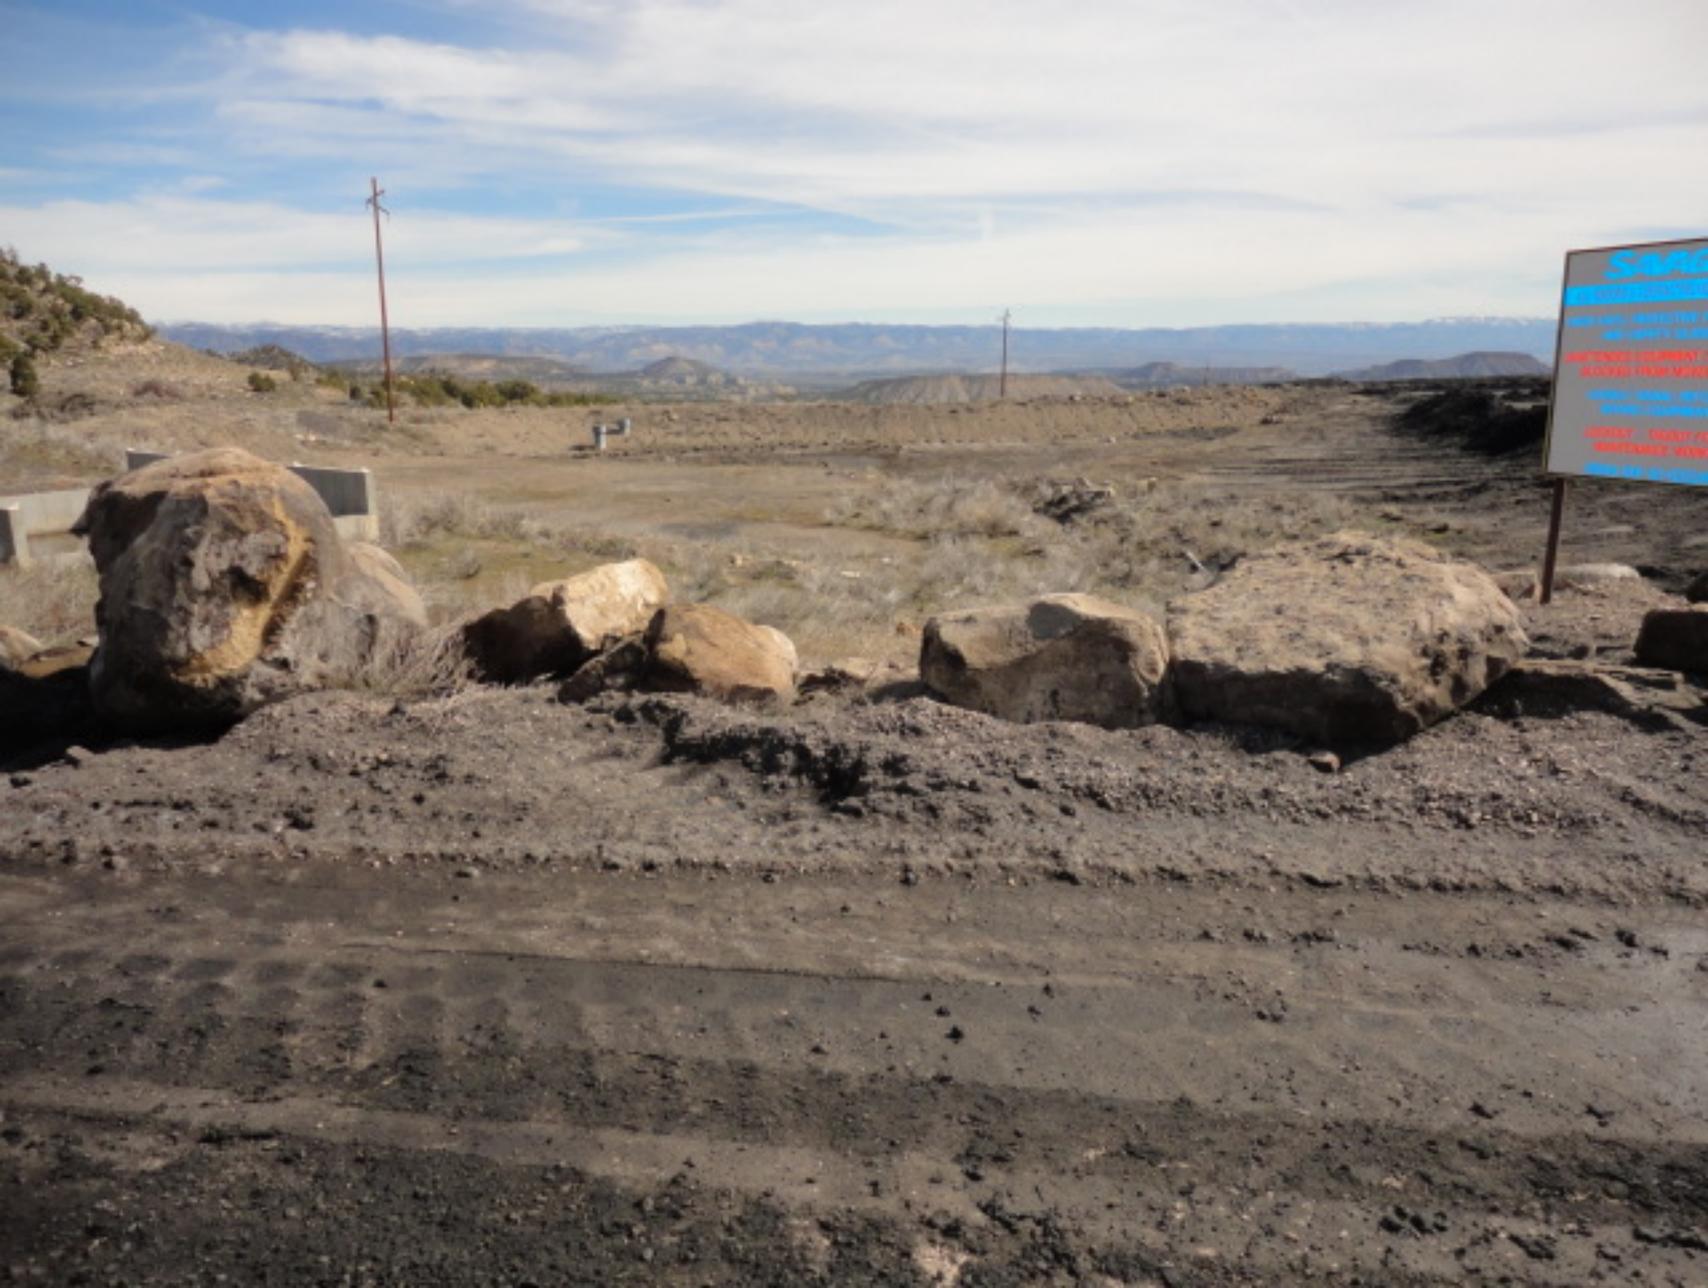
I inspected diversions and culverts throughout the property. They were open and would function as designed during a storm event. Some of the structures were not inspected due to muddy road conditions. It was impossible to travel to these areas due to the mud. See photos

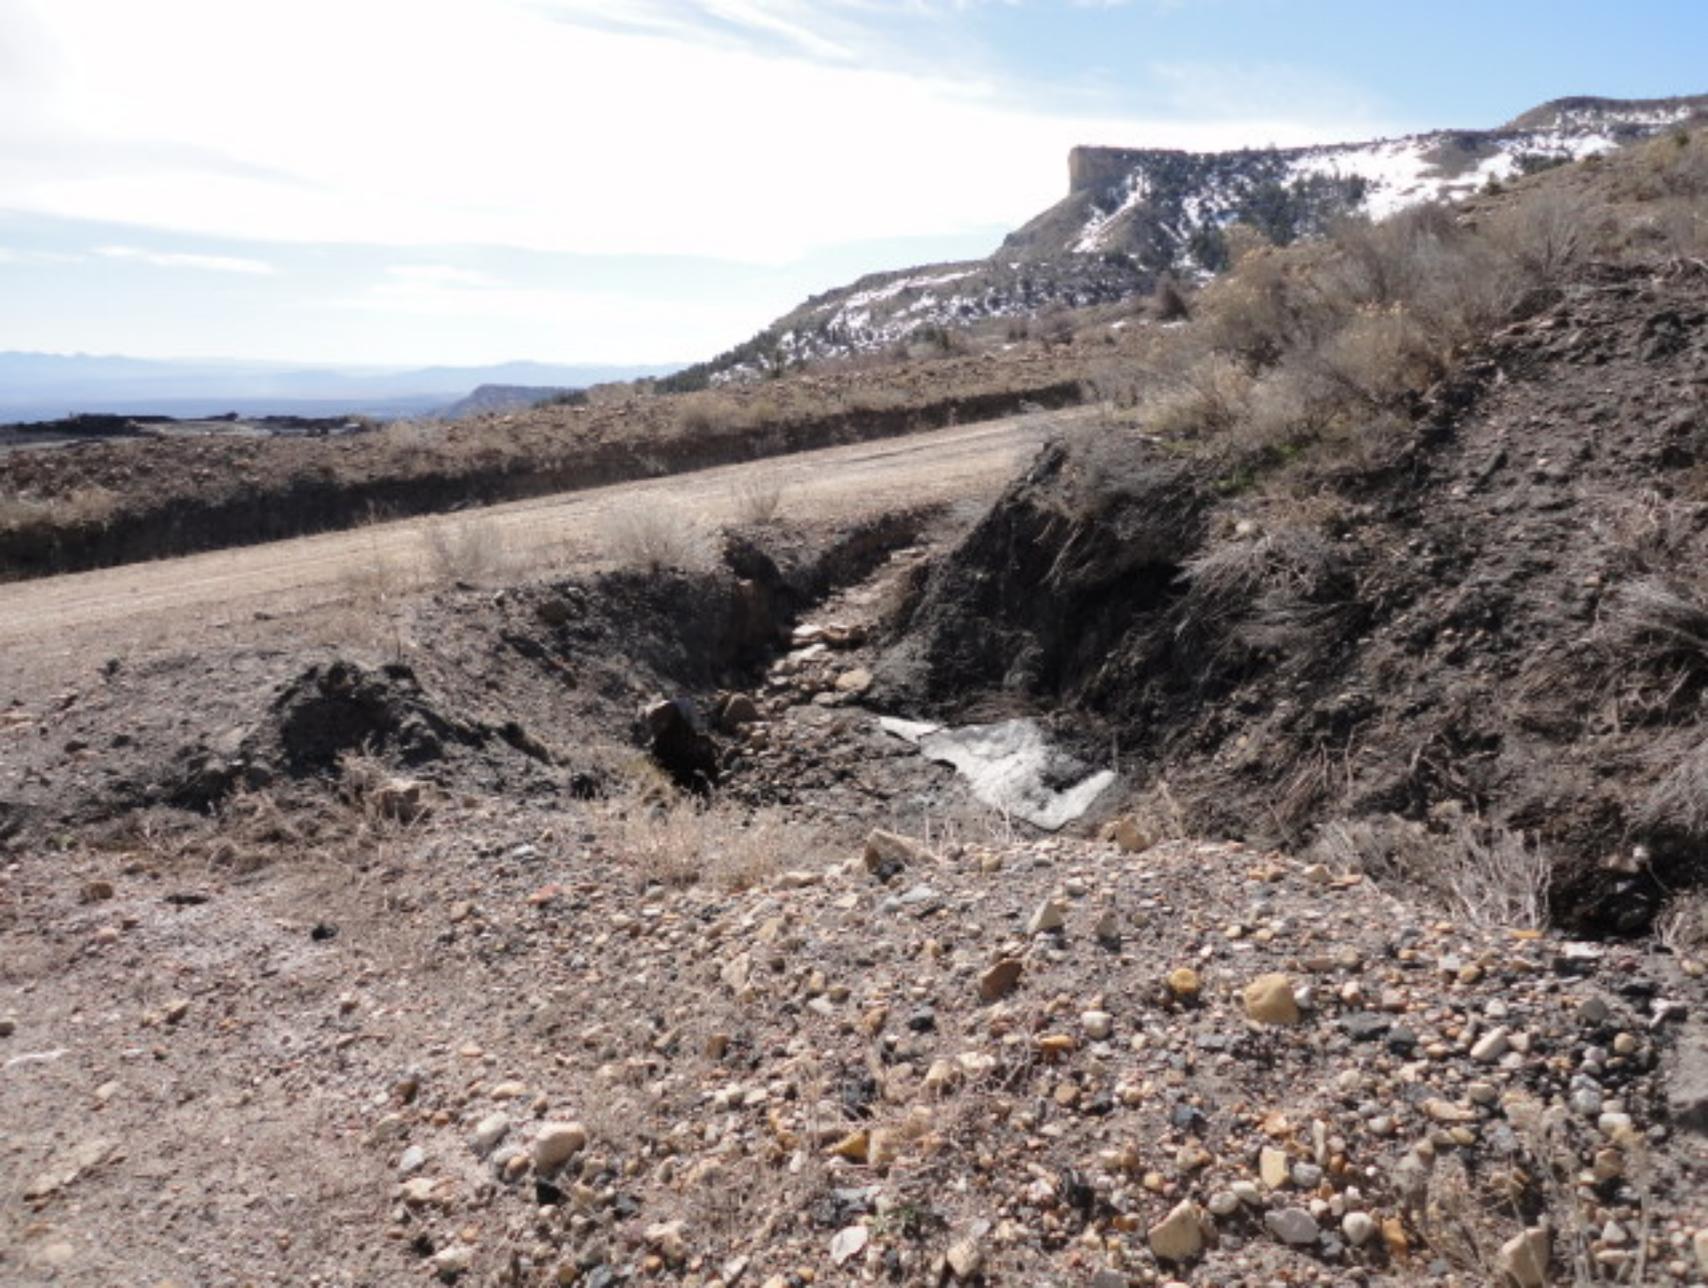
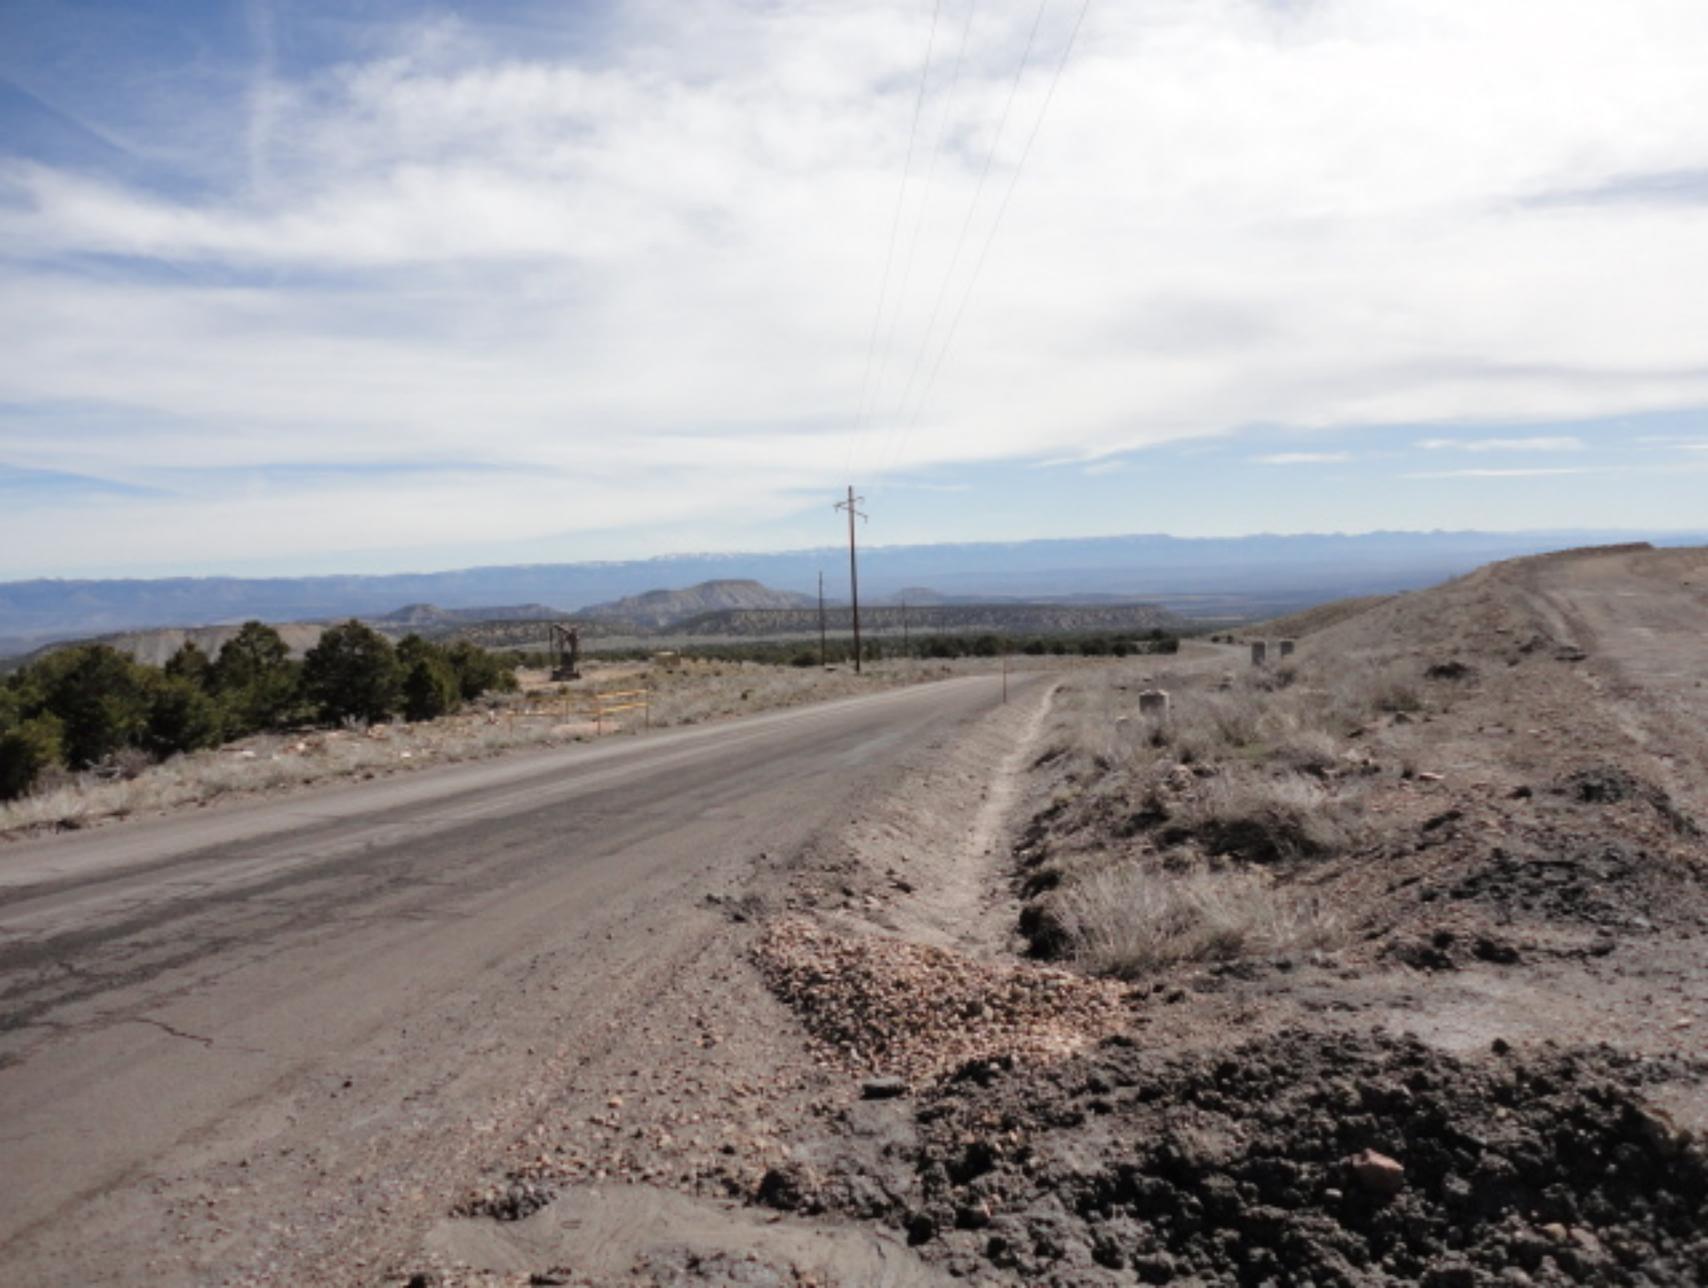
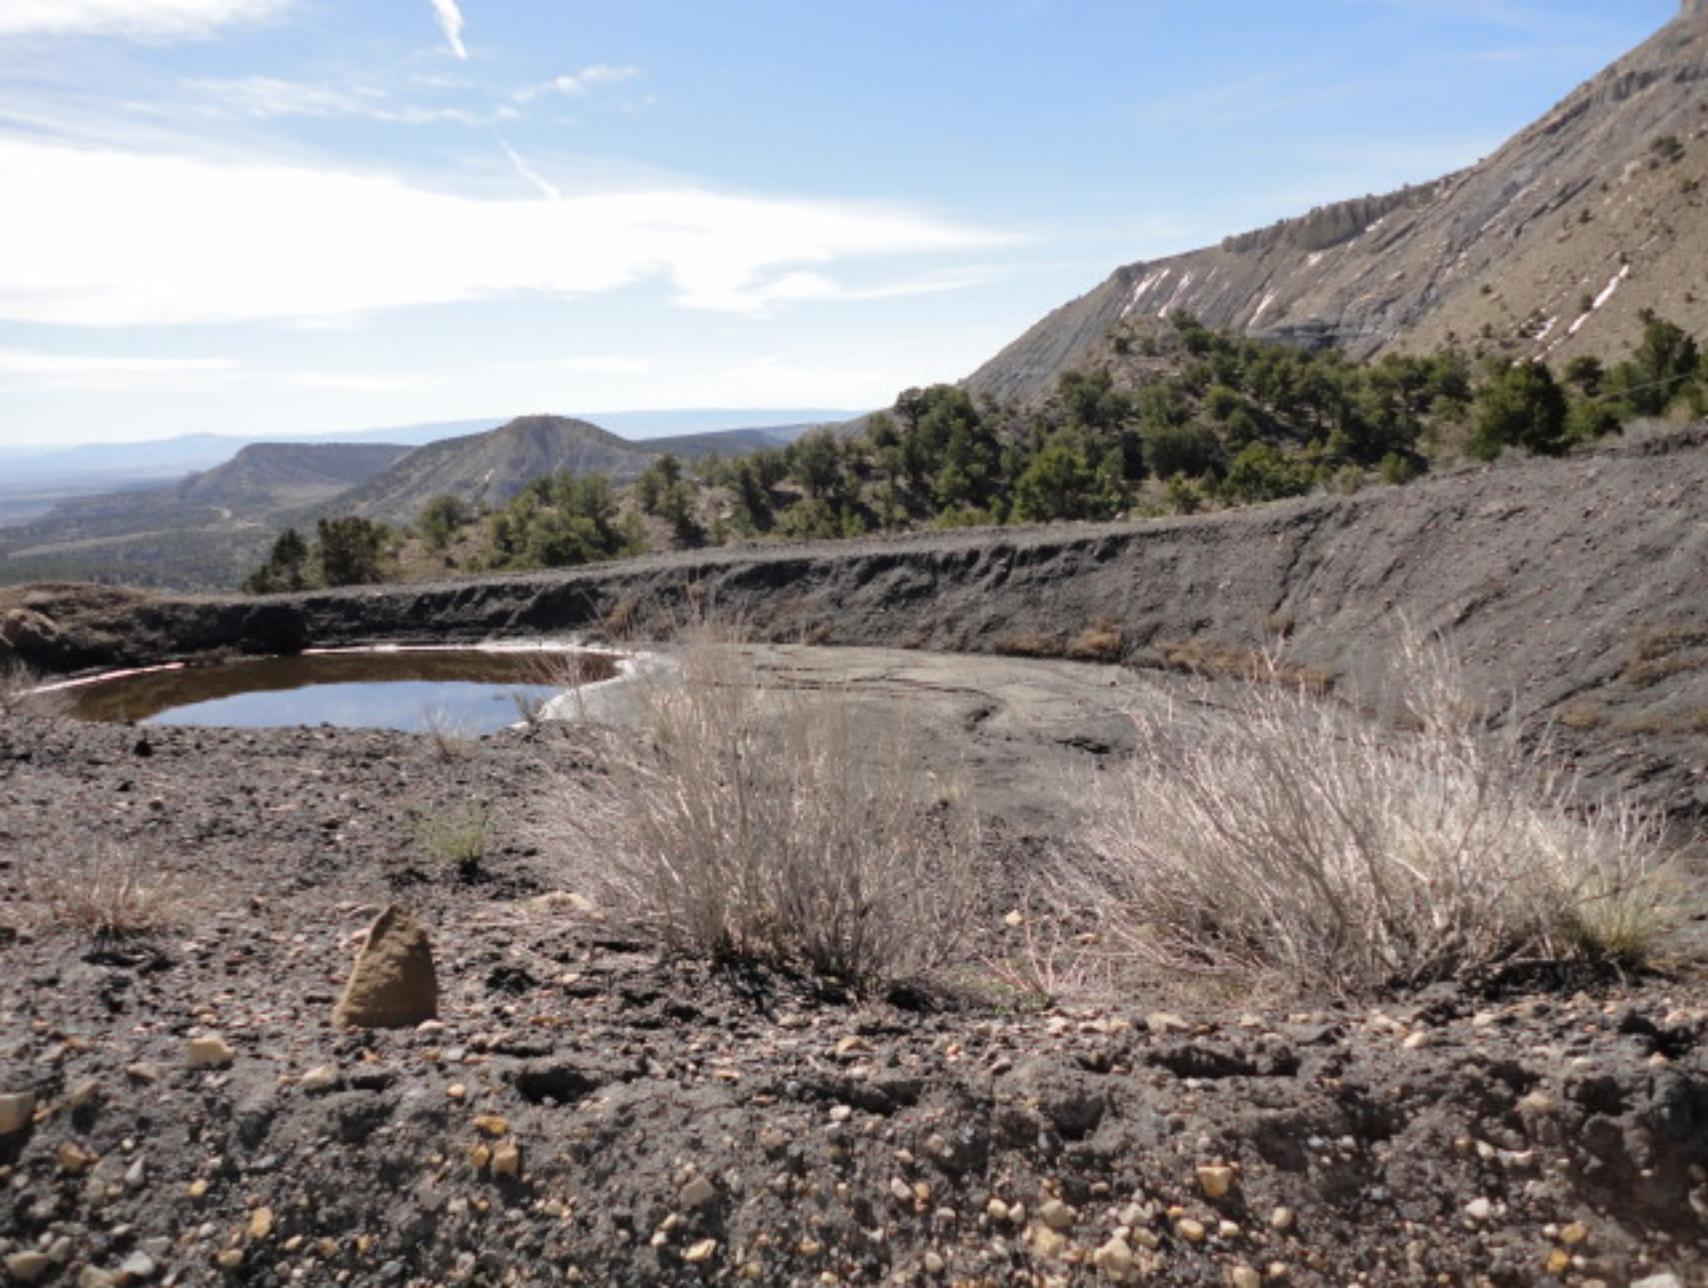
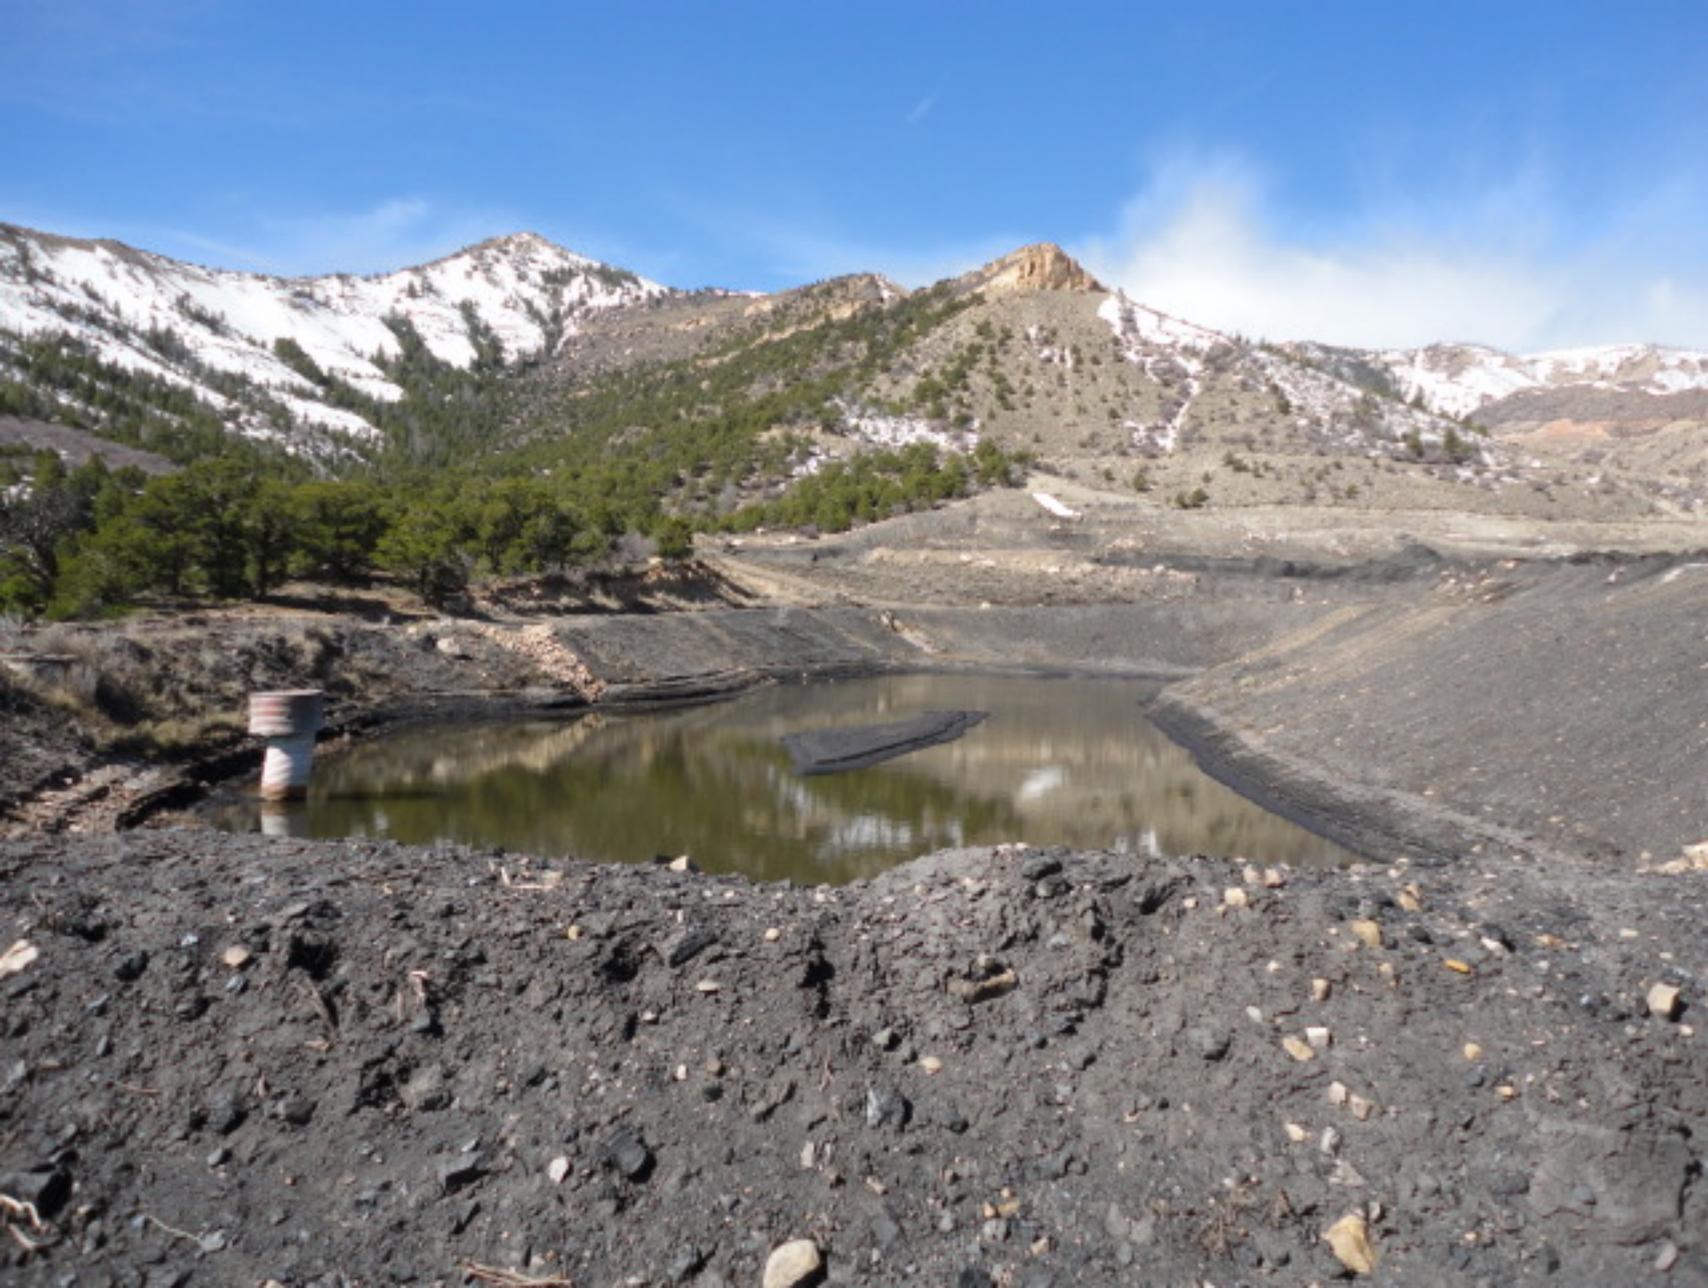
I inspected the road diversions and culverts throughout the property. They were functioning as designed. See Photos
