## Inspection Report

Permit Number:	<b>C0070042</b>
Inspection Type:	COMPLETE
Inspection Date:	Tuesday, February 12, 2019
Start Date/Time:	2/12/2019 9:30:00 AM
End Date/Time:	2/12/2019 12:00:00 PM
Last Inspection:	Thursday, January 10, 2019

Permitee: **SUNNYSIDE COGENERATION ASSOCIATES**

Site: **STAR POINT REFUSE**

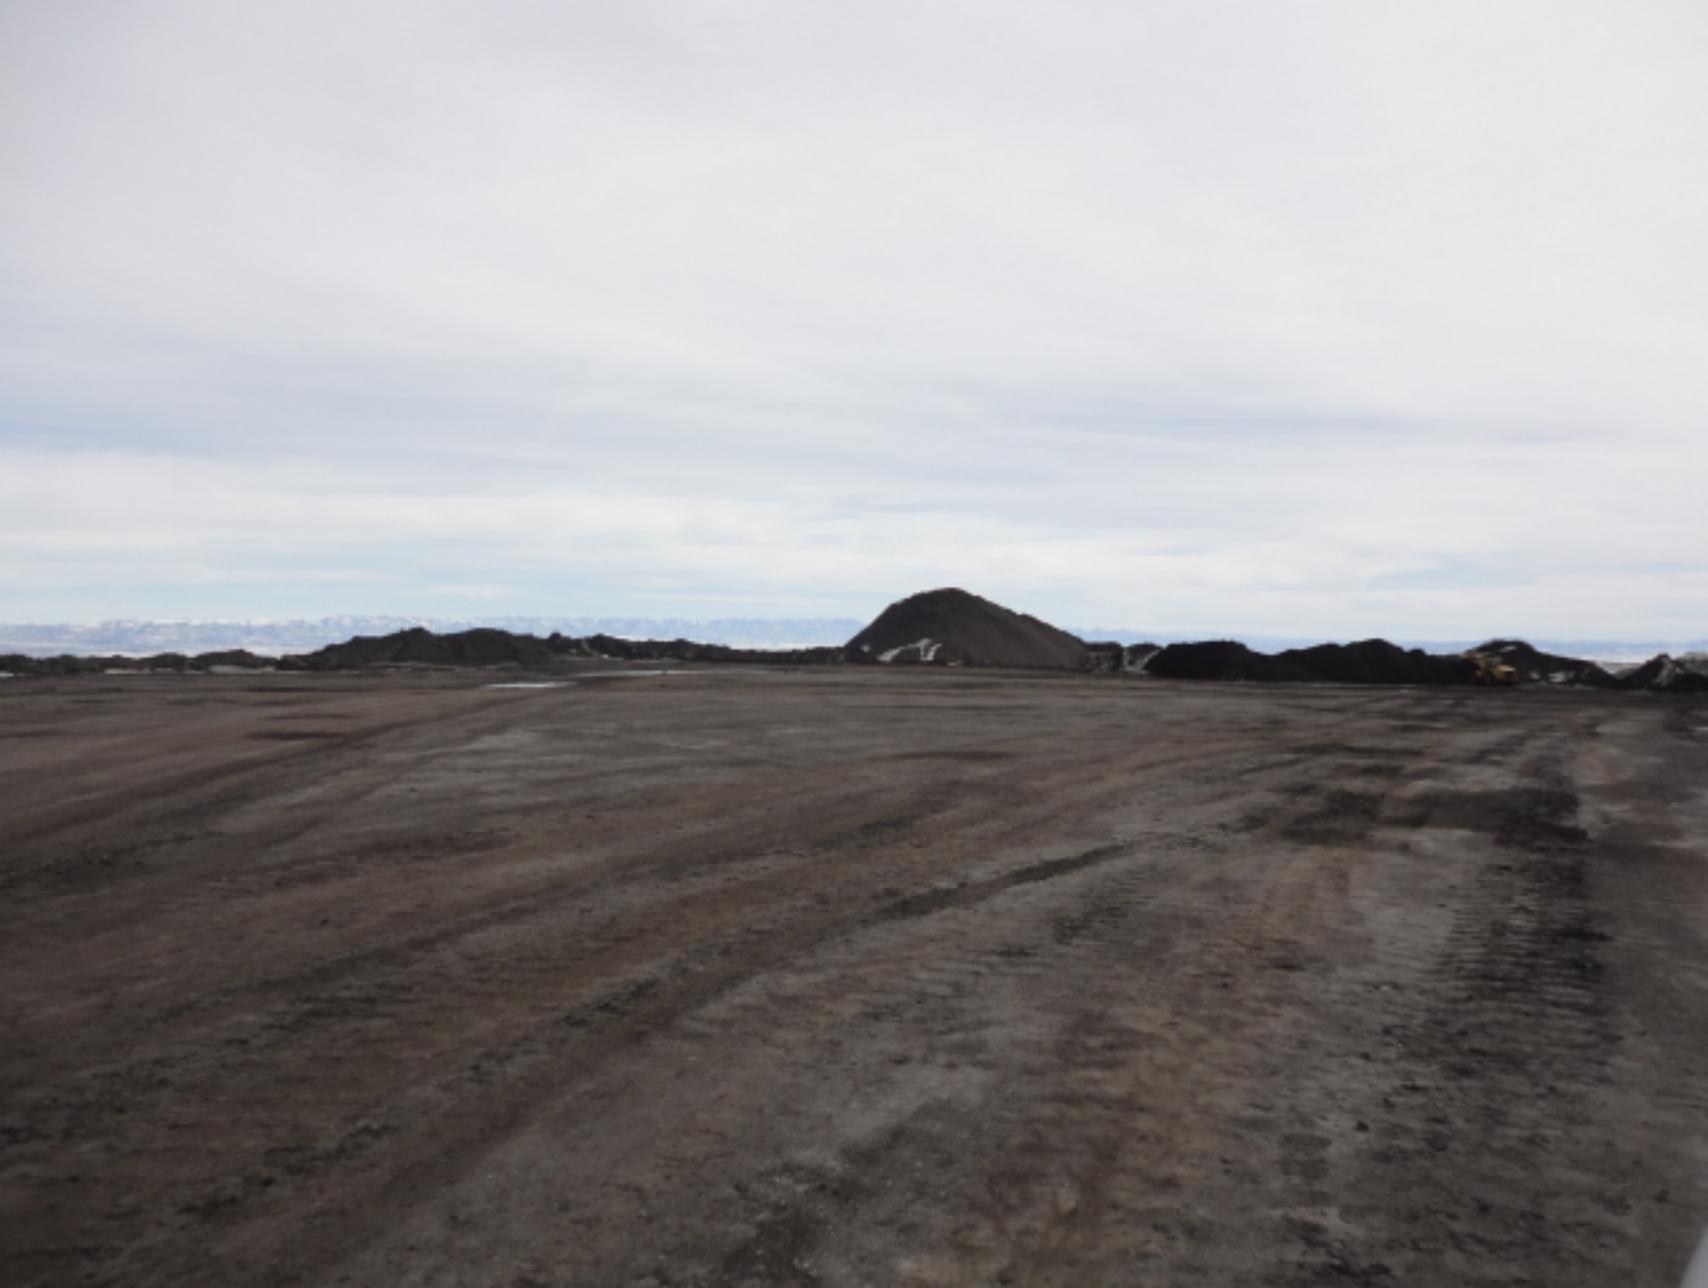
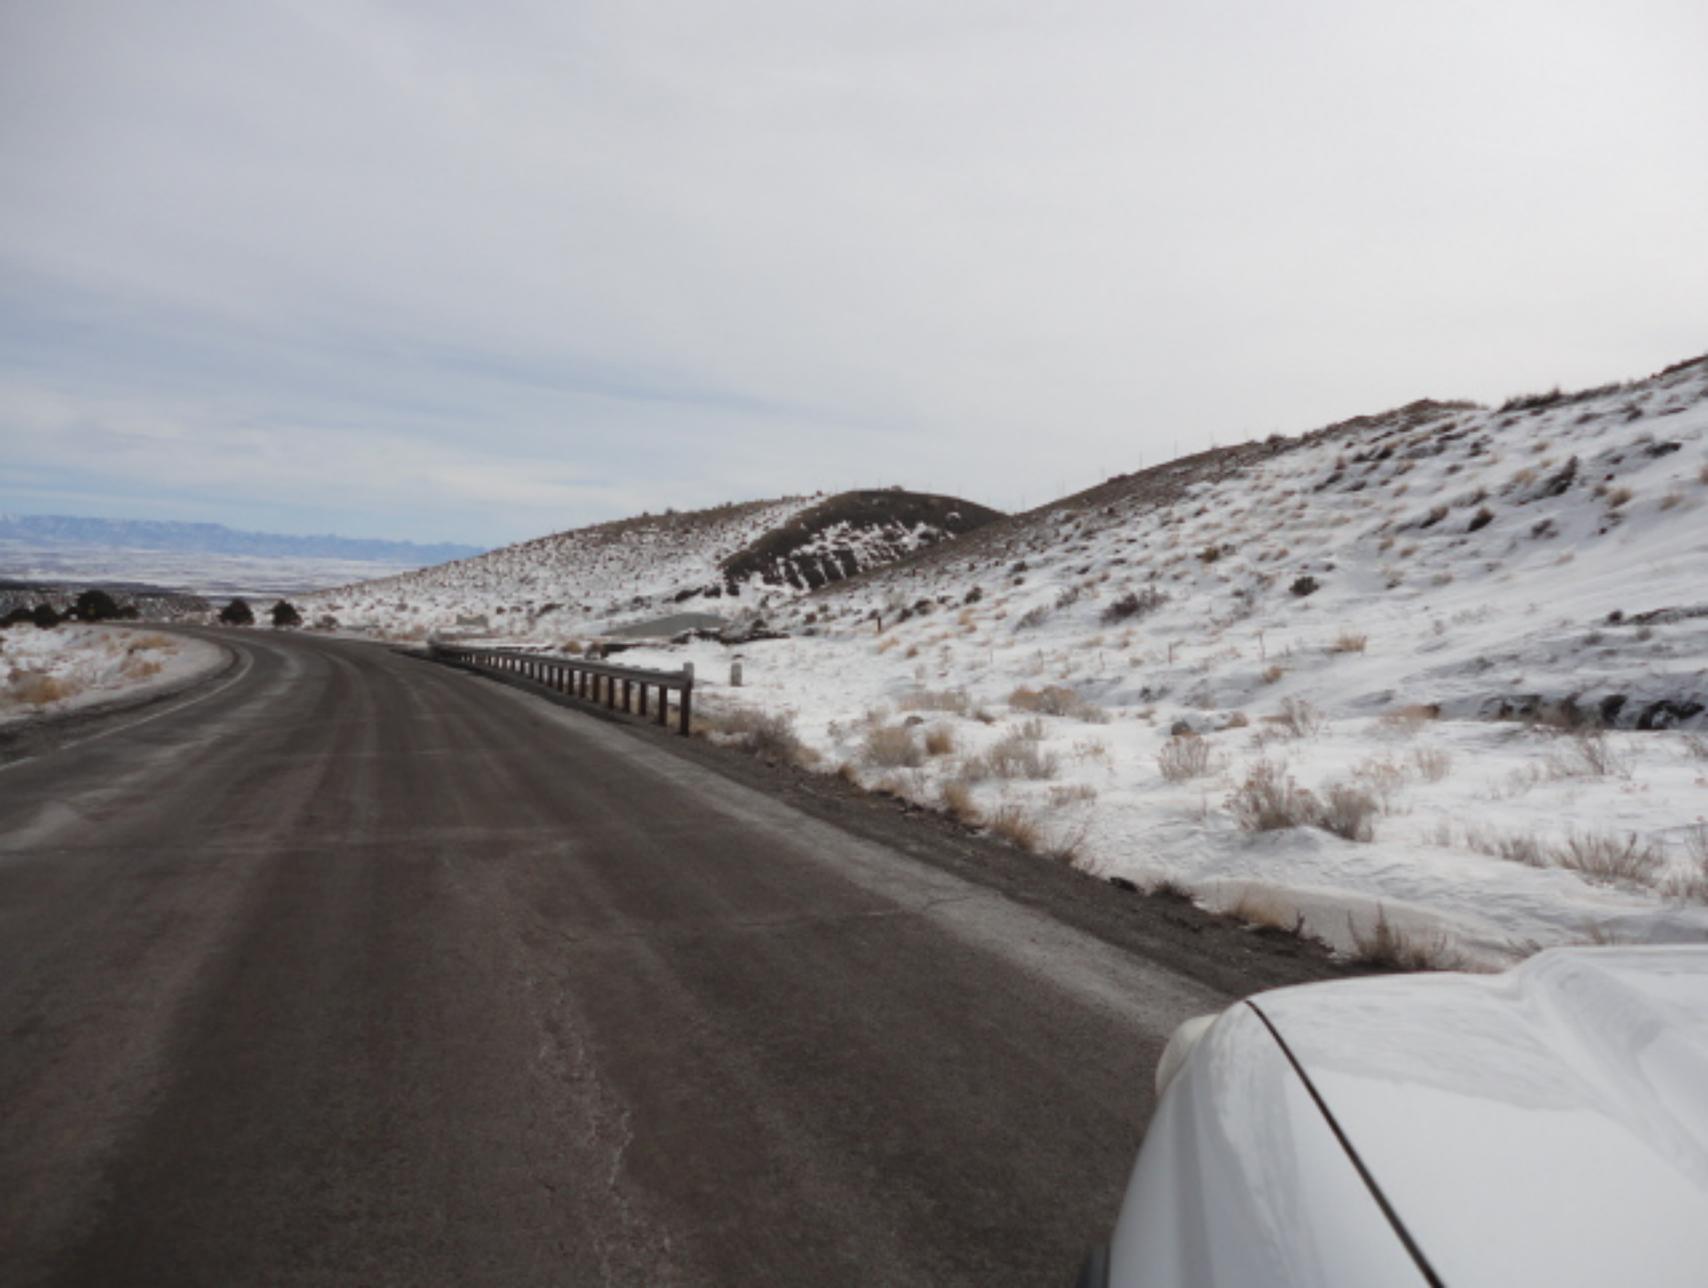
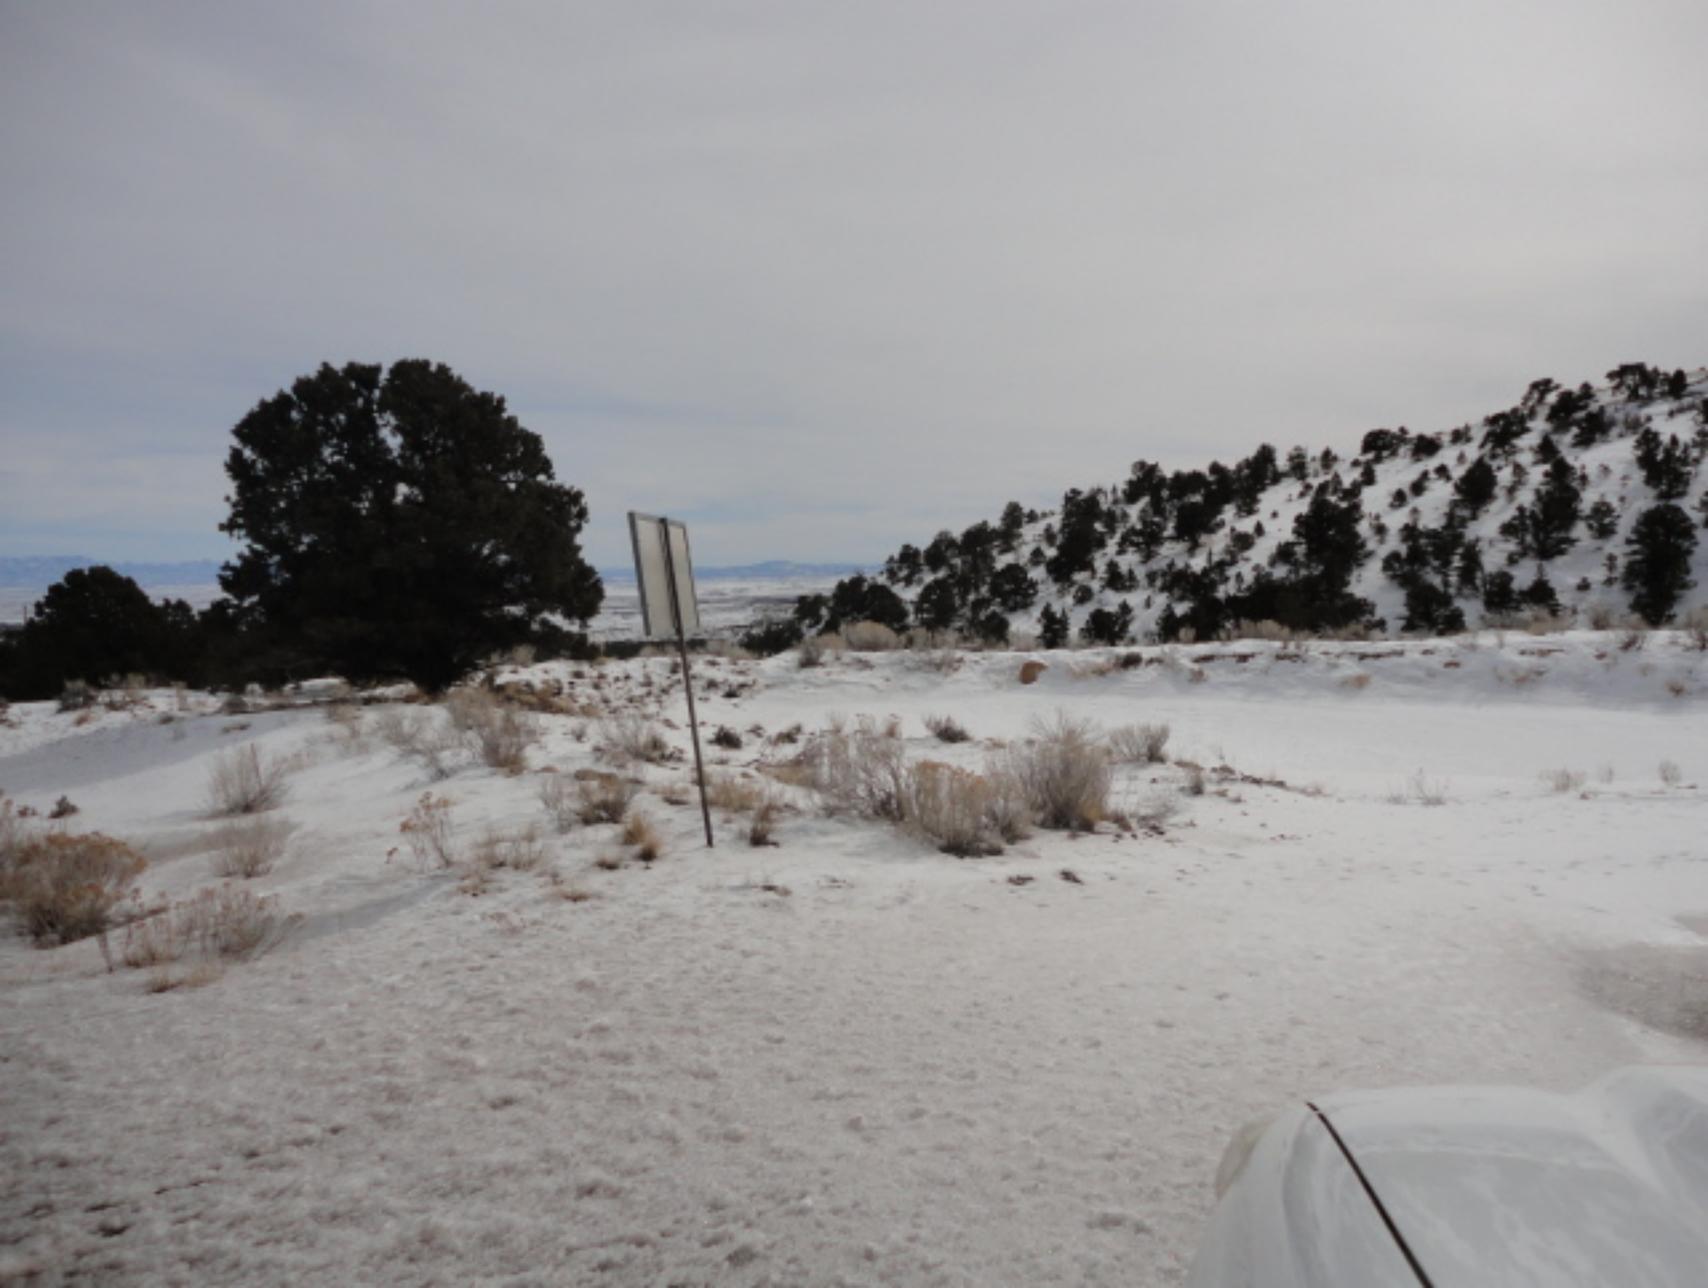
I inspected the refuse pile and it appears to be stable. I did not notice any hazardous conditions to the embankments. The refuse pile is active. The permittee conducted a third quarter refuse pile inspection on December 27, 2018. This document is P.E. certified. No hazardous conditions were reported. See Photos
