# Inspection Report

Permit Number:	C0070045
Inspection Type:	PARTIAL
Inspection Date:	Tuesday, December 12, 2017
Start Date/Time:	12/12/2017 10:00:00 AM
End Date/Time:	12/12/2017 1:30:00 PM
Last Inspection:	Wednesday, November 1, 2017

Permitee: **BRC WELLINGTON, LLC**  
 Operator: **BOWIE REFINED COAL, LLC**  
 Site: **WELLINGTON DRY-COAL CLEANING FACILITY**  
 Address: **1865 WEST RIDGE ROAD, WELLINGTON UT 84654**  
 County: **CARBON**  
 Permit Type: **PERMANENT COAL PROGRAM**  
 Permit Status: **ACTIVE**

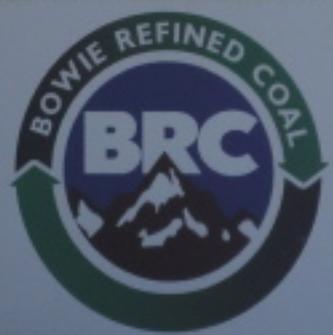
The identification sign was inspected and it meets the requirements of the R645 Coal Rules. See Photo

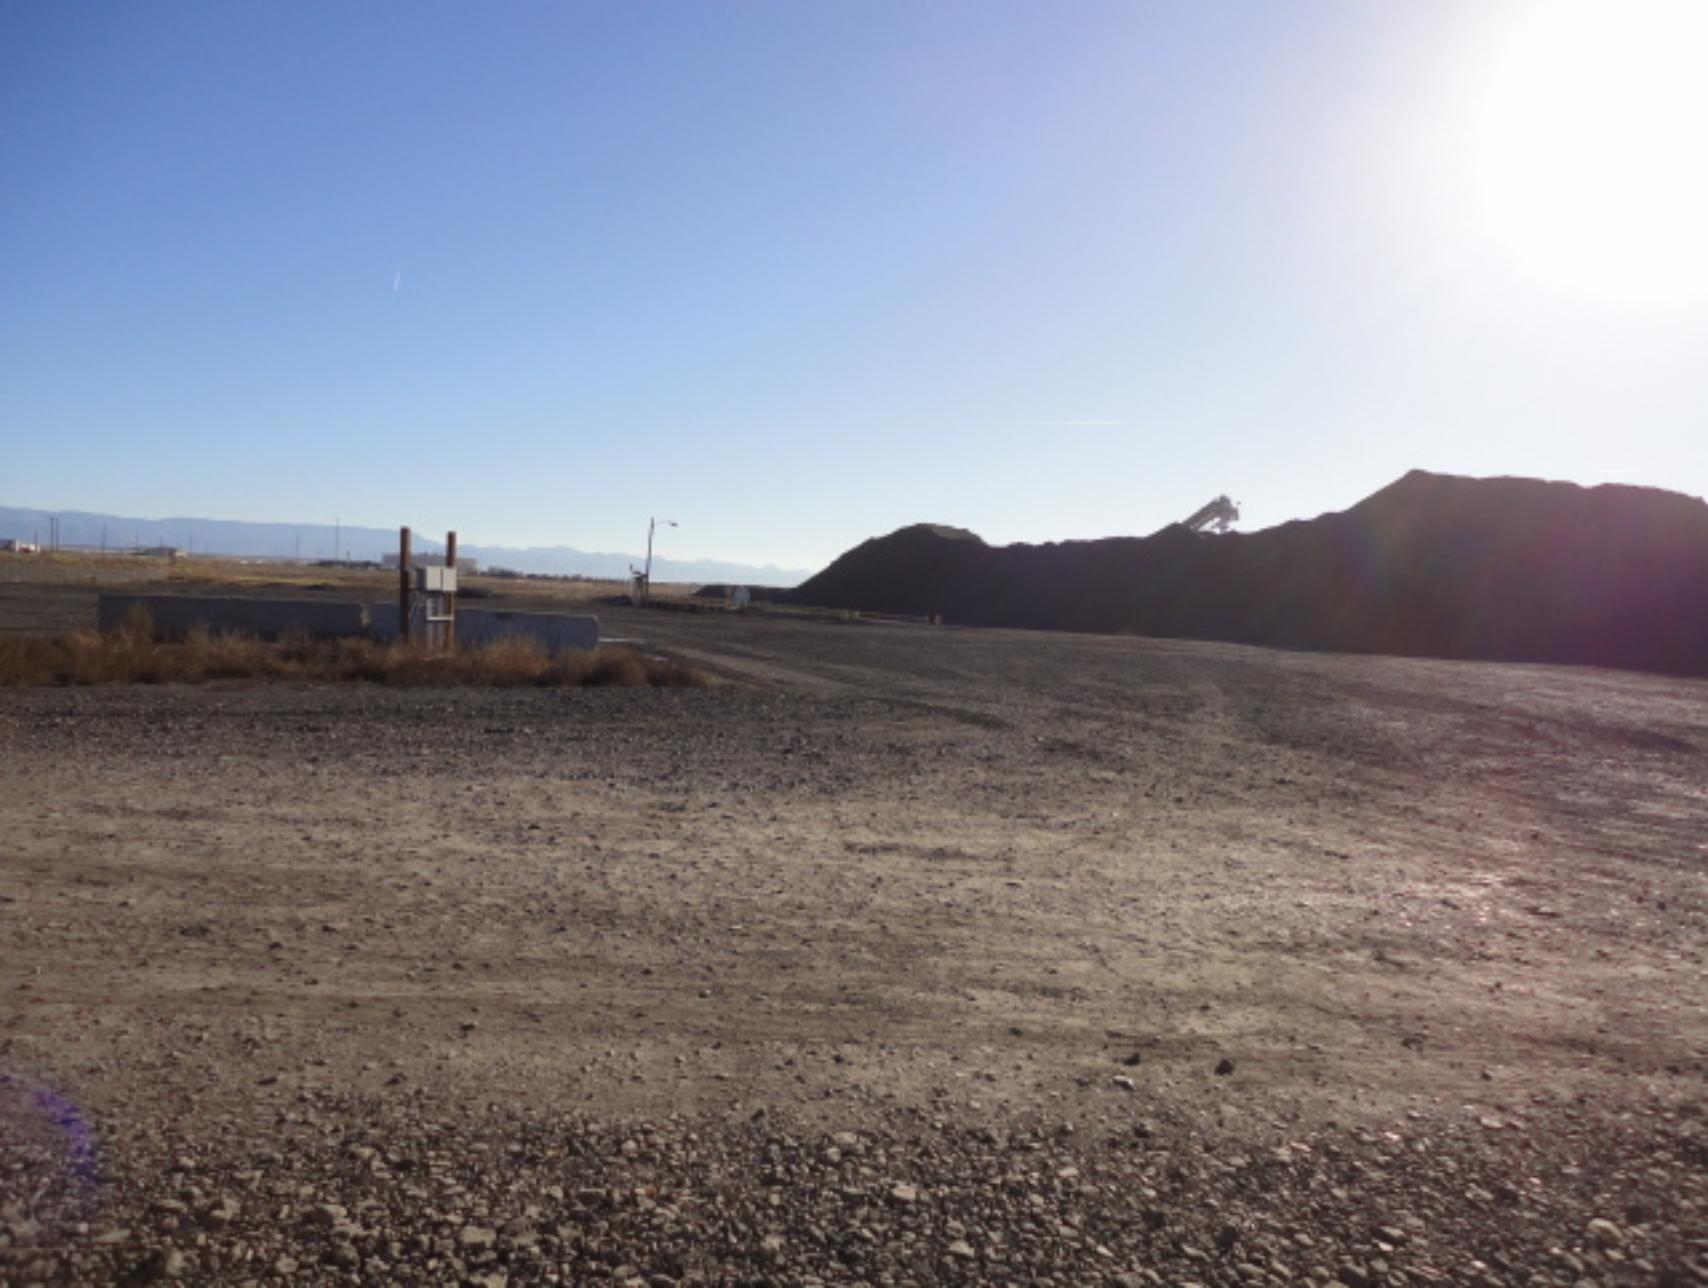
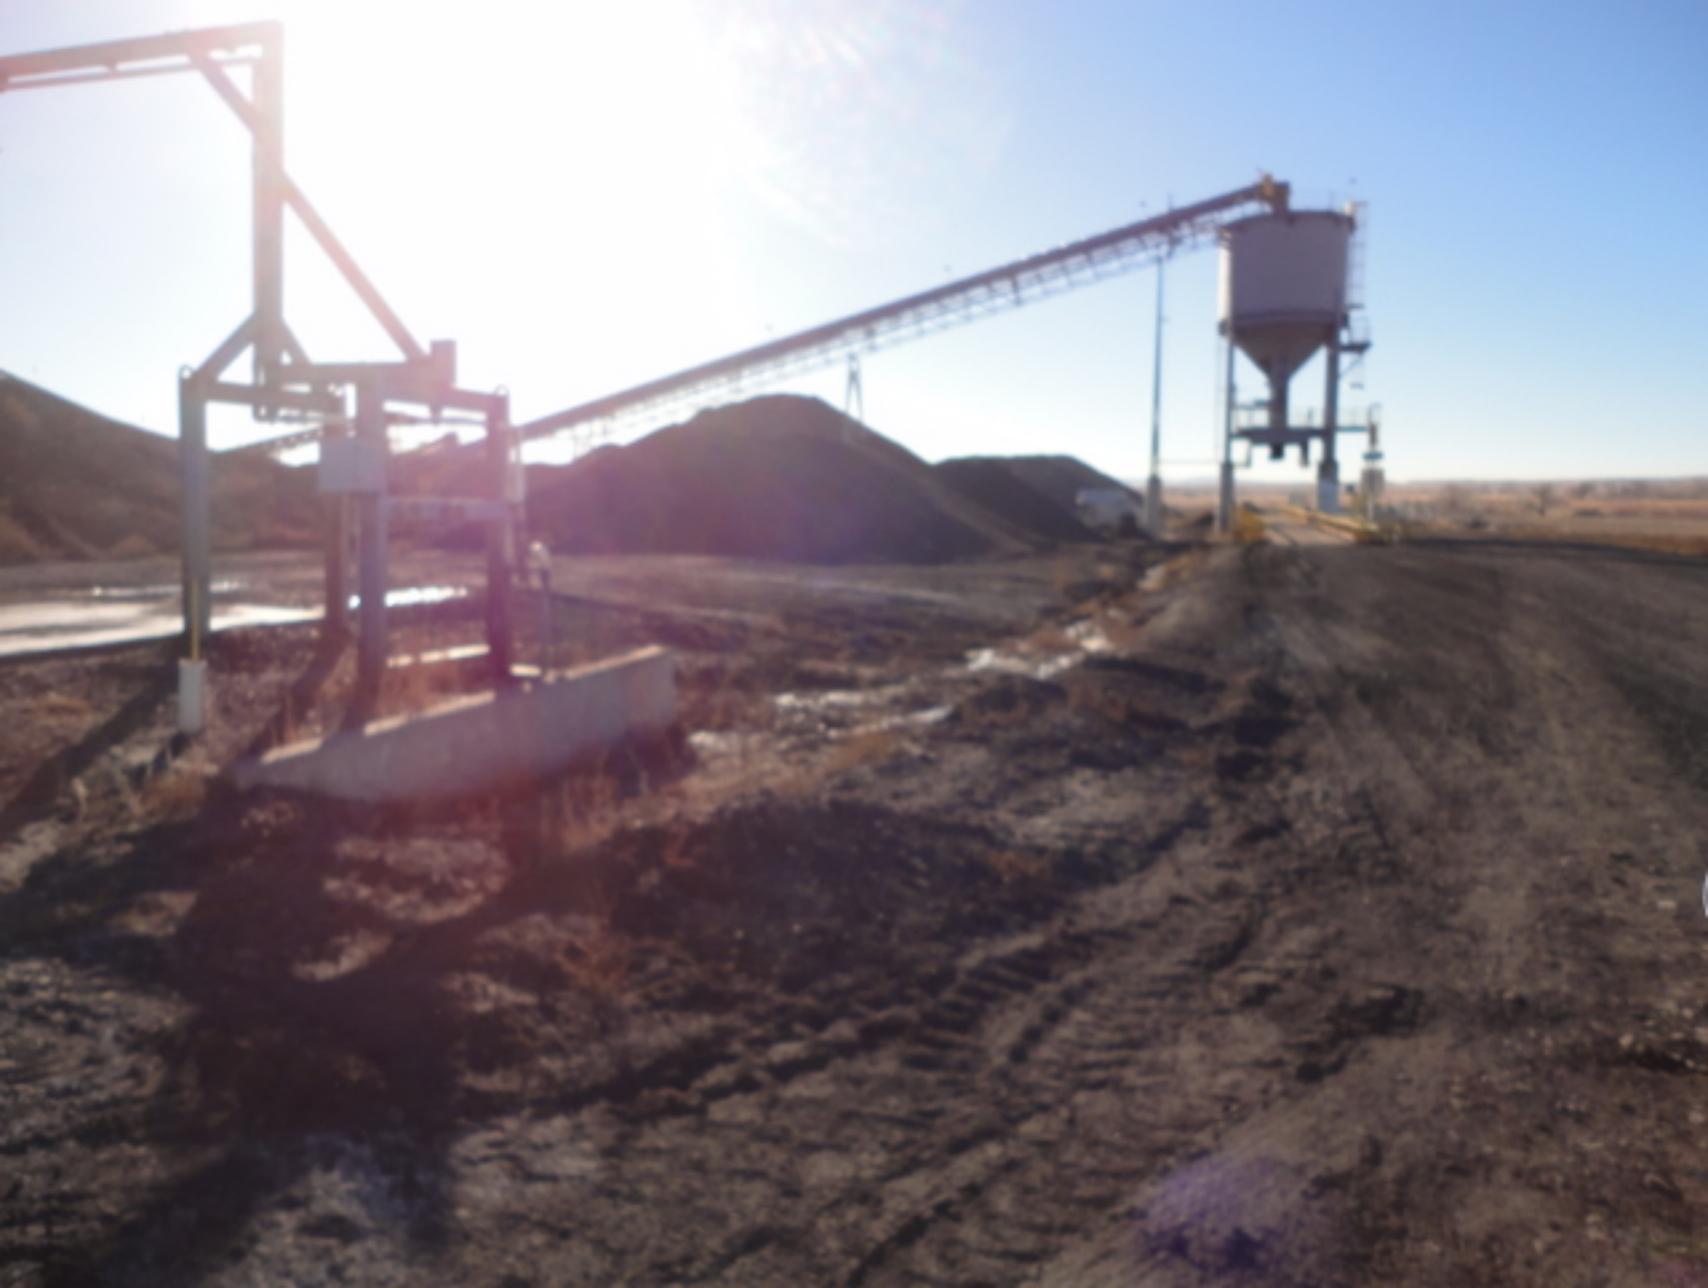
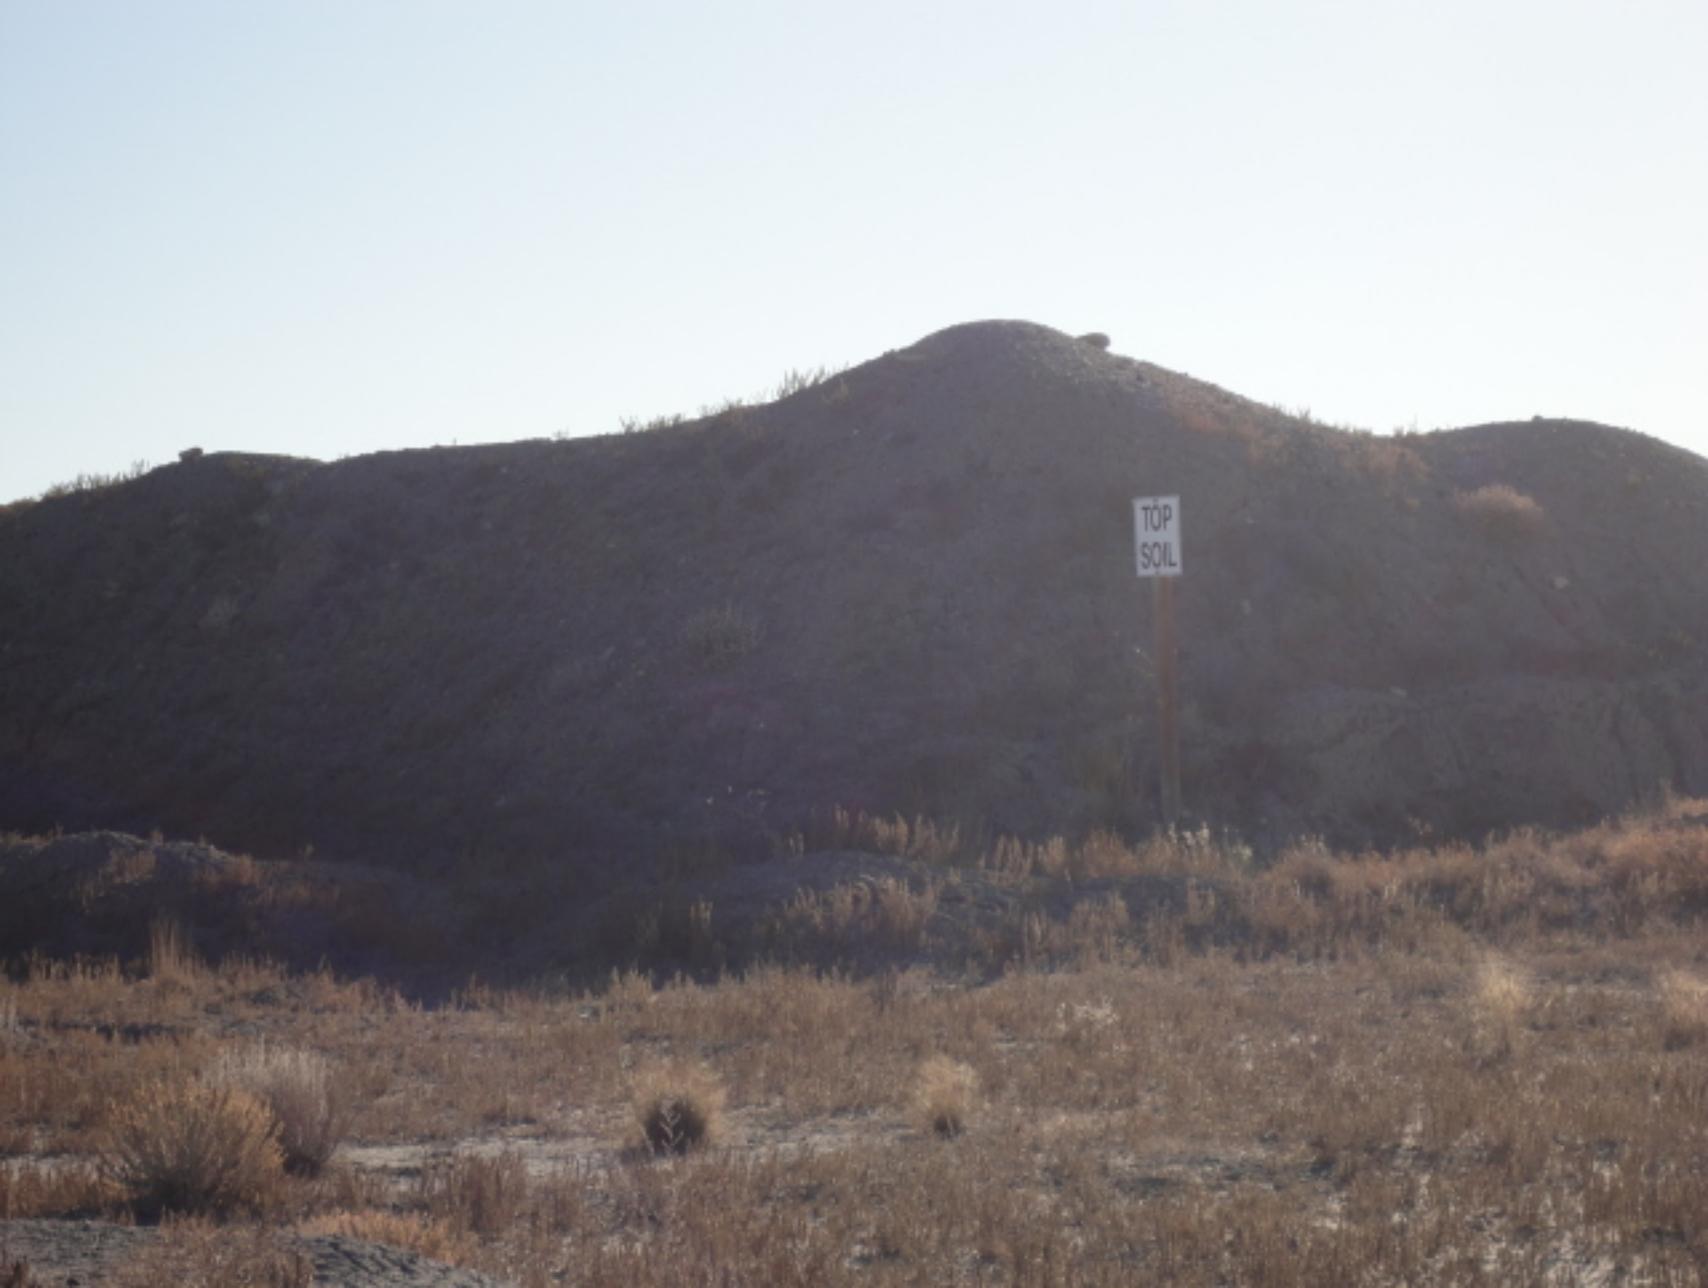
The permittee had removed weeds within the diversions since the inspection. The diversions and culverts were open and could convey water to the sediment ponds during a storm event. See Photos

I inspected the road diversions and culverts throughout the property. They were functioning as designed. See Photos
