**HIDDEN VALLEY COAL COMPANY**

**PLAN FOR ABATEMENT  
OF  
NOTICE OF VIOLATION  
N91-26-8-2**

December 8, 1992

**HIDDEN VALLEY MINE**  
**Revegetation Monitoring Study**  
**Fall, 1992**

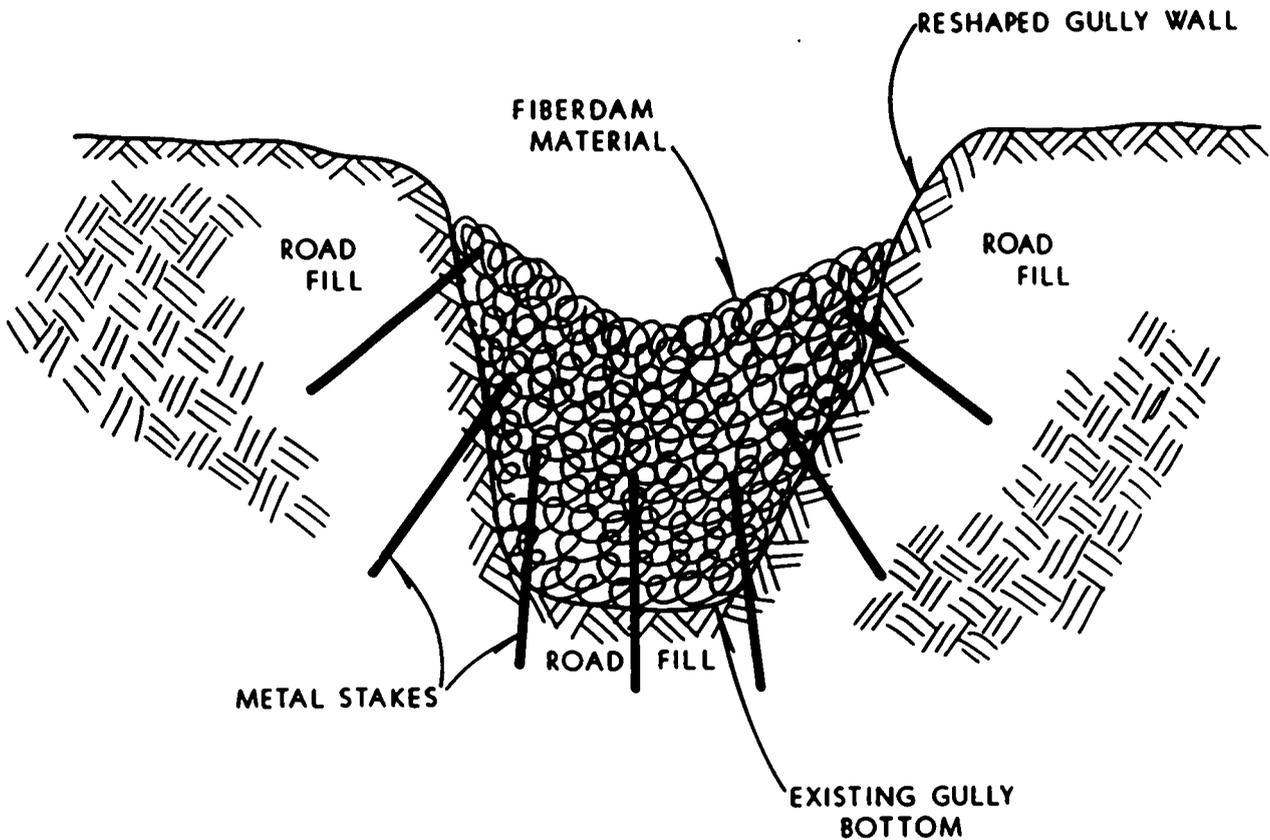
SCHEMATIC CROSS SECTION  
THROUGH WATER BAR OUTFALL  
SHOWING TYPICAL  
POROUS CHECK DAM TREATMENT

- PLACE FIBER INTO THE CHANNEL AT THE RECOMMENDED THICKNESS UNTIL CHANNEL DEPTH IS 90% FILLED.
- PLACE FIBER AT EACH EDGE OF THE FIBERDAM UNTIL A "U" SHAPE IS FORMED AT THE TOP OF THE CHANNEL.
- ANCHOR THE FIBER TO THE SIDES OF THE CHANNEL USING STAKES OR STAPLES. THE MIDDLE OF THE DAM SHOULD BE LOWER THAN THE EDGES.
- PLACE STAKES AT THE BACK OF THE FIBERDAM AWAY FROM THE WATER FLOW.
- STAKES MAY PENETRATE THE FIBERDAM TO HOLD IT IN PLACE.
- STAKES SHOULD NOT BE PLACED GREATER THAN 6 INCHES APART. (SEE FIGURE 1)

- INSTALL THE NEXT FIBERDAM USING THE PROCEDURE OUTLINED IN STEP 1.
- REPEAT STEPS 1 AND 2 IN SEQUENCE UNTIL THE TOP OF THE CHANNEL IS REACHED.
- ON SOME INSTALLATIONS, IT IS RECOMMENDED THAT LANDSTRAND, COATED WITH ASPHALT EMULSION, BE USED BETWEEN FIBERDAMS TO AID IN COLLECTING SEDIMENT AND ENHANCING VEGETATION GROWTH.

Next, small, porous check dams will be installed at frequent intervals along the outfall channels. These dams will be constructed of a fiber barrier using a product equivalent to the fiberdam material constructed by Synthetic Industries. Manufacturer's recommendations (attached at the end of this report) for material installation will be followed. The material is a flexible, moldable mass of fibers that, although irregular in shape, can be molded to fit within a non-uniform cross sectional area. It will be shaped to about a one-foot thickness, with maximum height approximately two feet. The center of the dams will be lower than the edges and will function as a spillway. The dams will be held in place with 18- 24-inch long metal rebar stakes. A schematic cross section showing the check dam treatment follows this report.

These dams will be spaced closely down the outfall; distance between dams will not be uniform, but is expected to range between approximately 5 - 15 feet. Generally, they will be spaced such that the downstream toe of a given dam will be at approximately the same elevation as the maximum potential elevation of sediments deposited behind the next dam downstream. The level to which sediments can be deposited above a dam is dependant upon the

The function of these porous dams will be to reduce velocity of runoff in the outfall, causing deposition of sediments behind and within the fiber dams. Water will pass through the dams, as well as over the spillways; the porous nature of the dams will not block flow or set up conditions whereby forces against the dams are excessive. Allowing water to pass through the dams also reduces the chance of erosion around the edges of the dams, causing failure. Over time, sediments will eventually clog the dams. This, in combination with deposition behind the dams, will in effect, build back up the gully floor to some reasonable elevation. The retention of the fine sediments will, in turn, allow greater moisture retention and these areas will have a greater opportunity for plant colonization. The result will be a series of steps down the outfall, with the flat sections vegetated and the steep sections stabilized.

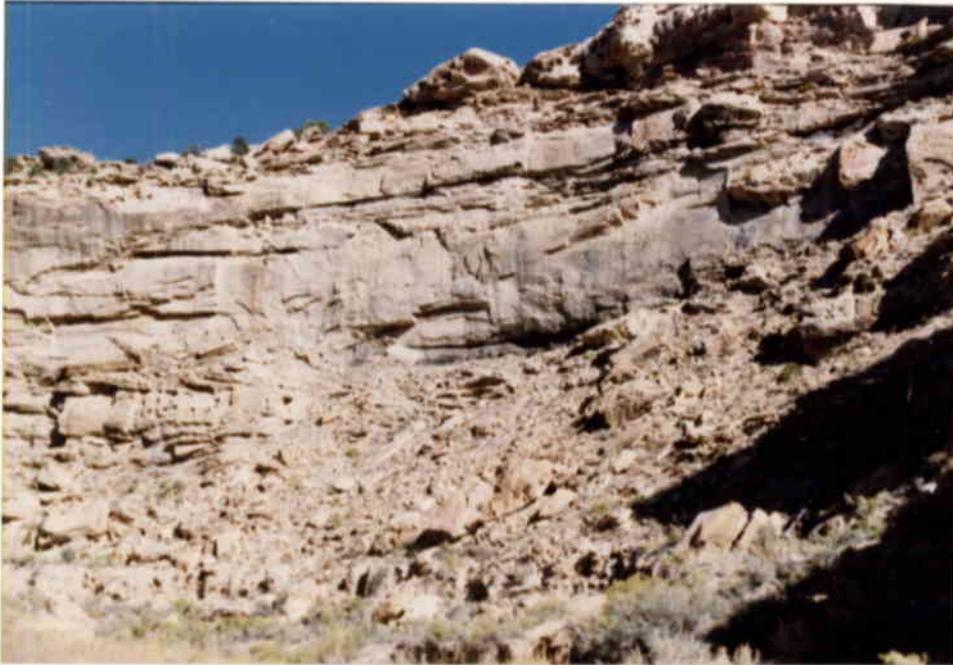
Photo No. 1 Reference area 10-13-92 - This area is immediately northwest of the reclaimed area. It has the same aspect, elevation etc. as the reclaimed area.

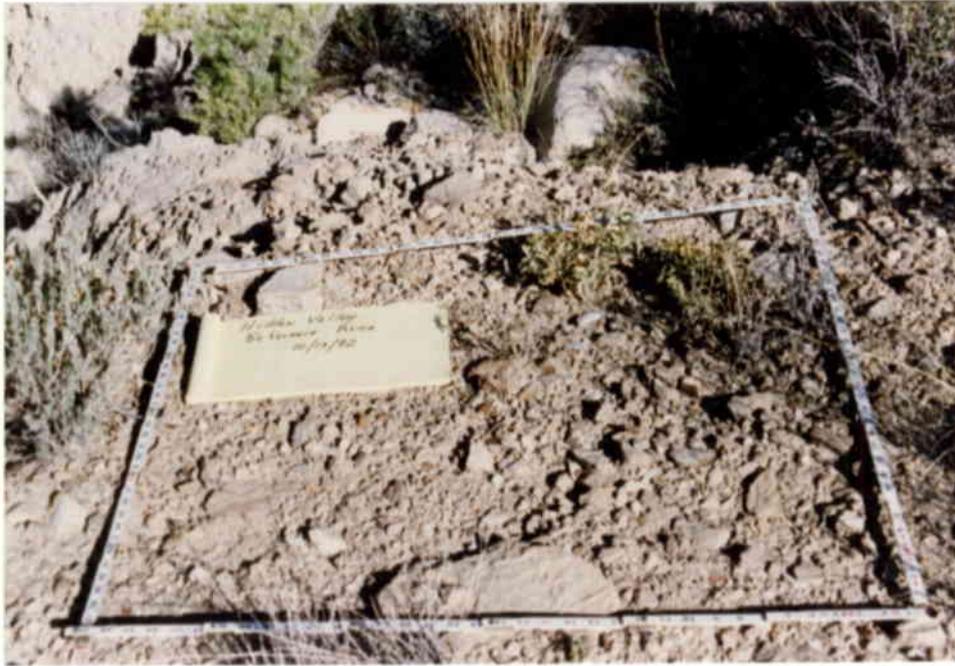
**Photo No.2** Typical desert ground cover conditions on the reference area - Very sparse vegetation - The rest is rock, pavement and bare ground.

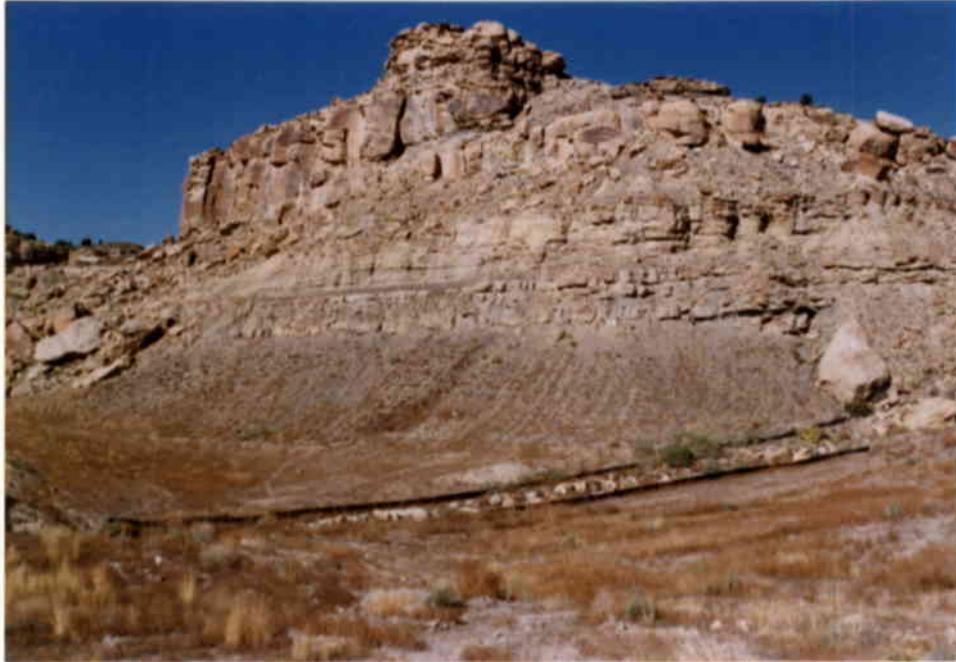
**Photo No. 3** View of part of the reclaimed area - on 10-13-92 of the Hidden Valley mine - The mine entrance has been obliterated, the channel has been stabilized and permanent vegetation established on the reclaimed.

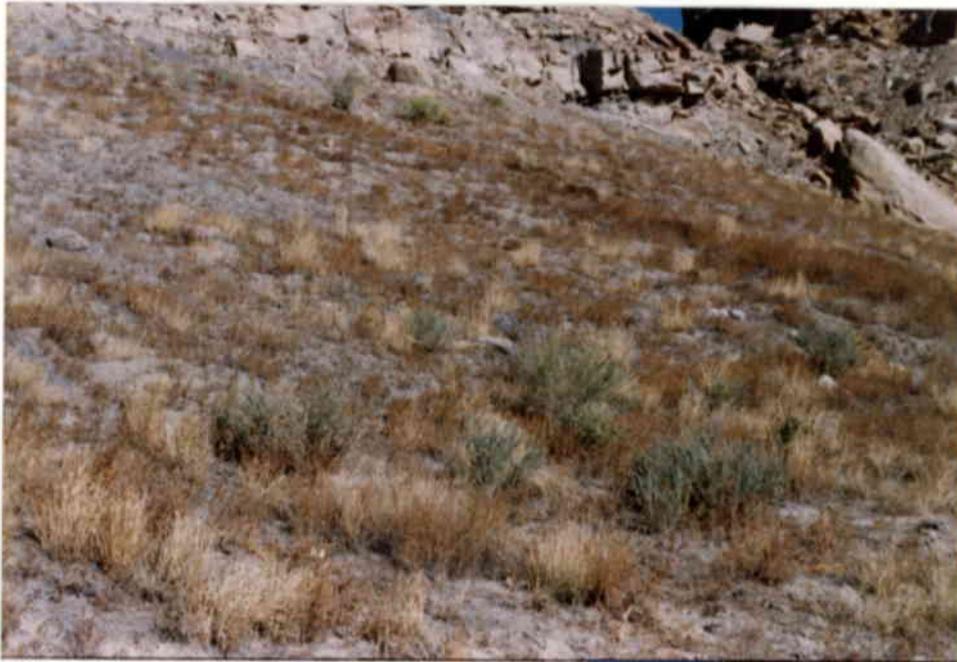
**Photo No.4** Closeup of revegetation on the reclaimed area on 10-13-92 - In spite of the drought, permanent vegetation has been established over the area. Crested wheatgrass, Russian wildrye, four-wing saltbush and shadscale are now established over the reclaimed area.

Permanent vegetation consisting of crested wheatgrass, Russian wildrye, four-wing saltbush and shadscale are now established over the reclaimed area. These plants will now provide a seed source that can fill any niches that still may be available on this very arid area.
