Inspection Report

Permit Number:	C0150007
Inspection Type:	COMPLETE
Inspection Date:	Thursday, March 31, 2005
Start Date/Time:	3/31/2005 10:30:00 AM
End Date/Time:	3/31/2005 2:30:00 PM
Last Inspection:	Monday, February 28, 2005

Permittee: **CONSOLIDATION COAL CO**
 Operator: **CONSOLIDATION COAL CO MID-CONTINENT REGION**
 Site: **HIDDEN VALLEY MINE**
 Address: **PO BOX 566, SESSER IL 62884**
 County: **EMERY**
 Permit Type: **PERMANENT COAL PROGRAM**
 Permit Status: **RECLAIMED**

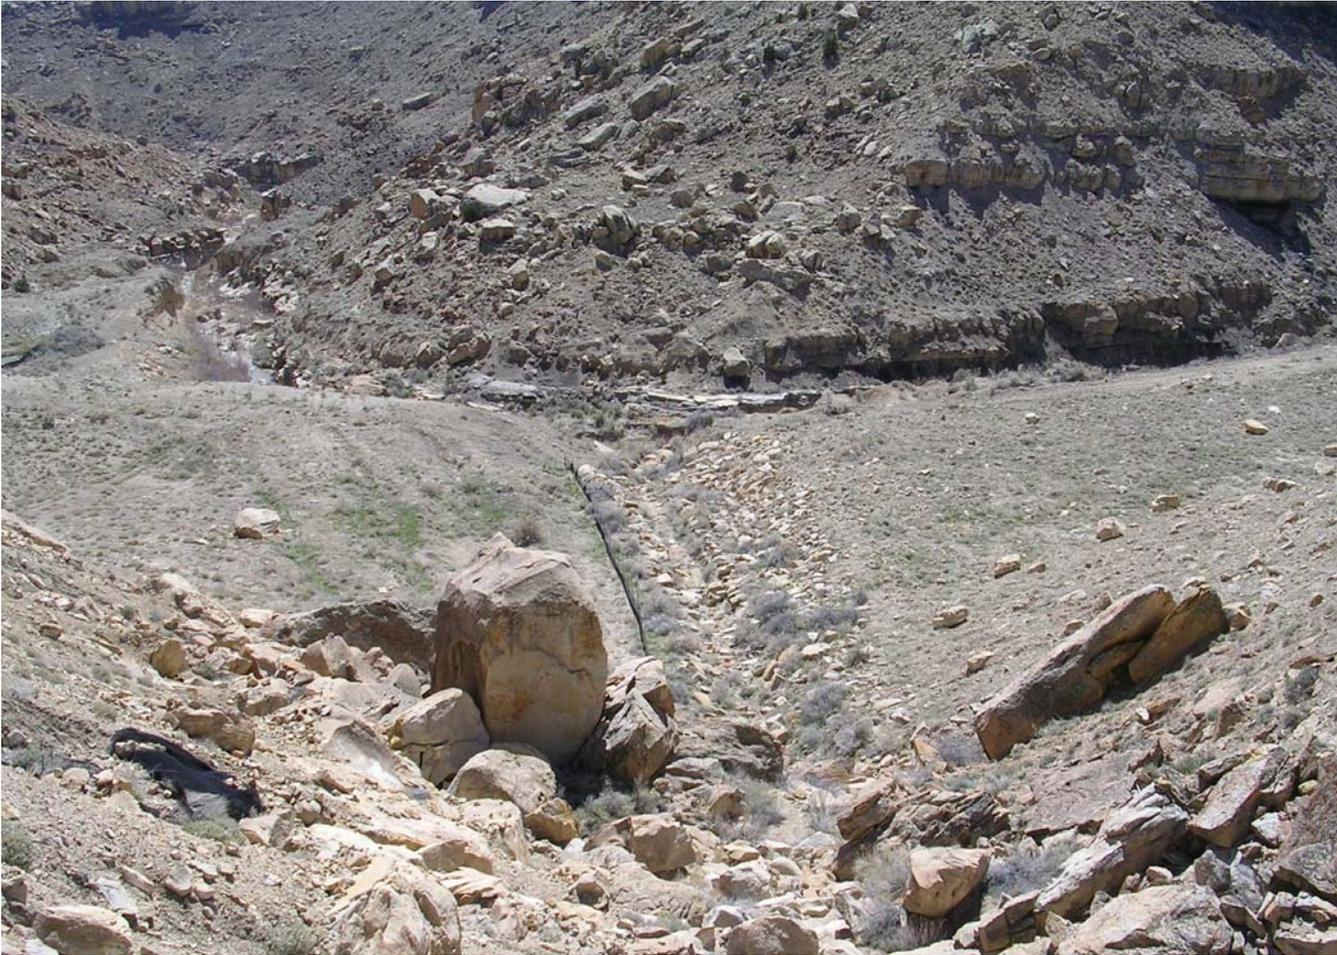
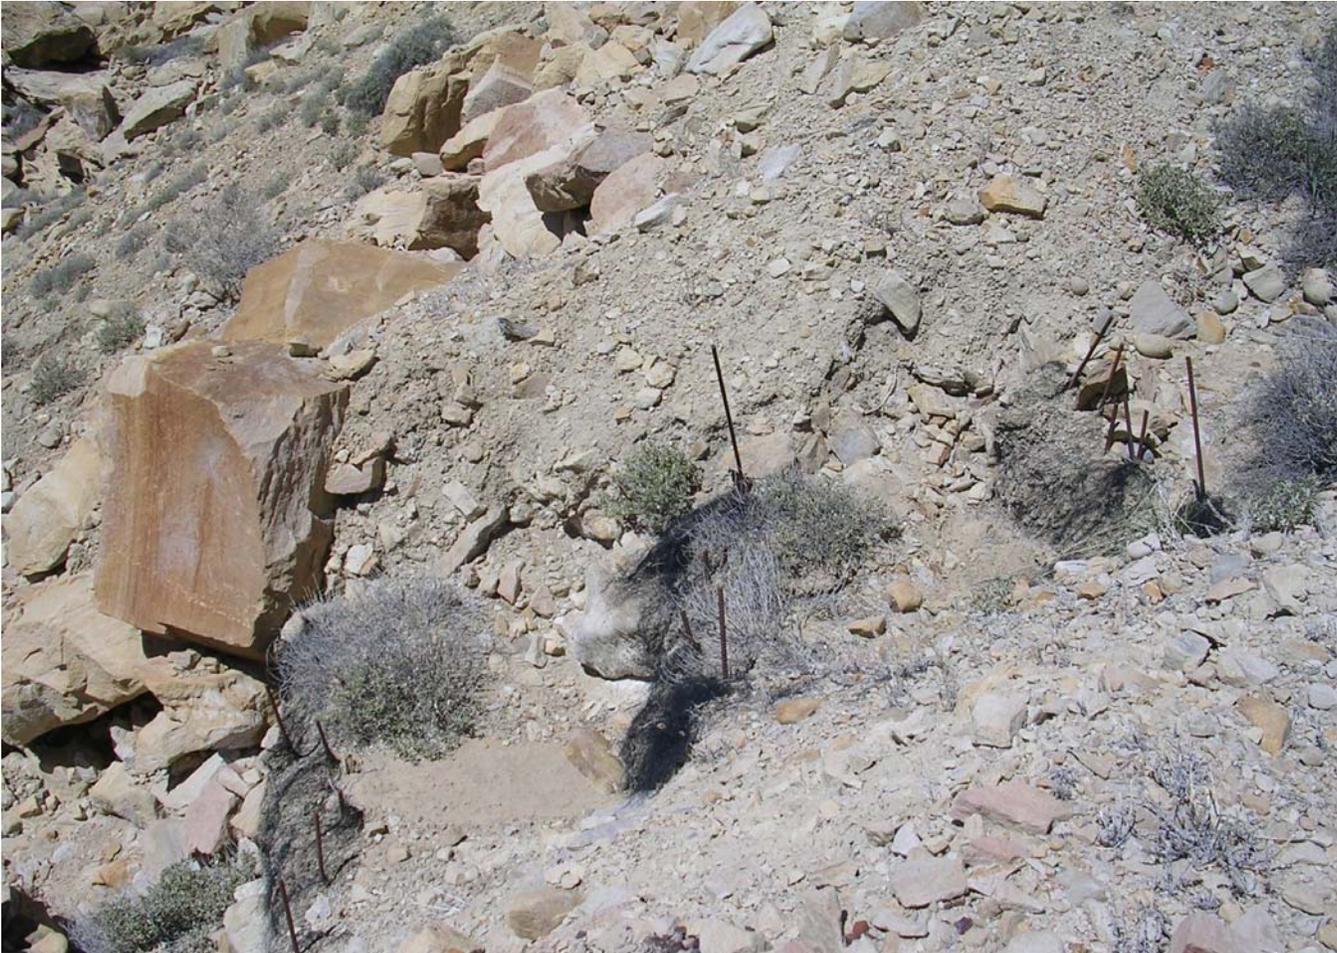
Discussed likely scenario for regrading the A seam side and replacing silt fences with pocking and rock. Photo taken to illustrate the different approaches taken on the A and B seam side. I.e. A side has silt fence which requires maintenance. B side uses rock and pocking to control sediment. No maintenance required after 8 years.

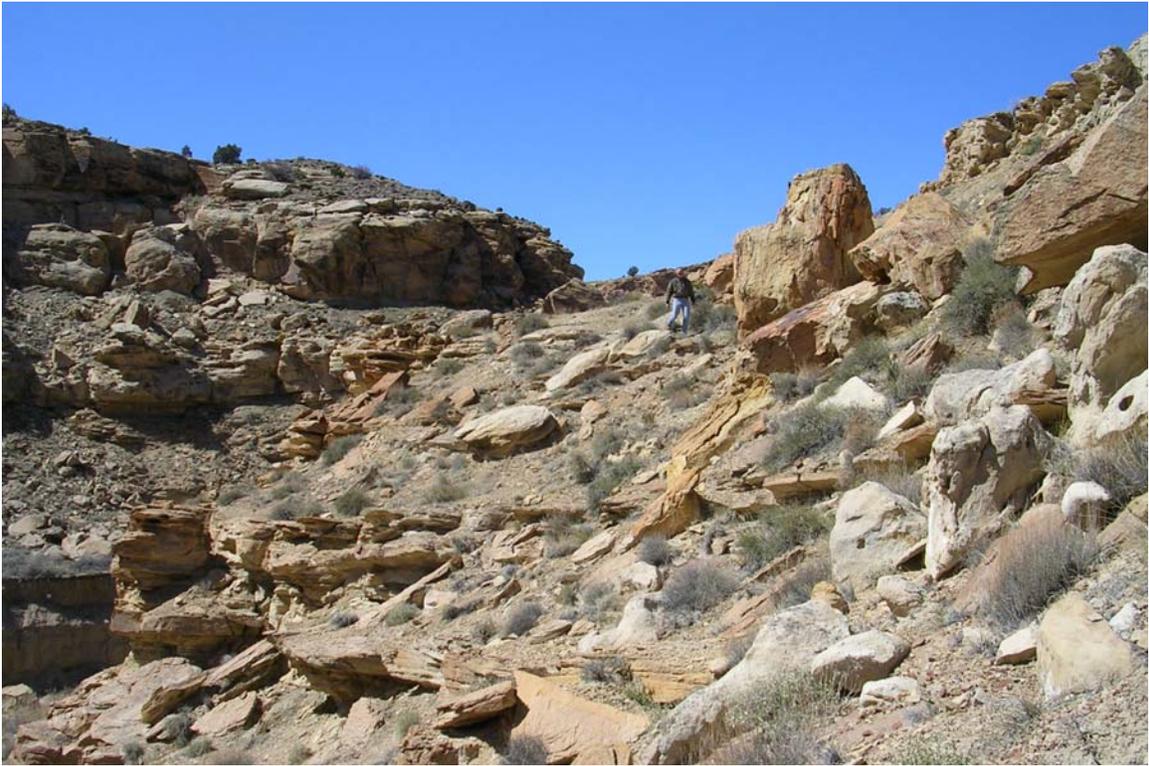
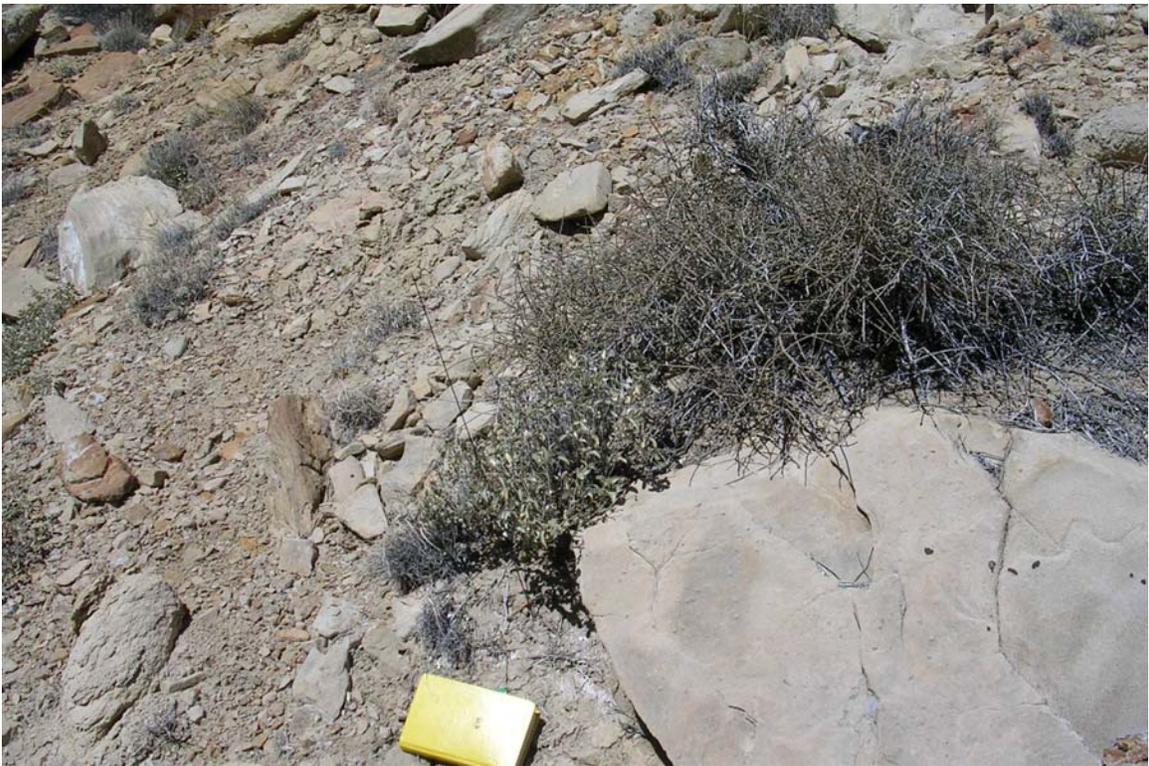
B seam regraded and seeded in Nov/Dec 1998. Atriplex species (saltbush) is dominant on B seam side. Cheat grass (*Bromus tectorum*) was noted to be a major weed pest at the site, both A and B seam sides. The location of the vegetation reference area was pointed out by Mr. Behling, see attached photos. The corner stakes should be made more visible (I.e. with flagging or paint).
