Inspection Report

Permit Number:	C0150007
Inspection Type:	PARTIAL
Inspection Date:	Tuesday, September 1, 2020
Start Date/Time:	9/1/2020 1:30:00 PM
End Date/Time:	9/1/2020 3:30:00 PM
Last Inspection:	Tuesday, August 11, 2020

Permittee: **BRONCO UTAH OPERATIONS, LLC**
 Operator: **BRONCO UTAH OPERATIONS, LLC**
 Site: **HIDDEN VALLEY MINE**
 Address: **PO BOX 527, EMERY UT 84522**
 County: **EMERY**
 Permit Type: **PERMANENT COAL PROGRAM**
 Permit Status: **ACTIVE**

ATTACHMENT A – Photos Hidden Valley September 1, 2020 site visit

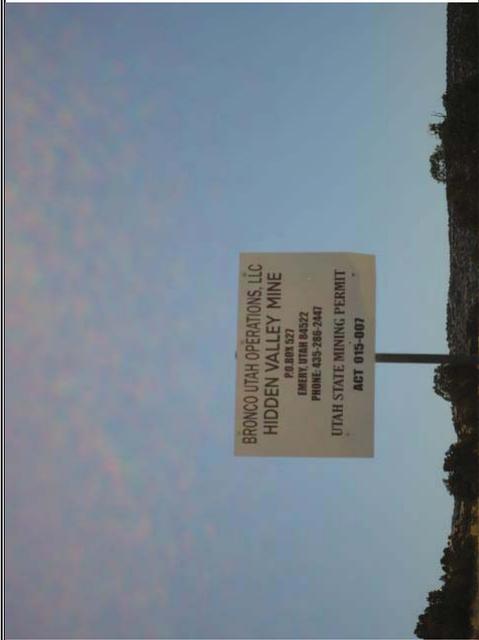
This sign is posted at the end of the Sevier County road and the beginning of the entrance point into the Hidden Valley mine site. The sign posts the name, address, phone number and mining permit number from the Utah Coal Program. This items are required by law to be posted for public information. The sign was inspected and found to be in compliance.

<p>PHOTO 1</p> <p>Hidden Valley Mine Identification Sign</p>	<p>PHOTO 2</p> <p>Hidden Valley Mine Straw Wattle</p>

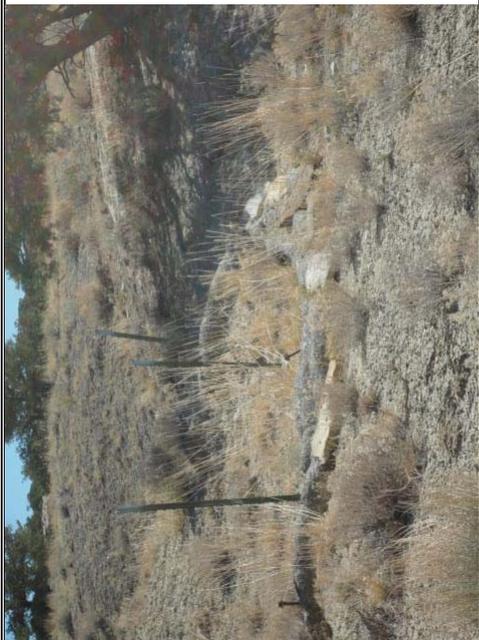
There is a straw wattle structure near the mine identification sign. This structure is in good repair.

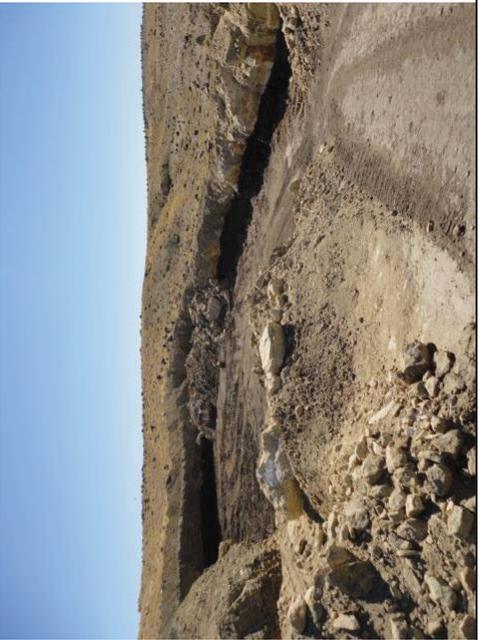
Pictures were taken of the Miracle Rock mining area. This area is not coal mining related. The mining in this area are associated with the minerals program. At the inception of their mining activity they were in the Hidden Valley permit area. Since that time their mining area has been carved out of the Hidden Valley permit area.

<p>PHOTO 3</p> <p>Miracle Rock Mining Pit</p>	<p>PHOTO 4</p> <p>Miracle Rock Overview</p>
